DATE: April 15, 2025

TO: Emily Brickman, P.G., *Senior Project Manager – Geologist, EnSafe*

FROM: Caleb Gourley, Senior Staff Scientist, *Harbor*

RE: Bi-weekly Site Inspection
NABORS Landfill
Mountain Home, AR
Harbor Project No: ENSF-23299

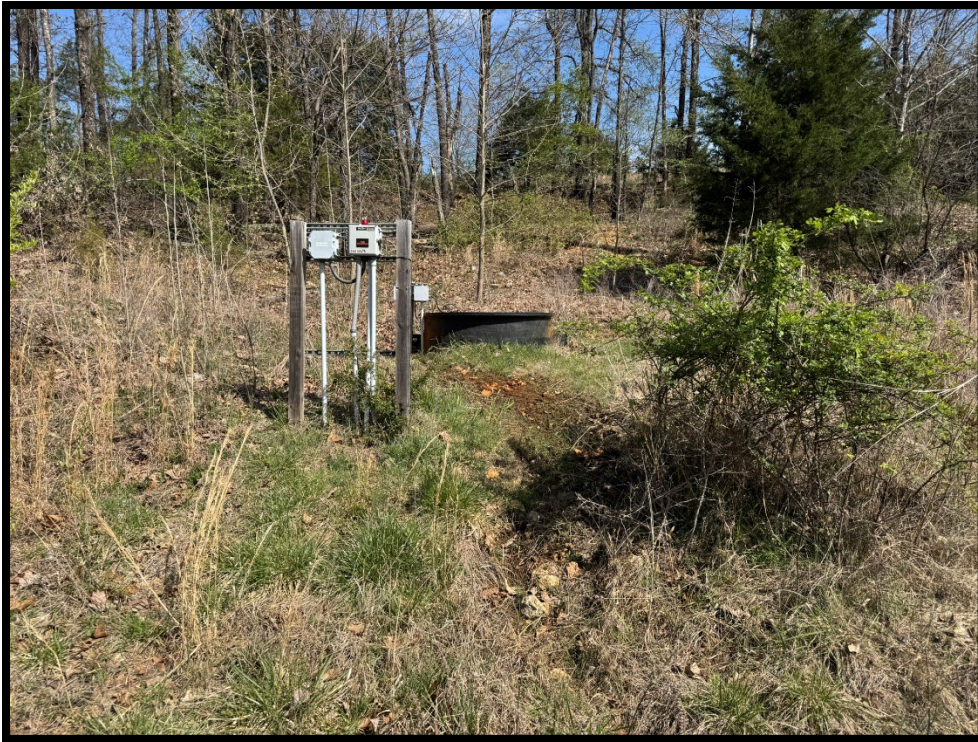
- Vertical leachate collection sump (VLCS)-1 is not functioning correctly and was observed at capacity and overflowing (see photographs 1-2).
 - VLCS-2 appeared to be functioning correctly and was observed at 1/2 capacity.

Photograph 1: View of erosional rill from VLCS-1 overflow.

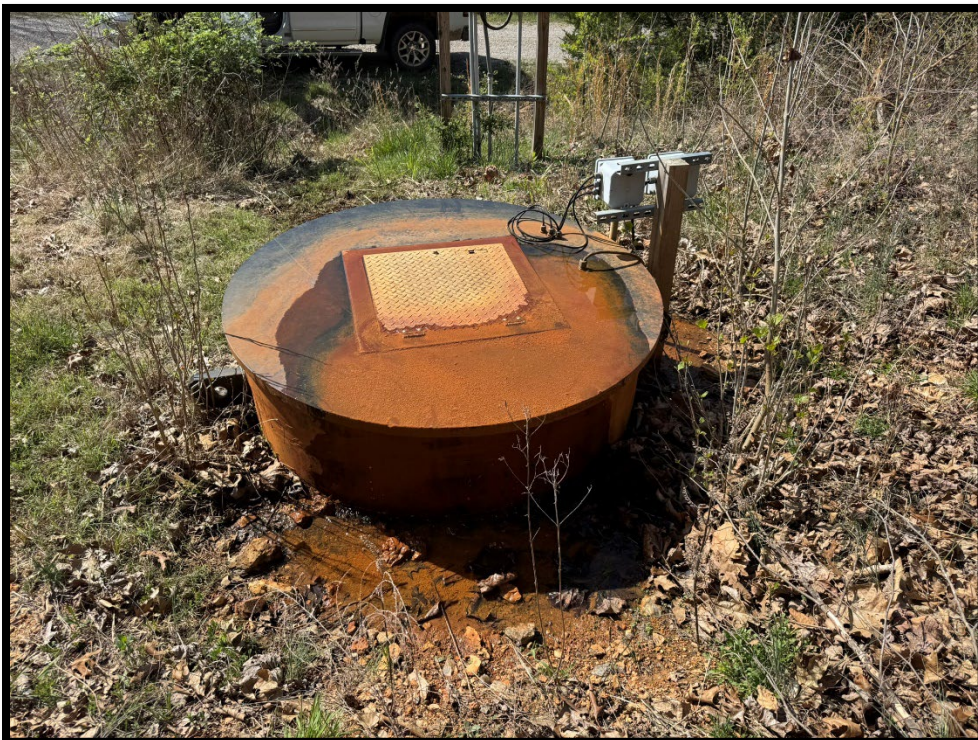
Photograph 2: View of VLCS-1 sump at capacity.

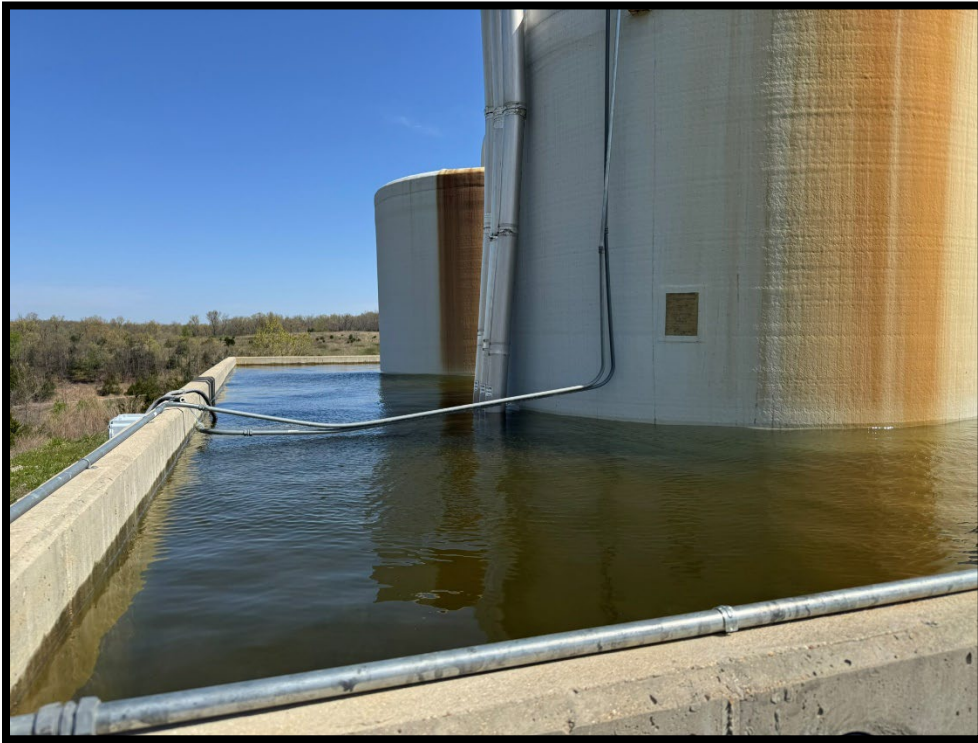
- The NABORS Landfill area received approximately 12.92 inches of precipitation since the last site inspection on February 13, 2025 (based on data published by the Southern Regional Climate Center). As such, the leachate tank battery containment was near full at the time of inspection (see photographs 3-5). The water inside the containment had no odor, good clarity, and the pH was measured at 8.44 standard units. The stormwater was released from the containment.

- Staining was later observed on the side of several of the leachate storage tanks inside the secondary containment. Based on this, it appears that leachate likely overflowed through the top vent system into the secondary containment (see photographs 3-5).

Photograph 3: View of leachate tank containment near capacity and staining on sides of tanks.

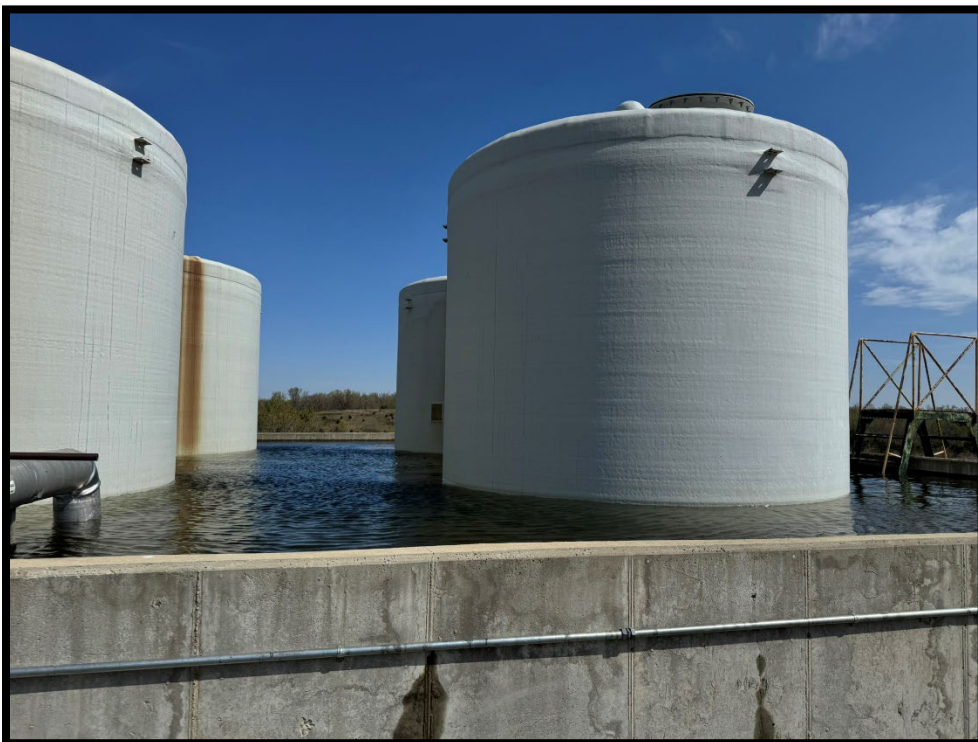
Photograph 4: View of leachate tank containment near capacity.

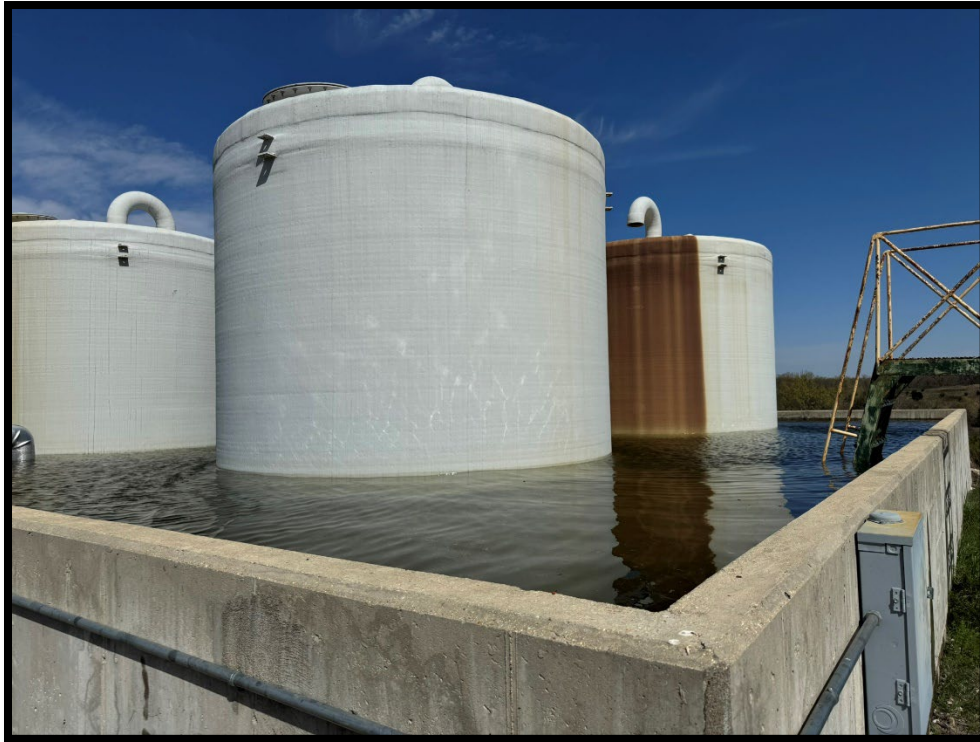
Photograph 5: View of leachate tank containment near capacity and staining on side of tank.

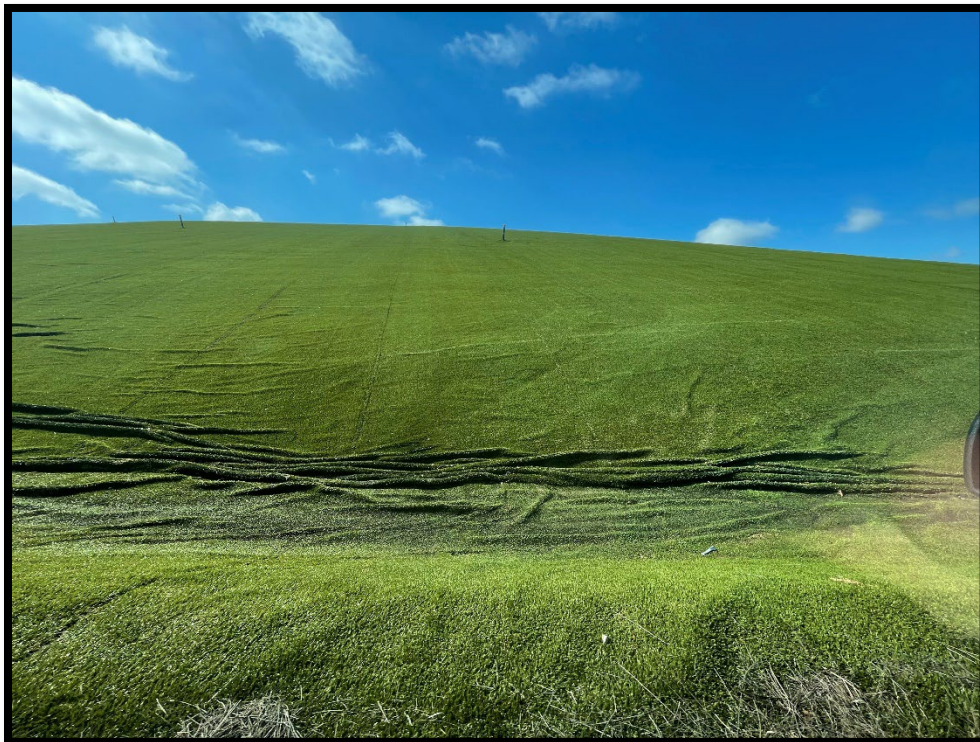
- The closure turf has some significant rills present near LCS-1 and LCS-2 (see photograph 6). These rills have sediment deposited in them which allows vegetation to grow. An erosional washout is present along the road between LCS-4 and LCS-5.

Photograph 6: View of rills in closure turf on the north side of Area 1-2.

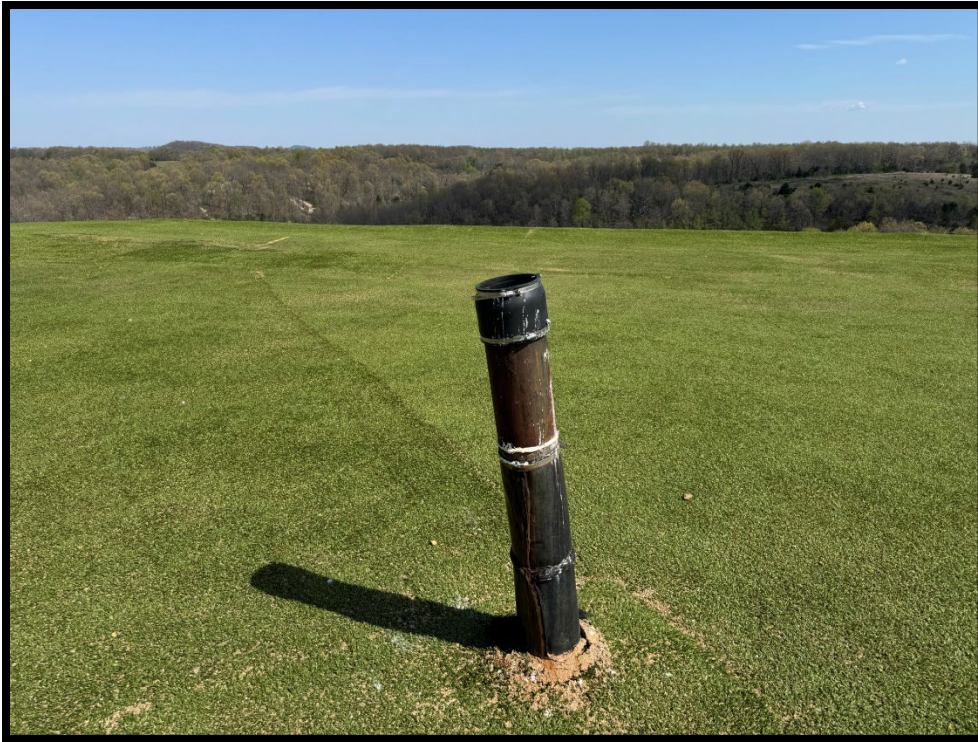
- A turbine vent atop of Area 1-2 has become detached near coordinates 36.46114, -92.45014 (see photograph 7).
- Damaged closure turf was observed around a pressure relief vent on the north side of Area 1-2 (see photograph 8).

Photograph 7: View of detached turbine vent on north side of Area 1-2.

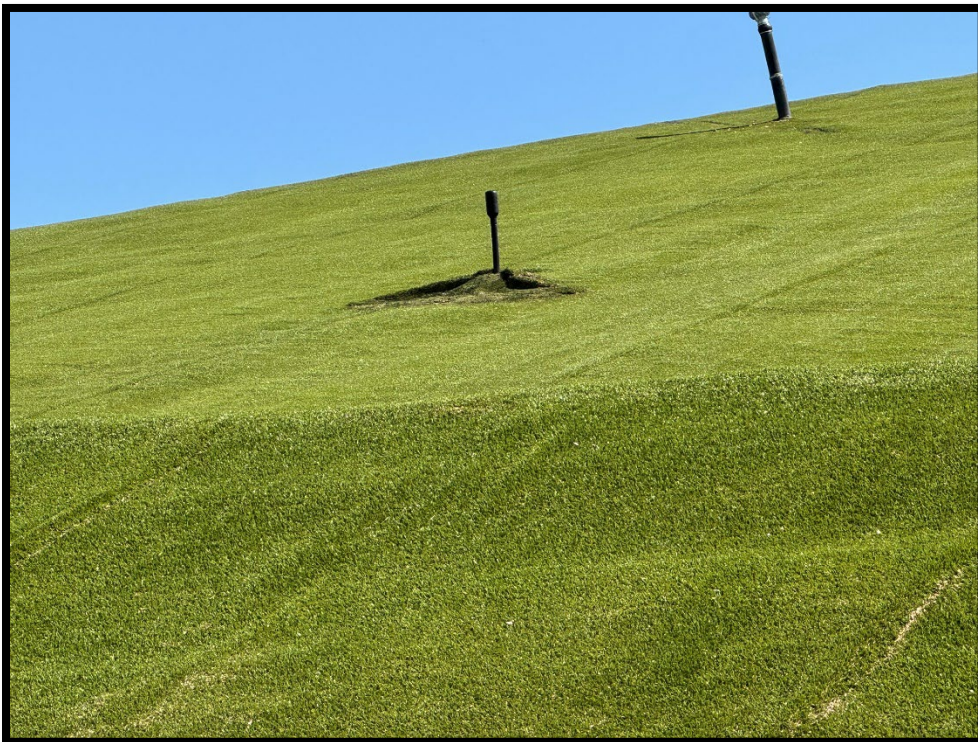
Photograph 8: View of damaged turf around PRV on north side of Area 1-2.

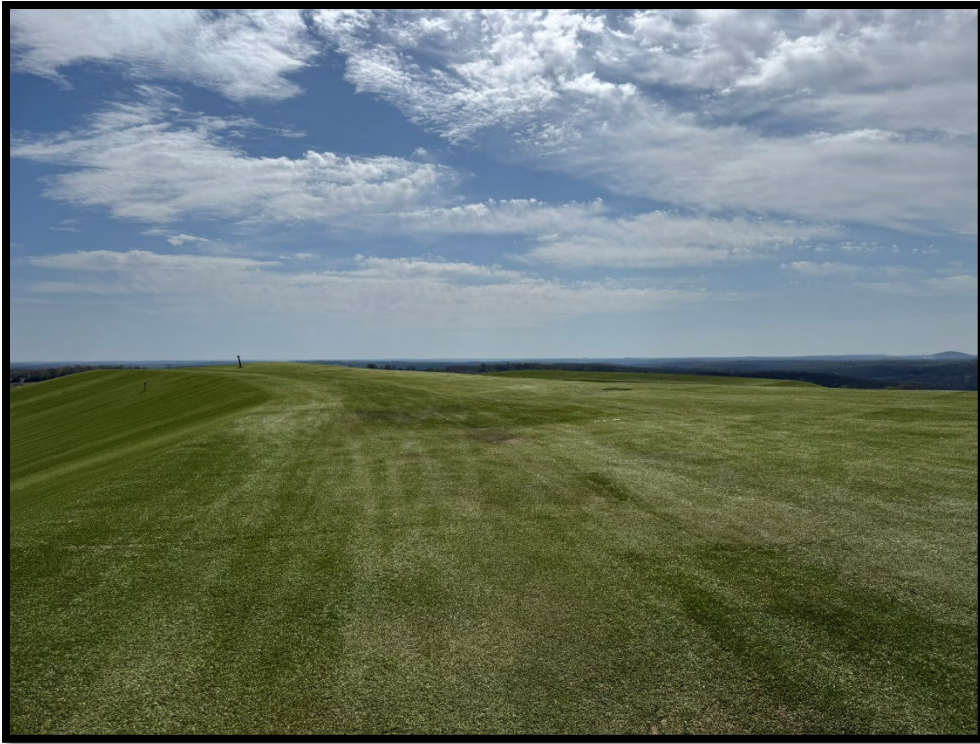
- No damage to the closure turf was observed on top of the landfill cells (see photographs 9-12).

Photograph 9: View across the top of Area 1-2.

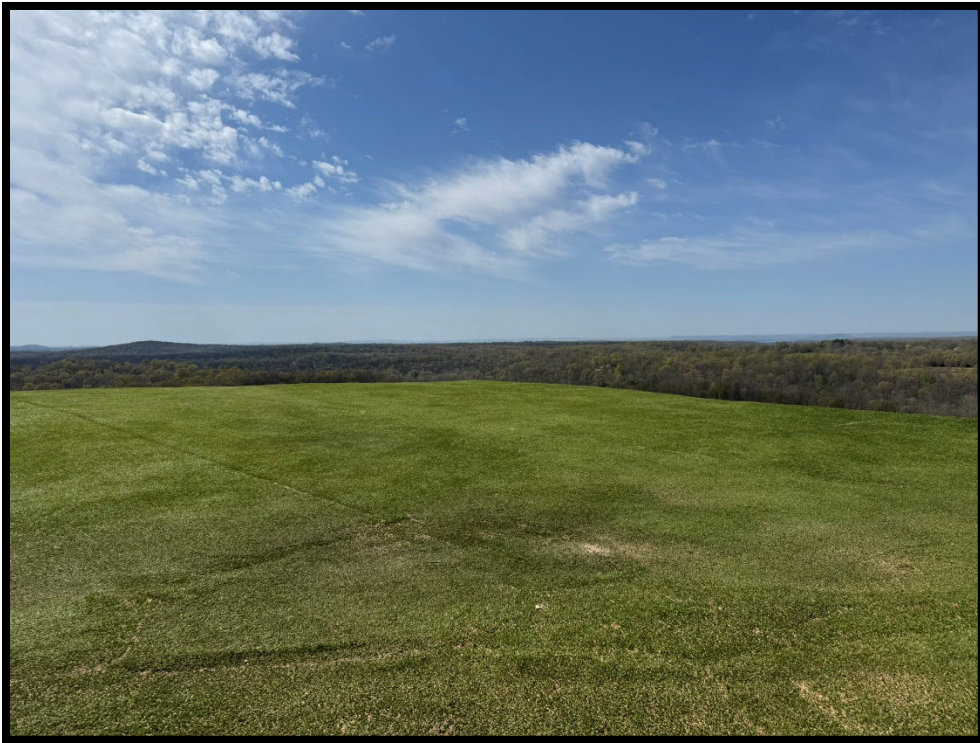
Photograph 10: View across the top of Area 1-2.

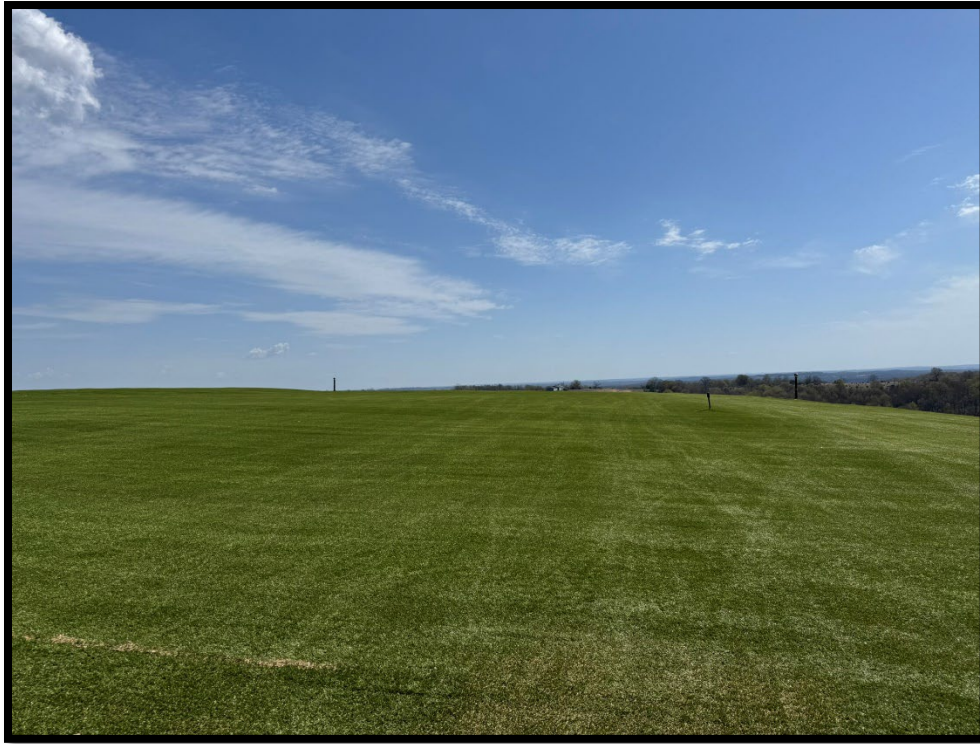
Photograph 11: View across the top of Area 1-3.

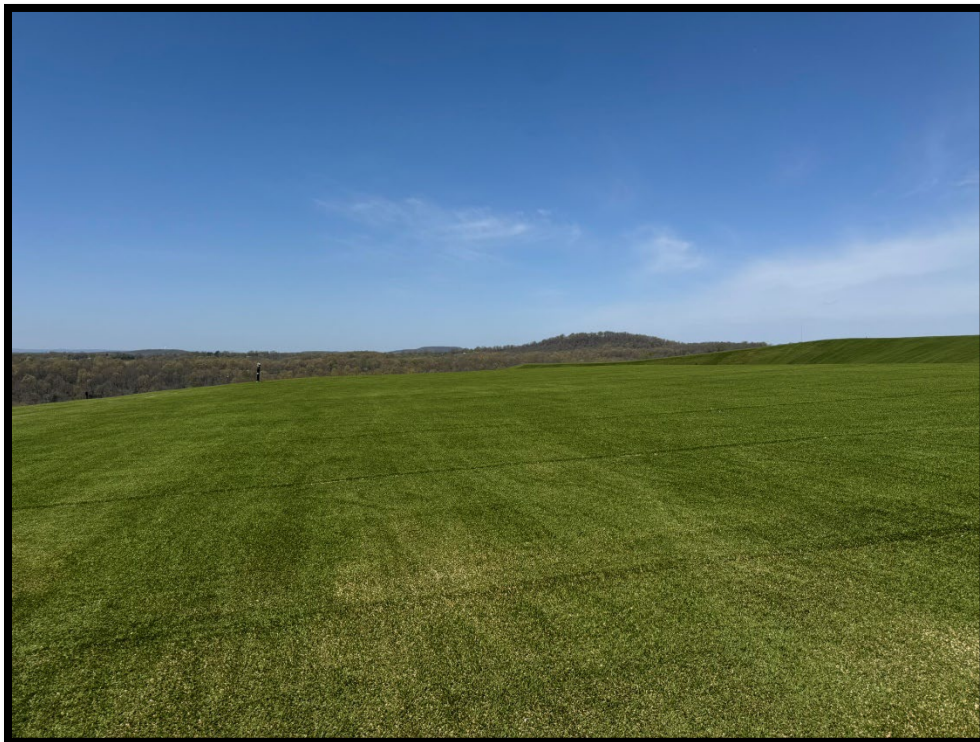
Photograph 12: View across the top of Area 1-3.
