DATE: April 24, 2025

TO: Emily Brickman, P.G., *Senior Project Manager – Geologist, EnSafe*

FROM: Ian Klein, *Staff Engineer, Harbor*

RE: Bi-weekly Site Inspection
NABORS Landfill
Mountain Home, AR
Harbor Project No: L8247885

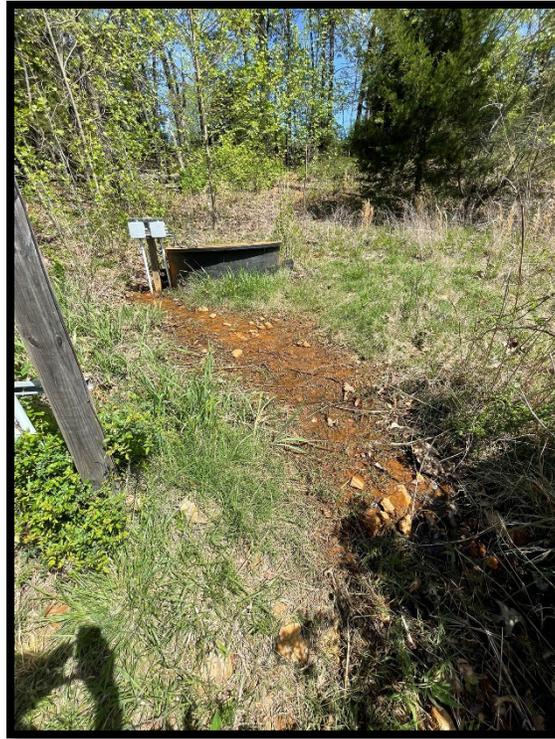
- Vertical leachate collection sump (VLCS)-1 is not functioning correctly and was observed at capacity and overflowing (see photographs 1-2).
 - VLCS-2 appeared to be functioning correctly and was observed at 1/2 capacity.
 - The leachate tank battery level was at 131.9 inches.
 - There was no stormwater in the leachate tank containment.
 - The panel displays were off at all LCS stations except LCS-2, and LCS-5.
 - LCS-2 level was at 0.0 inches and did not activate when the sump was placed in "hand" or "auto" mode. LCS-2 also displayed a pump fault alarm.
 - LCS-5 level remained at 9.7 inches and did not activate when the sump was placed in "hand" or "auto" mode.
 - The display at LCS-9 had been removed.
-

Photograph 1: View of erosional rill from VLCS-1 overflow.

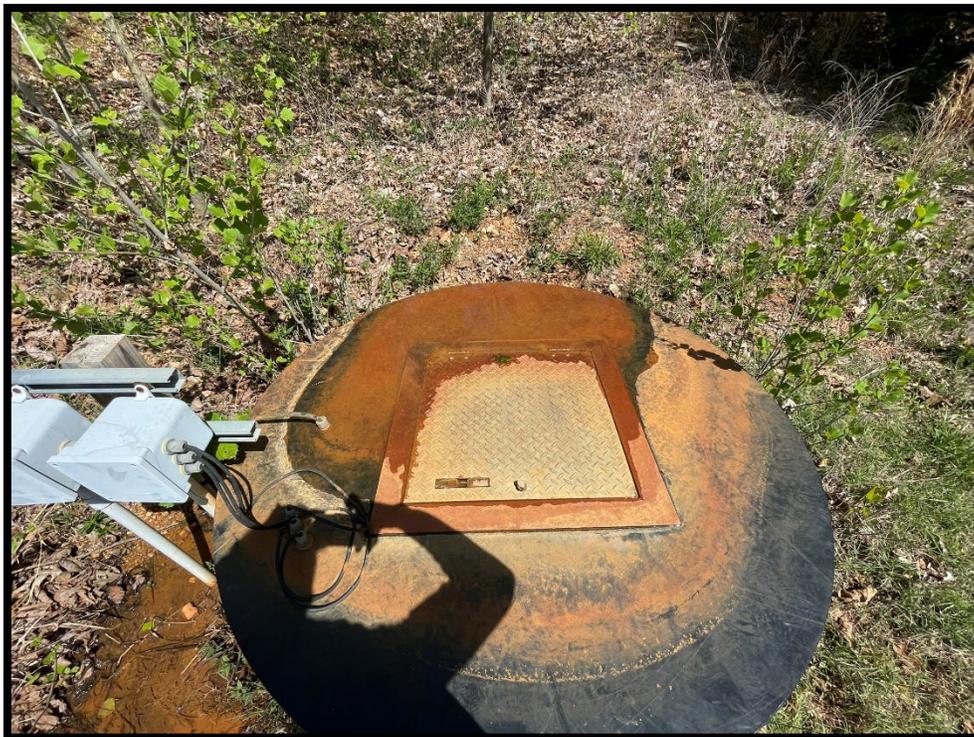
Photograph 2: View of VLCS-1 sump at capacity.

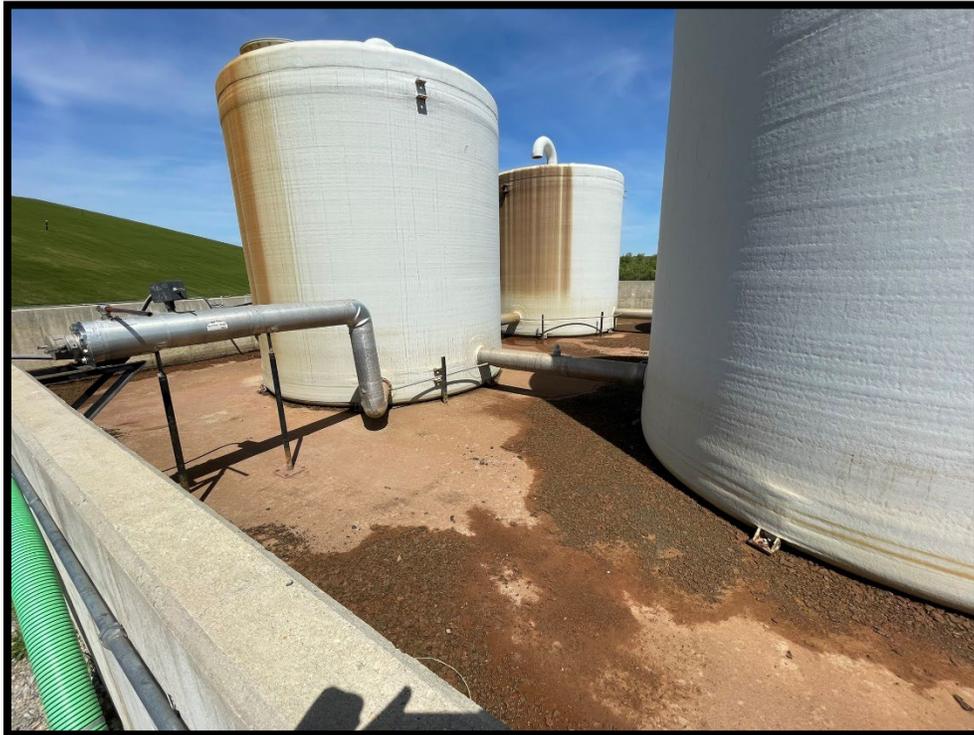
Photograph 3: View of leachate tank containment.

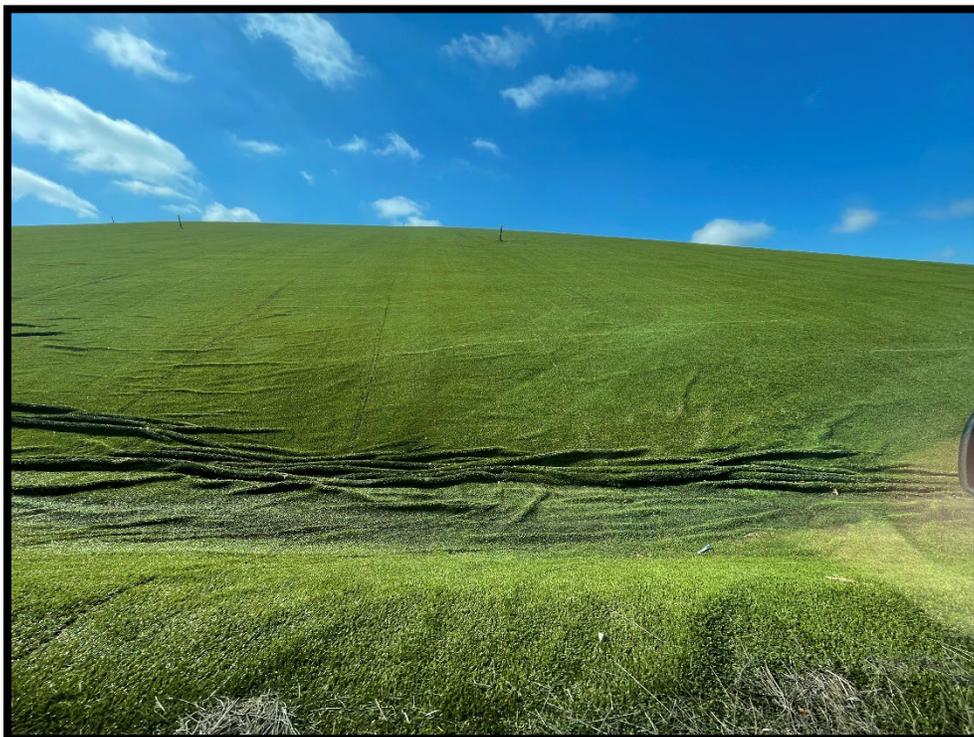
- The closure turf has some significant rills present near LCS-1 and LCS-2 (see photograph 4). These rills have sediment deposited in them which is allowing vegetation to grow. An erosional washout is present along the road between LCS-4 and LCS-5.
- A turbine vent on top of Area 1-2 has become detached near coordinates 36.46114, -92.45014 (see photograph 5).
- Damaged closure turf was observed around a pressure relief vent on the north side of Area 1-2 (see photograph 6).

Photograph 4: View of rills in closure turf on the north side of Area 1-2.

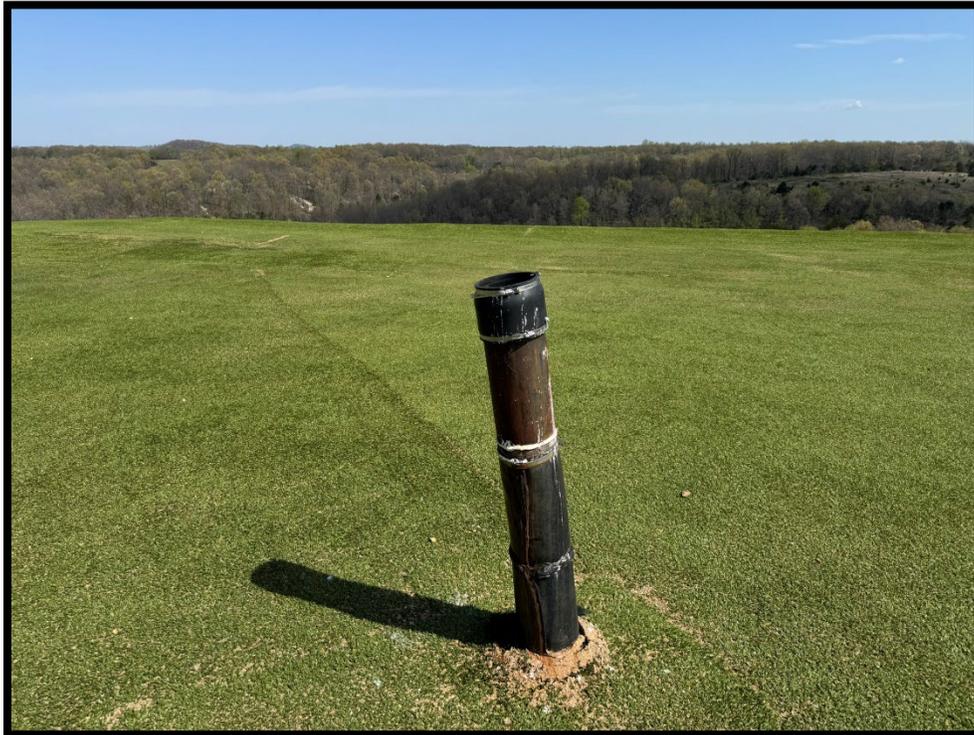
Photograph 5: View of detached turbine vent on north side of Area 1-2.

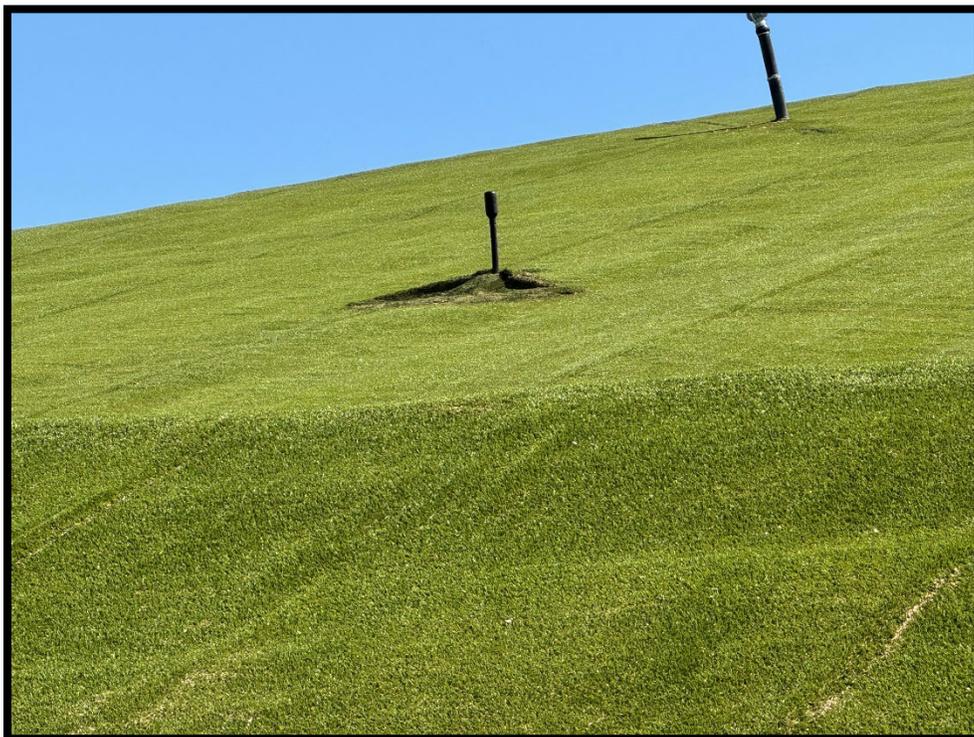
Photograph 6: View of damaged turf around PRV on north side of Area 1-2.
