TECHNICAL MEMORANDUM

RE: Bi-weekly Site Inspection

NABORS Landfill Mountain Home, AR

Harbor Project No: L8247885

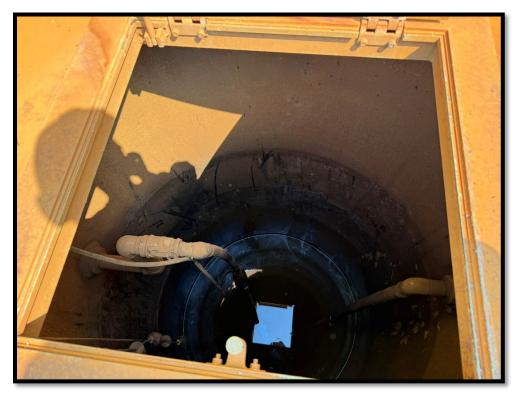
- Vertical leachate collection sump (VLCS)-1 was not overflowing and observed at $\frac{1}{2}$ capacity (see photograph 1).
- VLCS-2 appeared to be functioning correctly and was observed at ¼ capacity.
- The leachate tank battery level was -22.4 inches. As noted in previous inspections, it appears that the leachate tank level indicator is not functioning correctly (see photograph 2).
- No stormwater was observed in the tank containment. As such, none was released while Harbor was on-site (see photograph 3).

Photograph 1: View of VLCS-1 sump level.

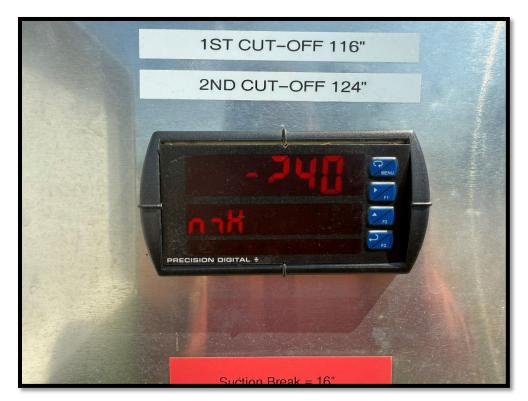
Photograph 2: View leachate tank level indicator.

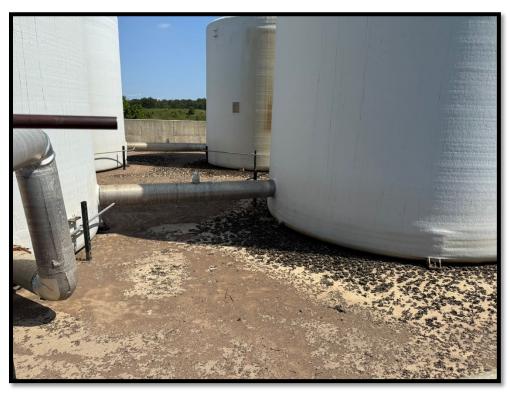
Photograph 3: View of no stormwater in containment.

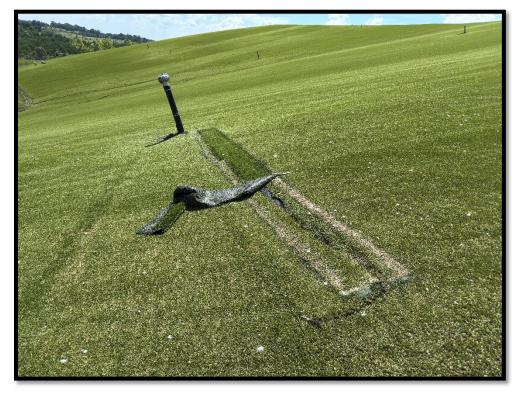
- Damaged closure turf was observed on the north side of Area 1-2 at coordinates 36.46181, -92.45045 (see photograph 4).
- Damaged closure turf was observed on the east side of Area 1-3, above LCS-7 (see photograph 5).

Photograph 4: View of damaged closure turf on the north side of Area 1-2.

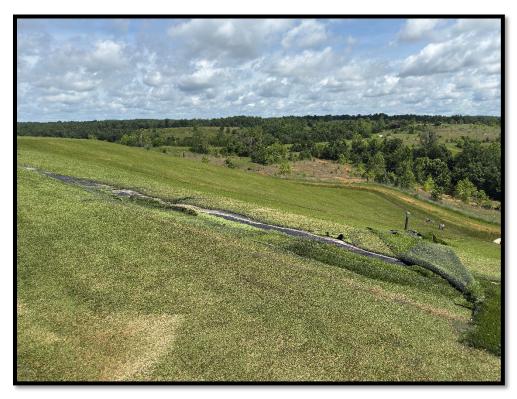
Photograph 5: View of damaged closure turf on east side of Area 1-3.
