DATE: September 9, 2025

FROM: Ian Klein, Staff Engineer, Harbor

RE: Bi-weekly Site Inspection
NABORS Landfill
Mountain Home, AR
Harbor Project No: L8247885

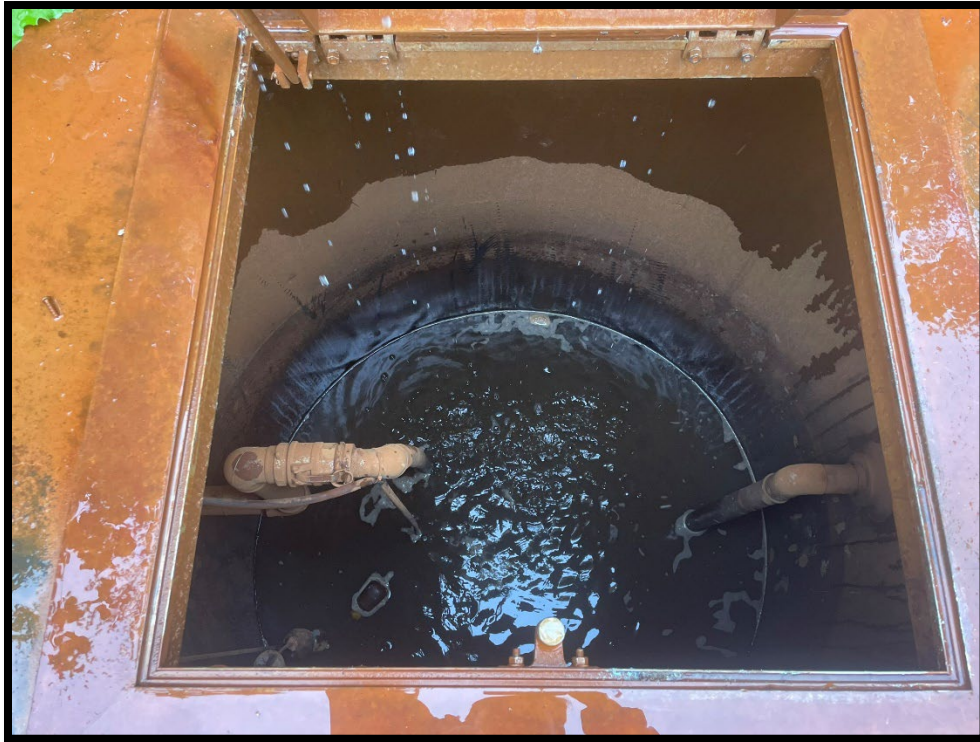
- Vertical leachate collection sump (VLCS)-1 was not overflowing and observed at 3/4 capacity (see photograph 1).
 - VLCS-2 appeared to be functioning correctly and was observed at 3/4 capacity.
 - The leachate tank battery level was -23.7 inches. As noted in previous inspections, it appears that the leachate tank level indicator is not functioning correctly (see photograph 2).
 - No stormwater was observed in the tank containment. As such, none was released while Harbor was on-site (see photograph 3).
-

Photograph 1: View at VLCS-1 sump level.

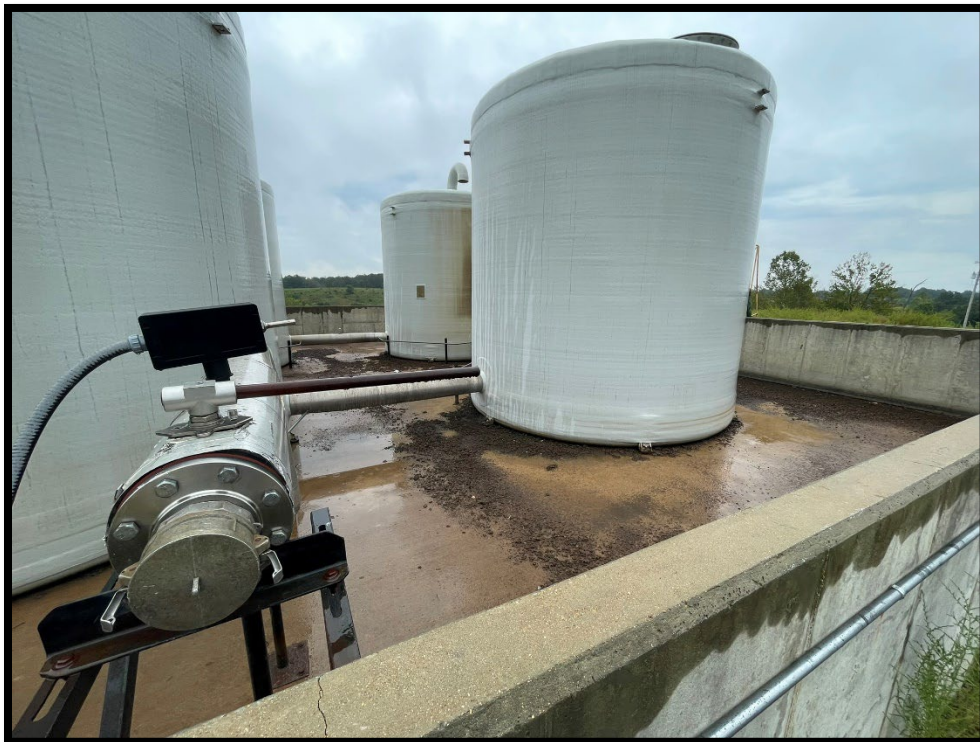
Photograph 2: View of no stormwater in containment.

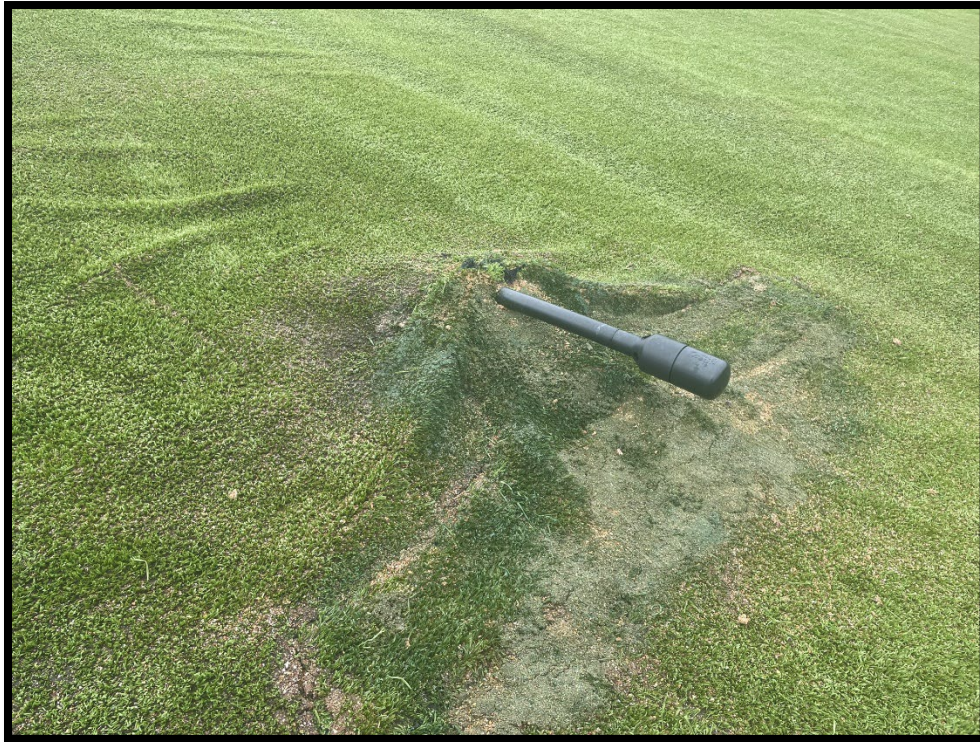
- A damaged pressure relief vent was observed on the west side of Area 1-2, between LCS-1 and LCS-2 (see photograph 3).
- Damaged closure turf was observed on the north side of Area 1-2 at coordinates 36.46181, -92.45045 (see photograph 4).

Photograph 3: View of damaged pressure relief vent on west side of Area 1-2.

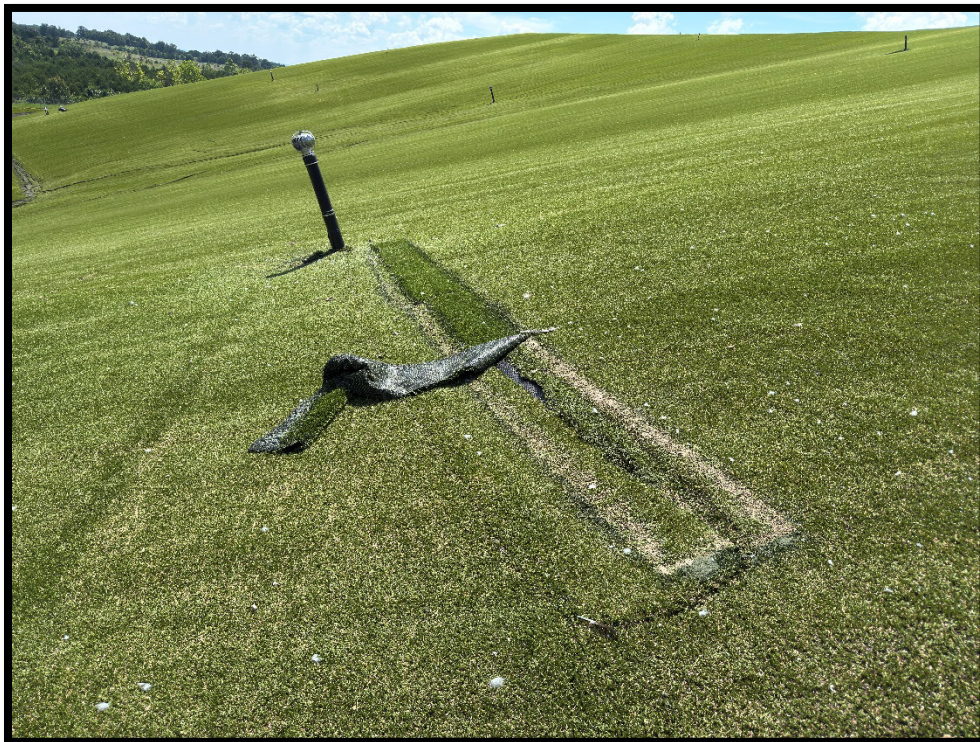
Photograph 4: View of damaged closure turf on the north side of Area 1-2.

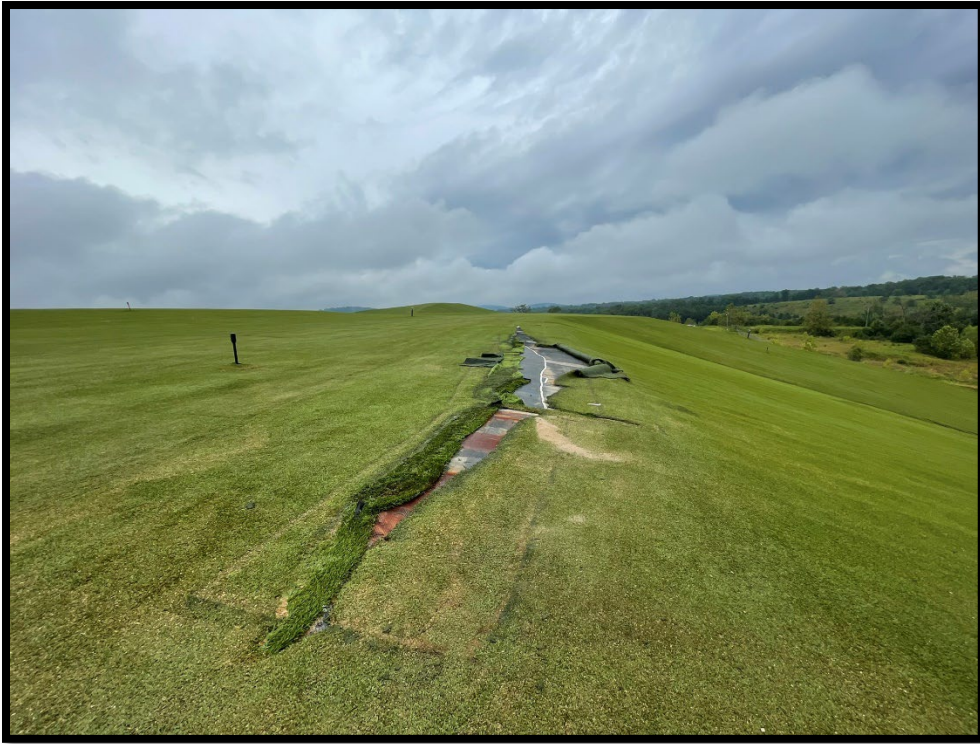
- Damaged closure turf was observed on the east side of Area 1-3, above LCS-7 (see photograph 5).

Photograph 5: View of damaged closure turf on east side of Area 1-3.
