DATE: December 20, 2024

RE: Bi-weekly Site Inspection
NABORS Landfill
Mountain Home, AR
Harbor Project No: ENSF-23299

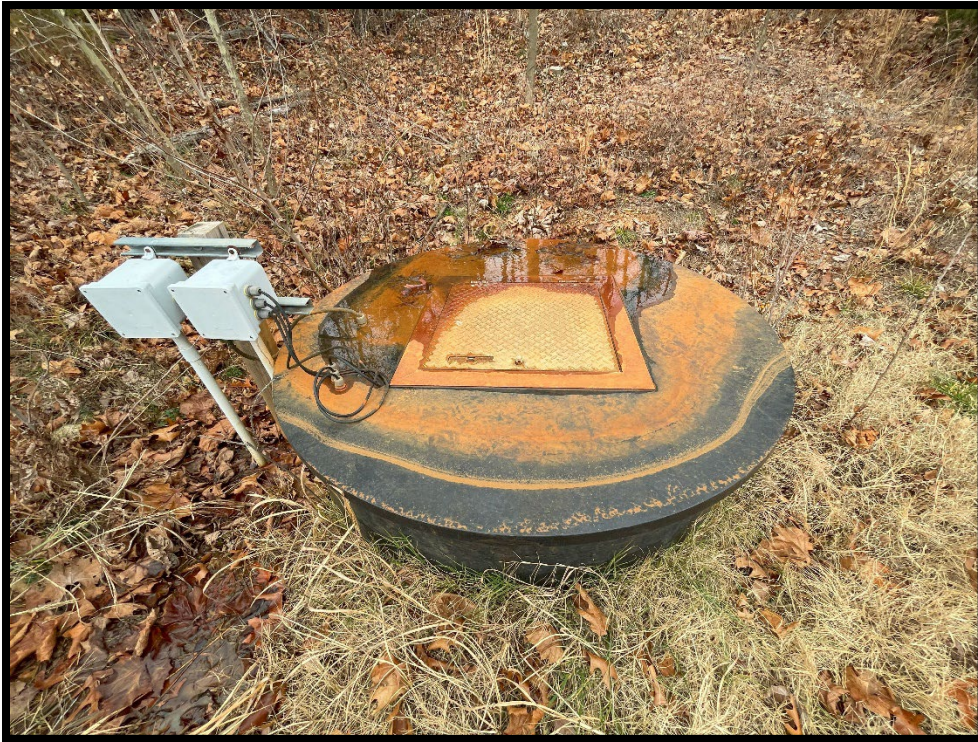
- Vertical leachate collection sump (VLCS)-1 is not functioning correctly and was observed at capacity and overflowing (see photograph 1).
 - VLCS-2 appeared to be functioning correctly, and the sump was at approximately $\frac{3}{4}$ capacity.
 - Approximately three inches of stormwater was observed in the leachate tank battery containment. The stormwater had a pH of 9.45, which exceeded the 9-pH threshold. No water was released (see photograph 2).
 - The panel displays were off at all LCS stations except LCS-55 and LCS-9.
 - LCS-5 displayed a level of 9.7 inches and did not activate when the sump was placed in "hand" or "auto" mode.
-

Photograph 1: View of VLCS-1 at capacity and beginning to overflow.

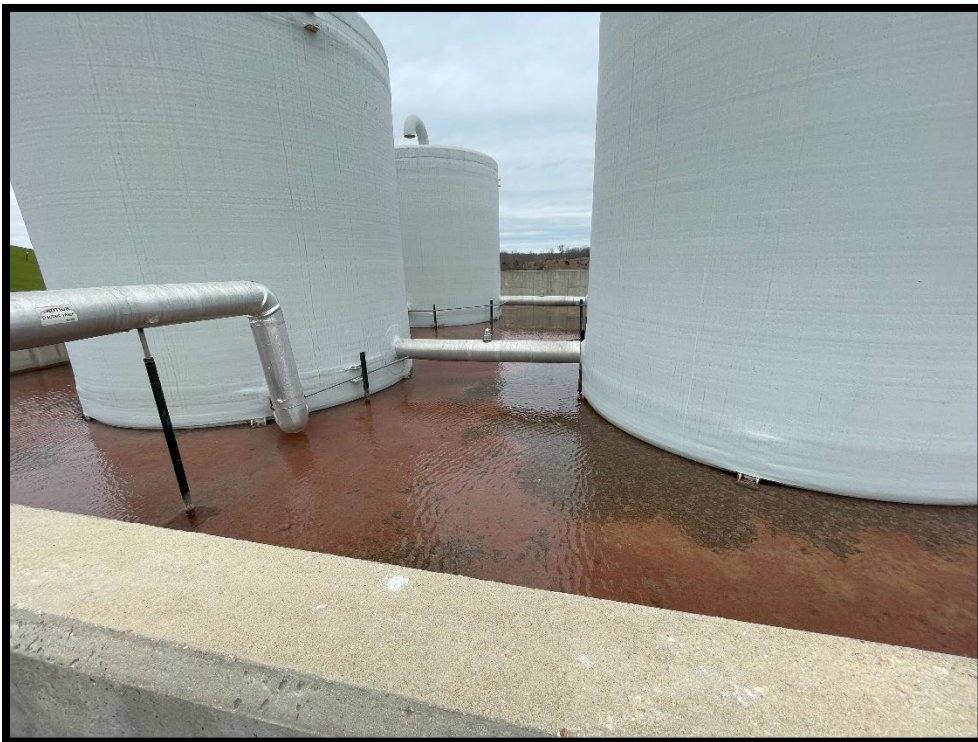
Photograph 2: View of stormwater in leachate tank containment.
