**DATE:** December 17, 2025

**RE:** Bi-weekly Site Inspection  
NABORS Landfill  
Mountain Home, AR  
*Harbor Project No: L8247885*

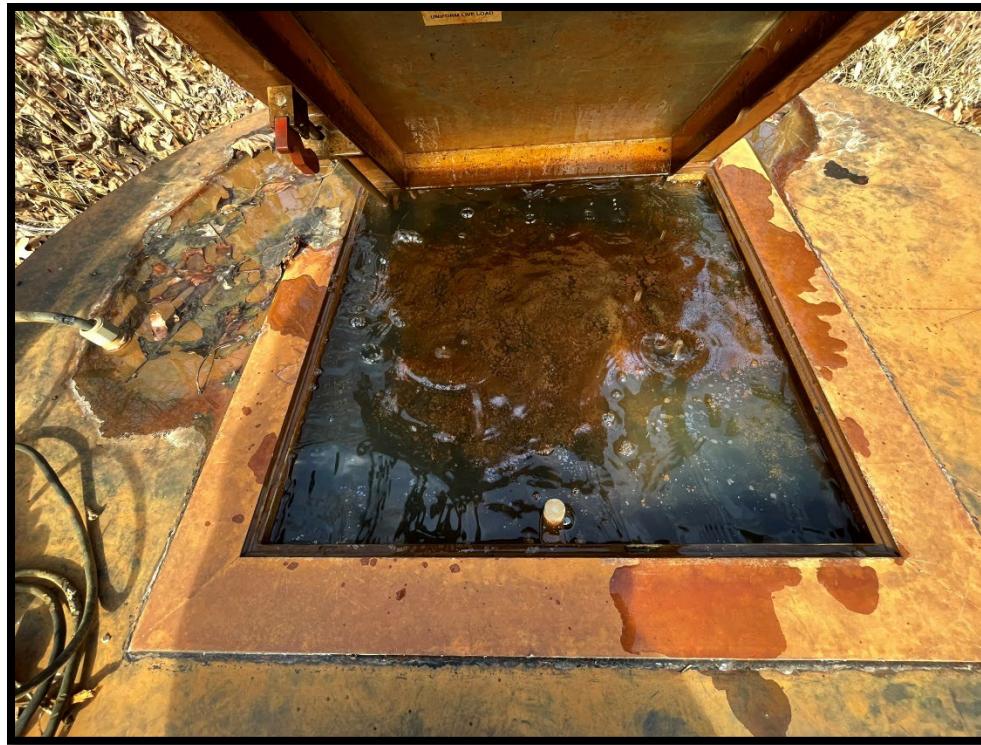
- Vertical leachate collection sump (VLCS)-1 was not functioning correctly, and the sump was observed overflowing (see photograph 1).
- VLCS-2 appeared to be functioning correctly and was observed at 1/2 capacity.
- The leachate tank battery level was 67.6 inches.

**Photograph 1:** View of VLCS-1 at capacity and overflowing.

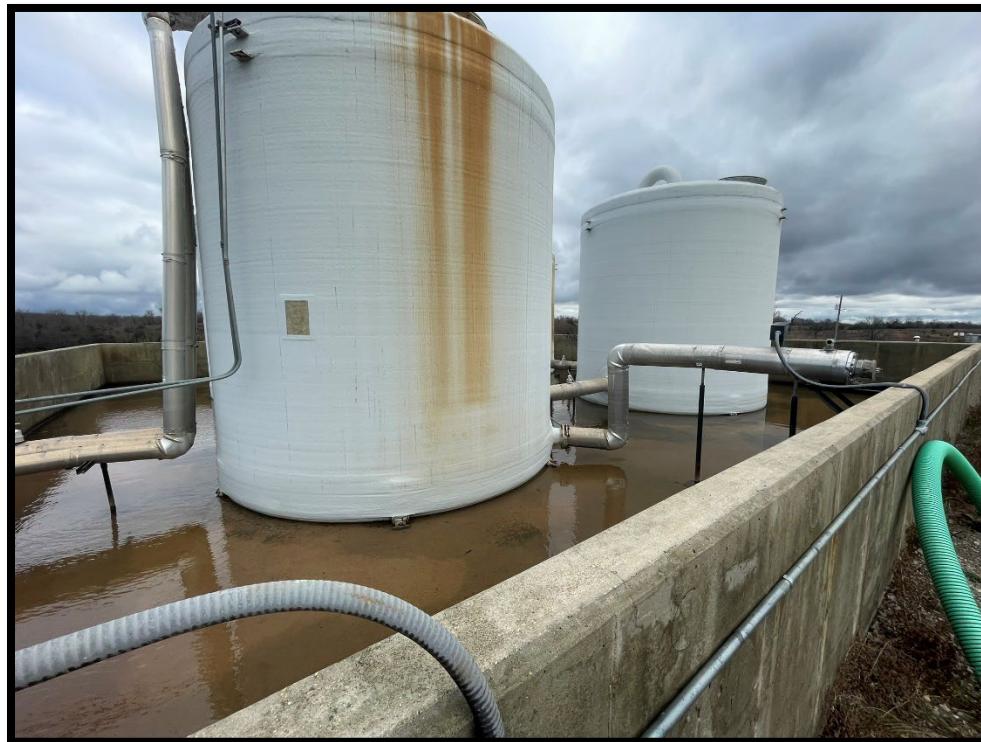
- Approximately two inches of stormwater was observed in the secondary containment. The pH of the stormwater was measured at 9.1, and the drainpipe was not opened (see photograph 2).

**Photograph 2:** View of stormwater in secondary containment at leachate tank battery.

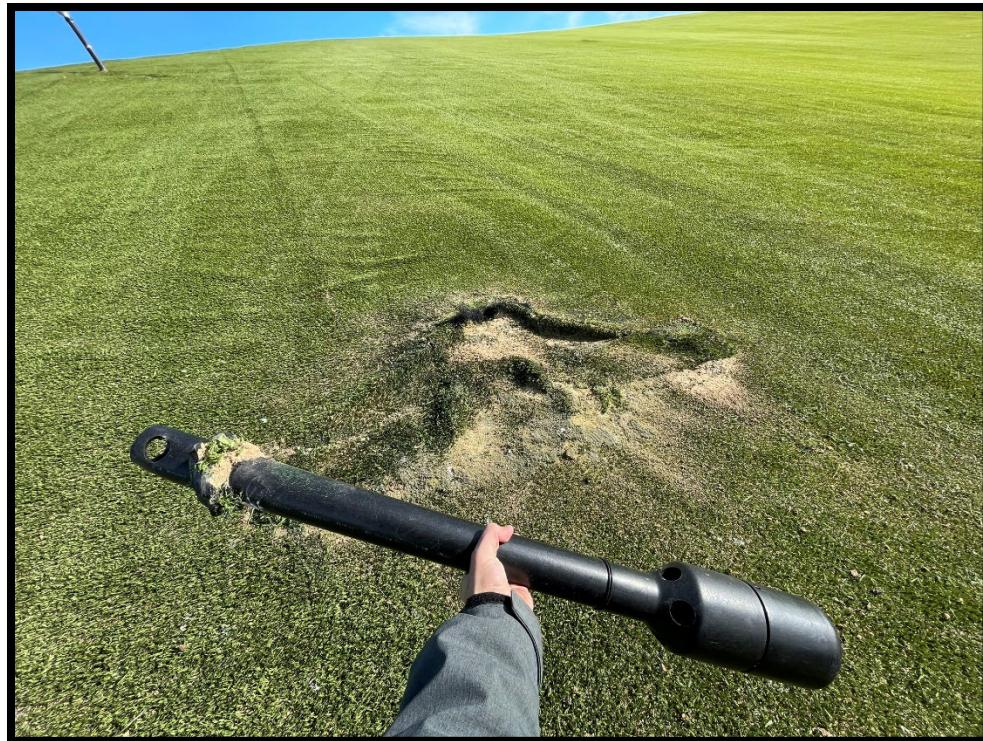
- An erosional washout is present along the road between LCS-4 and LCS-5.
- Two damaged pressure relief vents (PRV) were observed on the west side of Area 1-2, between LCS-1 and LCS-2 (see photograph 3 and 4). The damage is located near coordinates 36.46144, -92.45128.

**Photograph 3:** View of first damaged pressure relief vent on west side of Area 1-2.

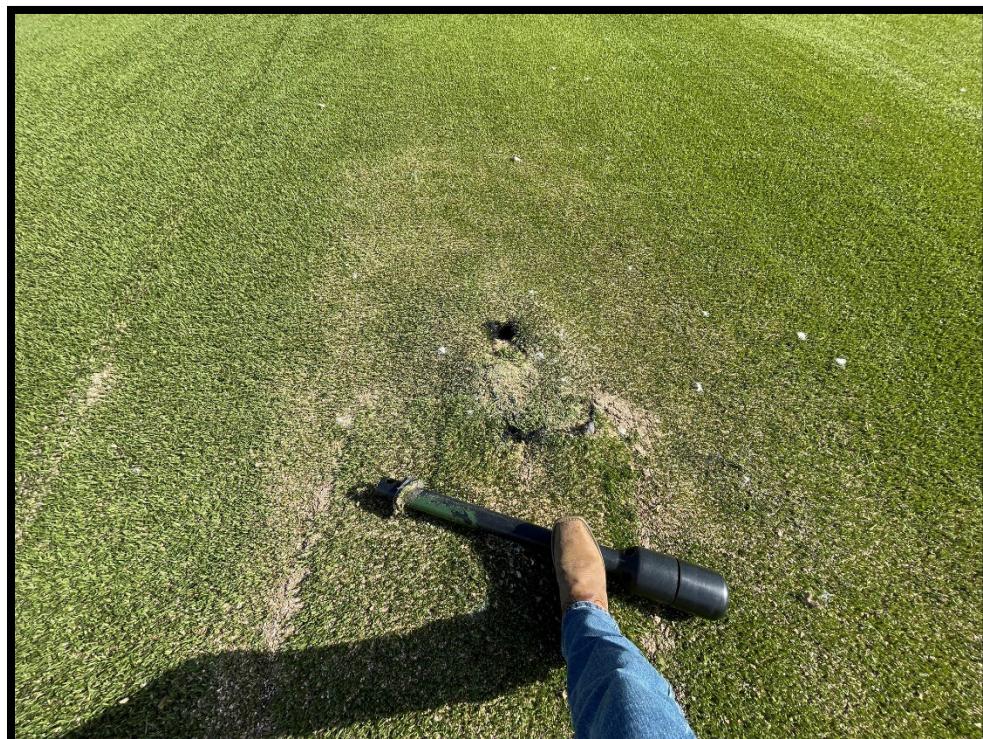
**Photograph 4:** View of second damaged pressure relief vent on west side of Area 1-2

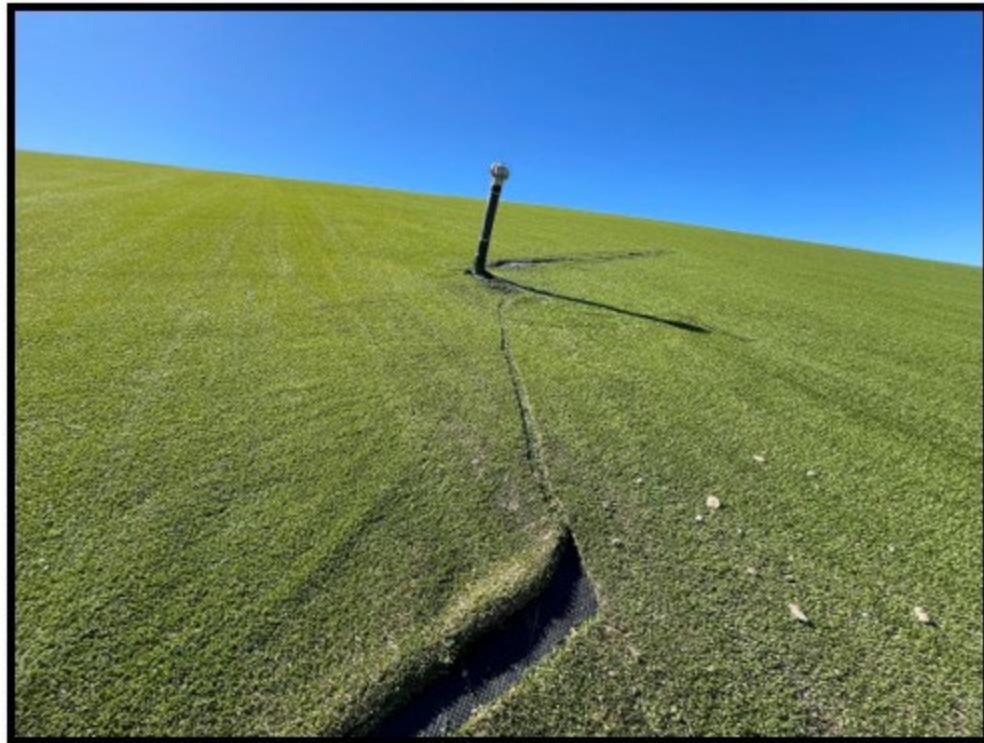
- Damaged closure turf was observed on the north side of Area 1-2 at coordinates 36.46181, -92.45045 (see photograph 5). The damage is approximately 30 feet long by 3 feet wide. The damage was first observed on July 2, 2025.

**Photograph 5:** View of damaged closure turf on the north side of Area 1-2.

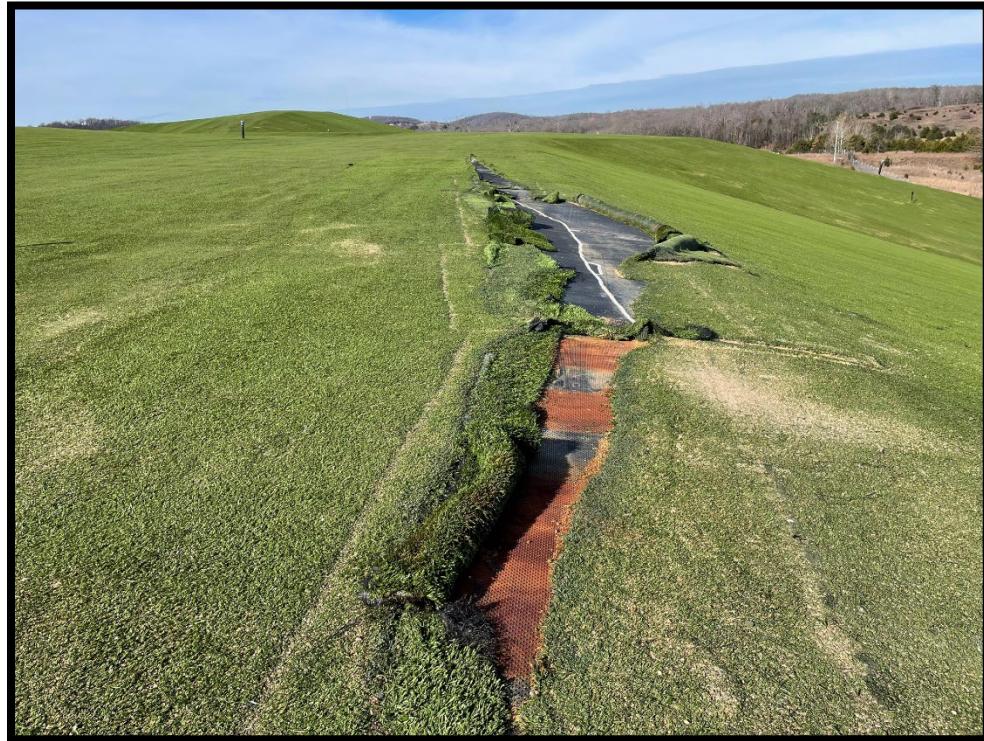
- Damaged closure turf was observed on the east side of Area 1-3, above LCS-7 (see photograph 6). The damage is approximately 100 feet long by 9 feet wide. The closure turf tear was first observed on June 17, 2025.

**Photograph 6:** View of damaged closure turf on east side of Area 1-3.
