DATE: February 17, 2025

RE: Bi-weekly Site Inspection
NABORS Landfill
Mountain Home, AR
Harbor Project No: ENSF-23299

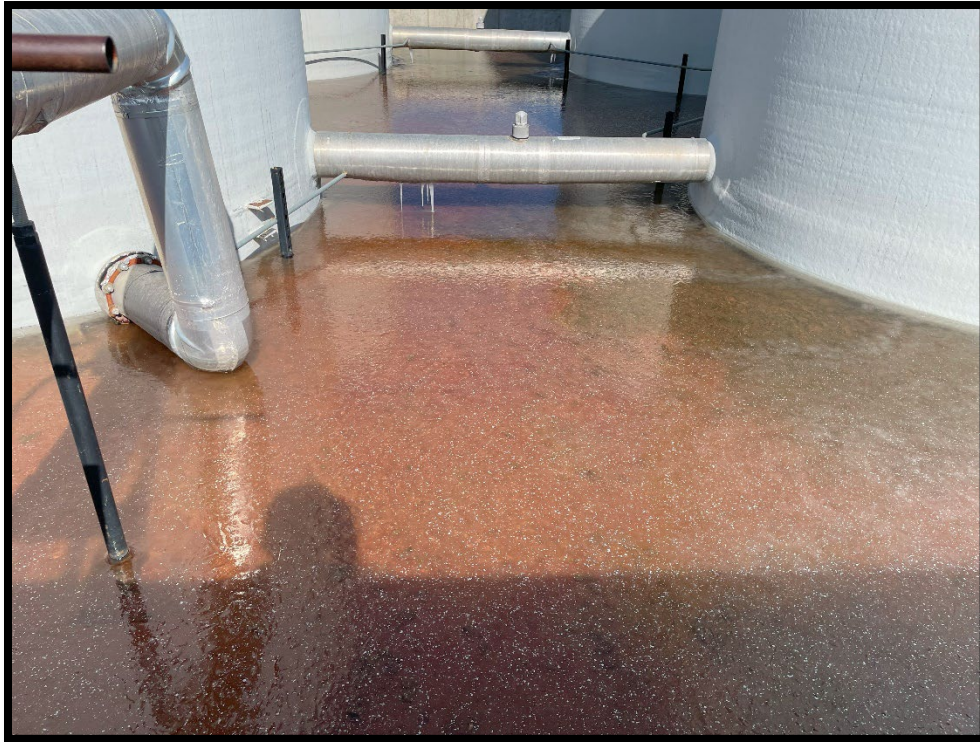
- The stormwater in the leachate tank battery containment was frozen (see photograph 1). The pH of the stormwater was not measured, and no water was released.

Photograph 1: Secondary containment frozen solid.

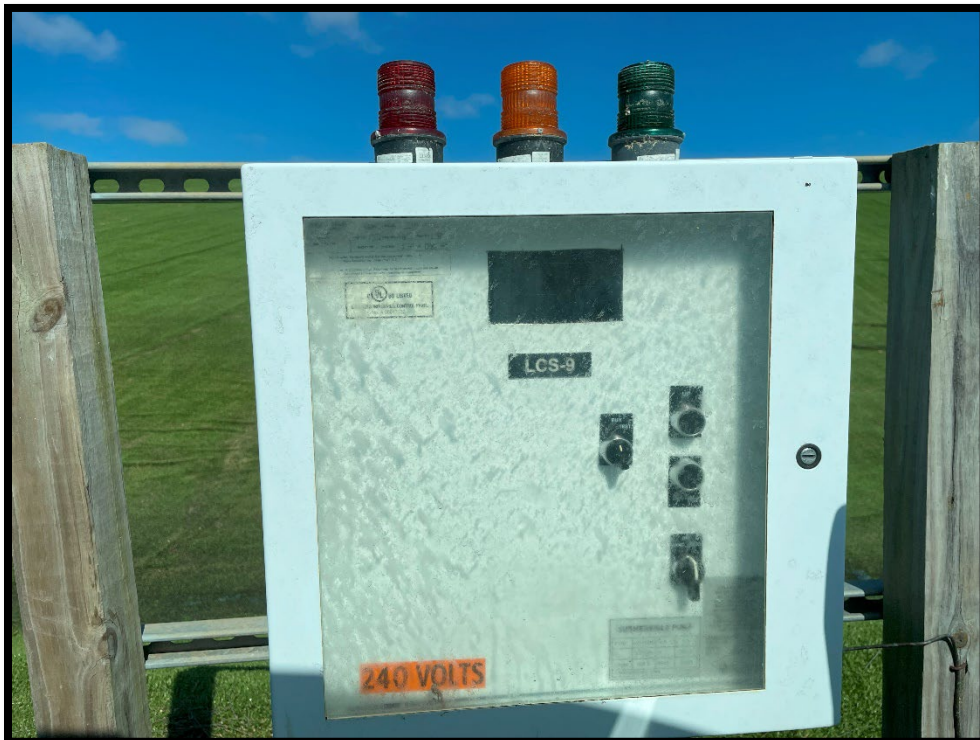
- The display at LCS-9 had been removed (see photograph 2).
-

Photograph 2: View of missing display in LCS-9 panel.

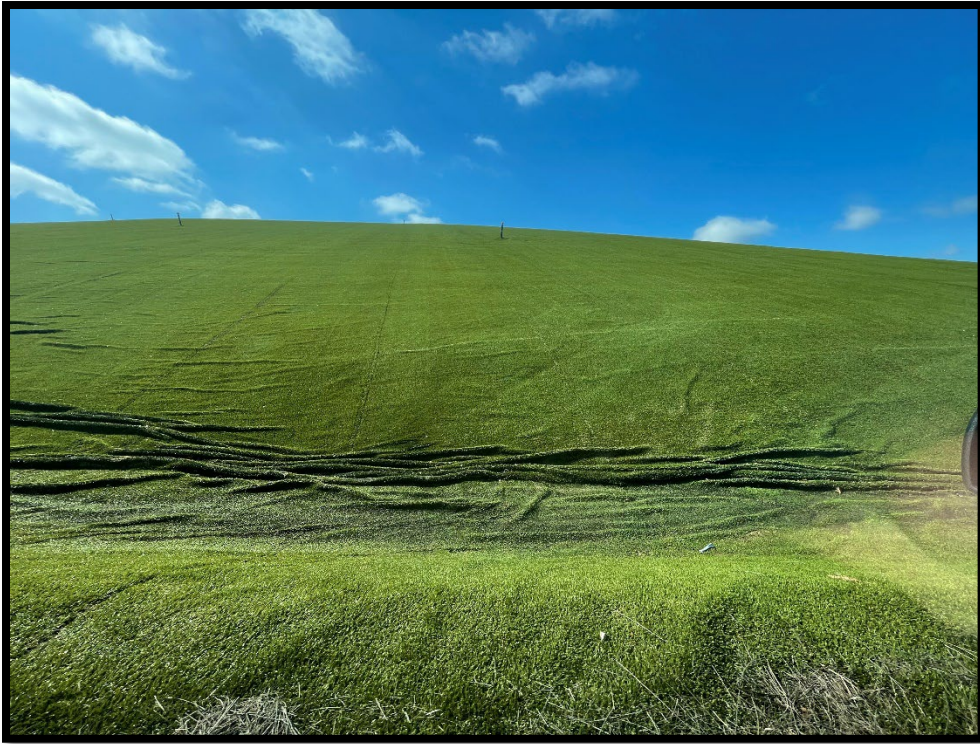
- The closure turf has some significant rills present near LCS-1 and LCS-2 (see photograph 3). These rills have sediment deposited in them which allows vegetation to grow. An erosional washout is present along the road between LCS-4 and LCS-5.

Photograph 3: View of rills near LCS-1.
