DATE: January 21, 2025

FROM: Thomas Huetter, P.G., *Senior Project Manager, Harbor*

RE: Bi-weekly Site Inspection
NABORS Landfill
Mountain Home, AR
Harbor Project No: ENSF-23299

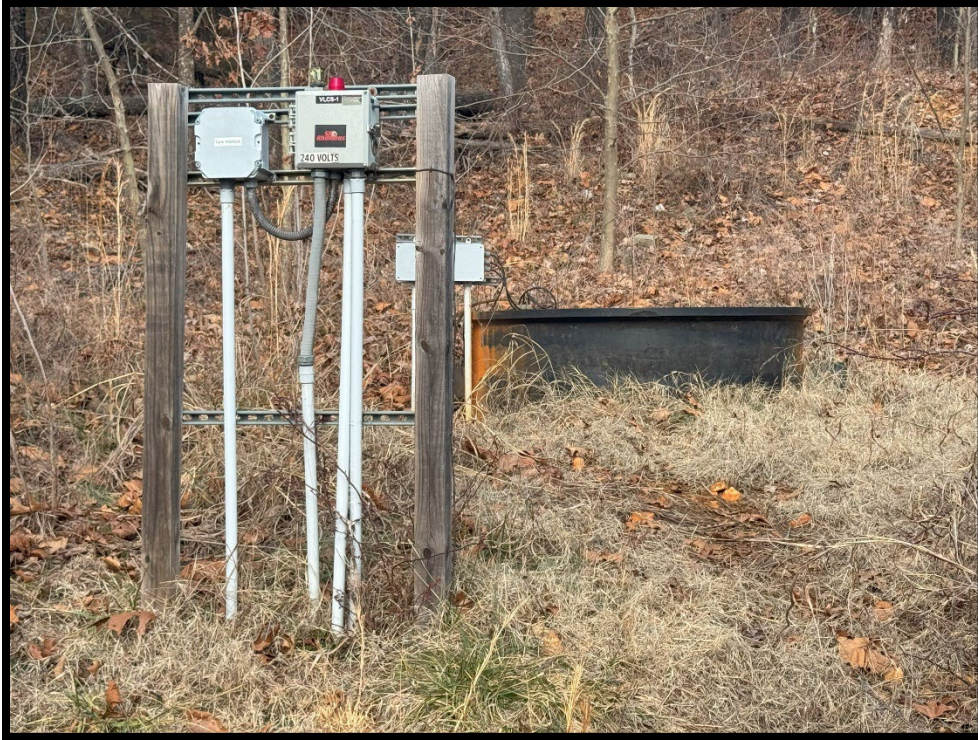
- Vertical leachate collection sump (VLCS)-1 is functioning correctly and was observed at 2/3 capacity (see photographs 1 and 2).
 - VLCS-2 appeared to be functioning correctly, and the sump was at approximately 1/3 capacity (see photographs 3 and 4).

Photograph 1: View of VLCS-1.

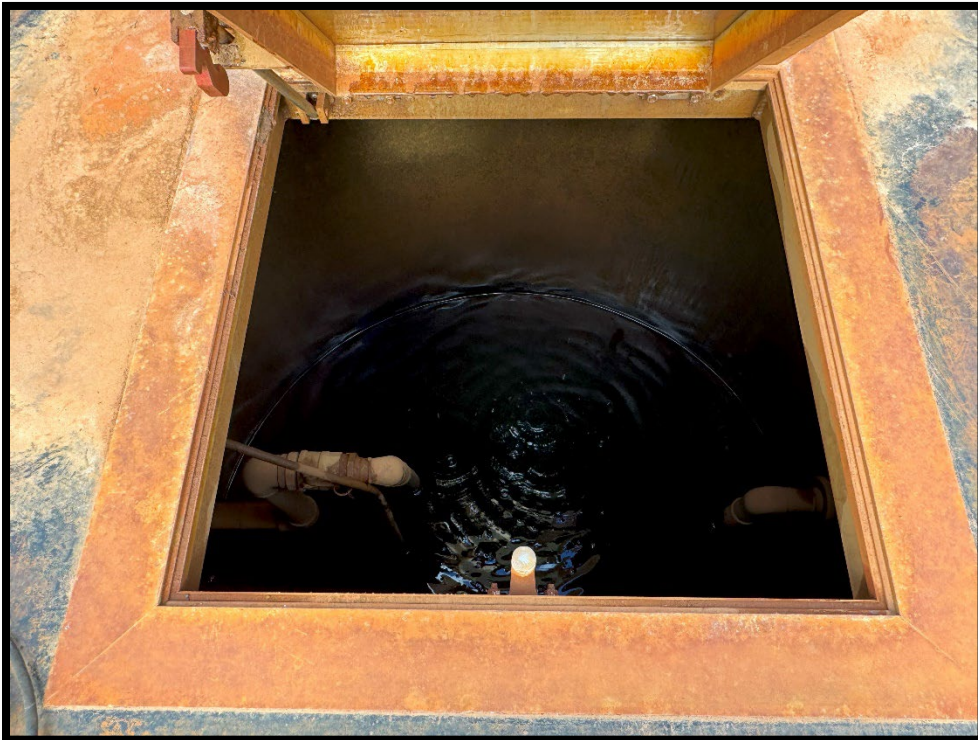
Photograph 2: Leachate at 2/3 full in VLCS-1 sump.

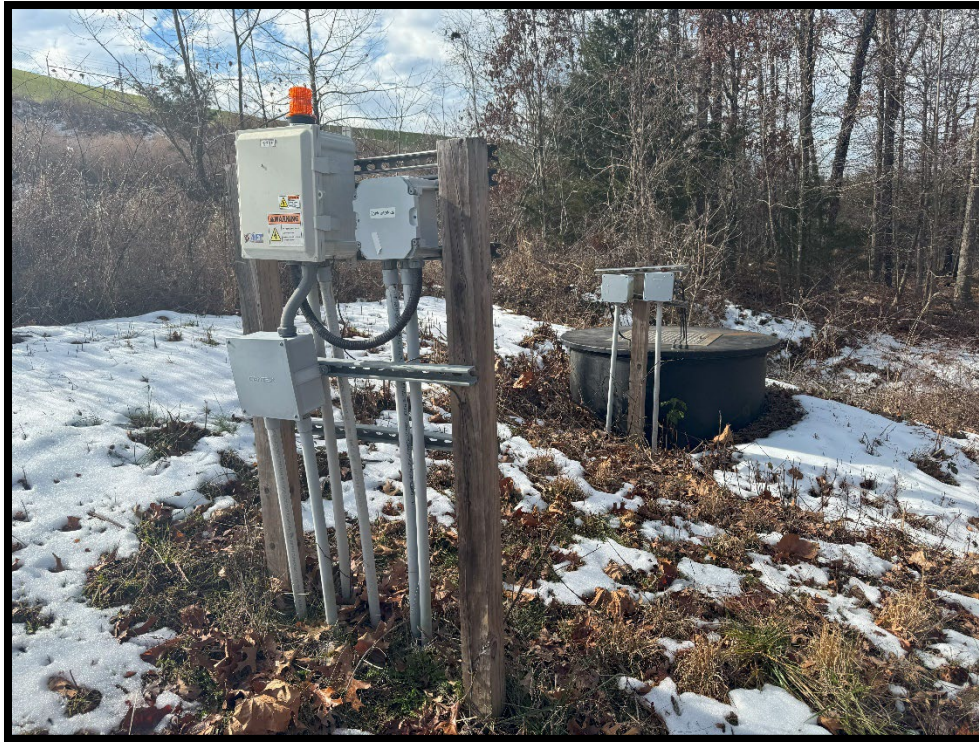
Photograph 3: View of VLCS-2.

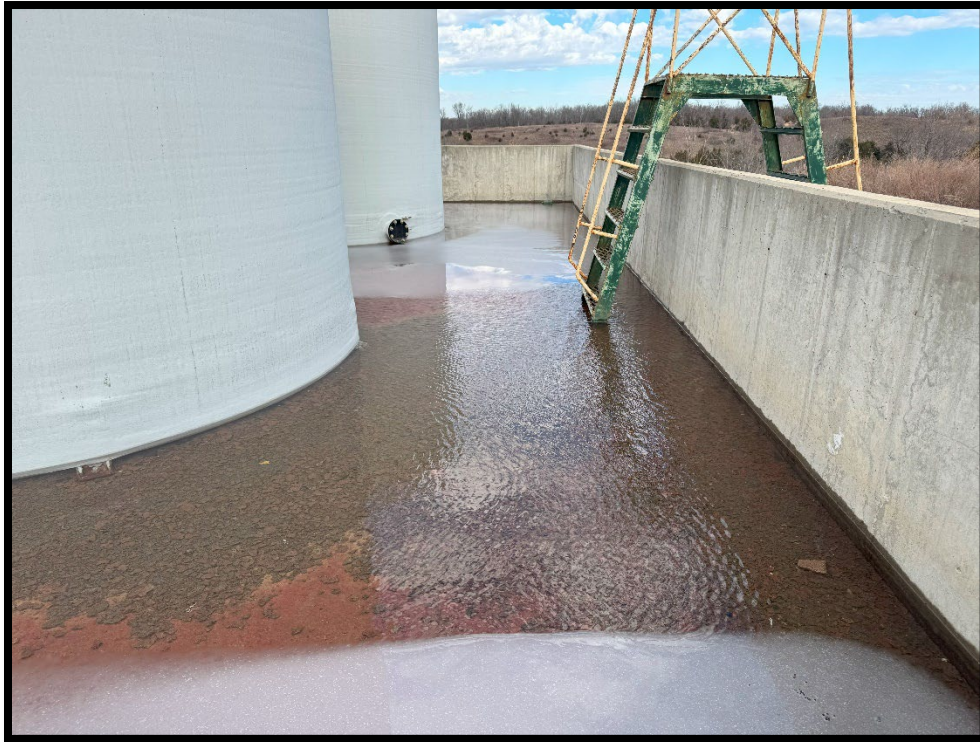
- Approximately 4-5 inches of stormwater was observed in the leachate tank battery containment (see photograph 5). The pH of the stormwater was measured at 8.48 and approximately two inches of stormwater was released while on site (see photograph 6).

Photograph 5: View of approximately 4-5 inches of stormwater in secondary containment.

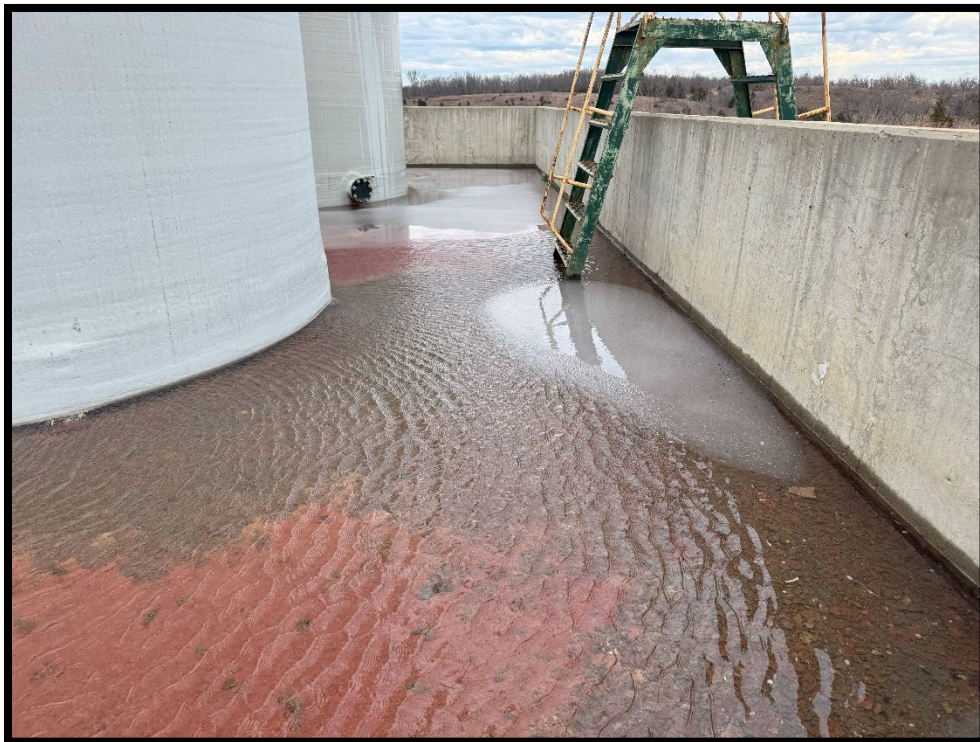
Photograph 6: View of stormwater in secondary containment after release of approximately two inches.

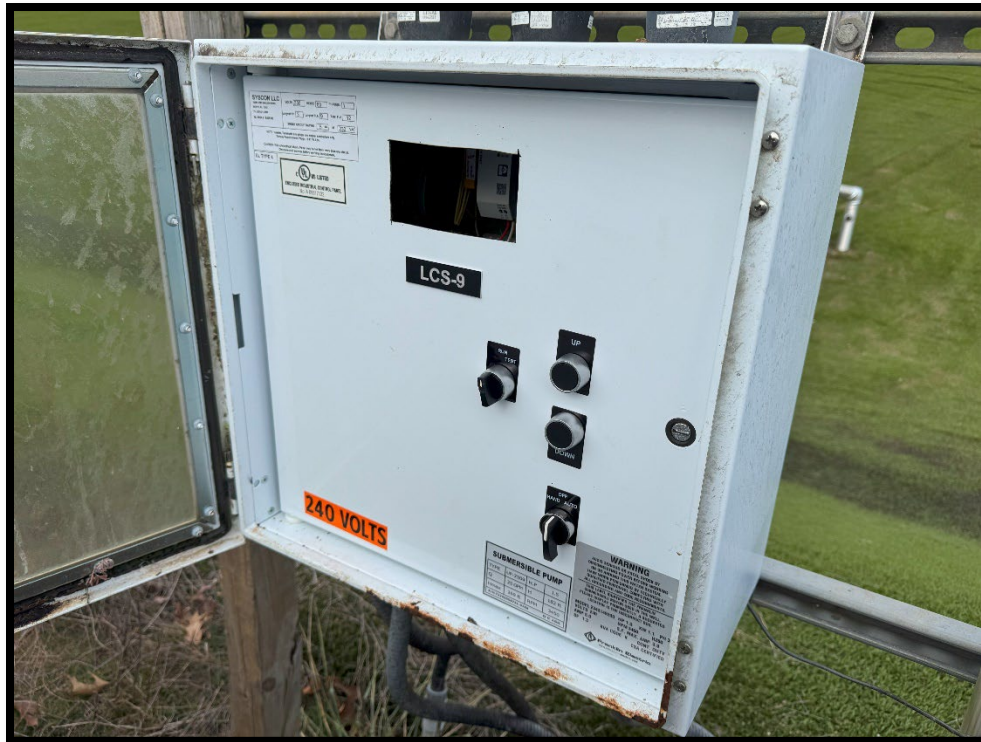
- The display at LCS-9 had been removed (see photograph 7). In addition, the cover for the LCS-9 sump had either been manually removed or had fallen off (see photograph 8).
- The closure turf has some significant rills present between LCS-1 and LCS-2 on the north side of Area 1-2. These rills have sediment deposited in them which allows vegetation to grow. An erosional washout is present along the road between LCS-4 and LCS-5.

Photograph 7: View of missing display in LCS-9 panel.

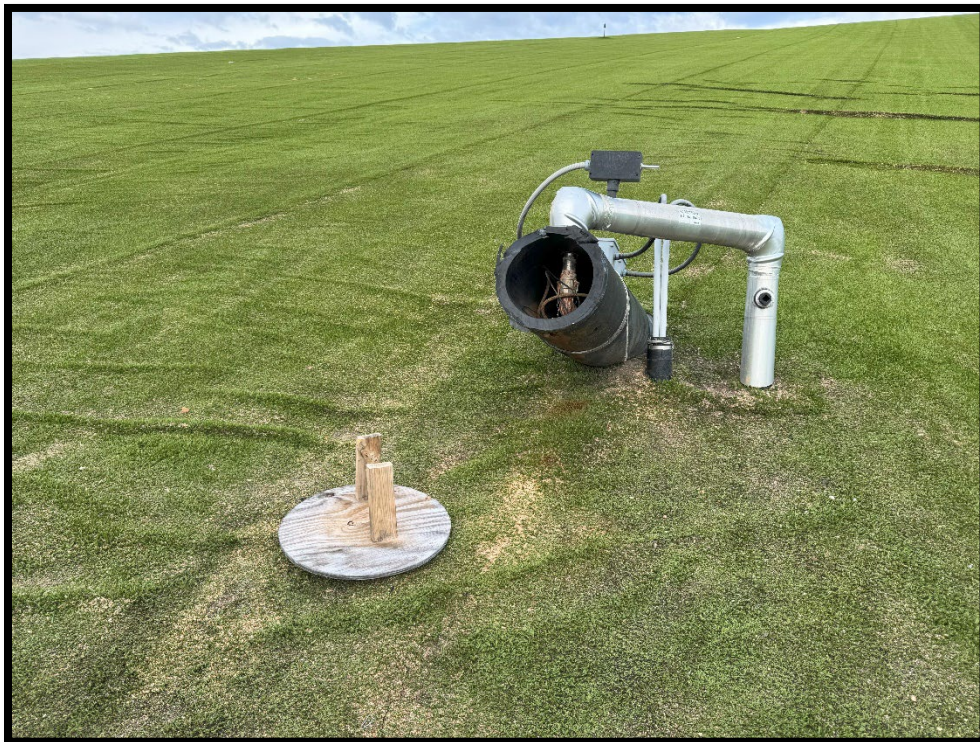
Photograph 8: View of cover removed from LCS-9 sump.
