DATE: February 3, 2025

RE: Bi-weekly Site Inspection
NABORS Landfill
Mountain Home, AR
Harbor Project No: ENSF-23299

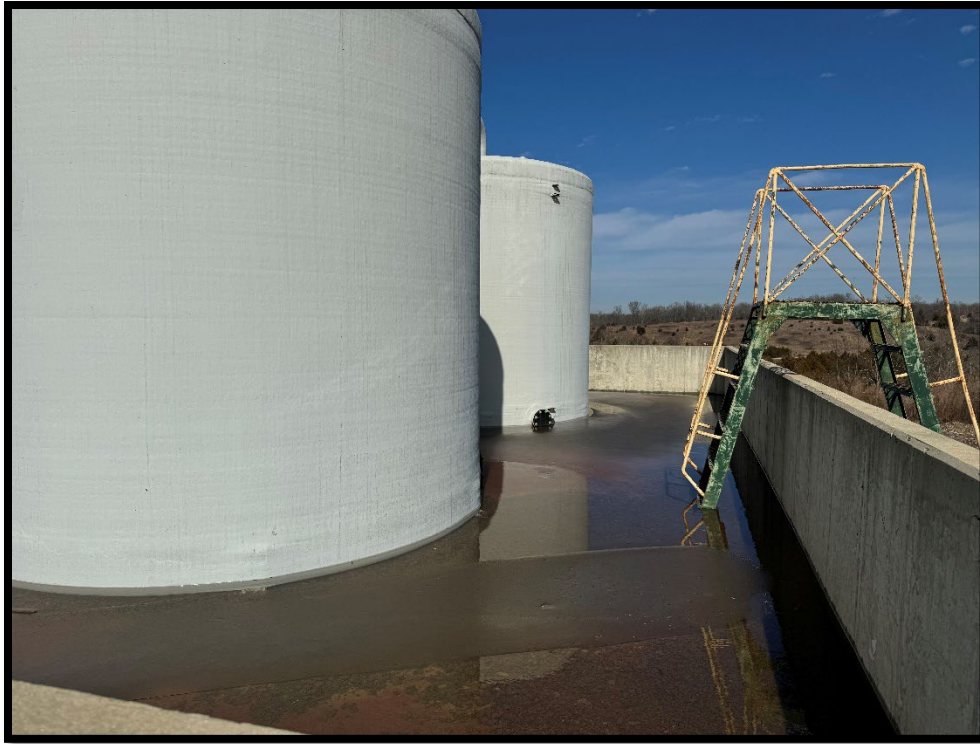
- Approximately 7.5 inches of stormwater was observed in the leachate tank battery containment (see photograph 1). The pH of the stormwater was measured at 7.45 and approximately 1.5 inches of stormwater was released while on site.

Photograph 1: View of approximately 7.5 inches of stormwater in secondary containment.

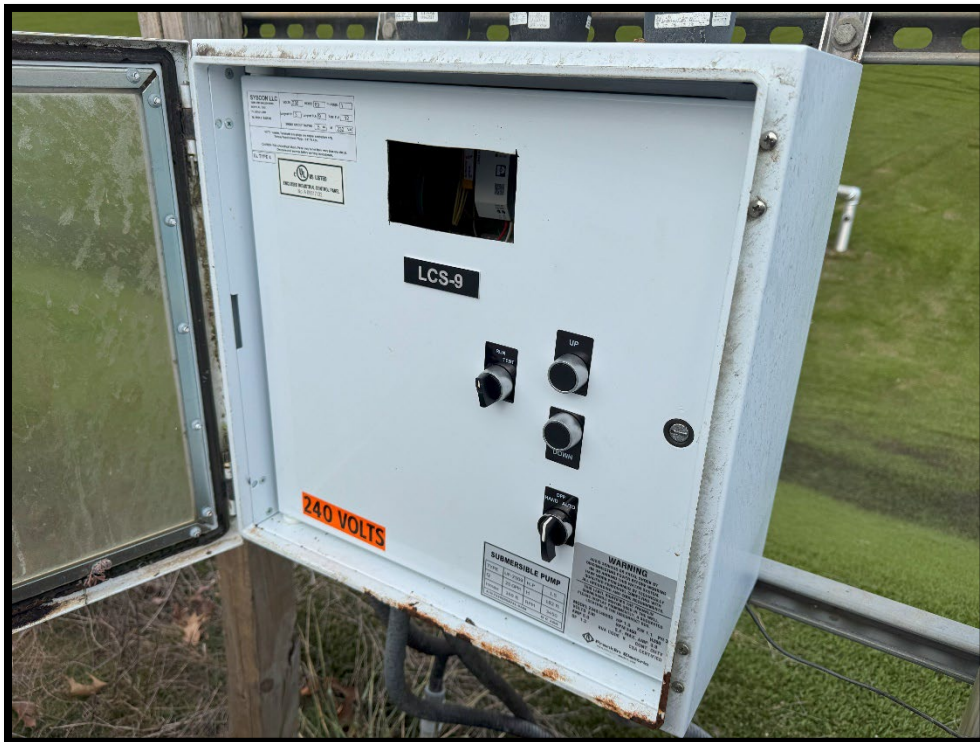
Photograph 2: View of missing display in LCS-9 panel.

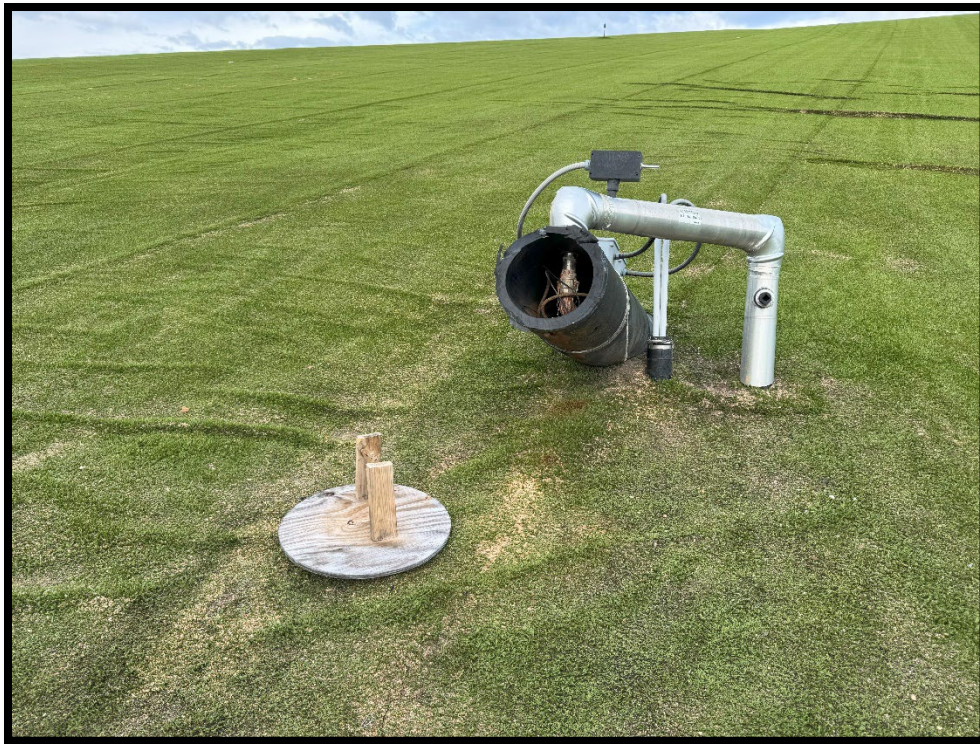
Photograph 3: View of cover removed from LCS-9 sump.
