RE: Bi-weekly Site Inspection
NABORS Landfill
Mountain Home, AR
Harbor Project No: L8247885

Harbor visited the NABORS landfill in Mountain Home, Arkansas on July 16, 2025, to conduct the bi-weekly site inspection to assess the general condition of the landfill and the leachate collection system (LCS). The LCS was last fully repaired by Advanced Fluid Technologies (AFT) in October and November of 2022; however, within a few weeks of these repairs, the LCS began malfunctioning. By March 2023, most of the LCS points were malfunctioning. A quote was then requested and received from AFT to again repair the system. No authorization for the subsequent repairs was provided prior to the expiration of Harbor's contract with DEQ in June 2023.

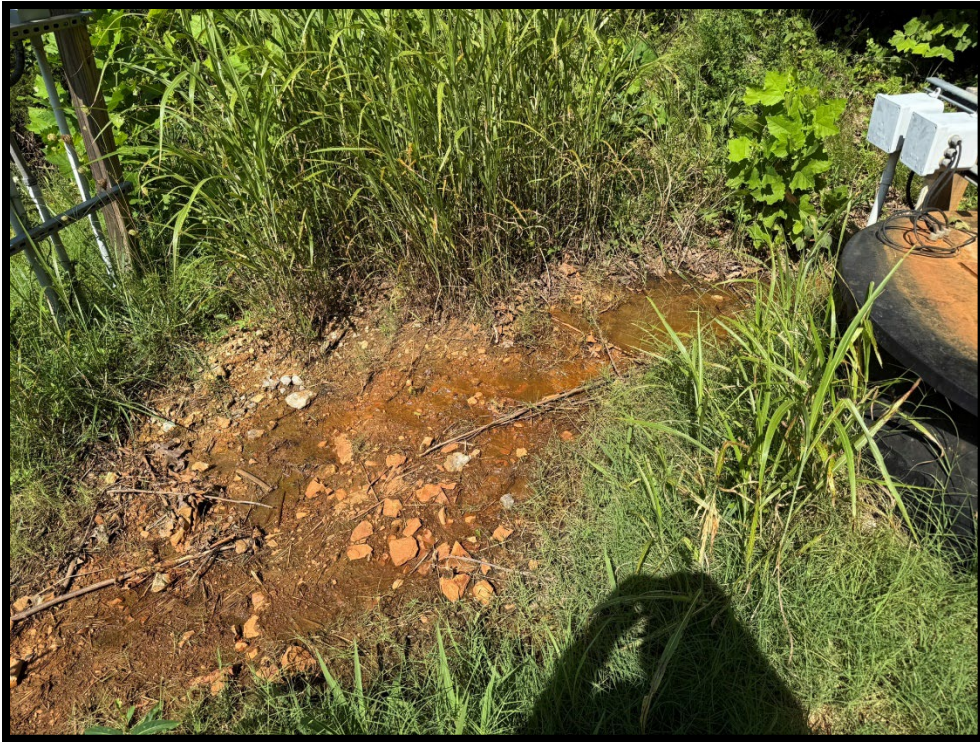
- Vertical leachate collection sump (VLCS)-1 was at capacity and observed overflowing (see photographs 1-2).
 - VLCS-2 appeared to be functioning correctly and was observed at 1/2 capacity.
 - The leachate tank battery level was 72.6 inches. As noted in previous inspections, it appears that the leachate tank level indicator is not functioning correctly.
 - Minimal stormwater was observed in the tank containment. As such, none was released while Harbor was on-site (see photograph 3).
 - The panel displays were off at all LCS stations except LCS-2, LCS-5, and LCS-7.
-

Photograph 1: View of erosional rill present at VLCS-1.

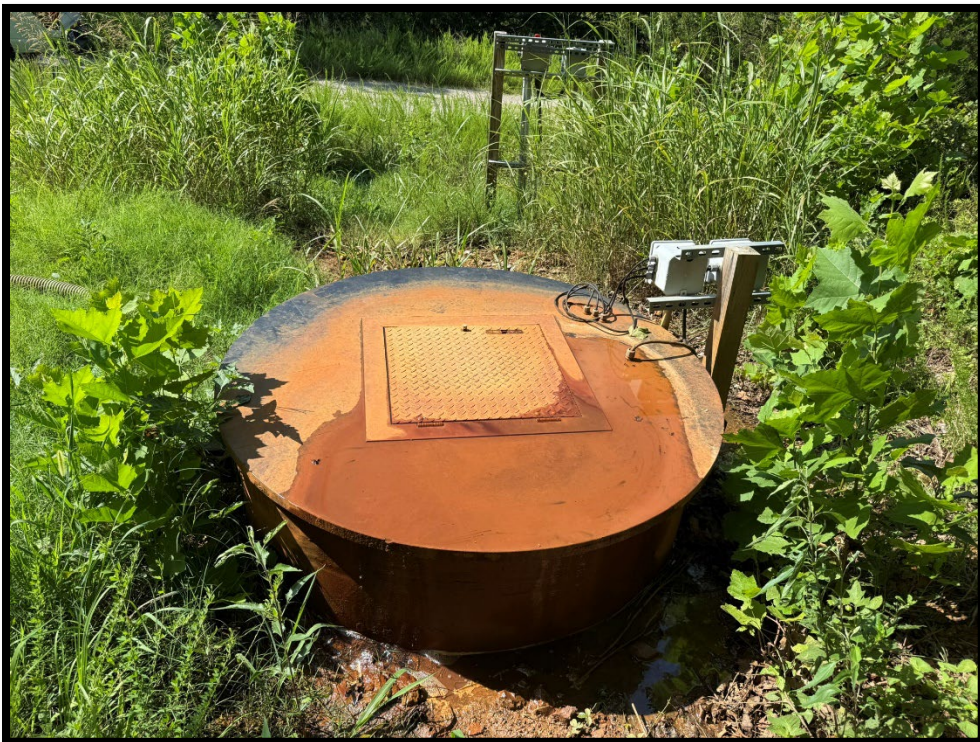
Photograph 2: View of VLCS-1 at capacity.

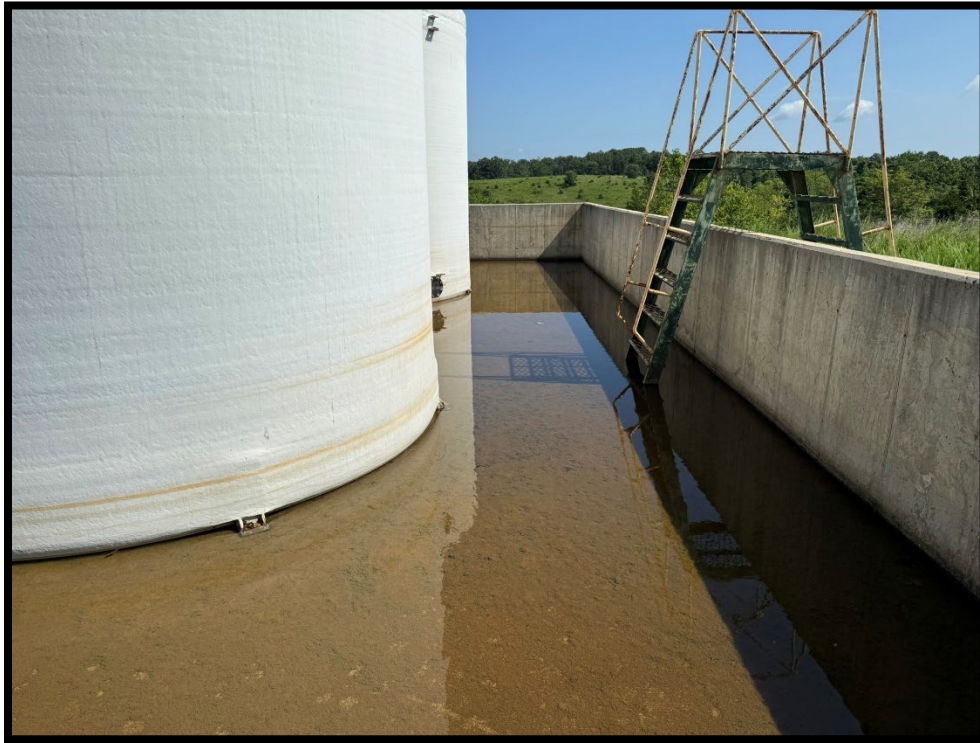
Photograph 3: View of minimal stormwater in containment.
