RE: Bi-weekly Site Inspection
NABORS Landfill
Mountain Home, AR
Harbor Project No: L8247885

Harbor visited the NABORS landfill in Mountain Home, Arkansas on July 2, 2025, to conduct the bi-weekly site inspection to assess the general condition of the landfill and the leachate collection system (LCS). The LCS was last fully repaired by Advanced Fluid Technologies (AFT) in October and November of 2022; however, within a few weeks of these repairs, the LCS began malfunctioning. By March 2023, most of the LCS points were malfunctioning. A quote was then requested and received from AFT to again repair the system. No authorization for the subsequent repairs was provided prior to the expiration of Harbor's contract with DEQ in June 2023.

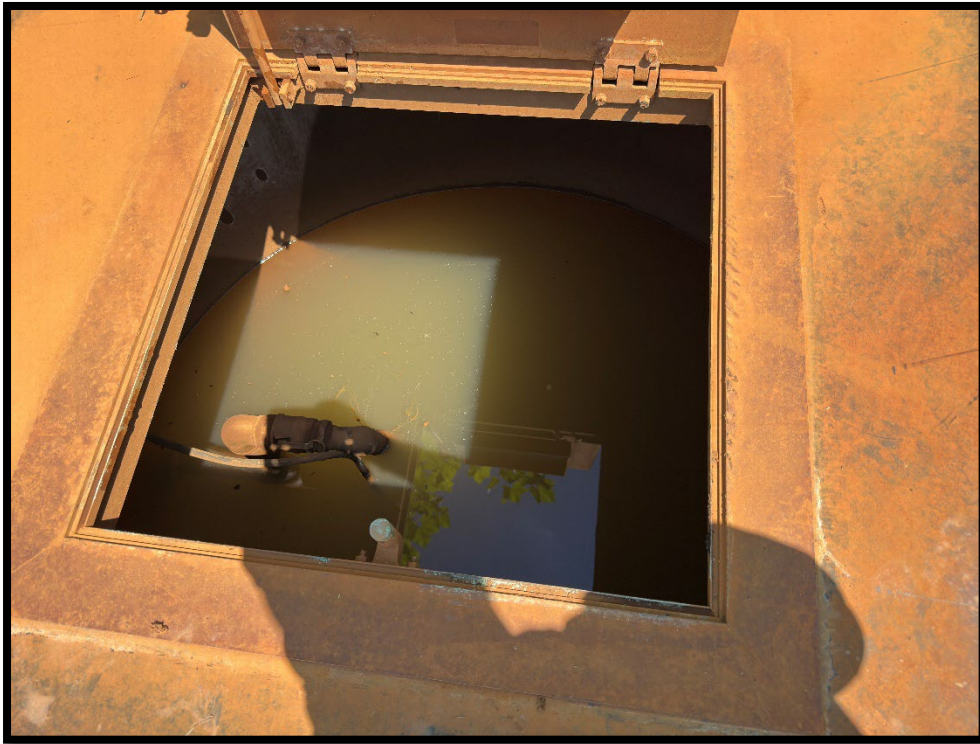
- Vertical leachate collection sump (VLCS)-1 was near capacity but was not observed overflowing (see photograph 1).
 - VLCS-2 appeared to be functioning correctly and was observed at 1/2 capacity.
 - The leachate tank battery level was -29.5 inches. As noted in the June 4th inspection, it appears that the leachate tank level indicator is not functioning correctly.
 - Minimal stormwater was observed in the tank containment. As such, none was released while Harbor was on-site. (see photograph 2).
 - The panel displays were off at all LCS stations except LCS-2, LCS-5, and LCS-7.
 - LCS-2 level was at 0.0 inches and did not activate when the sump was placed in "hand" or "auto" mode. LCS-2 also displayed a pump fault alarm.
 - LCS-5 level remained at 9.7 inches and did not activate when the sump was placed in "hand" or "auto" mode, despite the display giving a "station ok" notice.
-

Photograph 1: View of VLCS-1 nearing capacity.

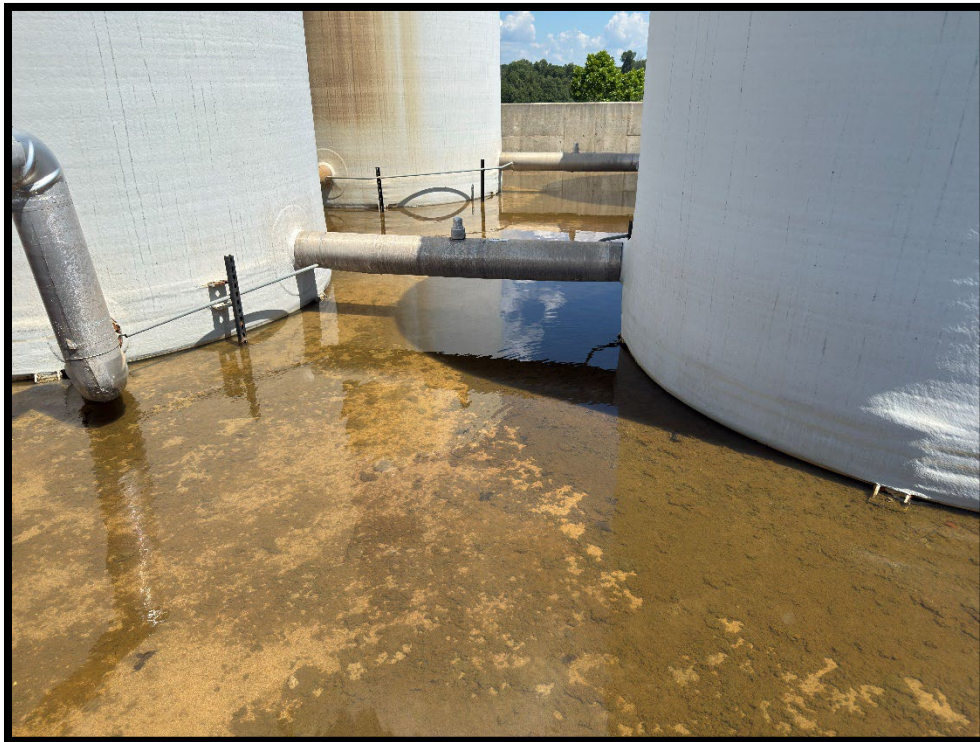
Photograph 2: View of minimal stormwater in leachate tank containment.

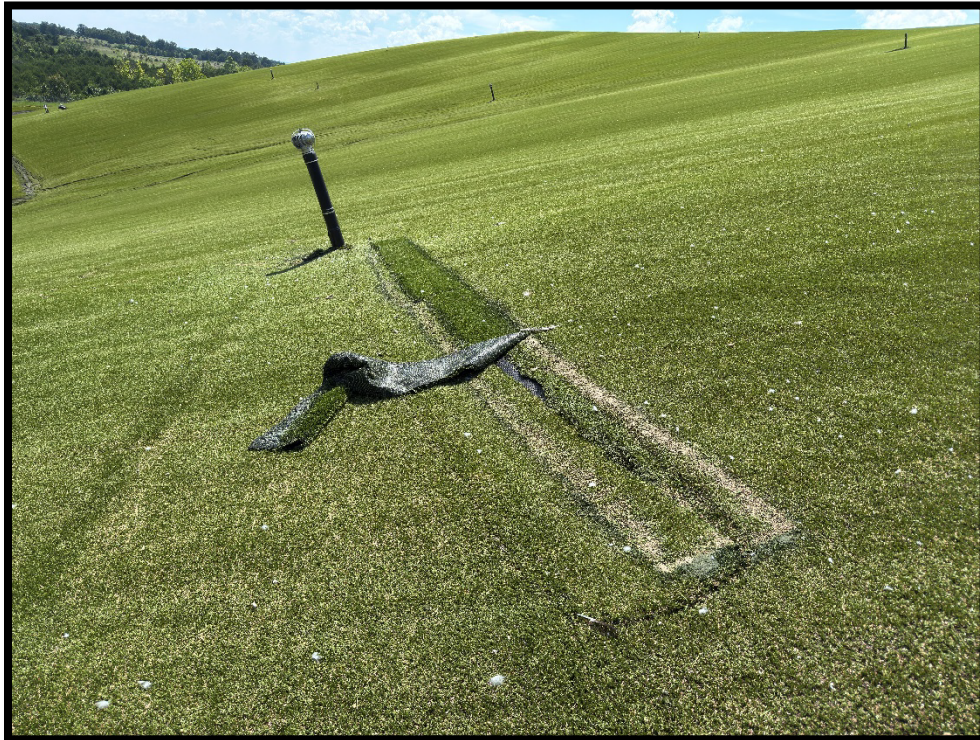
- LCS-7 level was at 0.0" and the station displayed a pump fault.
- The display at LCS-9 had been removed.
- An erosional washout is present along the road between LCS-4 and LCS-5.
- Damaged closure turf was observed on the north side of Area 1-2 at coordinates 36.46181, -92.45045 (see photograph 3).
- Damaged closure turf was observed on the east side of Area 1-3, above LCS-7 (see photographs 4-5).
- An outdoor literature box was affixed to the leachate tank containment that displays the wastewater contribution permit (see photograph 6).

Photograph 3: View of damaged closure turf on the north side of Area 1-2.

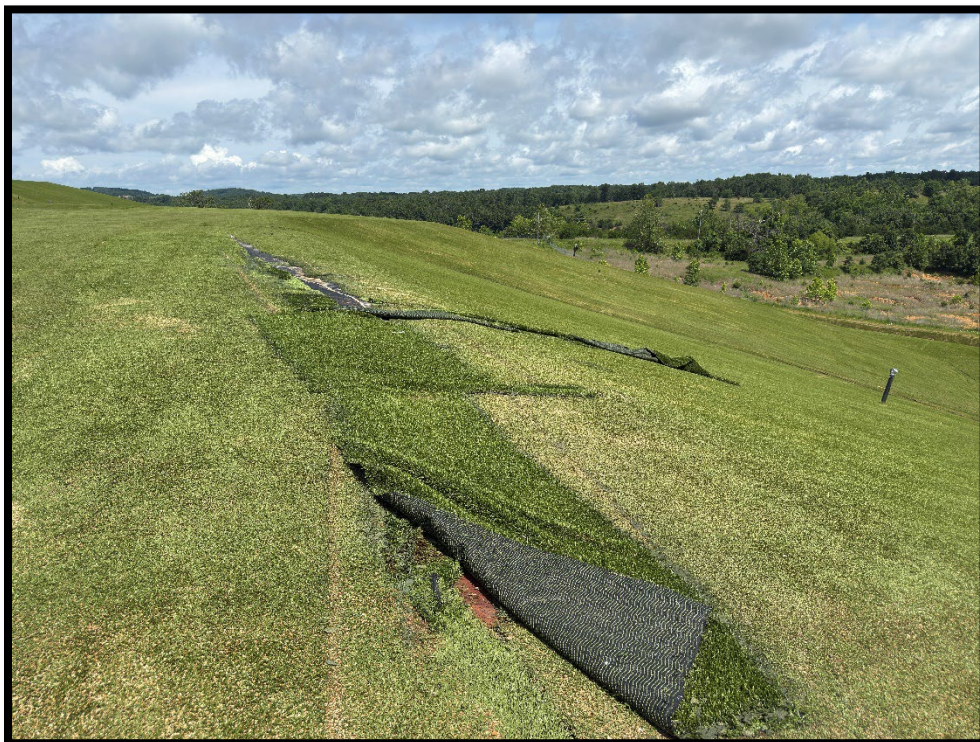
Photograph 4: View of damaged closure turf on east side of Area 1-3.

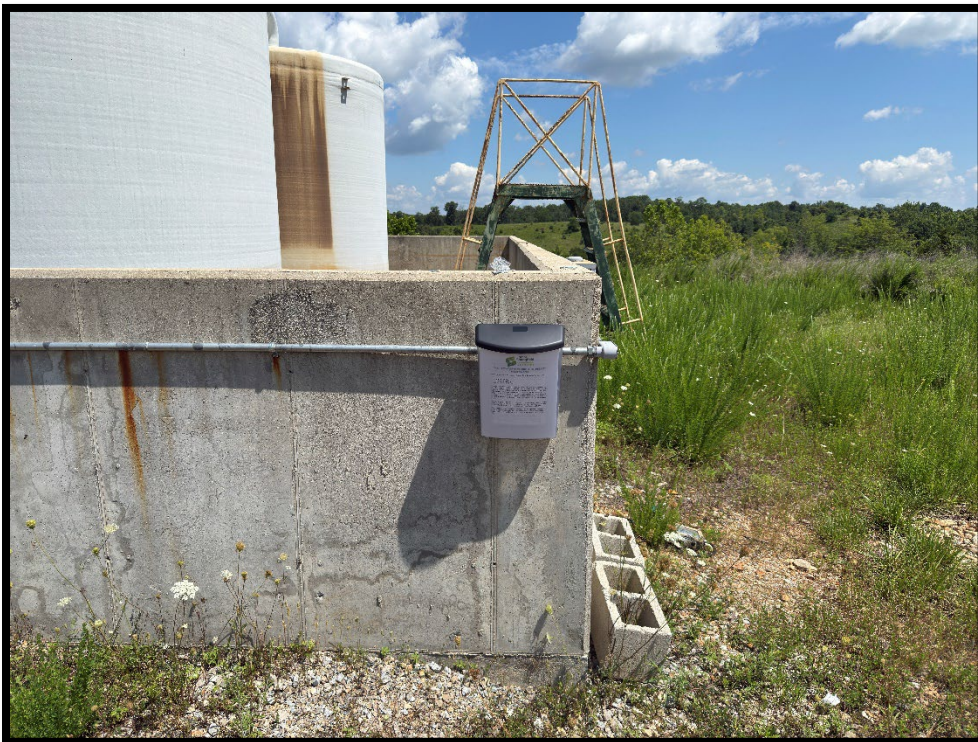
Photograph 6: View of literature box containing wastewater contribution permit.
