**DATE:** August 18, 2025

**RE:** Bi-weekly Site Inspection  
NABORS Landfill  
Mountain Home, AR  
*Harbor Project No: L8247885*

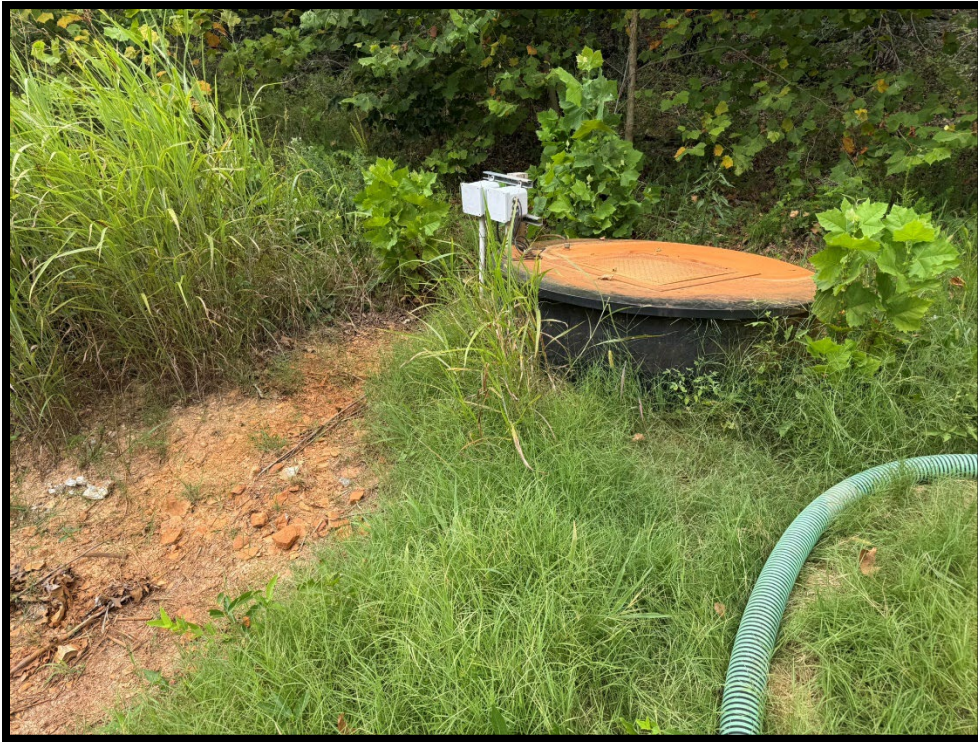
- Vertical leachate collection sump (VLCS)-1 was not overflowing and observed at  $\frac{1}{4}$  capacity (see photograph 1).
  - VLCS-2 appeared to be functioning correctly and was observed at  $\frac{1}{2}$  capacity.
  - The leachate tank battery level was -22.4 inches. As noted in previous inspections, it appears that the leachate tank level indicator is not functioning correctly (see photograph 2).
  - No stormwater was observed in the tank containment. As such, none was released while Harbor was on-site (see photograph 3).
-

**Photograph 1:** View of erosional rill present at VLCS-1.

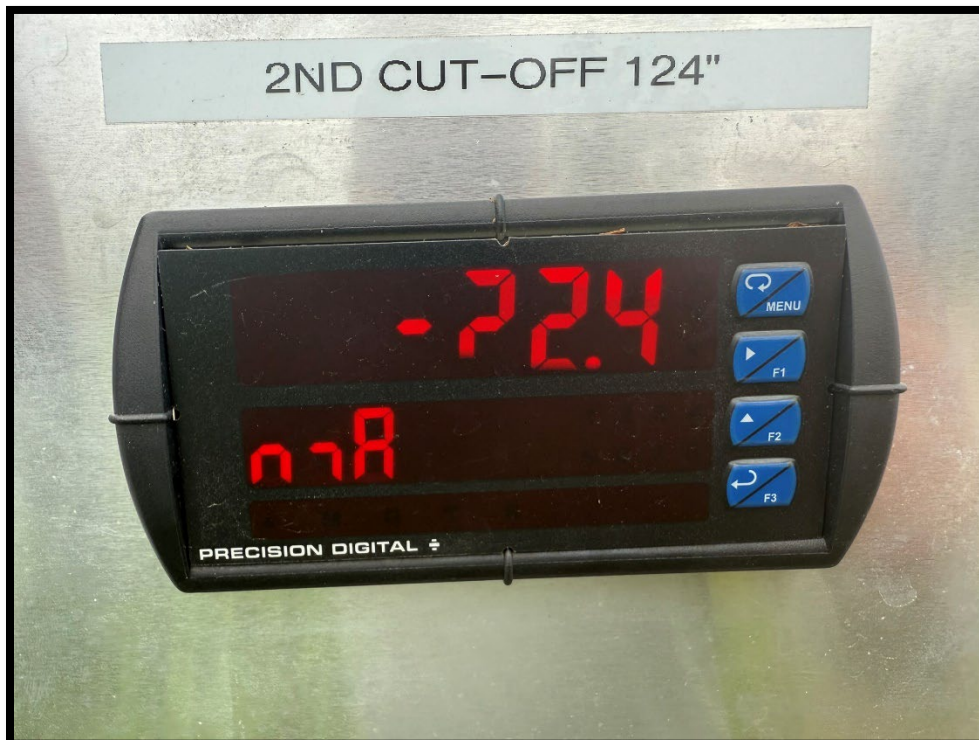
**Photograph 2:** View leachate tank level indicator.

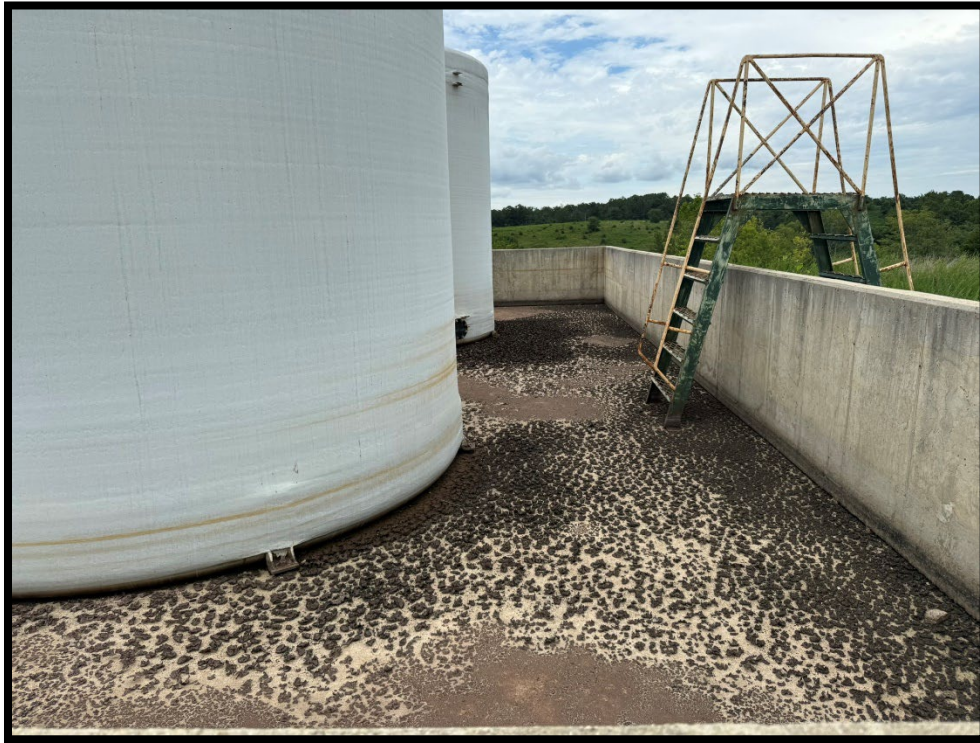
**Photograph 3:** View of no stormwater in containment.

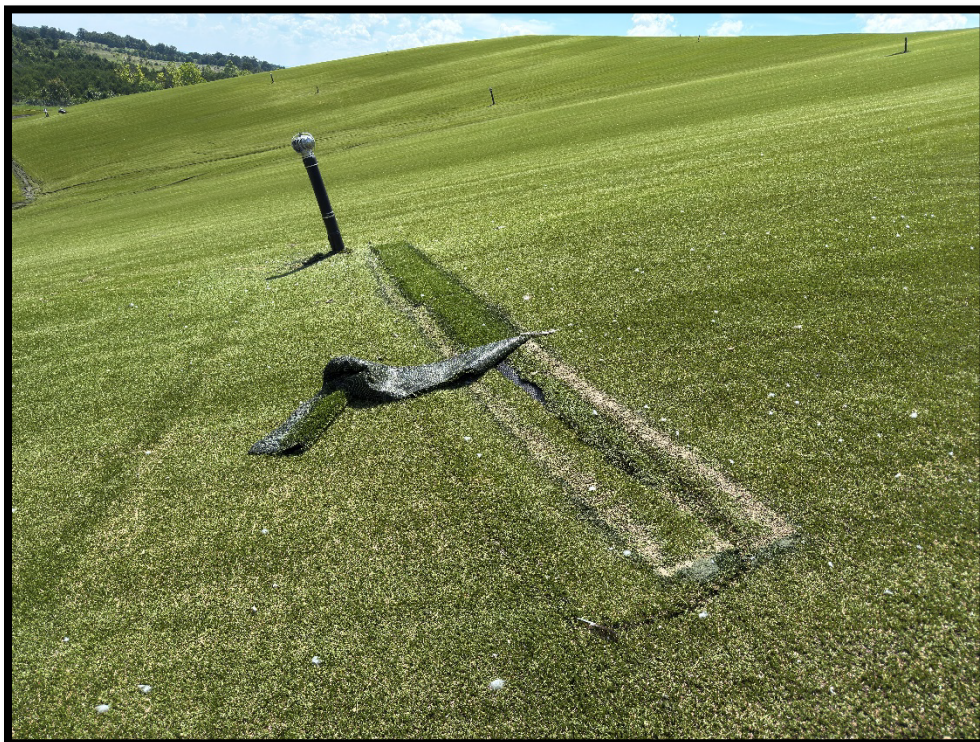
- Damaged closure turf was observed on the north side of Area 1-2 at coordinates 36.46181, -92.45045 (see photograph 4).
- Damaged closure turf was observed on the east side of Area 1-3, above LCS-7 (see photograph 5).

**Photograph 4:** View of damaged closure turf on the north side of Area 1-2.

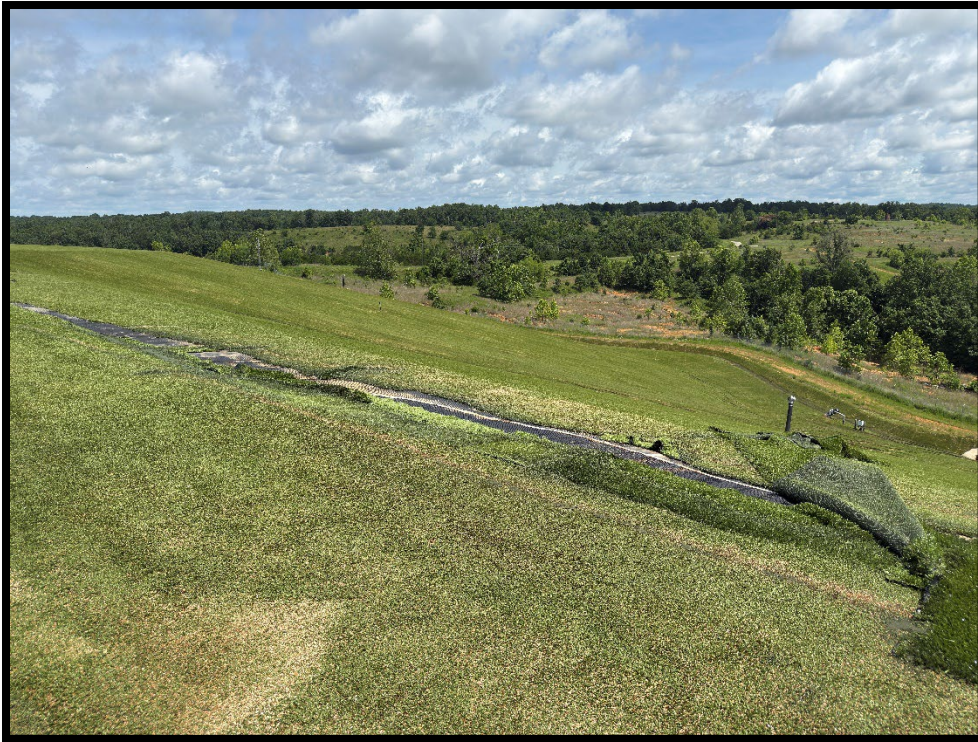
**Photograph 5:** View of damaged closure turf on east side of Area 1-3.
