**DATE:** June 20, 2025

**FROM:** Caleb Gourley, Senior Staff Scientist, Harbor

**RE:** Bi-weekly Site Inspection  
NABORS Landfill  
Mountain Home, AR  
*Harbor Project No: L8247885*

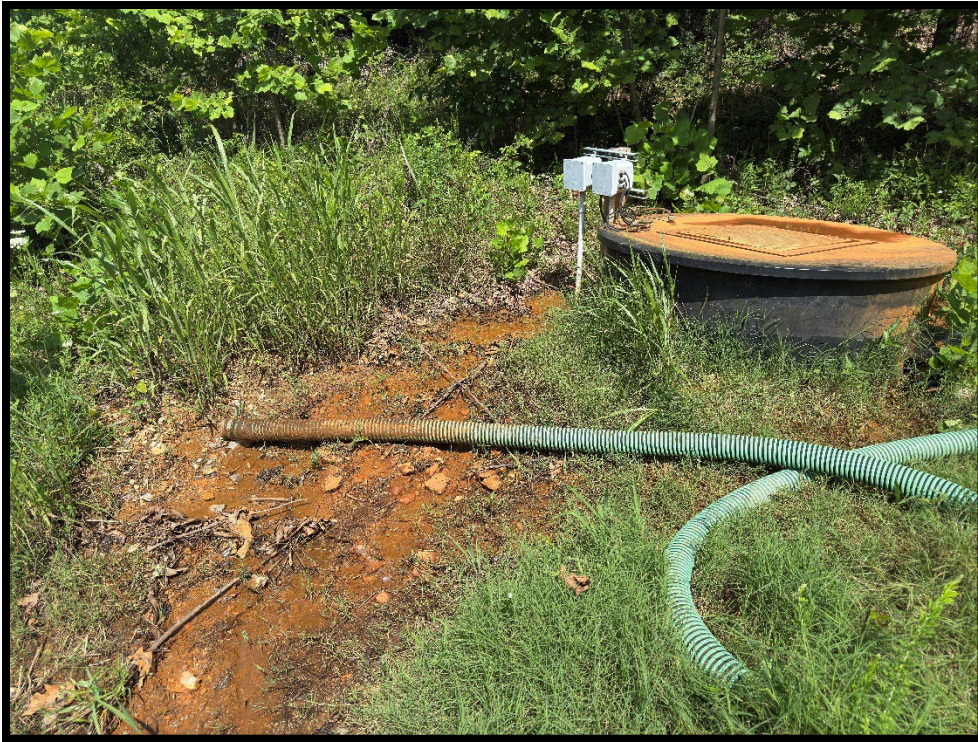
- Vertical leachate collection sump (VLCS)-1 is not functioning correctly. While Harbor was on-site, the Harbor contracted leachate hauler, 417 Services LLC (417 Services) was also on-site and had just recently pumped out VLCS-1. However, evidence of recent overflows was observed (see photographs 1-2). It appears that a fuse holder is missing a metal contact piece, which is causing the sump to malfunction.

**Photograph 1:** View of erosional rill from VLCS-1 overflow.

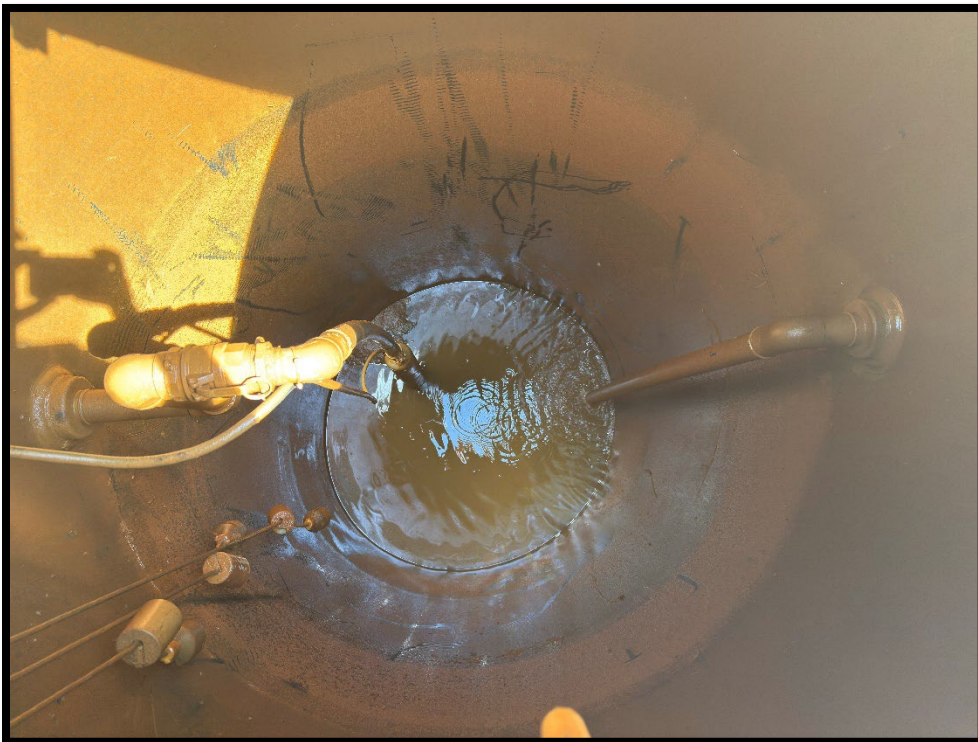
**Photograph 2:** View of VLCS-1 sump recently pumped out.

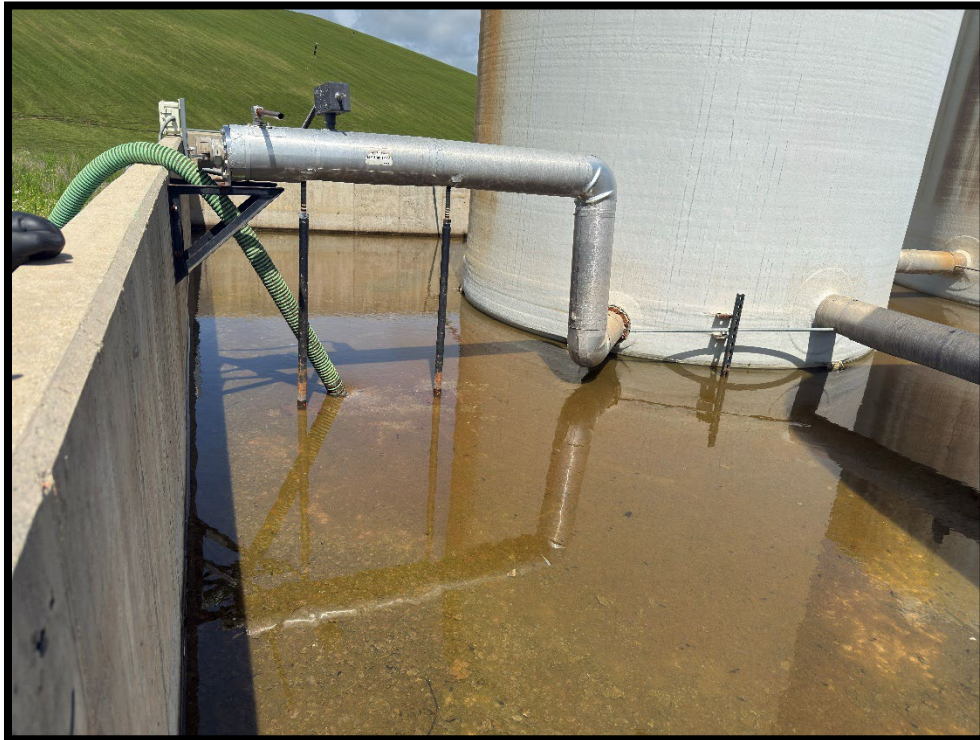
- Minimal stormwater was observed in the tank containment, as 417 Services were actively pumping the containment out (see photograph 3).
  - The panel displays were off at all LCS stations except LCS-2, LCS-5, and LCS-7.

**Photograph 3:** View of leachate tank containment.

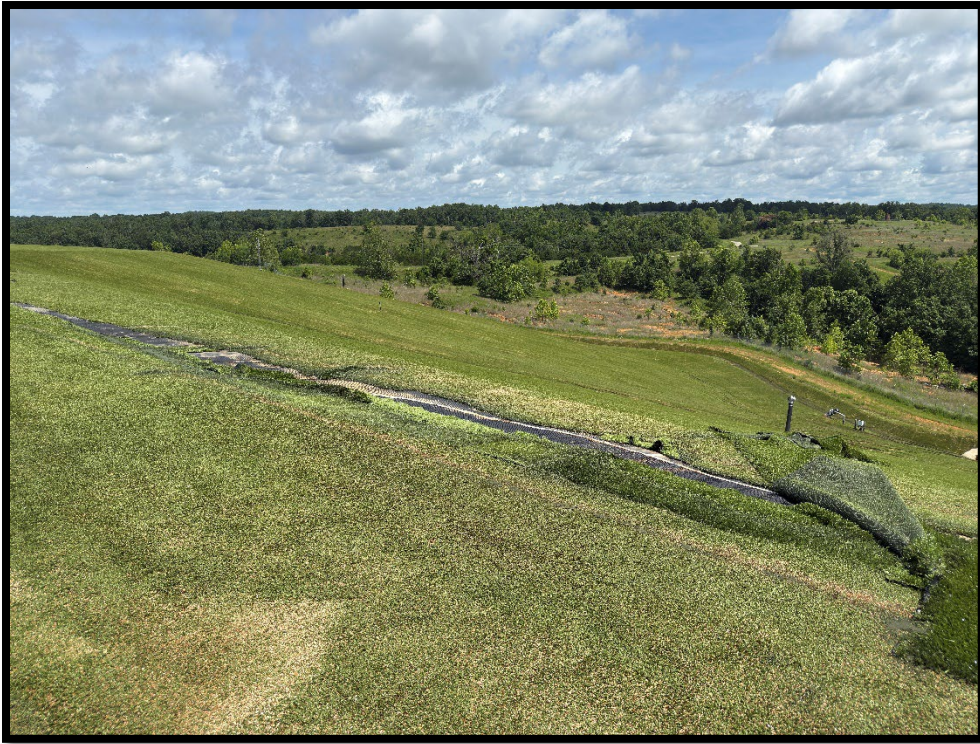
- LCS-5 level remained at 9.7 inches and did not activate when the sump was placed in “hand” or “auto” mode.
- LCS-7 level was at 0.0” and the station displayed a pump fault.
- The display at LCS-9 had been removed.
- An erosional washout is present along the road between LCS-4 and LCS-5.
- Damaged closure turf was observed on the east side of Area 1-3, above LCS-7 (see photographs 4-5).

**Photograph 5:** View of damaged closure turf on east side of Area 1-3.
