RE: Bi-weekly Site Inspection
NABORS Landfill
Mountain Home, AR
Harbor Project No: L82247885

Harbor visited the NABORS landfill in Mountain Home, Arkansas on June 4, 2025, to conduct the bi-weekly site inspection to assess the general condition of the landfill and the leachate collection system (LCS). The LCS was last fully repaired by Advanced Fluid Technologies (AFT) in October and November of 2022; however, within a few weeks of these repairs, the LCS began malfunctioning. By March 2023, most of the LCS points were malfunctioning. A quote was then requested and received from AFT to again repair the system. No authorization for the subsequent repairs was provided prior to the expiration of Harbor's contract with DEQ in June 2023.

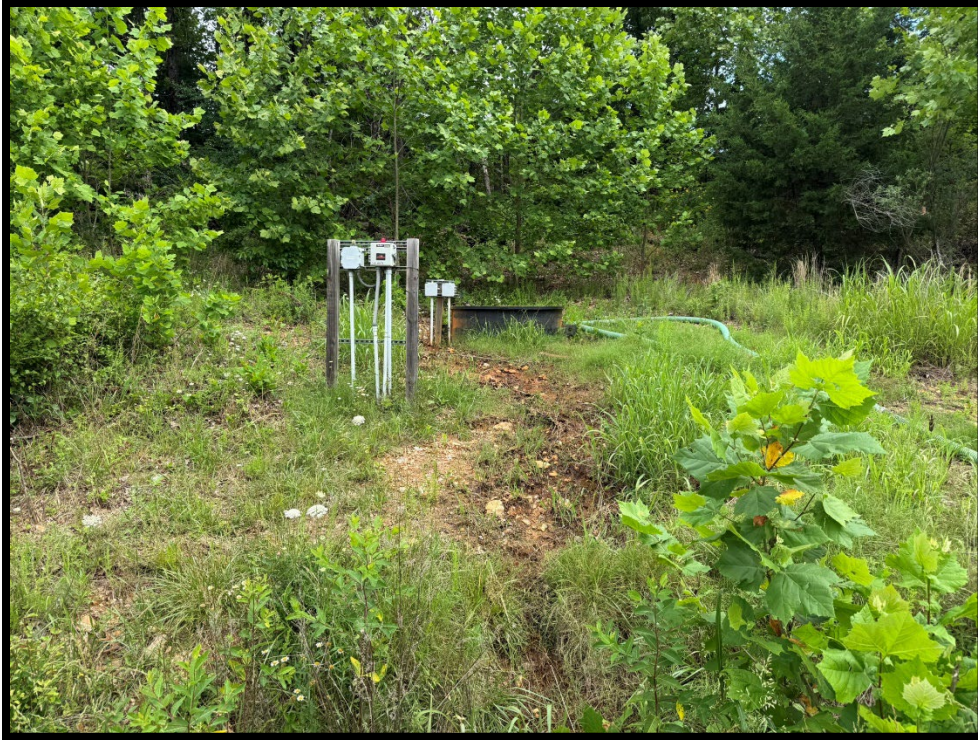
- Vertical leachate collection sump (VLCS)-1 is not functioning correctly and was observed at capacity and overflowing (see photographs 1-2). It appears that a fuse holder is missing a metal contact piece, which is causing the sump to malfunction.

Photograph 1: View of erosional rill from VLCS-1 overflow.

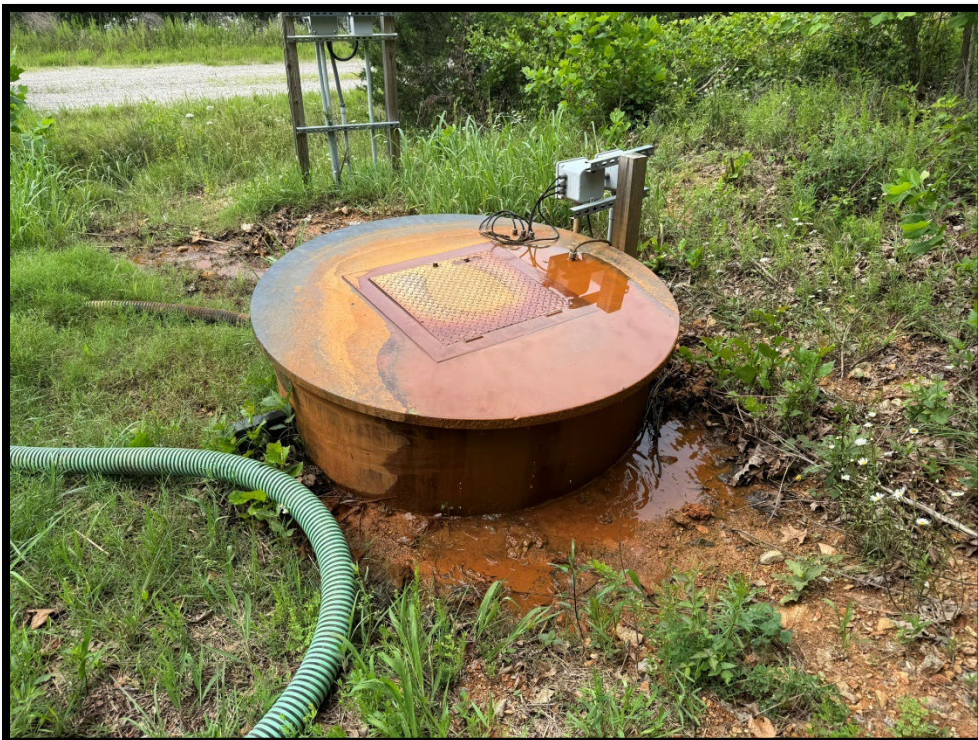
Photograph 2: View of VLCS-1 sump at capacity.

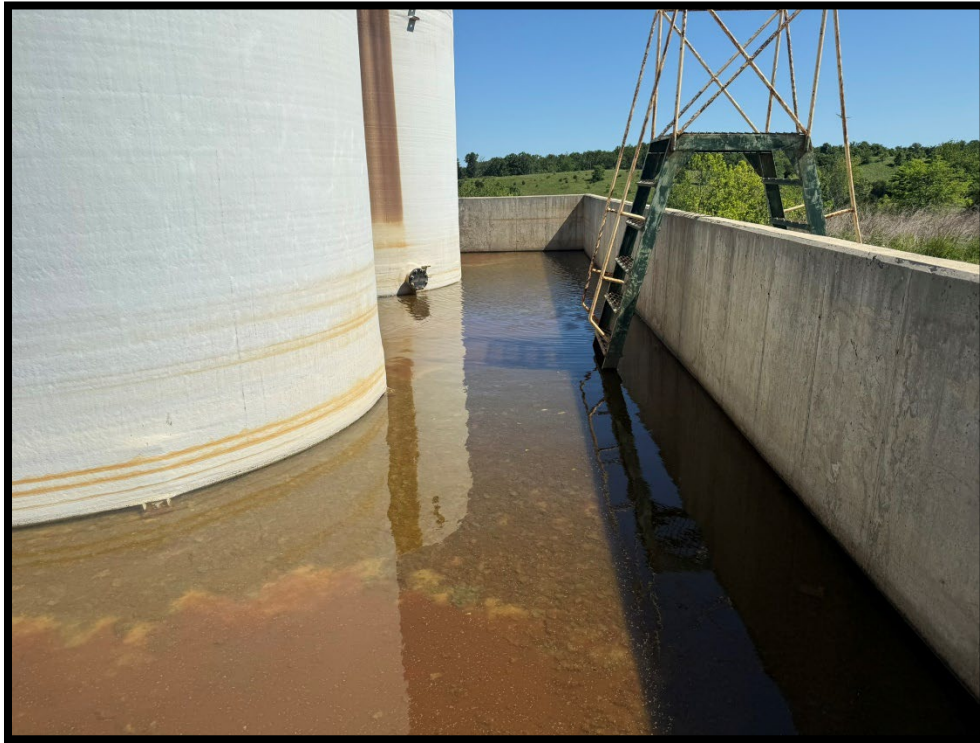
- Approximately eight inches of stormwater was observed in the leachate tank containment. Approximately three inches were released while Harbor was on-site (see photograph 3).

Photograph 3: View of leachate tank containment.
