**RE:** Bi-weekly Site Inspection  
NABORS Landfill  
Mountain Home, AR  
*Harbor Project No: ENSF-23299*

Harbor visited the NABORS landfill in Mountain Home, Arkansas on May 21, 2025, to conduct the bi-weekly site inspection to assess the general condition of the landfill and the leachate collection system (LCS). The LCS was last fully repaired by Advanced Fluid Technologies (AFT) in October and November of 2022; however, within a few weeks of these repairs, the LCS began malfunctioning. By March 2023, most of the LCS points were malfunctioning. A quote was then requested and received from AFT to again repair the system. No authorization for the subsequent repairs was provided prior to the expiration of Harbor's contract with DEQ in June 2023.

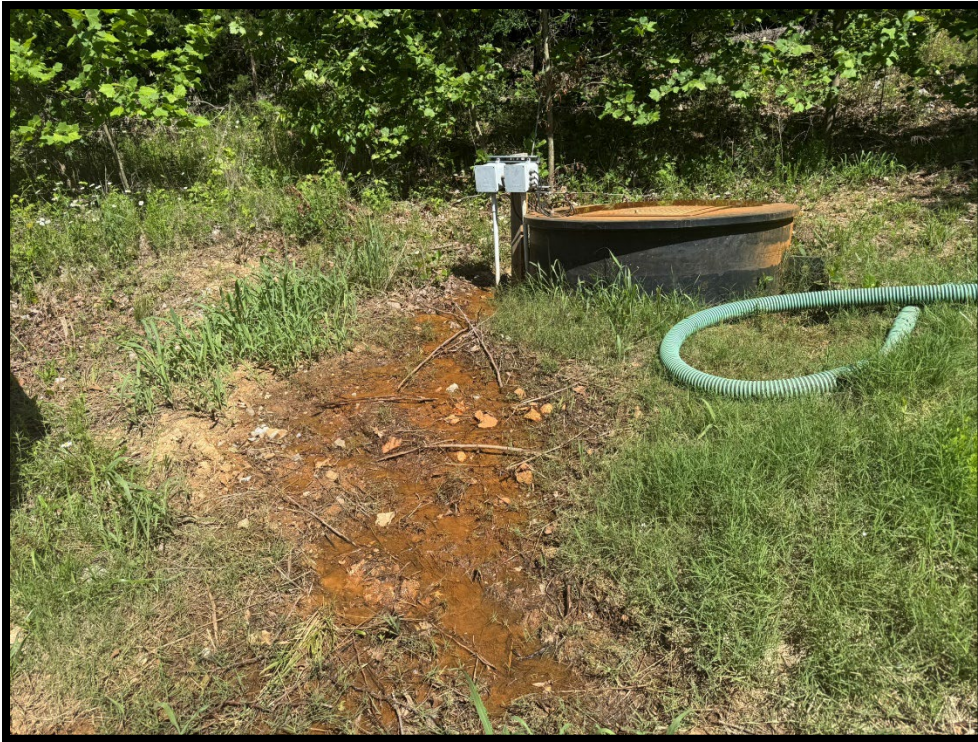
- Vertical leachate collection sump (VLCS)-1 is not functioning correctly and was observed at capacity and overflowing (see photographs 1-2). It appears that a fuse holder is missing a metal contact piece, which is causing the sump to malfunction.
  - VLCS-2 appeared to be functioning correctly and was observed at 1/2 capacity.
  - The leachate tank battery level was at 89.3 inches.
  - Minimal stormwater was observed in the leachate tank containment. As such, no water was released (see photograph 3).
  - The panel displays were off at all LCS stations except LCS-2, LCS-5, and LCS-7.
  - LCS-2 level was at 0.0 inches and did not activate when the sump was placed in "hand" or "auto" mode. LCS-2 also displayed a pump fault alarm.
  - LCS-5 level remained at 9.7 inches and did not activate when the sump was placed in "hand" or "auto" mode.
-

**Photograph 1:** View of erosional rill from VLCS-1 overflow.

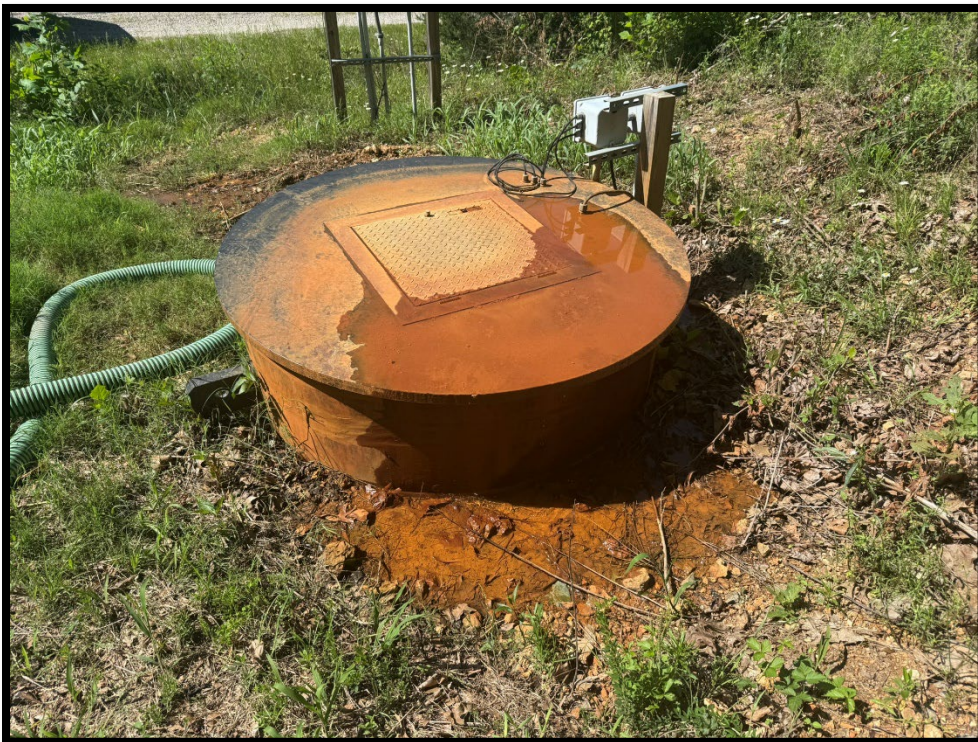
**Photograph 2:** View of VLCS-1 sump at capacity.

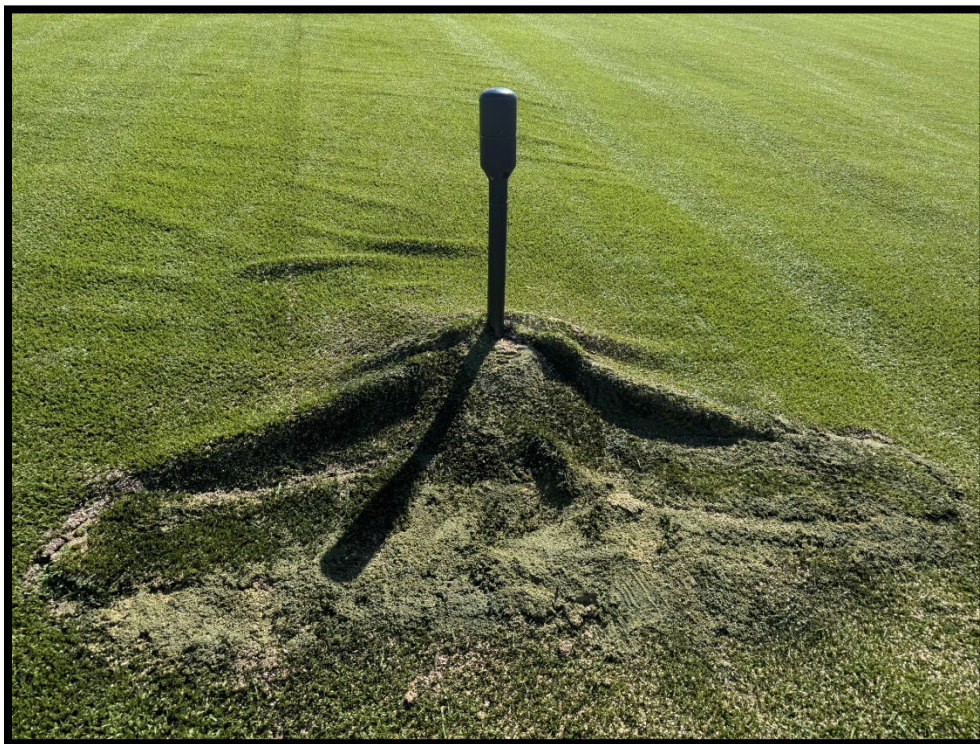
- LCS-7 level was at 0.0" and the station displayed a pump fault.
- The display at LCS-9 had been removed.
- The closure turf has some significant wrinkles present near LCS-1 and LCS-2. An erosional washout is present along the road between LCS-4 and LCS-5.
- According to a report from Watershed Geo, the closure turf wrinkles were stabilized using a material called DuraGuard by Cline Environmental. The report also stated that WatershedGeo and Cline Environmental made several repairs to the closure turf in September and December 2024. These repairs were apparent during Harbor's site visit (see photographs 4-6).

**Photograph 4:** View of repaired closure turf around a PRV on the north side of Area 1-2.

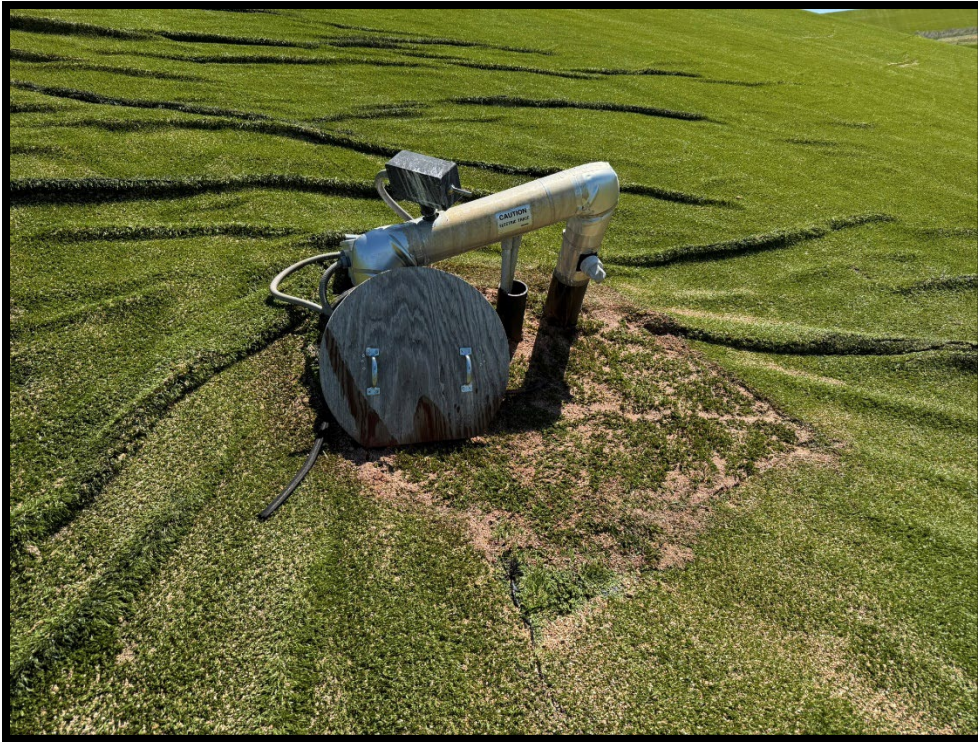
**Photograph 5:** View of closure turf repair at LCS-4 sump.

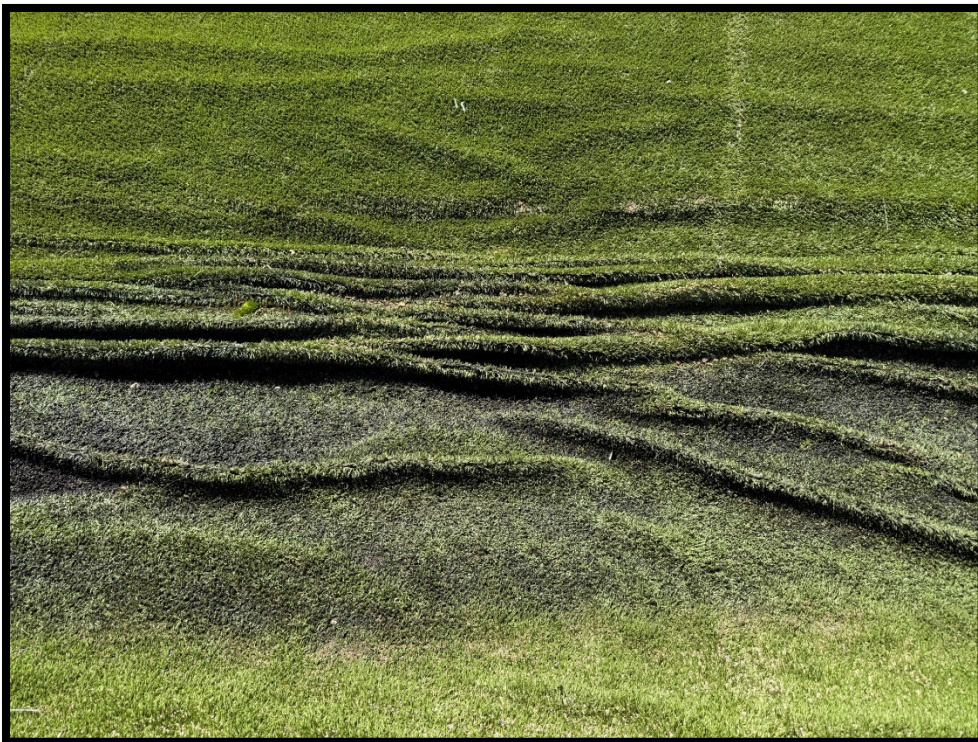
**Photograph 6:** View of coating added to closure turf wrinkles on north side Area 1-2.

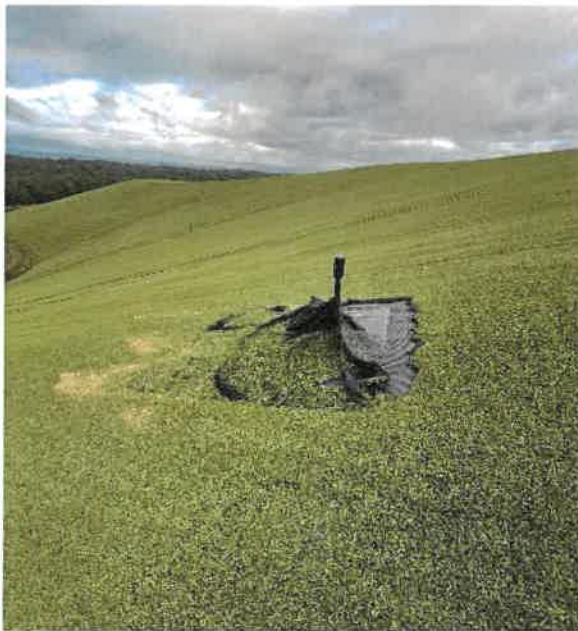
Figure 1. Bird damage around PRV

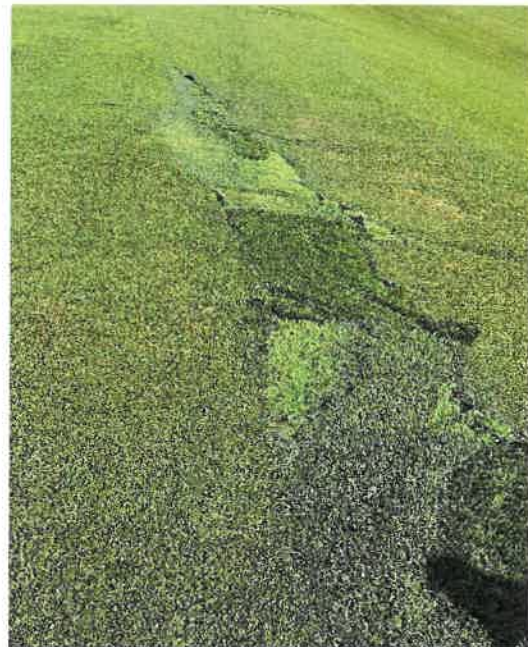
Figure 2. Bird damage at previously repaired location

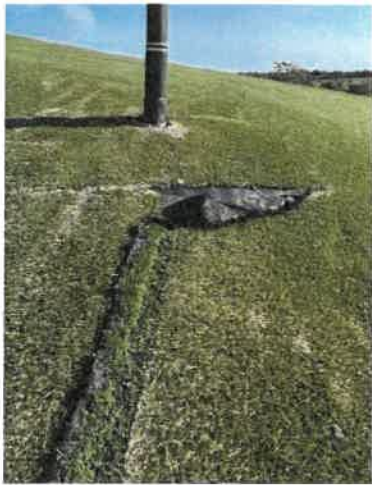
Figure 7. Bird damage at gas well

- Repaired bird damage around the gas well on the northwest slope as presented in Figure 7 and Figure 8;

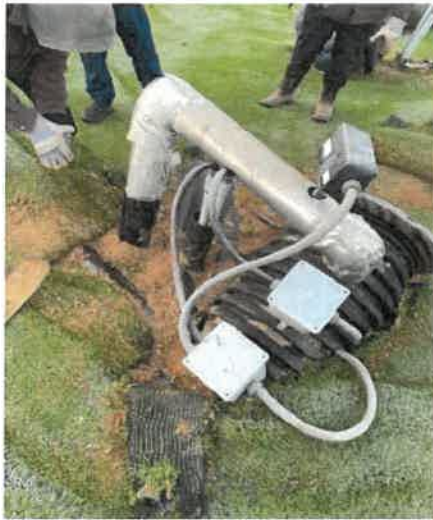
Figure 9. Settlement induced wrinkles and torn ClosureTurf® at leachate piping on south slope

- Addressed turf tears and wrinkles due to settlement near leachate piping on the south slope with new ClosureTurf®, infill, and UltraArmor™ as presented in Figure 9 and Figure 10; and

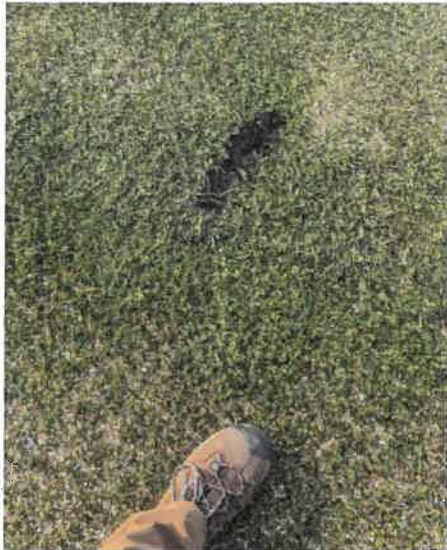
- There are areas of bird damage to the engineered turf layer. We observed approximately five (5) areas. Photos of the bird damage are shown in Attachment A – Photos 1, 2, and 3. The largest observed area of bird damage was approximately 10-ft by 10-ft as shown in Photo 3.
- The Passive Relief Vents (PRVs) appear to be in good condition with no observed movement or damage.
- The specified granular infill for the engineered turf is in place with no large areas of displacement or movement.
- The wrinkles previously noted along the north and west slopes of Area 1-2 do not appear to have changed since previous site visits.

**Photo 1 – Bird Damage of  
Engineered Turf**

- Fix the bird damage by replacing the engineered turf, welding the edges of the new turf to existing turf, and infilling the turf with a bound infill product (i.e., HydroBinder® or UltraArmor™).
- Repair or replace damaged PRVs. None were noted on our site visit, but WG will evaluate again.
- Replace infill in areas where there is no specified granular infill, and the backing geotextile of the engineered turf is exposed. No areas of infill displacement were noted on our site visit, but WG will evaluate again.
- Place DuraGuard™ protection on wrinkles as needed.

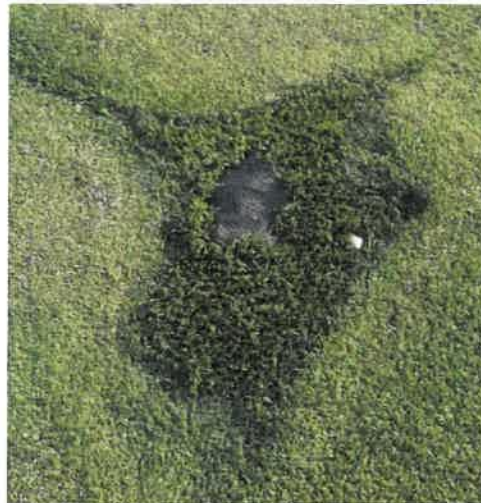
**Photo 2 – Bird Damage of  
Engineered Turf**

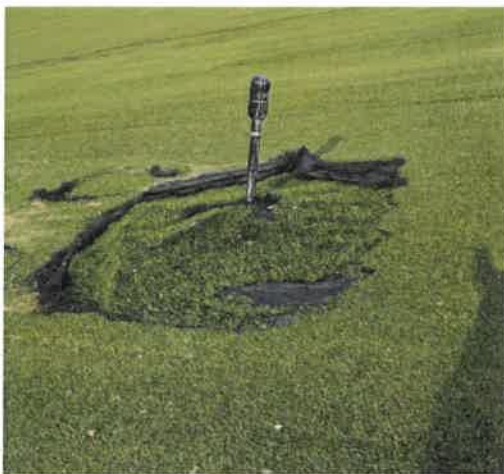
**Photo 3 – Bird Damage of  
Engineered Turf Around Passive  
Relief Vent (PRV)**

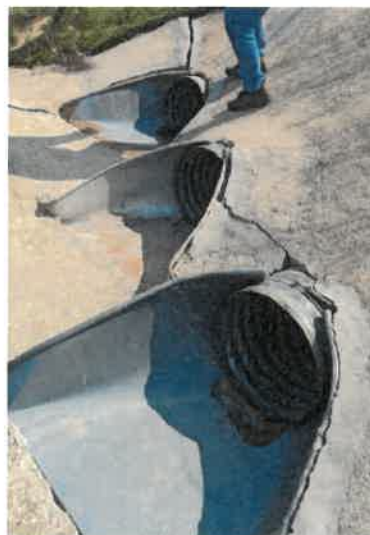
- The storm water inlet structure on the south side of Area 1-2 is settling, cracked, and undermined. See Photos 4, 5 and 6 in the Attachment A. This structure is not a part of the ClosureTurf system. If it continues to settle and undermine, it will impact the ClosureTurf and cause significant damage to the cover system, landfill storm water system, and landfill access road. WG suggests that ADEQ have this inlet structure repaired.

**Photo 4 – Storm Water Inlet  
Structure**

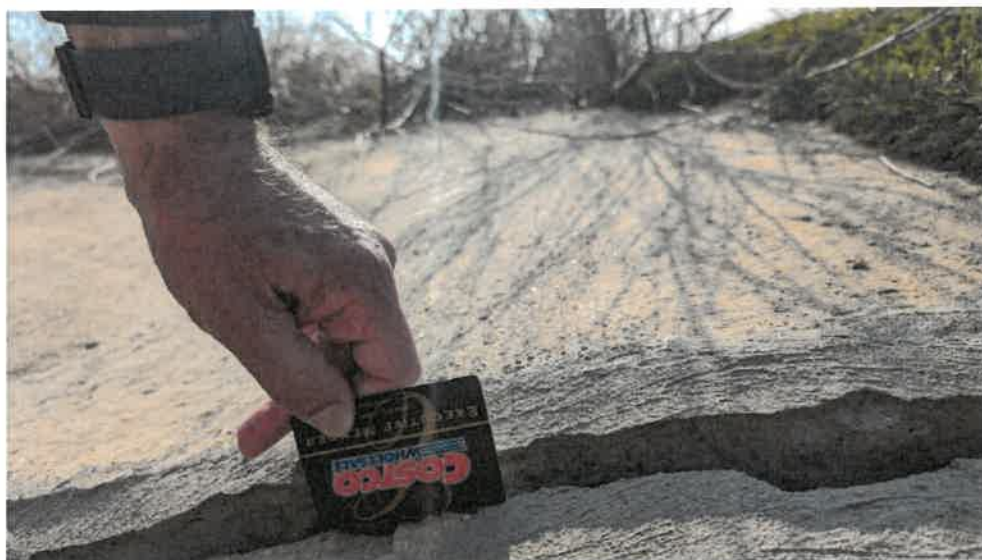
**Photo 5 – Storm Water Inlet  
Structure**

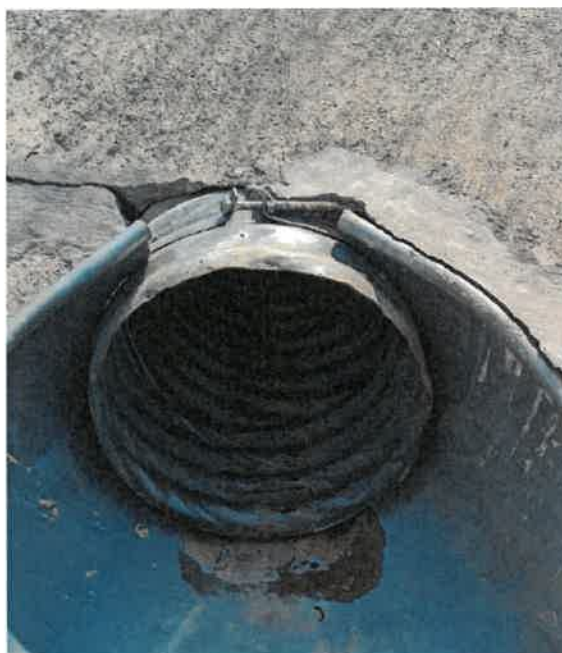
**Photo 6 – Storm Water Inlet  
Structure**
