DATE: May 15, 2025

FROM: Caleb Gourley, Senior Staff Scientist, Harbor

RE: Bi-weekly Site Inspection
NABORS Landfill
Mountain Home, AR
Harbor Project No: ENSF-23299

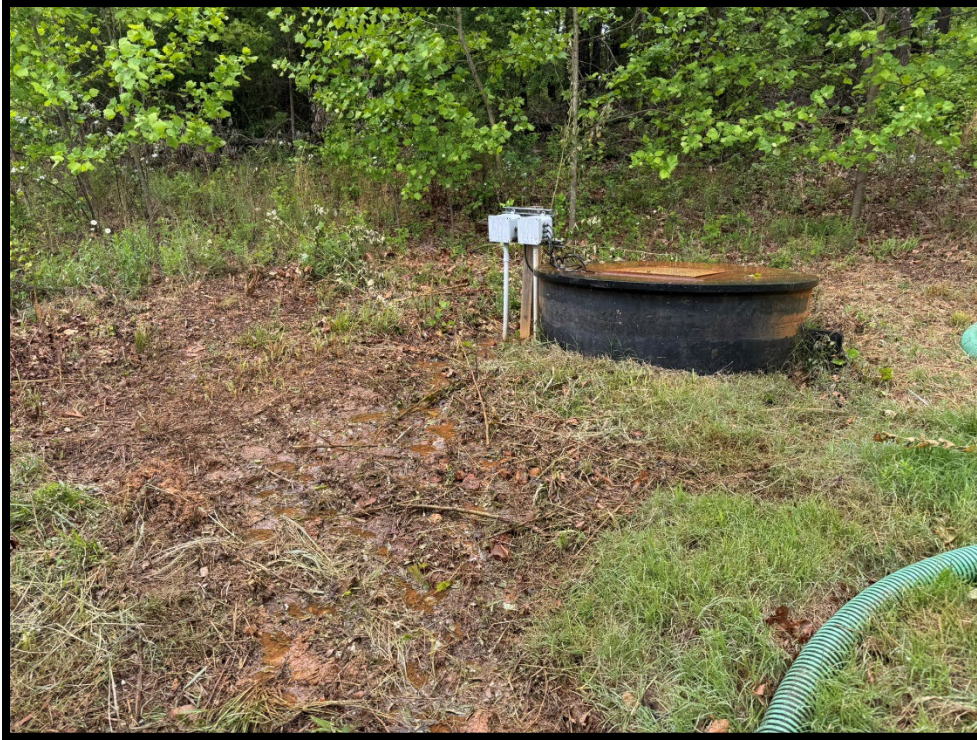
- Vertical leachate collection sump (VLCS)-1 is not functioning correctly and was observed at capacity and overflowing (see photographs 1-2). It appears that a fuse holder is missing a metal contact piece, which is causing the sump to malfunction.
 - VLCS-2 appeared to be functioning correctly and was observed at 1/2 capacity.
 - The leachate tank battery level was at 91.1 inches.
 - Minimal stormwater was observed in the leachate tank containment. As such, no water was released (see photograph 3).
 - The panel displays were off at all LCS stations except LCS-2, LCS-5, and LCS-7.
 - LCS-2 level was at 0.0 inches and did not activate when the sump was placed in "hand" or "auto" mode. LCS-2 also displayed a pump fault alarm.
 - LCS-5 level remained at 9.7 inches and did not activate when the sump was placed in "hand" or "auto" mode.
-

Photograph 1: View of erosional rill from VLCS-1 overflow.

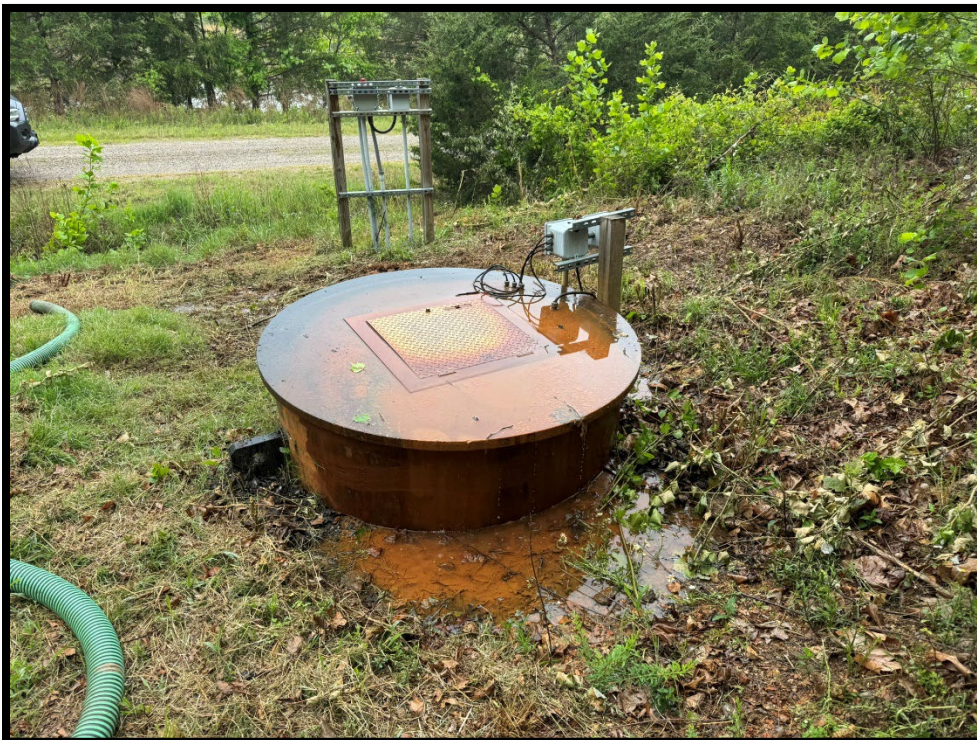
Photograph 2: View of VLCS-1 sump at capacity.

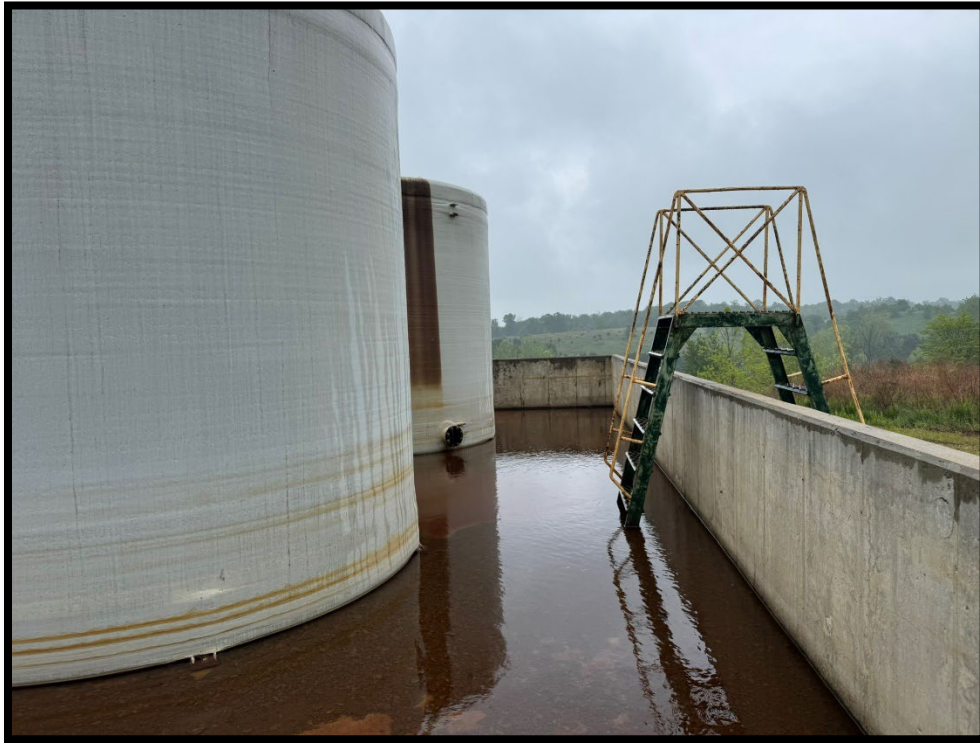
Photograph 3: View of leachate tank containment.

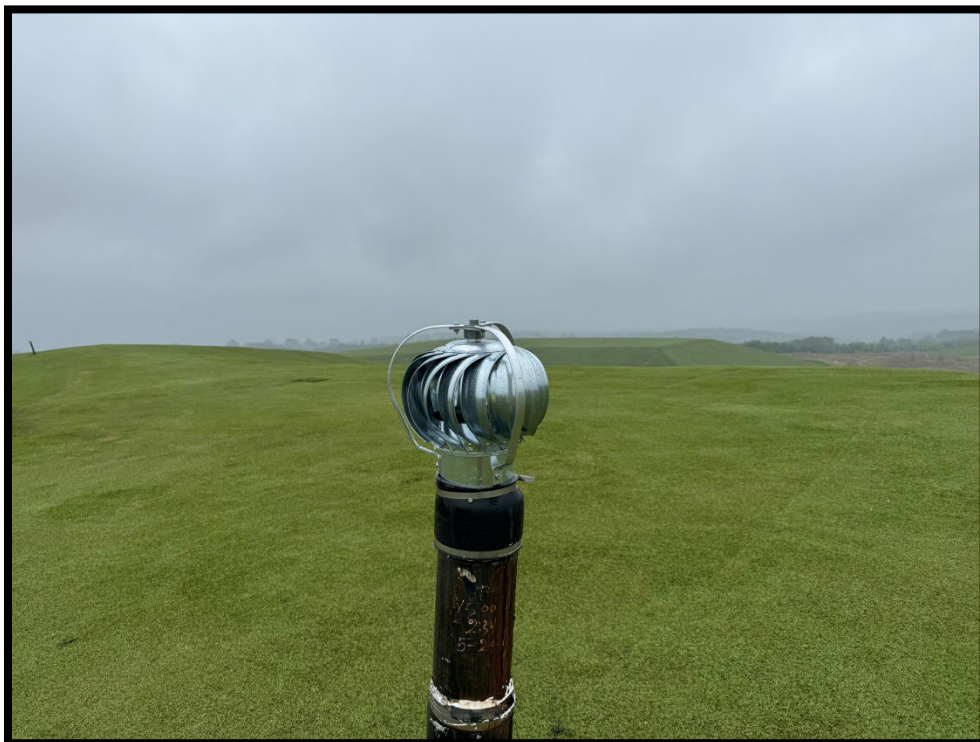
- LCS-7 level was at 0.0" and the station displayed a pump fault.
- The display at LCS-9 had been removed.
- The closure turf has some significant rills present near LCS-1 and LCS-2. These rills have sediment deposited in them which allows vegetation to grow. An erosional washout is present along the road between LCS-4 and LCS-5.
- The turbine vent that had become detached on Area 1-2 (near coordinates 36.46114, -92.45014) was repaired (see photograph 4).

Photograph 4: View of repaired turbine vent on north side of Area 1-2.
