RE: Bi-weekly Site Inspection

NABORS Landfill

Mountain Home, AR

Harbor Project No: L8247885

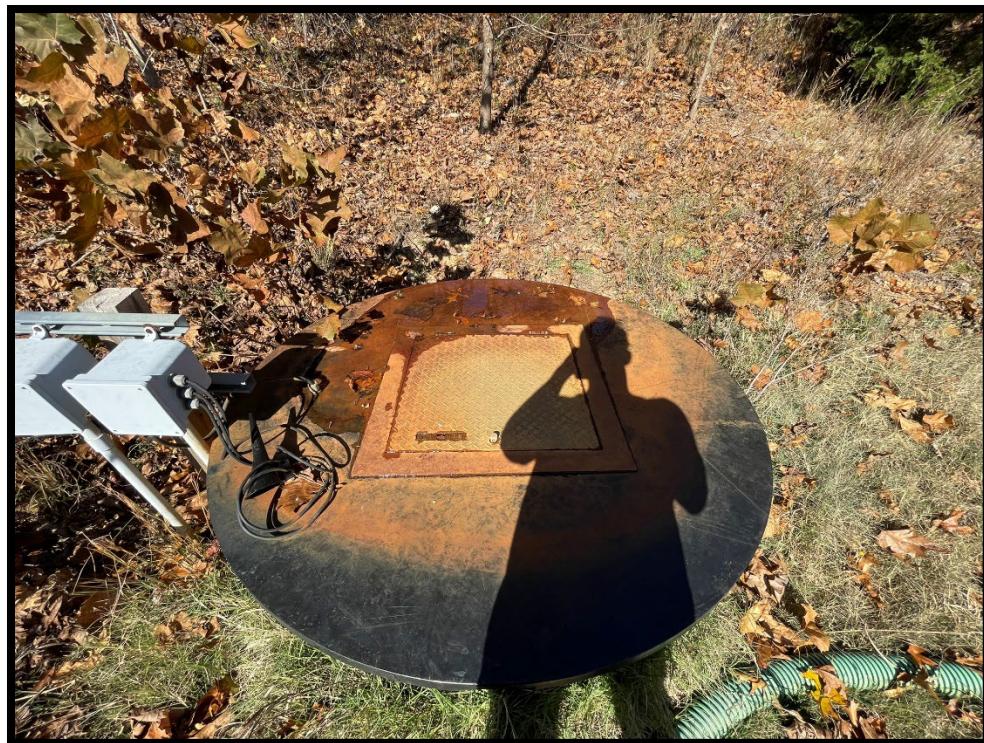
- Vertical leachate collection sump (VLCS)-1 was not functioning correctly, and the sump was observed overflowing (see photograph 1).
- VLCS-2 appeared to be functioning correctly and was observed at 1/2 capacity.
- The leachate tank battery level was 71.5 inches.
- No stormwater was observed in the secondary containment. As such, none was released (see photograph 2).

Photograph 1: View of VLCS-1 at capacity and overflowing.

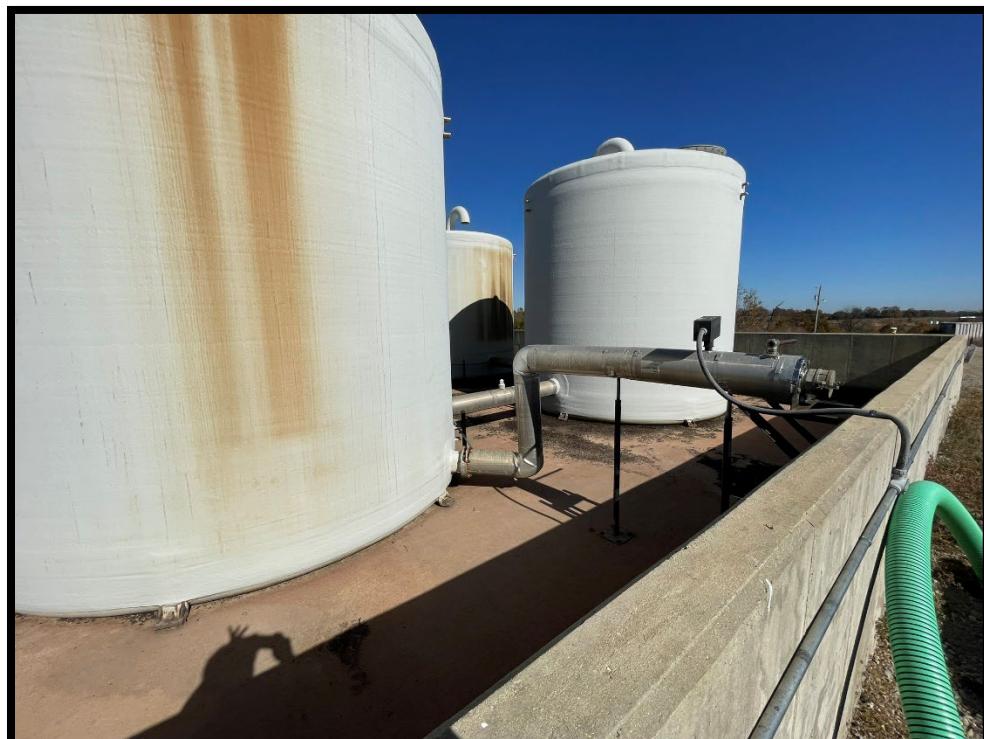
Photograph 2: View of empty secondary containment at leachate tank battery.

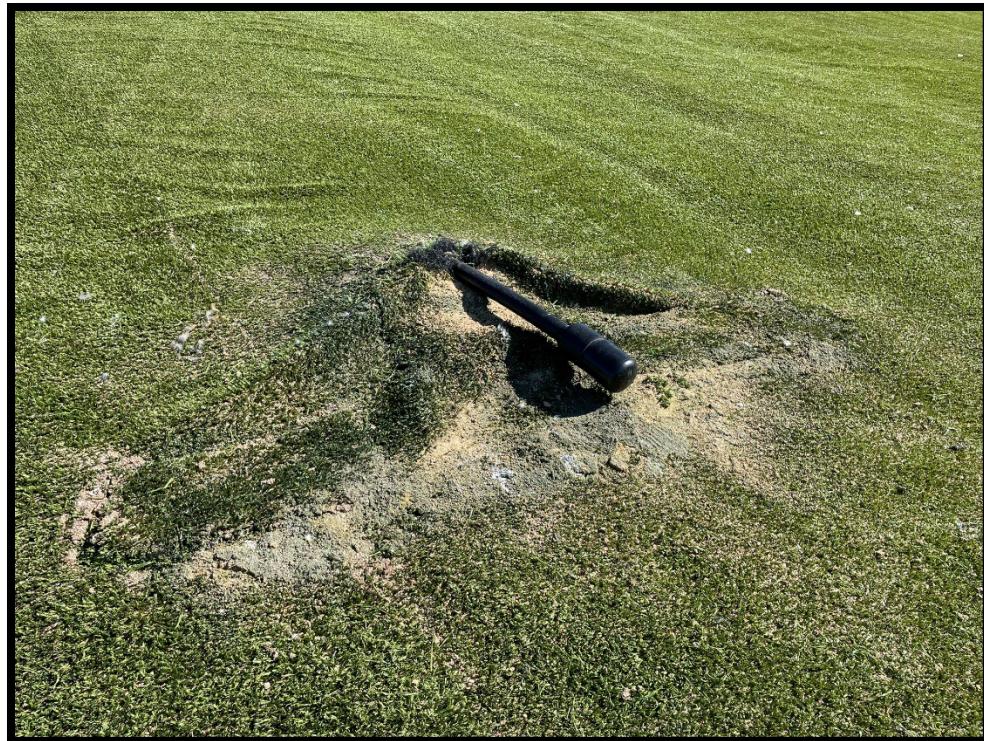
- An erosional washout is present along the road between LCS-4 and LCS-5.
- A damaged pressure relief vent (PRV) was observed on the west side of Area 1-2, between LCS-1 and LCS-2 (see photograph 3). The damage is located near coordinates 36.46144, -92.45128.

Photograph 3: View of damaged pressure relief vent on west side of Area 1-2.

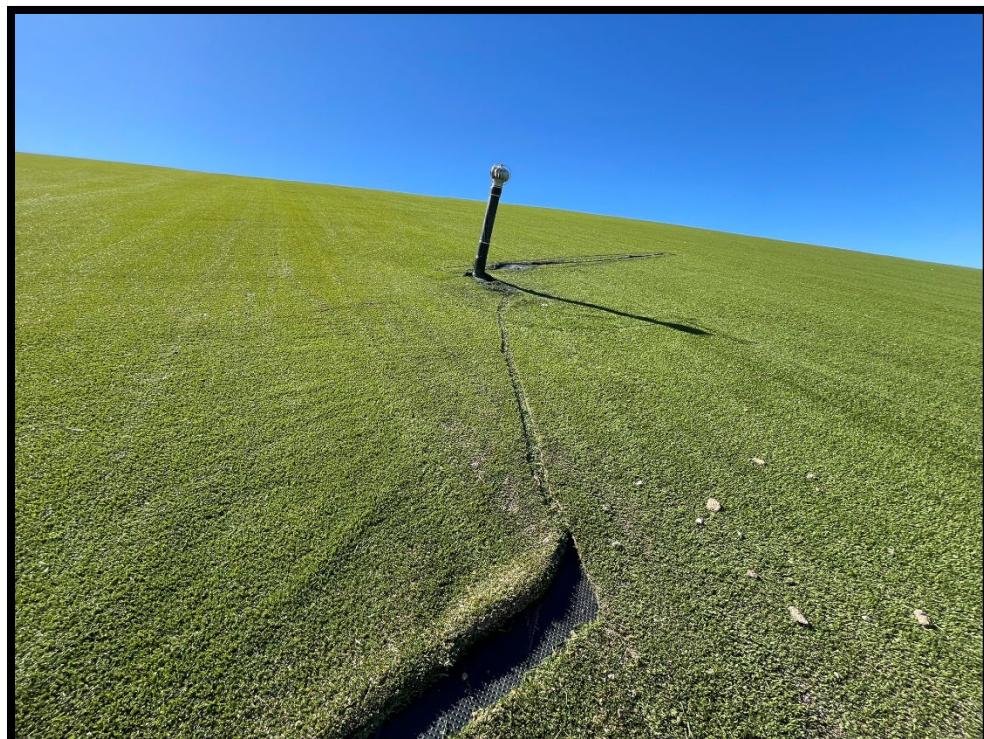
- Damaged closure turf was observed on the north side of Area 1-2 at coordinates 36.46181, -92.45045 (see photograph 4). The damage is approximately 30 feet long by 3 feet wide. The damage was first observed on July 2, 2025.

Photograph 4: View of damaged closure turf on the north side of Area 1-2.

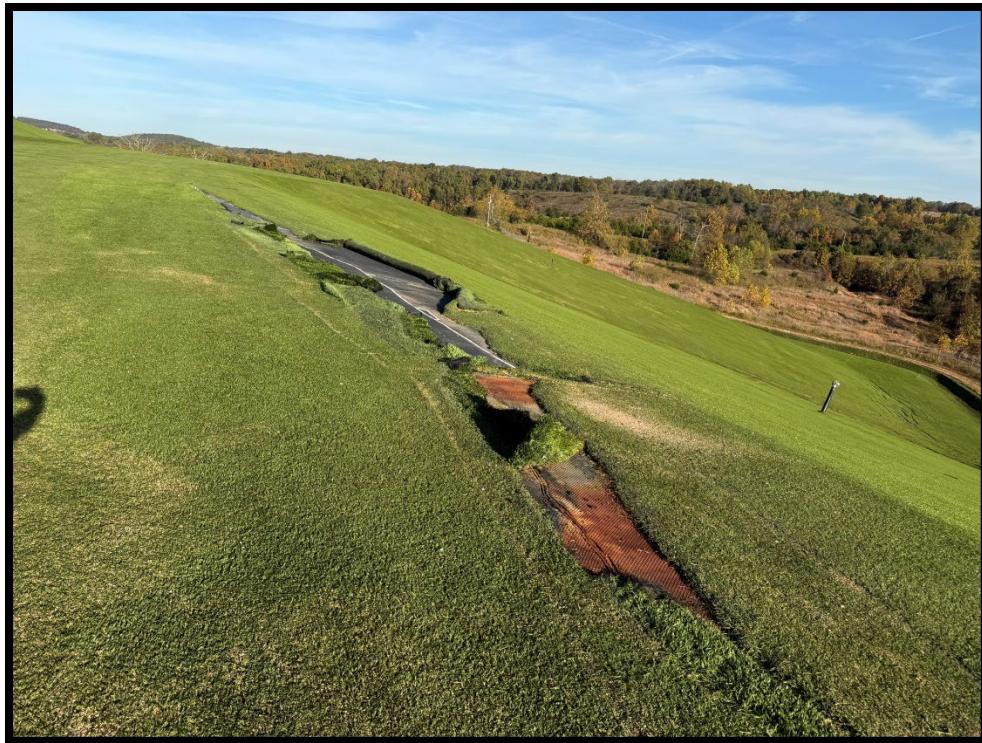
- Damaged closure turf was observed on the east side of Area 1-3, above LCS-7 (see photograph 5). The damage is approximately 100 feet long by 9 feet wide. The closure turf tear was first observed on June 17, 2025.

Photograph 5: View of damaged closure turf on east side of Area 1-3.
