DATE: December 1, 2025

FROM: Ian Klein, P.E., *Environmental Engineer, Harbor*

RE: Bi-weekly Site Inspection
NABORS Landfill
Mountain Home, AR
Harbor Project No: L8247885

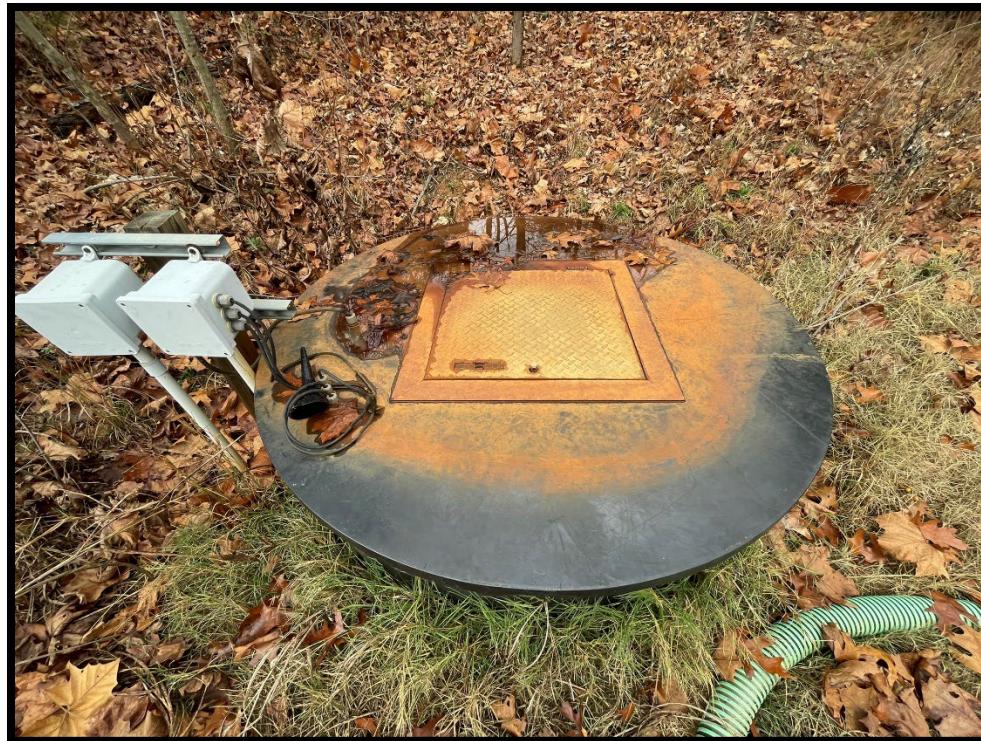
- Vertical leachate collection sump (VLCS)-1 was not functioning correctly, and the sump was observed overflowing (see photograph 1).
- VLCS-2 appeared to be functioning correctly and was observed at 1/2 capacity.
- The leachate tank battery level was 71.5 inches. This is the same level recorded during the previous site visit.

Photograph 1: View of VLCS-1 at capacity and overflowing.

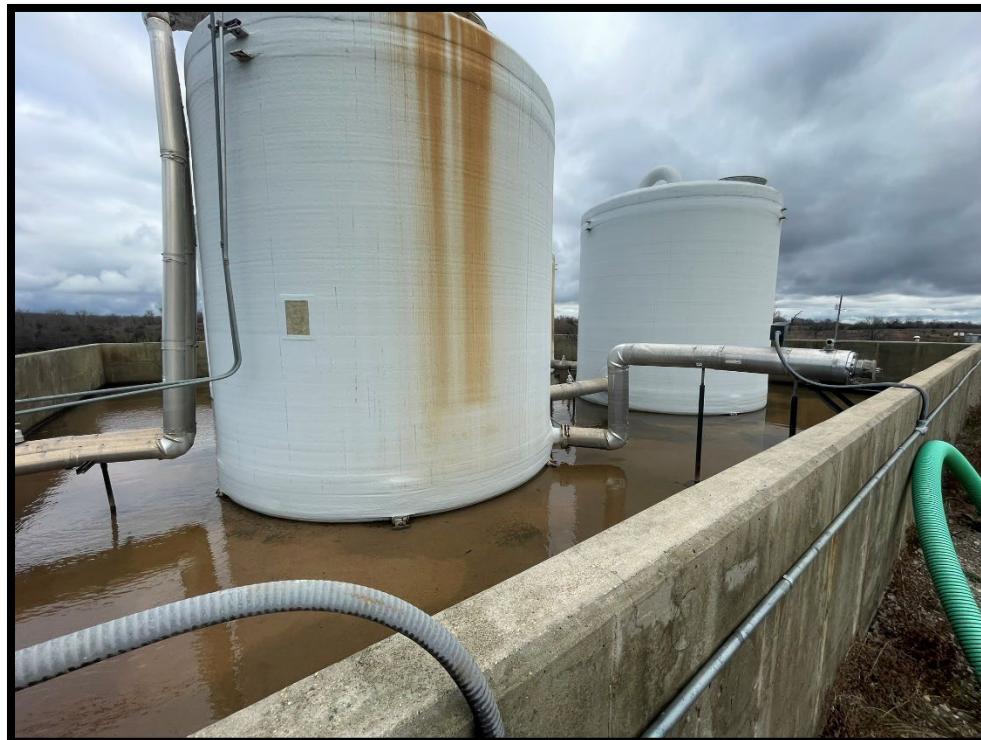
- Three inches of stormwater was observed in the secondary containment. The pH of the stormwater was measured at 8.9, and the drainpipe was opened to release it (see photograph 2).

Photograph 2: View of stormwater in secondary containment at leachate tank battery.

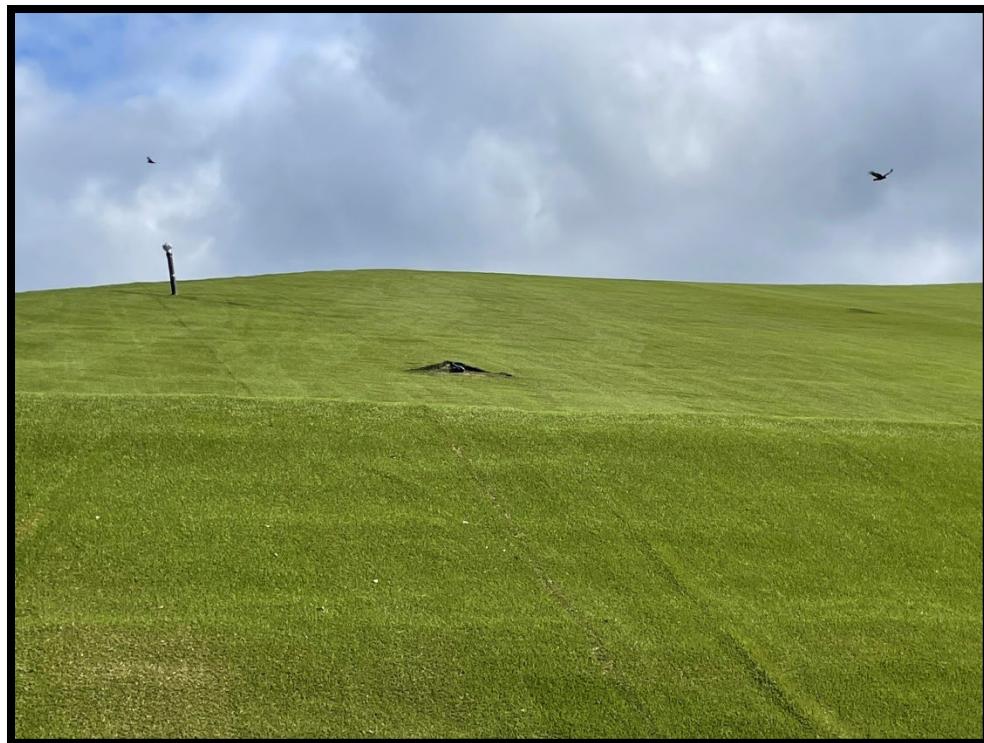
- An erosional washout is present along the road between LCS-4 and LCS-5.
- A damaged pressure relief vent (PRV) was observed on the west side of Area 1-2, between LCS-1 and LCS-2 (see photograph 3). The damage is located near coordinates 36.46144, -92.45128.

Photograph 3: View of damaged pressure relief vent on west side of Area 1-2.

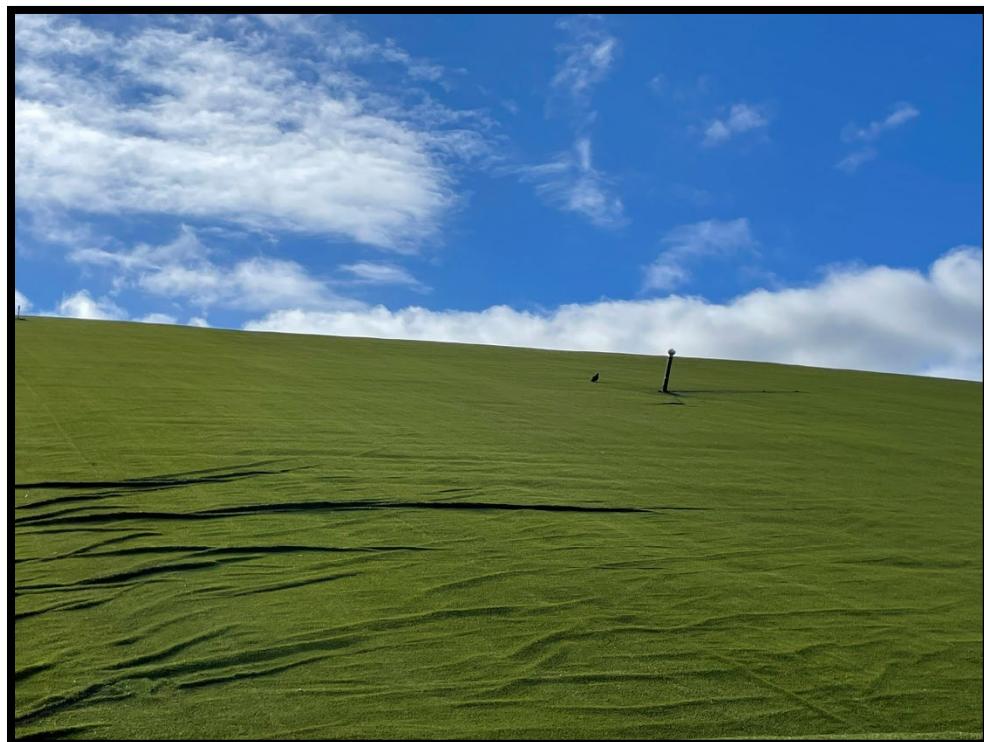
- Damaged closure turf was observed on the north side of Area 1-2 at coordinates 36.46181, -92.45045 (see photograph 4). The damage is approximately 30 feet long by 3 feet wide. The damage was first observed on July 2, 2025.

Photograph 4: View of damaged closure turf on the north side of Area 1-2.

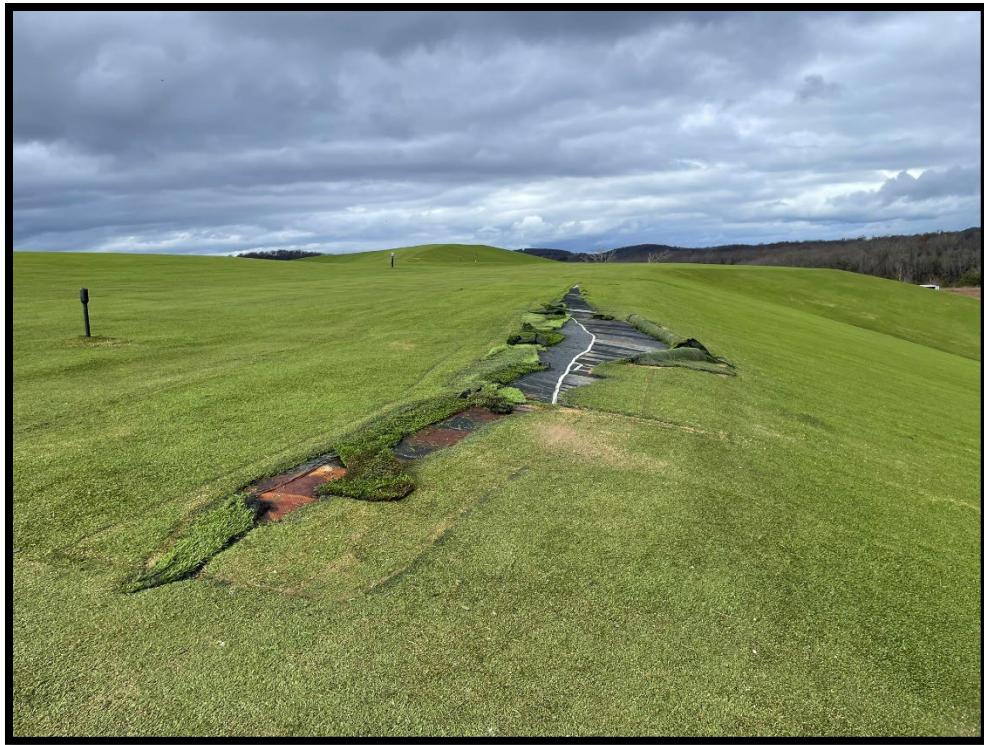
- Damaged closure turf was observed on the east side of Area 1-3, above LCS-7 (see photograph 5). The damage is approximately 100 feet long by 9 feet wide. The closure turf tear was first observed on June 17, 2025.

Photograph 5: View of damaged closure turf on east side of Area 1-3.
