**DATE:** October 15, 2025

**TO:** Emily Brickman, P.G., *Senior Project Manager – Geologist, EnSafe*

**FROM:** Caleb Gourley, Senior Staff Scientist, Harbor

**RE:** Bi-weekly Site Inspection  
NABORS Landfill  
Mountain Home, AR  
*Harbor Project No: L8247885*

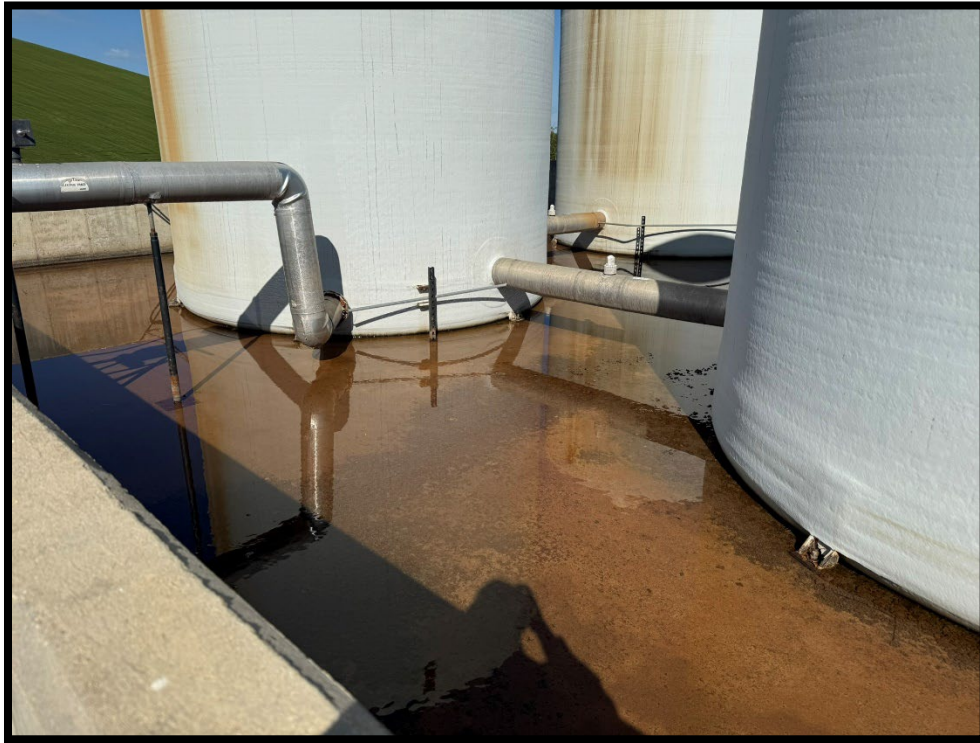
- Vertical leachate collection sump (VLCS)-1 was recently pumped out by 417 services to prevent an overflow event. As such, minimal leachate was observed in the sump.
  - VLCS-2 appeared to be functioning correctly and was observed at ½ capacity.
  - The leachate tank battery level was 113.5".
  - Minimal stormwater was observed in the tank containment. As such, none was released while Harbor was on-site (see photograph 1).
-

**Photograph 1:** View of minimal stormwater in containment.

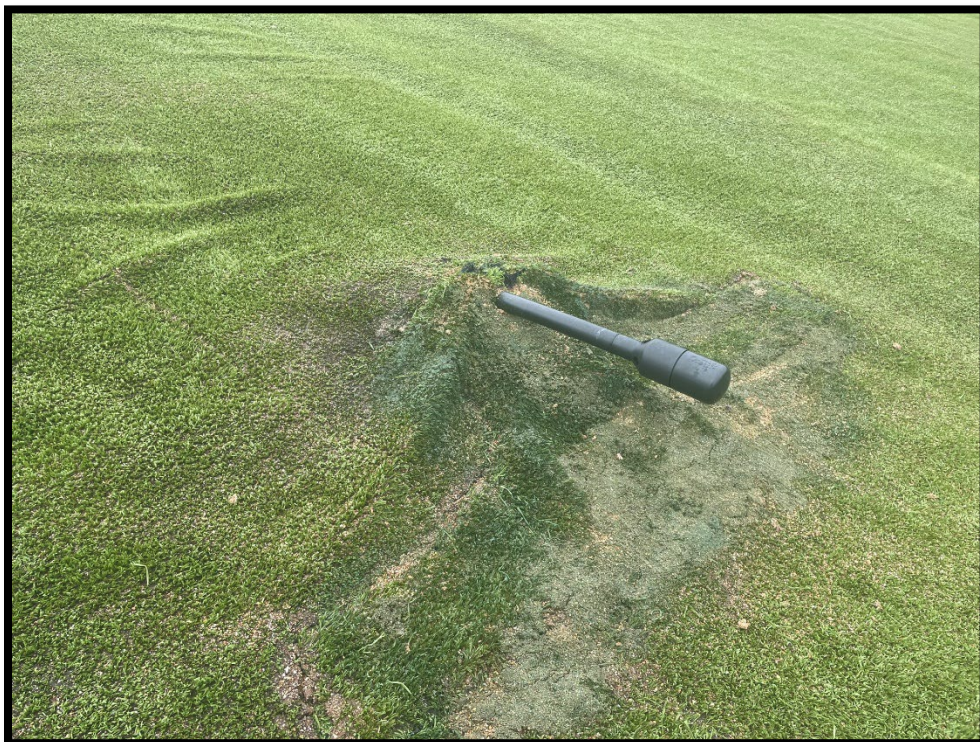
- An erosional washout is present along the road between LCS-4 and LCS-5.
- A damaged pressure relief vent (PRV) was observed on the west side of Area 1-2, between LCS-1 and LCS-2 (see photograph 2). The damage is located near coordinates 36.46144, -92.45128.

**Photograph 2:** View of damaged pressure relief vent on west side of Area 1-2.

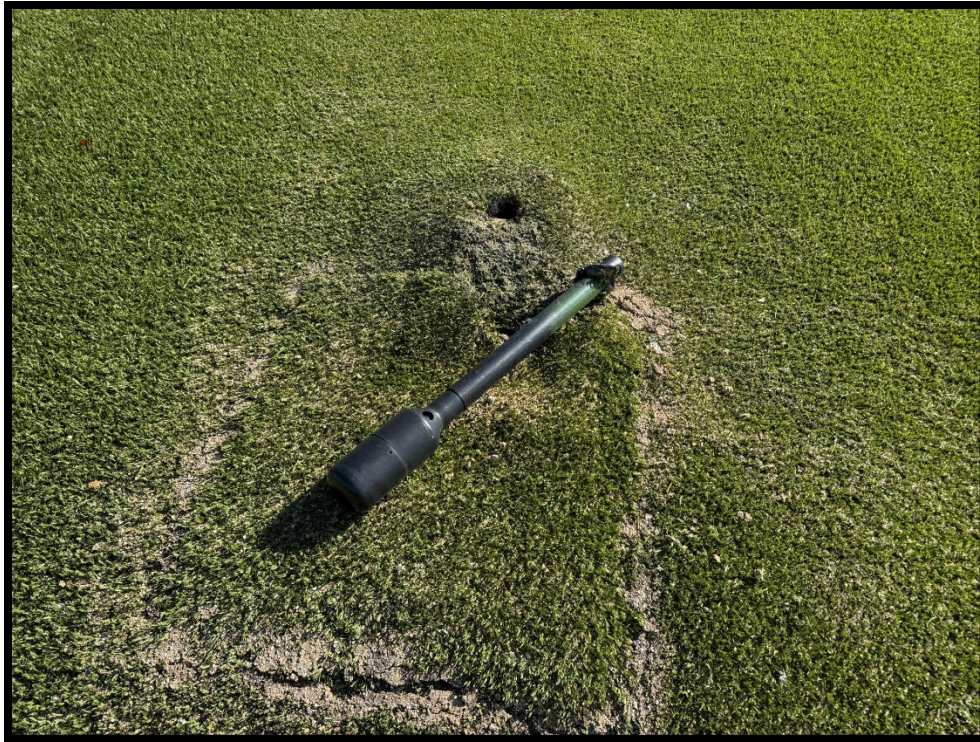
- An additional damaged PRV was observed on the west side of Area 1-2 (see photograph 3). The damage is located near coordinates 36.46133, -92.45082.
- Damaged closure turf was observed on the north side of Area 1-2 at coordinates 36.46181, -92.45045 (see photograph 4). The damage is approximately 30 feet long by 3 feet wide. The damage was first observed on 7/2/2025.

**Photograph 3:** View of damaged pressure relief vent on west side of Area 1-2.

- 2nd broken PRV

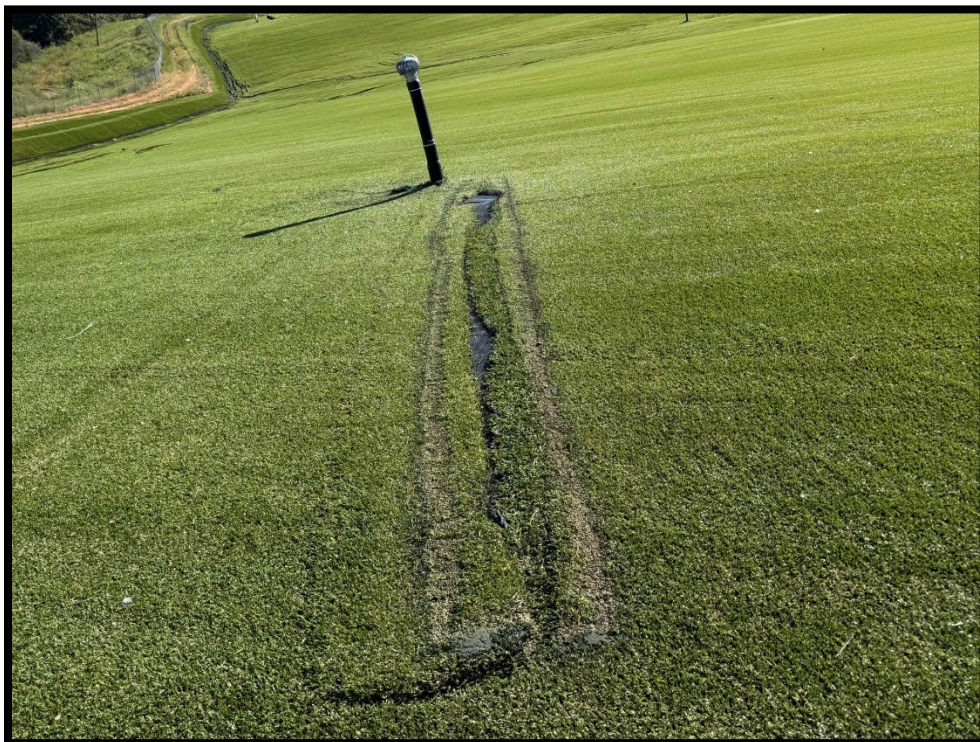
**Photograph 3:** View of damaged closure turf on the north side of Area 1-2.

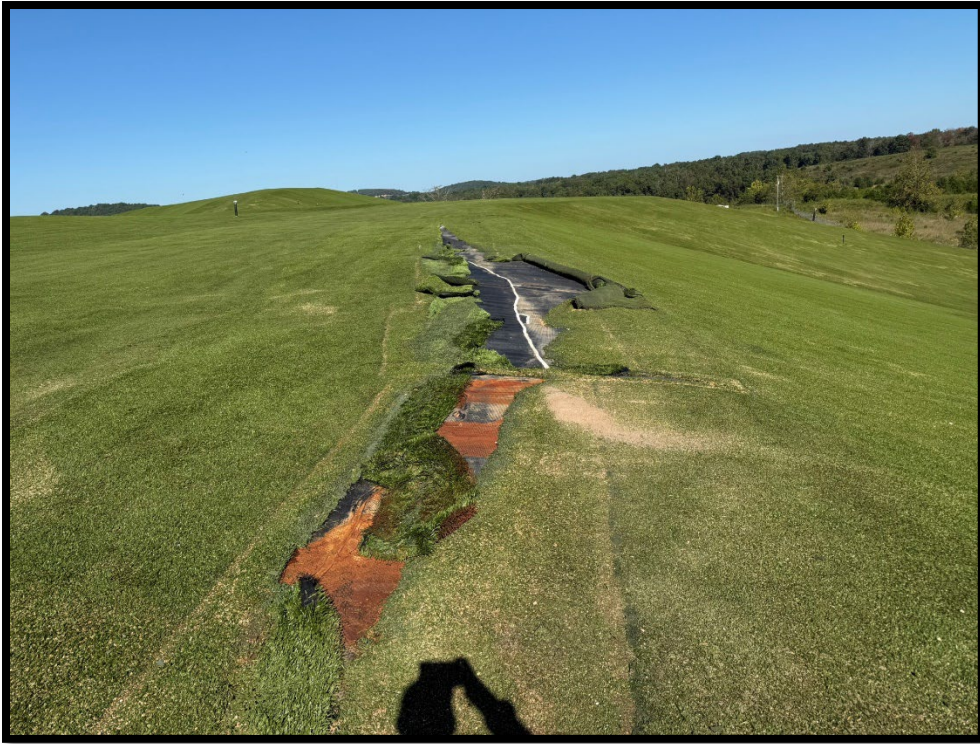
- Damaged closure turf was observed on the east side of Area 1-3, above LCS-7 (see photograph 5). The damage is approximately 100 feet long by 9 feet wide. The closure turf tear was first observed on 6/17/2025.

**Photograph 5:** View of damaged closure turf on east side of Area 1-3.
