RE: Bi-weekly Site Inspection
NABORS Landfill
Mountain Home, AR
Harbor Project No: L8247885

Harbor visited the NABORS landfill in Mountain Home, Arkansas on September 10, 2025, to conduct the bi-weekly site inspection to assess the general condition of the landfill and the leachate collection system (LCS). The LCS was last fully repaired by Advanced Fluid Technologies (AFT) in October and November of 2022; however, within a few weeks of these repairs, the LCS began malfunctioning. By March 2023, most of the LCS points were malfunctioning. A quote was then requested and received from AFT to again repair the system. No authorization for the subsequent repairs was provided prior to the expiration of Harbor's contract with DEQ in June 2023.

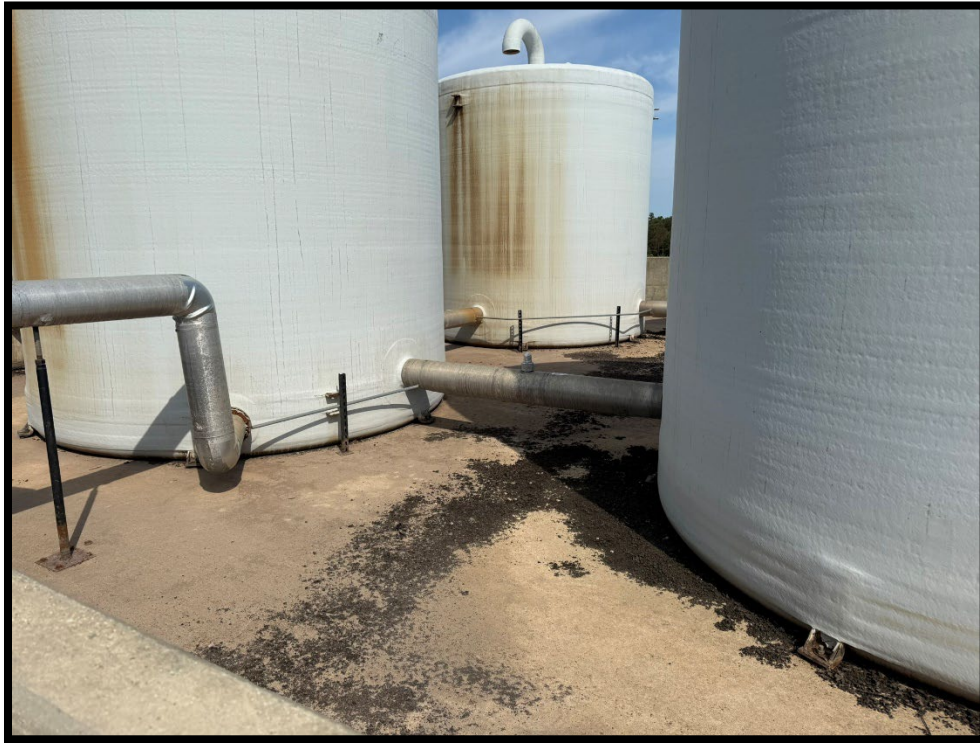
- Vertical leachate collection sump (VLCS)-1 was not overflowing and observed at 3/4 capacity.
 - VLCS-2 appeared to be functioning correctly and was observed at 1/4 capacity.
 - The leachate tank battery level was 115.9". Landmarc installed a new level indicator sensor on the leachate tanks while on-site.
 - No stormwater was observed in the tank containment. As such, none was released while Harbor was on-site (see photograph 1).
-

Photograph 1: View of no stormwater in containment.

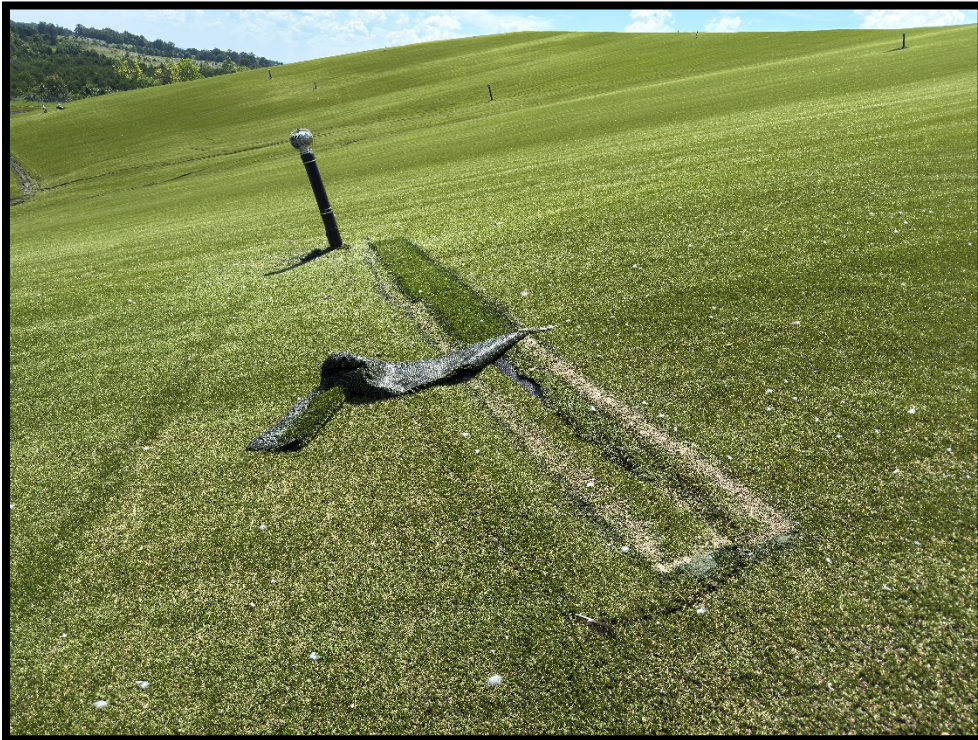
- Damaged closure turf was observed on the north side of Area 1-2 at coordinates 36.46181, -92.45045 (see photograph 3).
- Damaged closure turf was observed on the east side of Area 1-3, above LCS-7 (see photograph 4).

Photograph 3: View of damaged closure turf on the north side of Area 1-2.

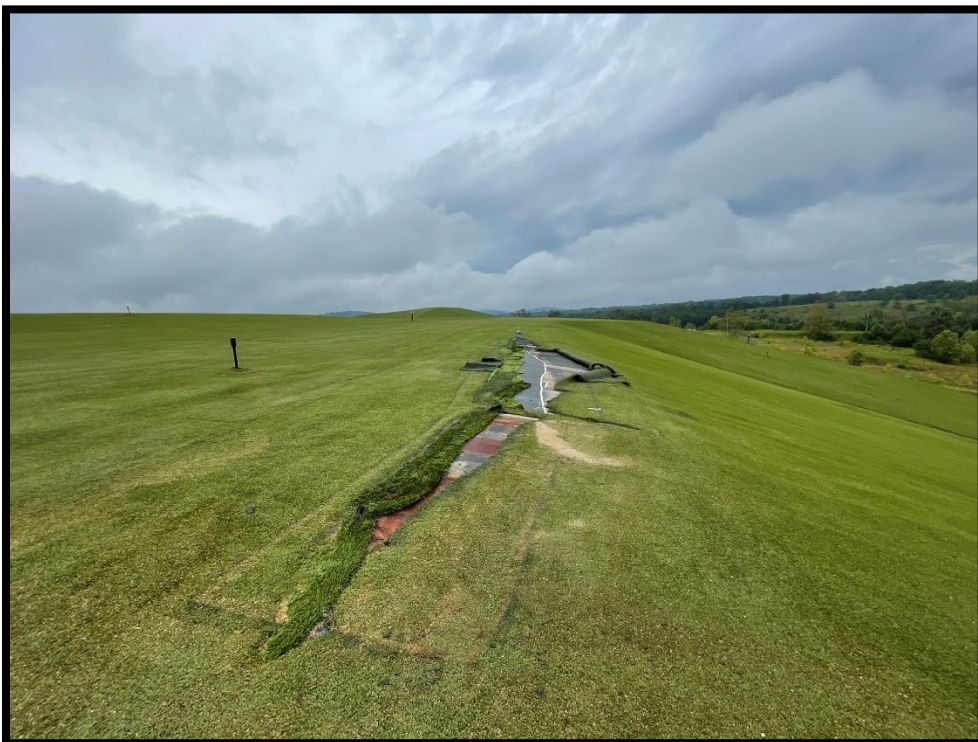
Photograph 4: View of damaged closure turf on east side of Area 1-3.
