**DATE:** July 16, 2024

**TO:** Emily Brickman, P.G., *Senior Project Manager – Geologist, EnSafe*

**FROM:** Caleb Gourley, *Project Manager, Harbor*

**RE:** Bi-weekly Site Inspection  
NABORS Landfill  
Mountain Home, AR  
*Harbor Project No: ENSF-23299*

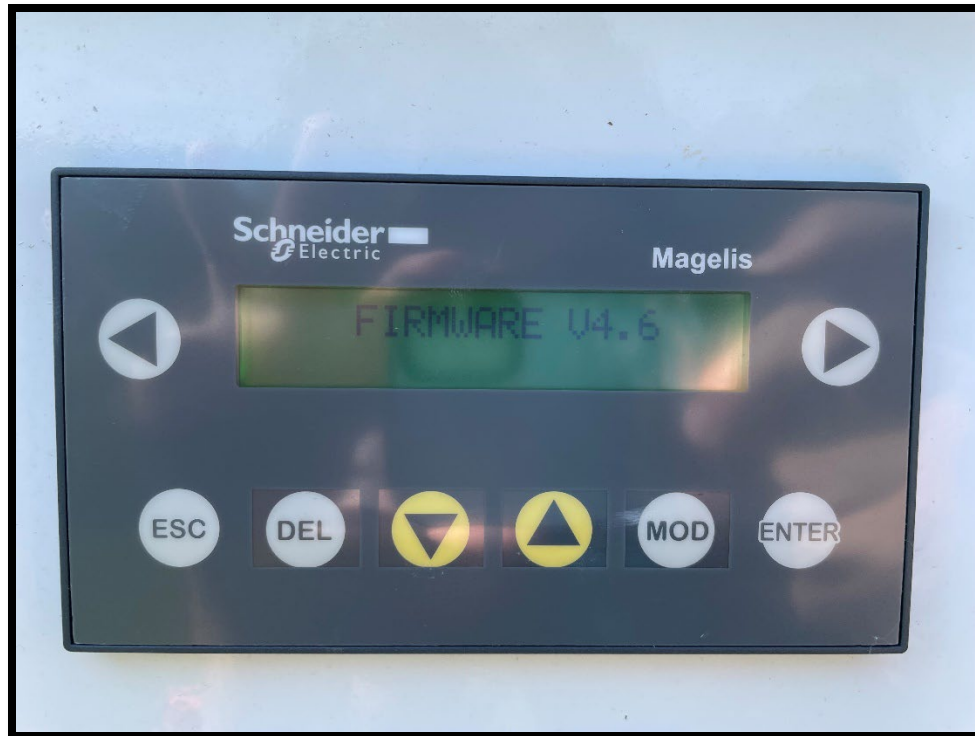
**Photograph 1:** Error message displayed at LCS-1.

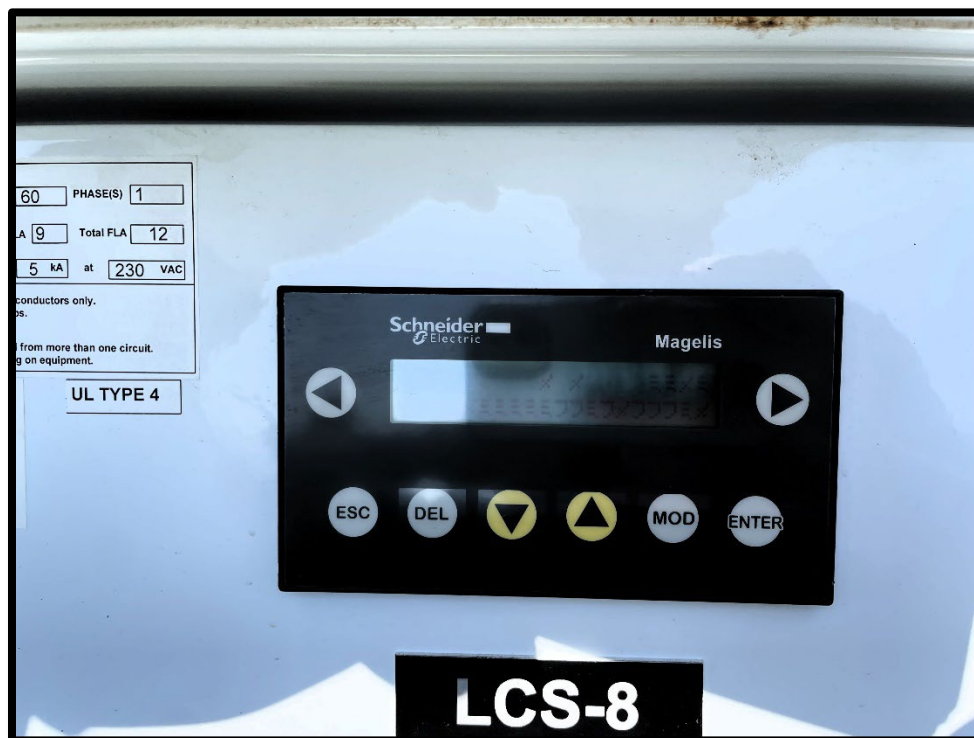
**Photograph 2:** Error message displayed at LCS-8.

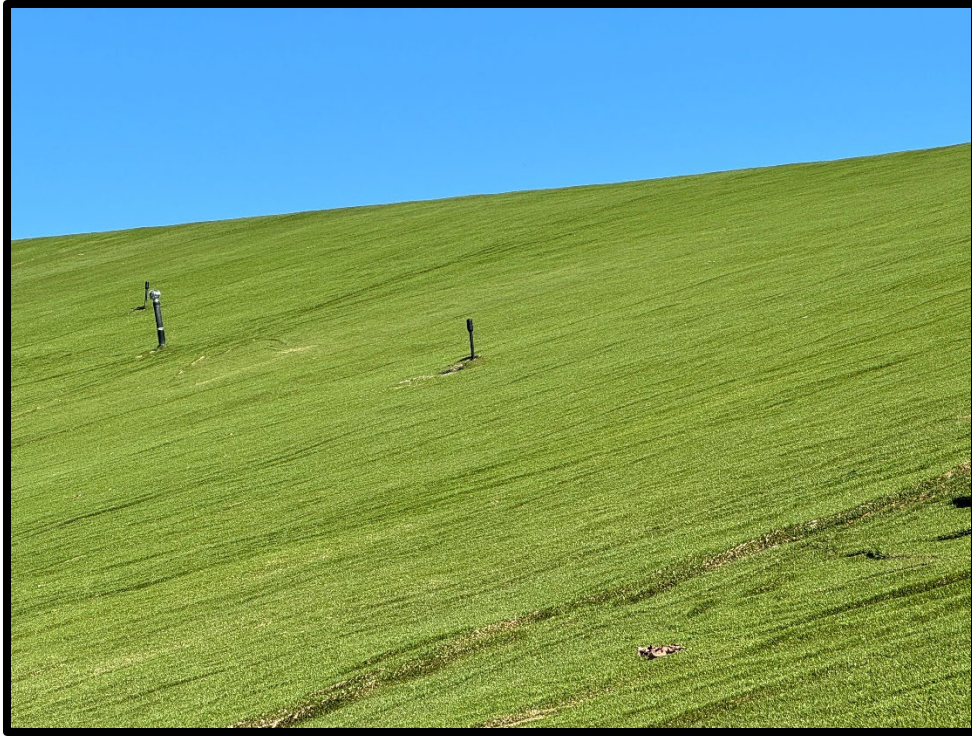
**Photograph 3:** Damaged closure turf around vent pipe near LCS-4.

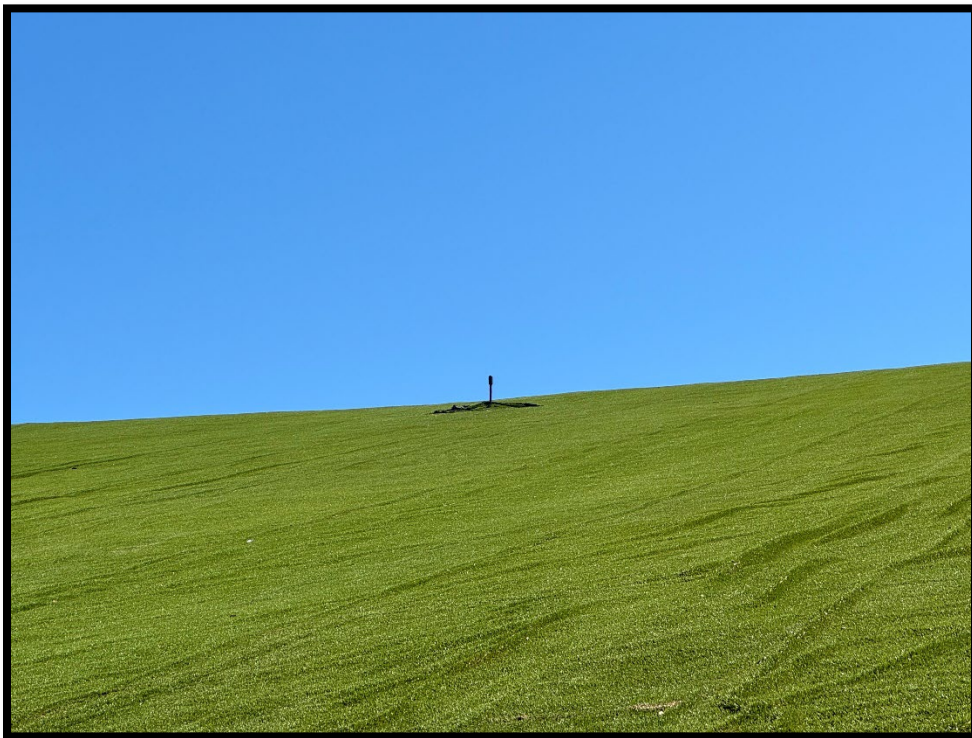
**Photograph 4:** Damaged closure turf around vent pipe near LCS-4.

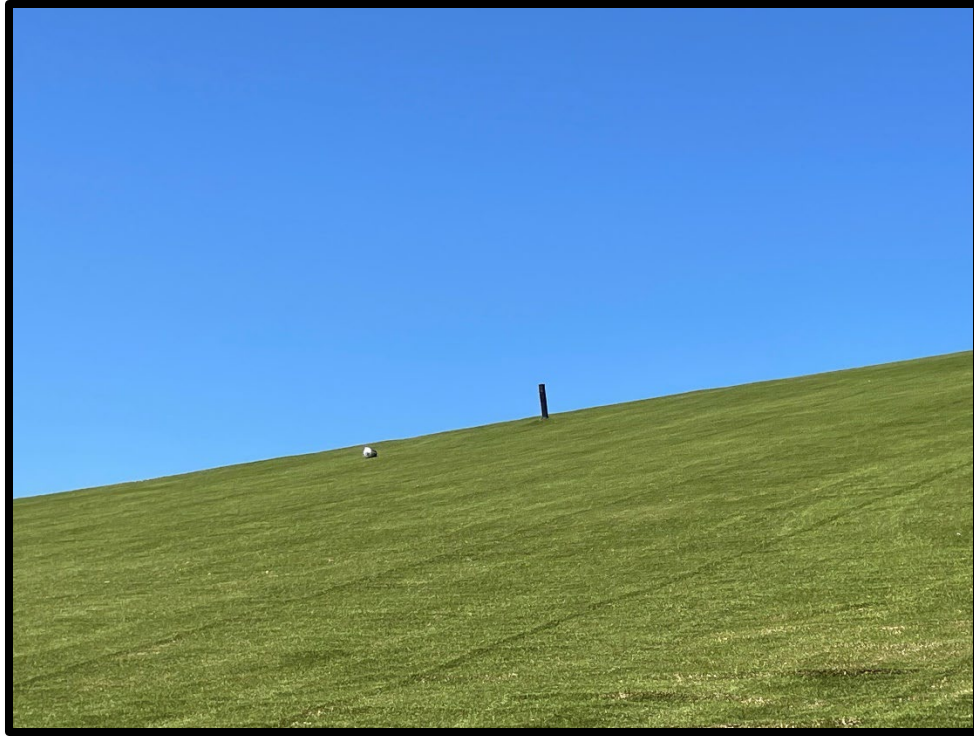
**Photograph 5:** Damaged wind turbine near LCS-8.

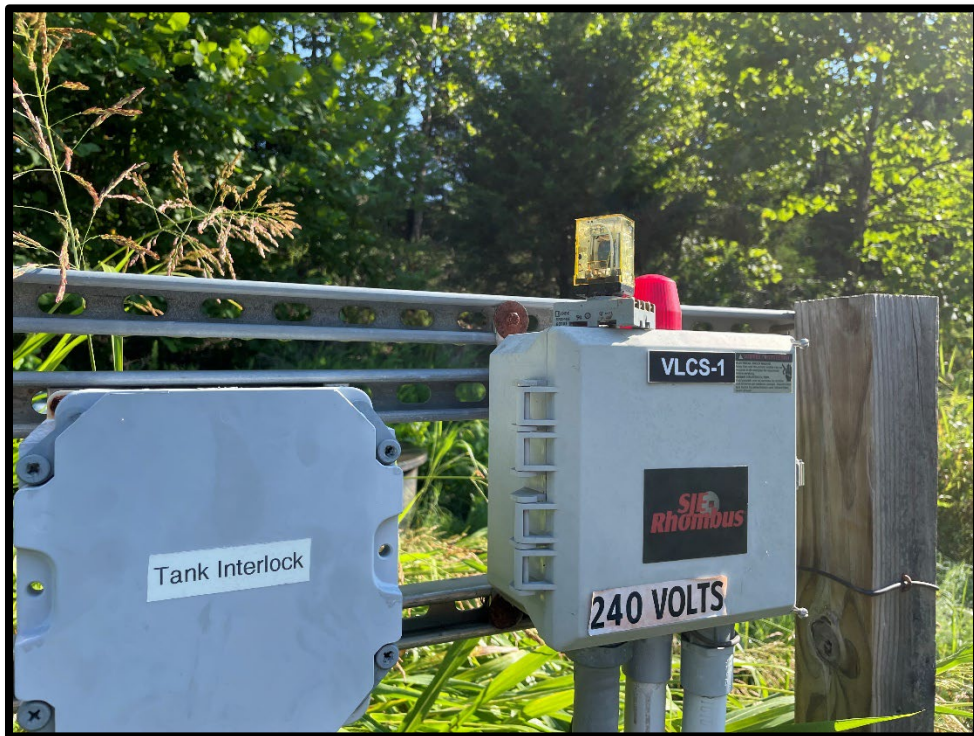
**Photograph 6:** Damaged electrical part on top of VLCS-1 housing.

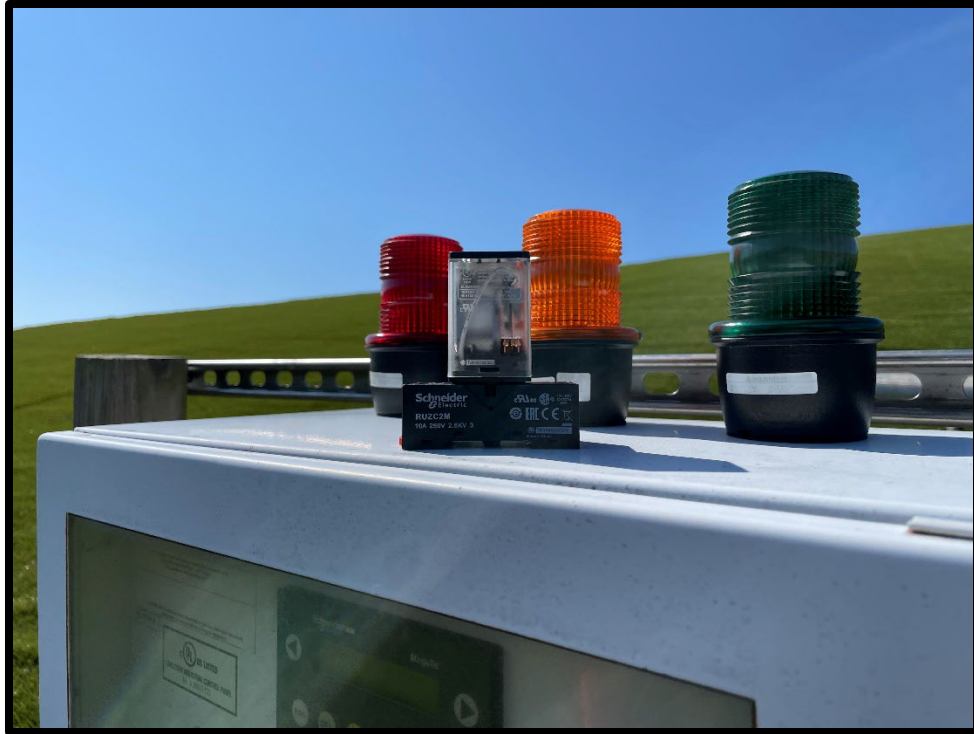
**Photograph 7:** Damaged electrical part on LCS-1 housing.

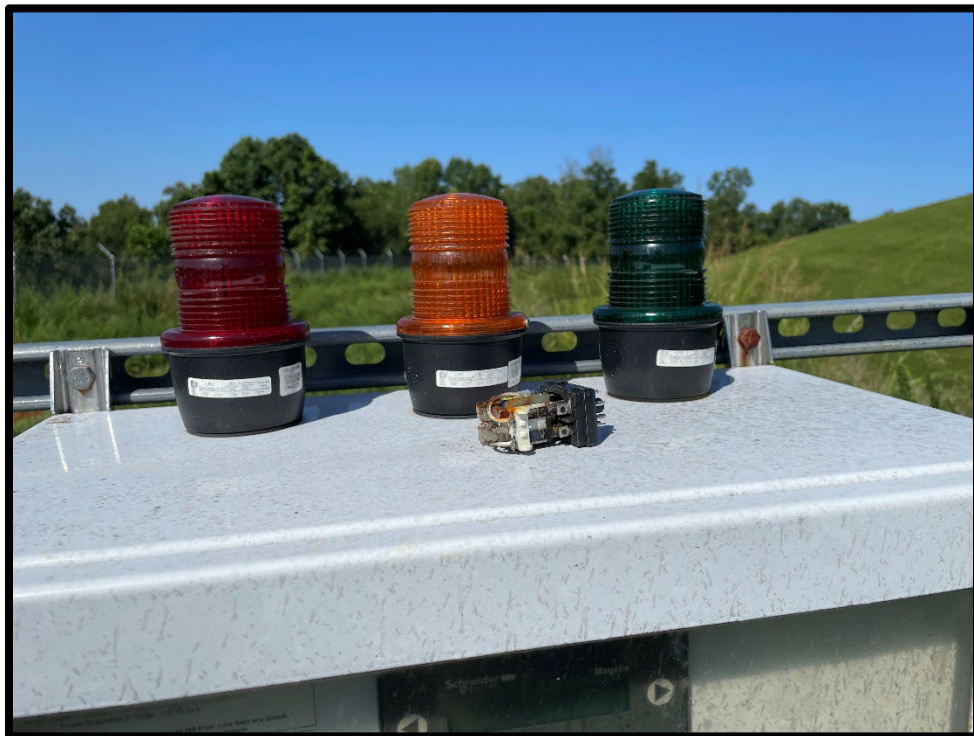
**Photograph 8:** Damaged electrical part on LCS-2 housing.
