Subject: Summary of Corrective Measures
Nabors Landfill
Baxter County, AR

Subject: Site Visit
Nabors Landfill
Baxter County, AR

Photos from Site Visit on March 21, 2024 Nabors Landfill

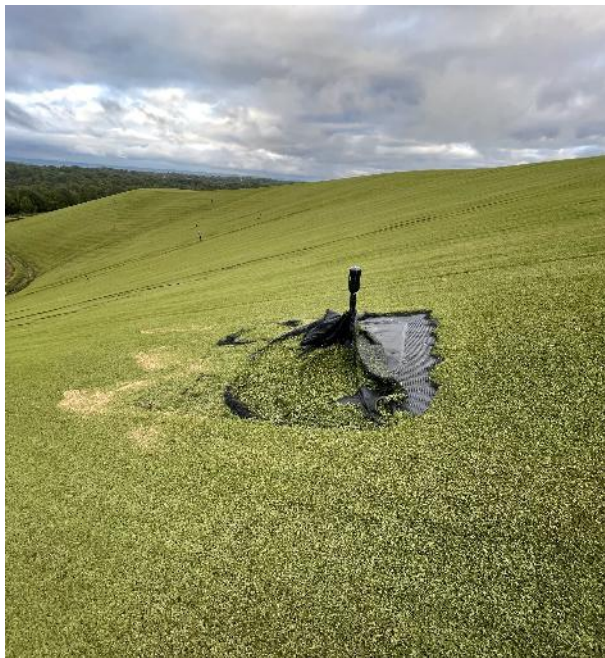
September 23–25, 2024: Watershed Geo® and Cline Environmental visually assessed Cells 1-2, 1-3 and 1-4. Bird damage, wrinkles and seam separation locations for DuraGuard® protection were noted for corrective action. Examples of bird damage are presented in Figure 1 and Figure 2. Cline Environmental subsequently repaired bird damage by removing and replacing engineered turf, welding new turf edges to existing turf, and infilling with specified aggregate infill and UltraArmor™. Corresponding examples of repaired bird damage are presented in Figure 3 and Figure 4. Other site bird damage locations were addressed in a similar manner.

Figure 1. Bird damage around PRV

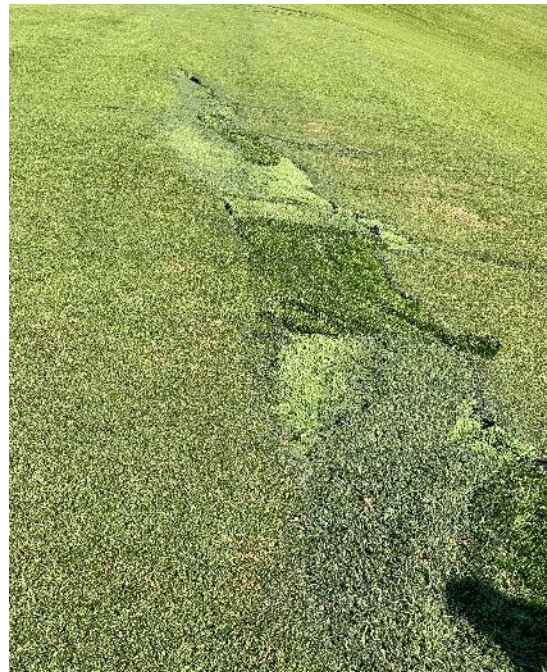
Figure 2. Bird damage at previously repaired location

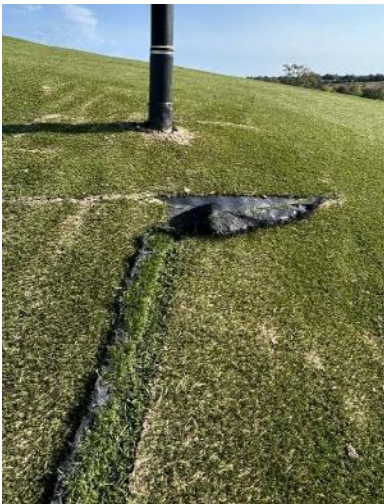
Figure 7. Bird damage at gas well

- Repaired bird damage around the gas well on the northwest slope as presented in Figure 7 and Figure 8;

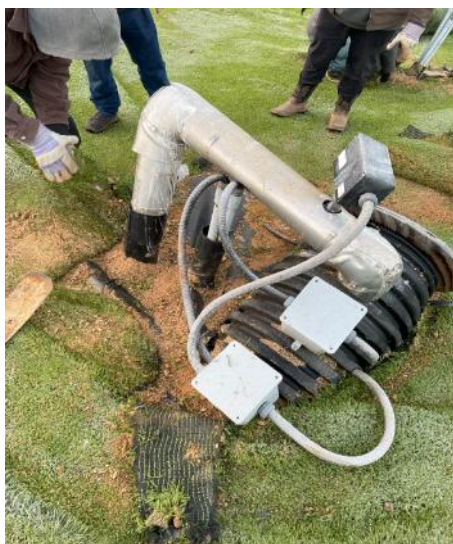
Figure 9. Settlement induced wrinkles and torn Closuresurf® at leachate piping on south slope

- Addressed turf tears and wrinkles due to settlement near leachate piping on the south slope with new ClosureTurf®, infill, and UltraArmor™ as presented in Figure 9 and Figure 10; and

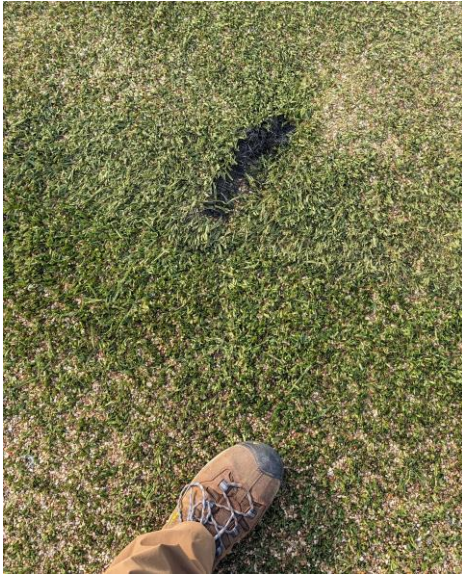
- There are areas of bird damage to the engineered turf layer. We observed approximately five (5) areas. Photos of the bird damage are shown in Attachment A – Photos 1, 2, and 3. The largest observed area of bird damage was approximately 10-ft by 10-ft as shown in Photo 3.
- The Passive Relief Vents (PRVs) appear to be in good condition with no observed movement or damage.
- The specified granular infill for the engineered turf is in place with no large areas of displacement or movement.
- The wrinkles previously noted along the north and west slopes of Area 1-2 do not appear to have changed since previous site visits.

**Photo 1 – Bird Damage of
Engineered Turf**

- Fix the bird damage by replacing the engineered turf, welding the edges of the new turf to existing turf, and infilling the turf with a bound infill product (i.e., HydroBinder® or UltraArmor™).
- Repair or replace damaged PRVs. None were noted on our site visit, but WG will evaluate again.
- Replace infill in areas where there is no specified granular infill, and the backing geotextile of the engineered turf is exposed. No areas of infill displacement were noted on our site visit, but WG will evaluate again.
- Place DuraGuard™ protection on wrinkles as needed.

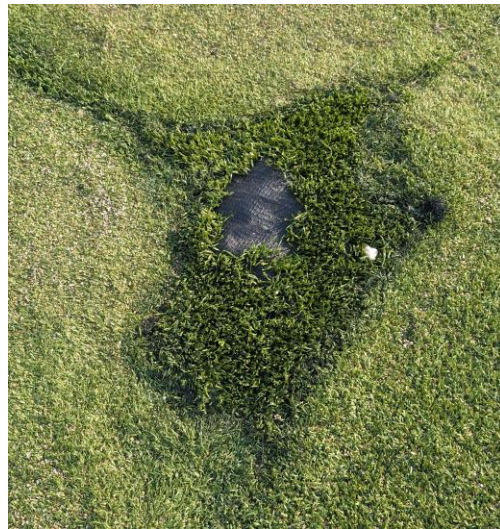
**Photo 2 – Bird Damage of
Engineered Turf**

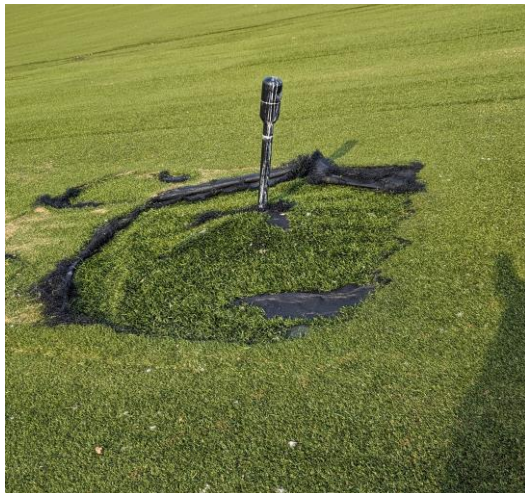
**Photo 3 – Bird Damage of
Engineered Turf Around Passive
Relief Vent (PRV)**

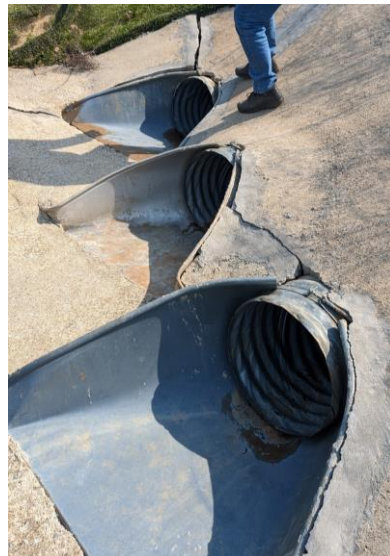
- The storm water inlet structure on the south side of Area 1-2 is settling, cracked, and undermined. See Photos 4, 5 and 6 in the Attachment A. This structure is not a part of the ClosureTurf system. If it continues to settle and undermine, it will impact the ClosureTurf and cause significant damage to the cover system, landfill storm water system, and landfill access road. WG suggests that ADEQ have this inlet structure repaired.

**Photo 4 – Storm Water Inlet
Structure**

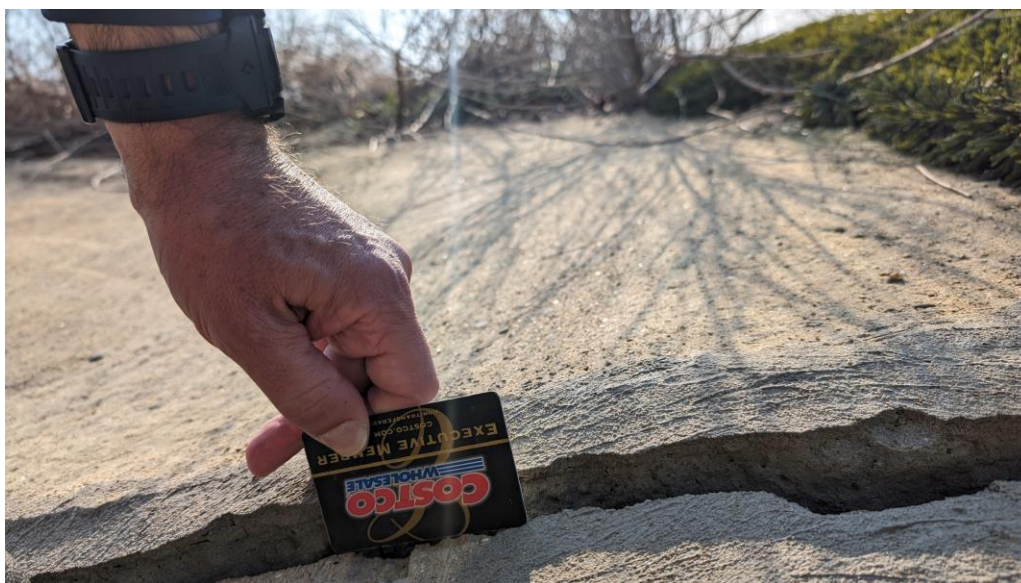
Photo 5 – Storm Water Inlet
Structure

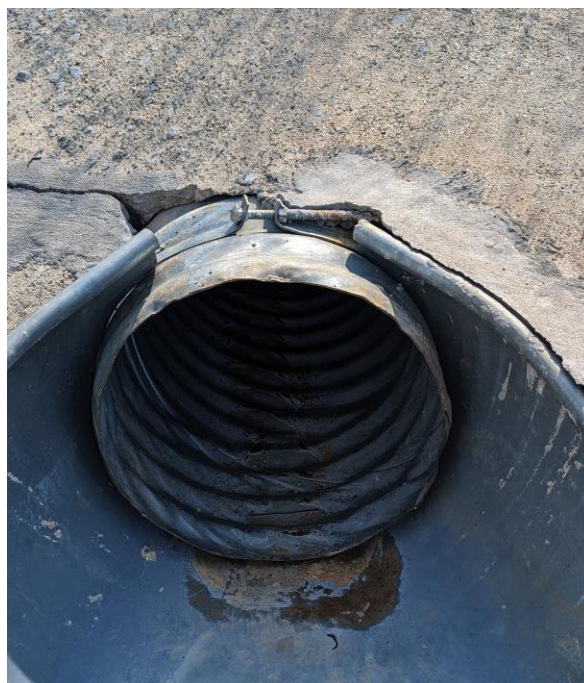
Photo 6 – Storm Water Inlet
Structure
