33167
Landfill

MEMORANDUM

TO : Mark Witherspoon, Chief, Solid Waste Division
FROM : Tony Morris, Geologist Solid Waste Division YM
DATE : 5-APR-1990
SUBJECT : Groundwater monitoring at the Sunray sanitation landfills (Permit No. 162-SR1 and 123-SR1)

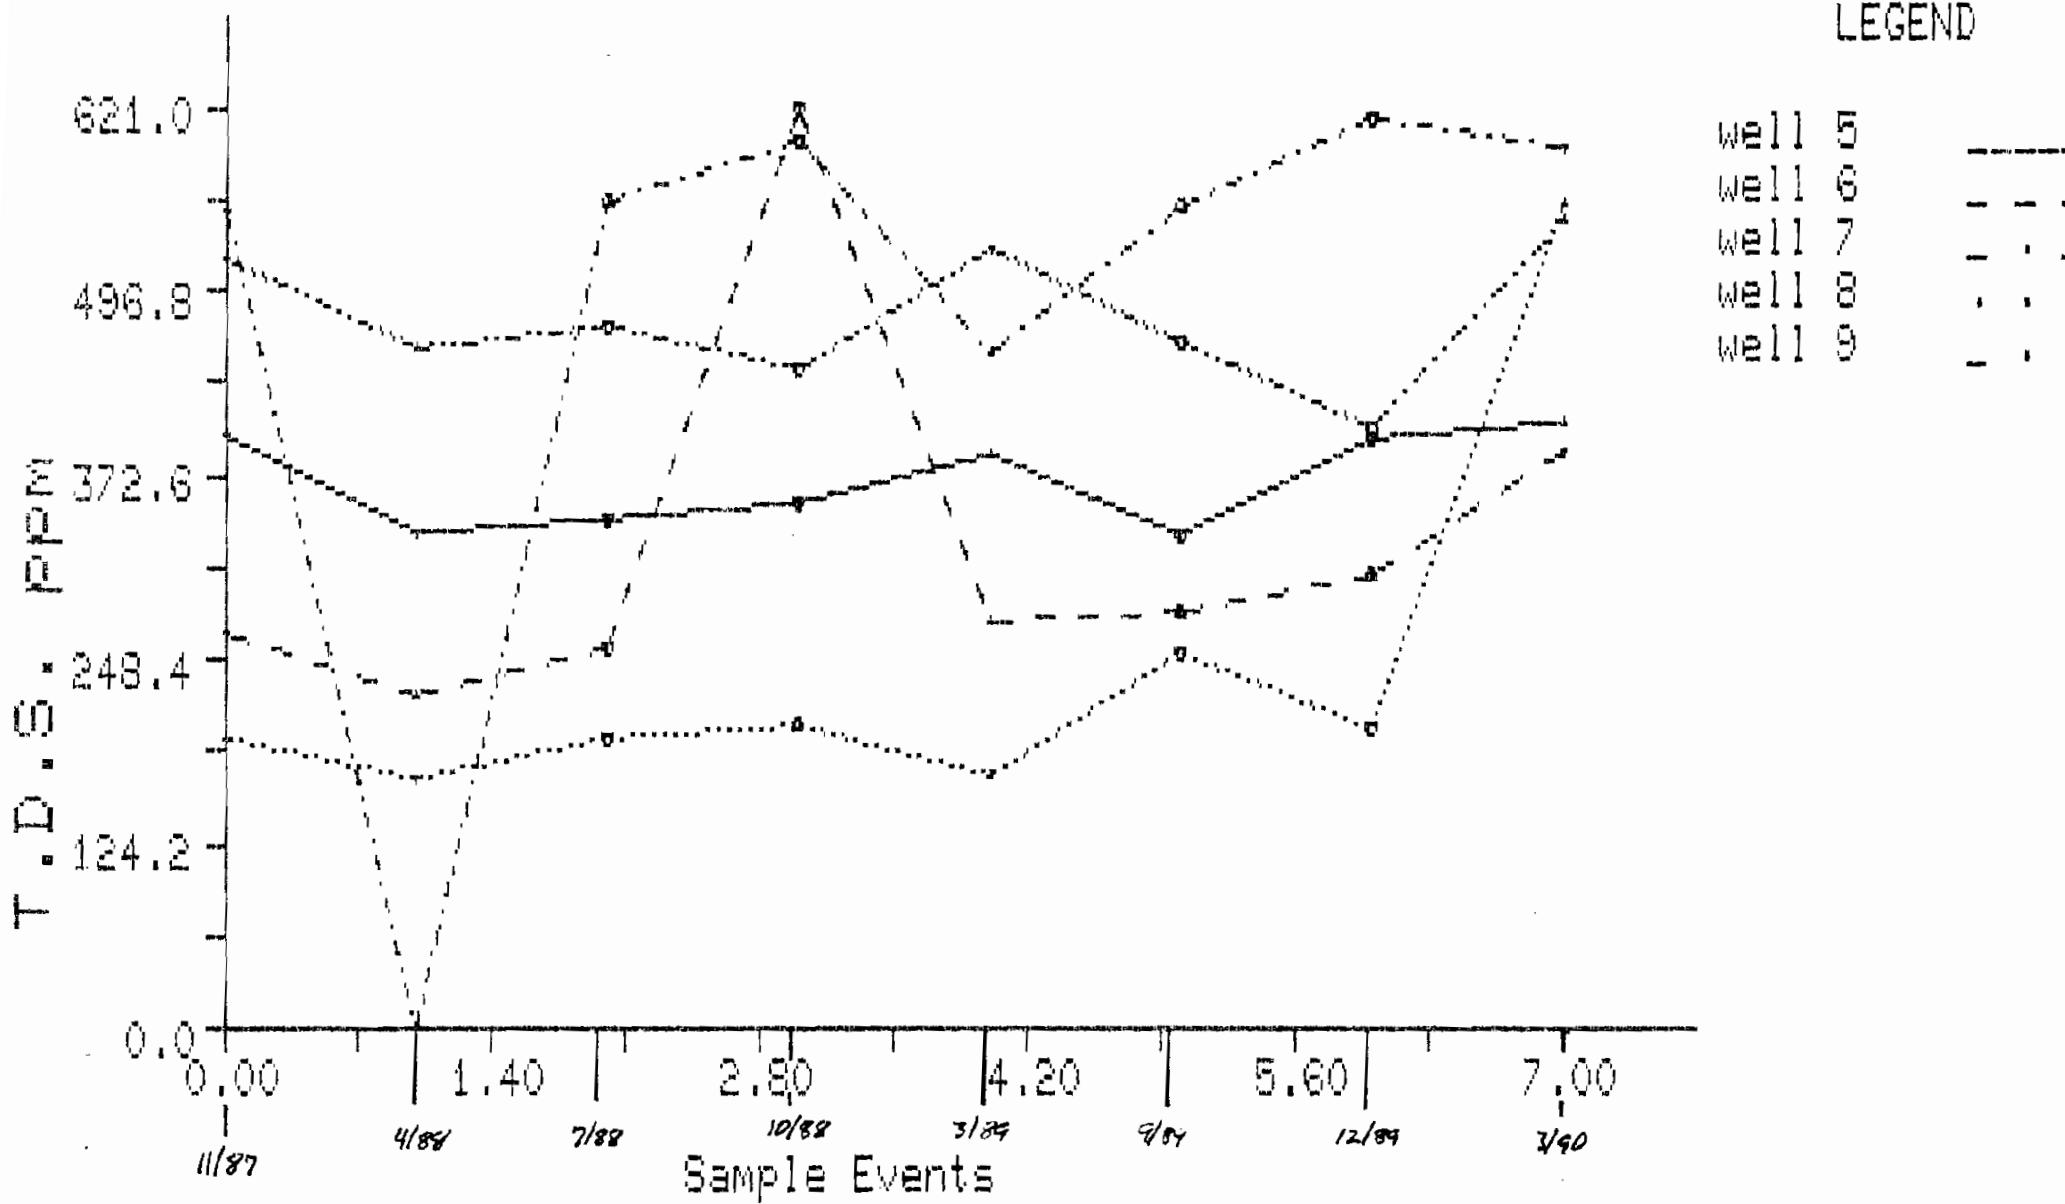
T.D.S. SR4

Secondary drinking water standard 500 ppm

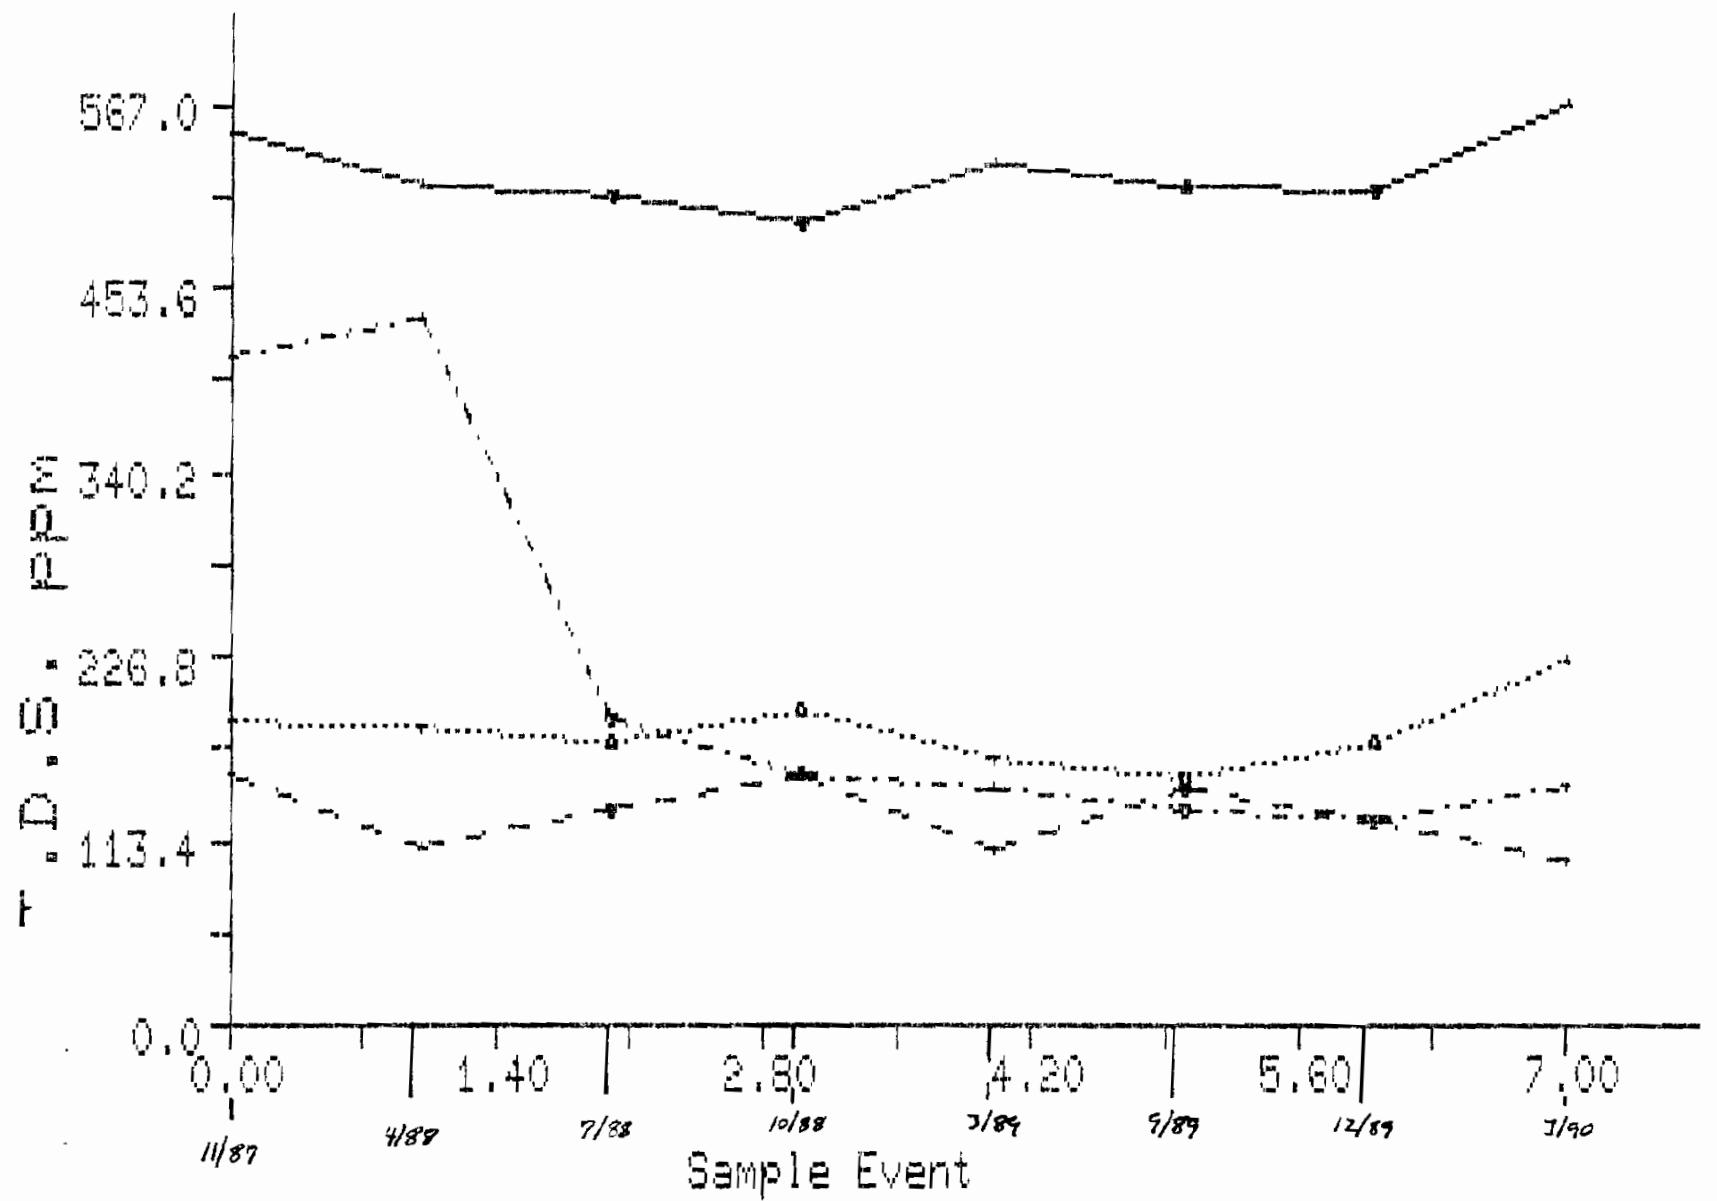
T.D.S SR3

Secondary drinking water standard 500 ppm

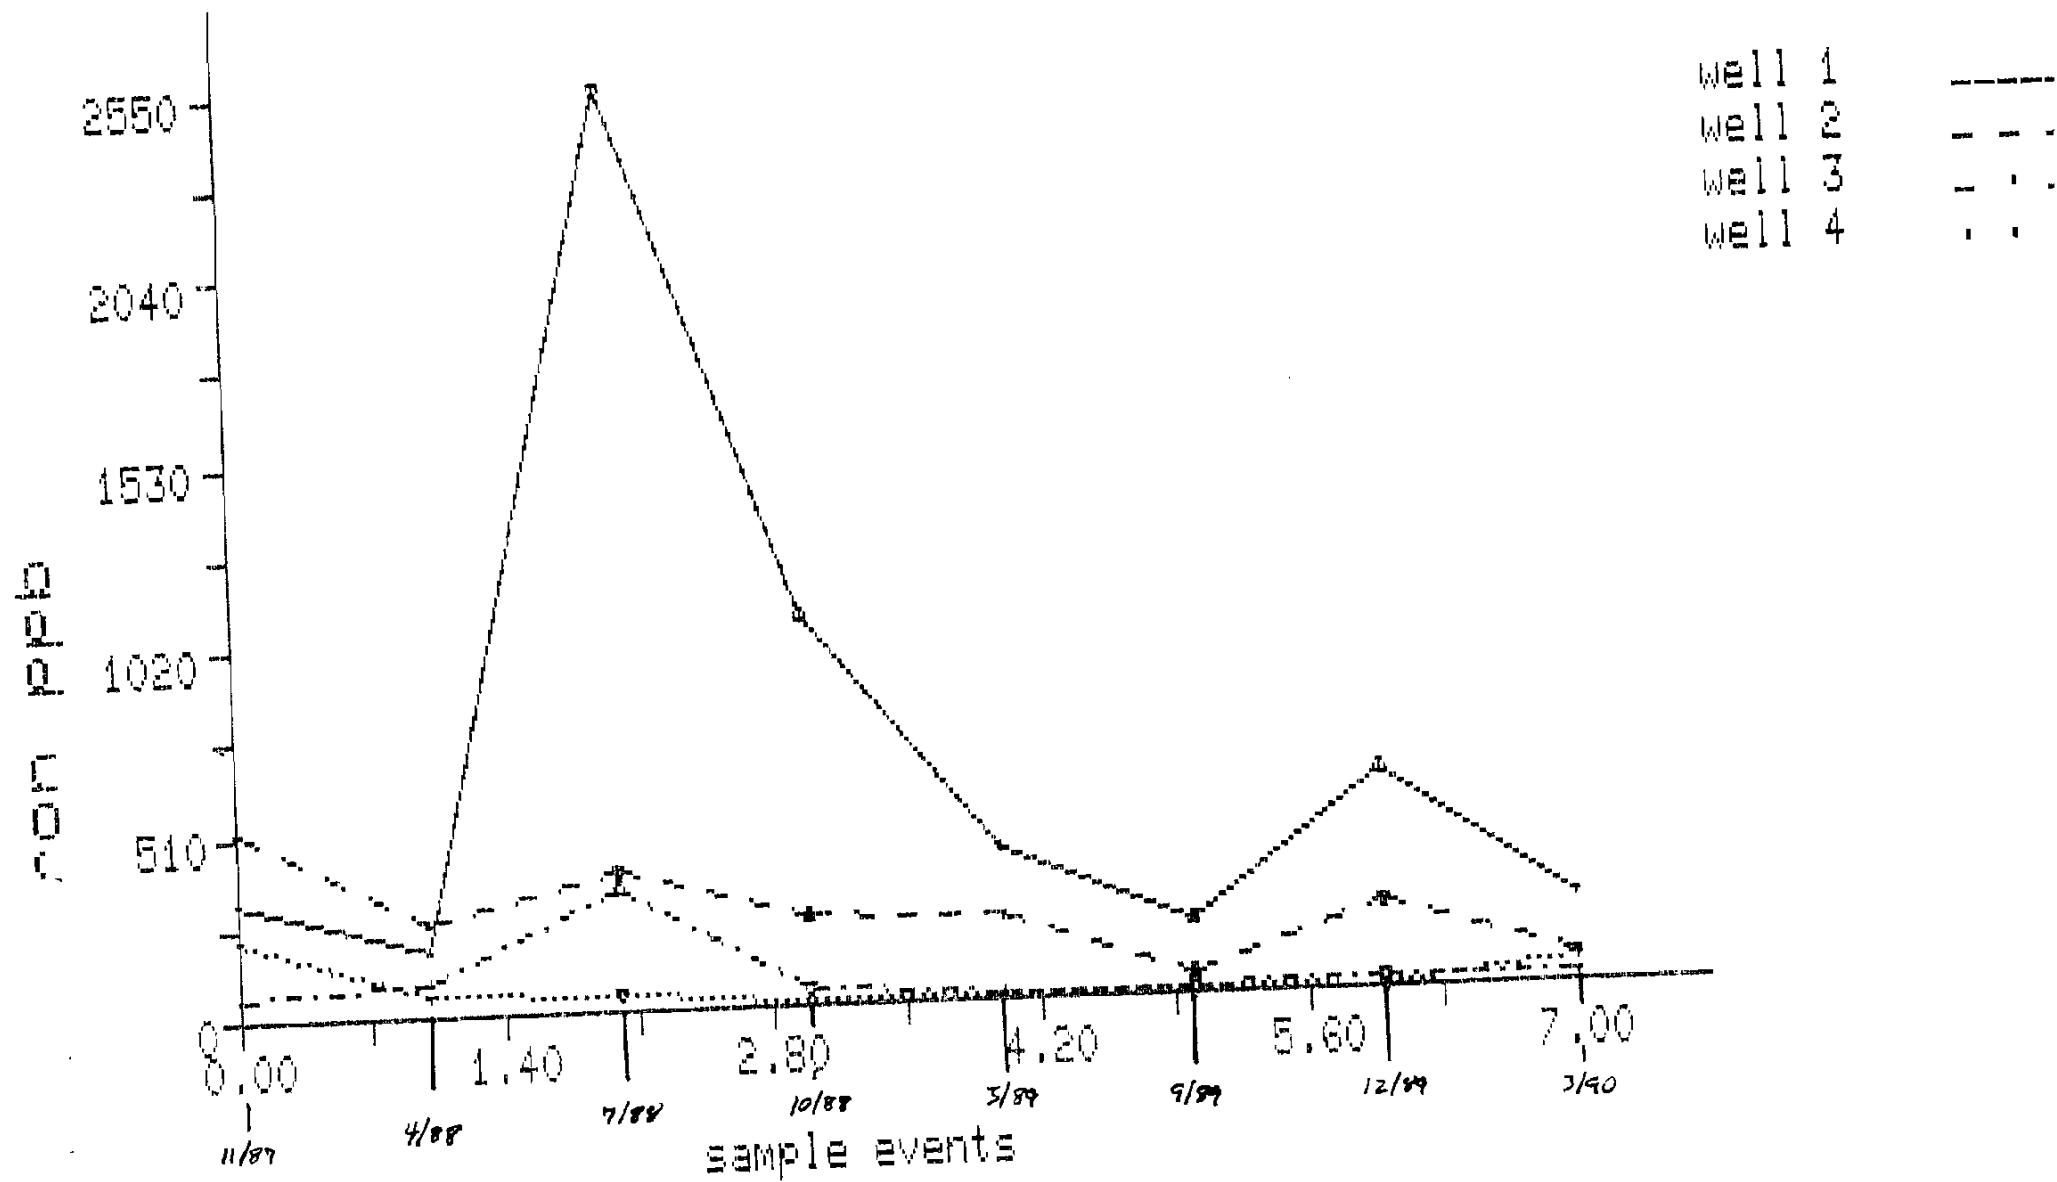
Iron SR3

Secondary drinking water standard 300 ppb

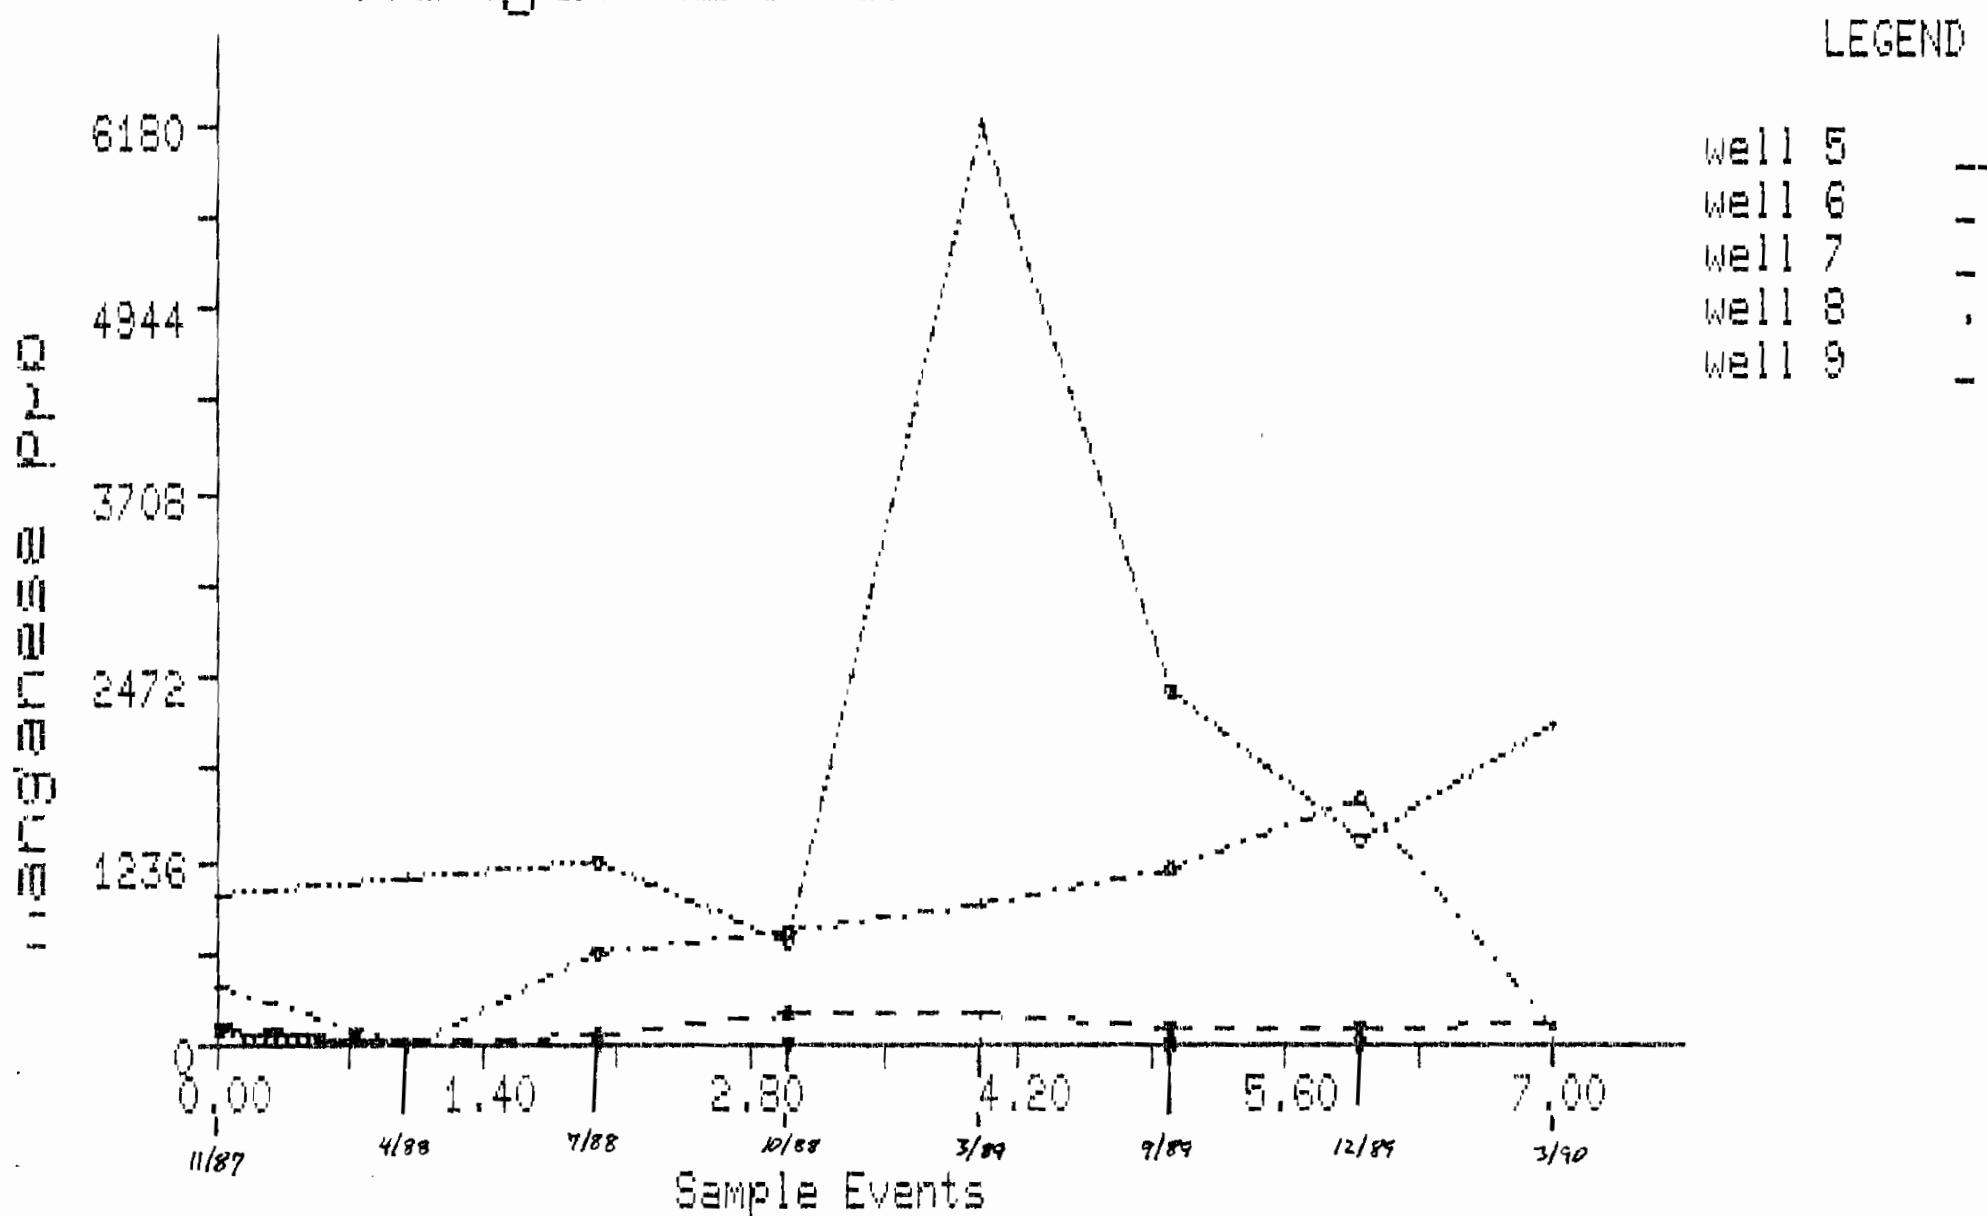
Manganese SR4

Secondary drinking water standard 50 ppb

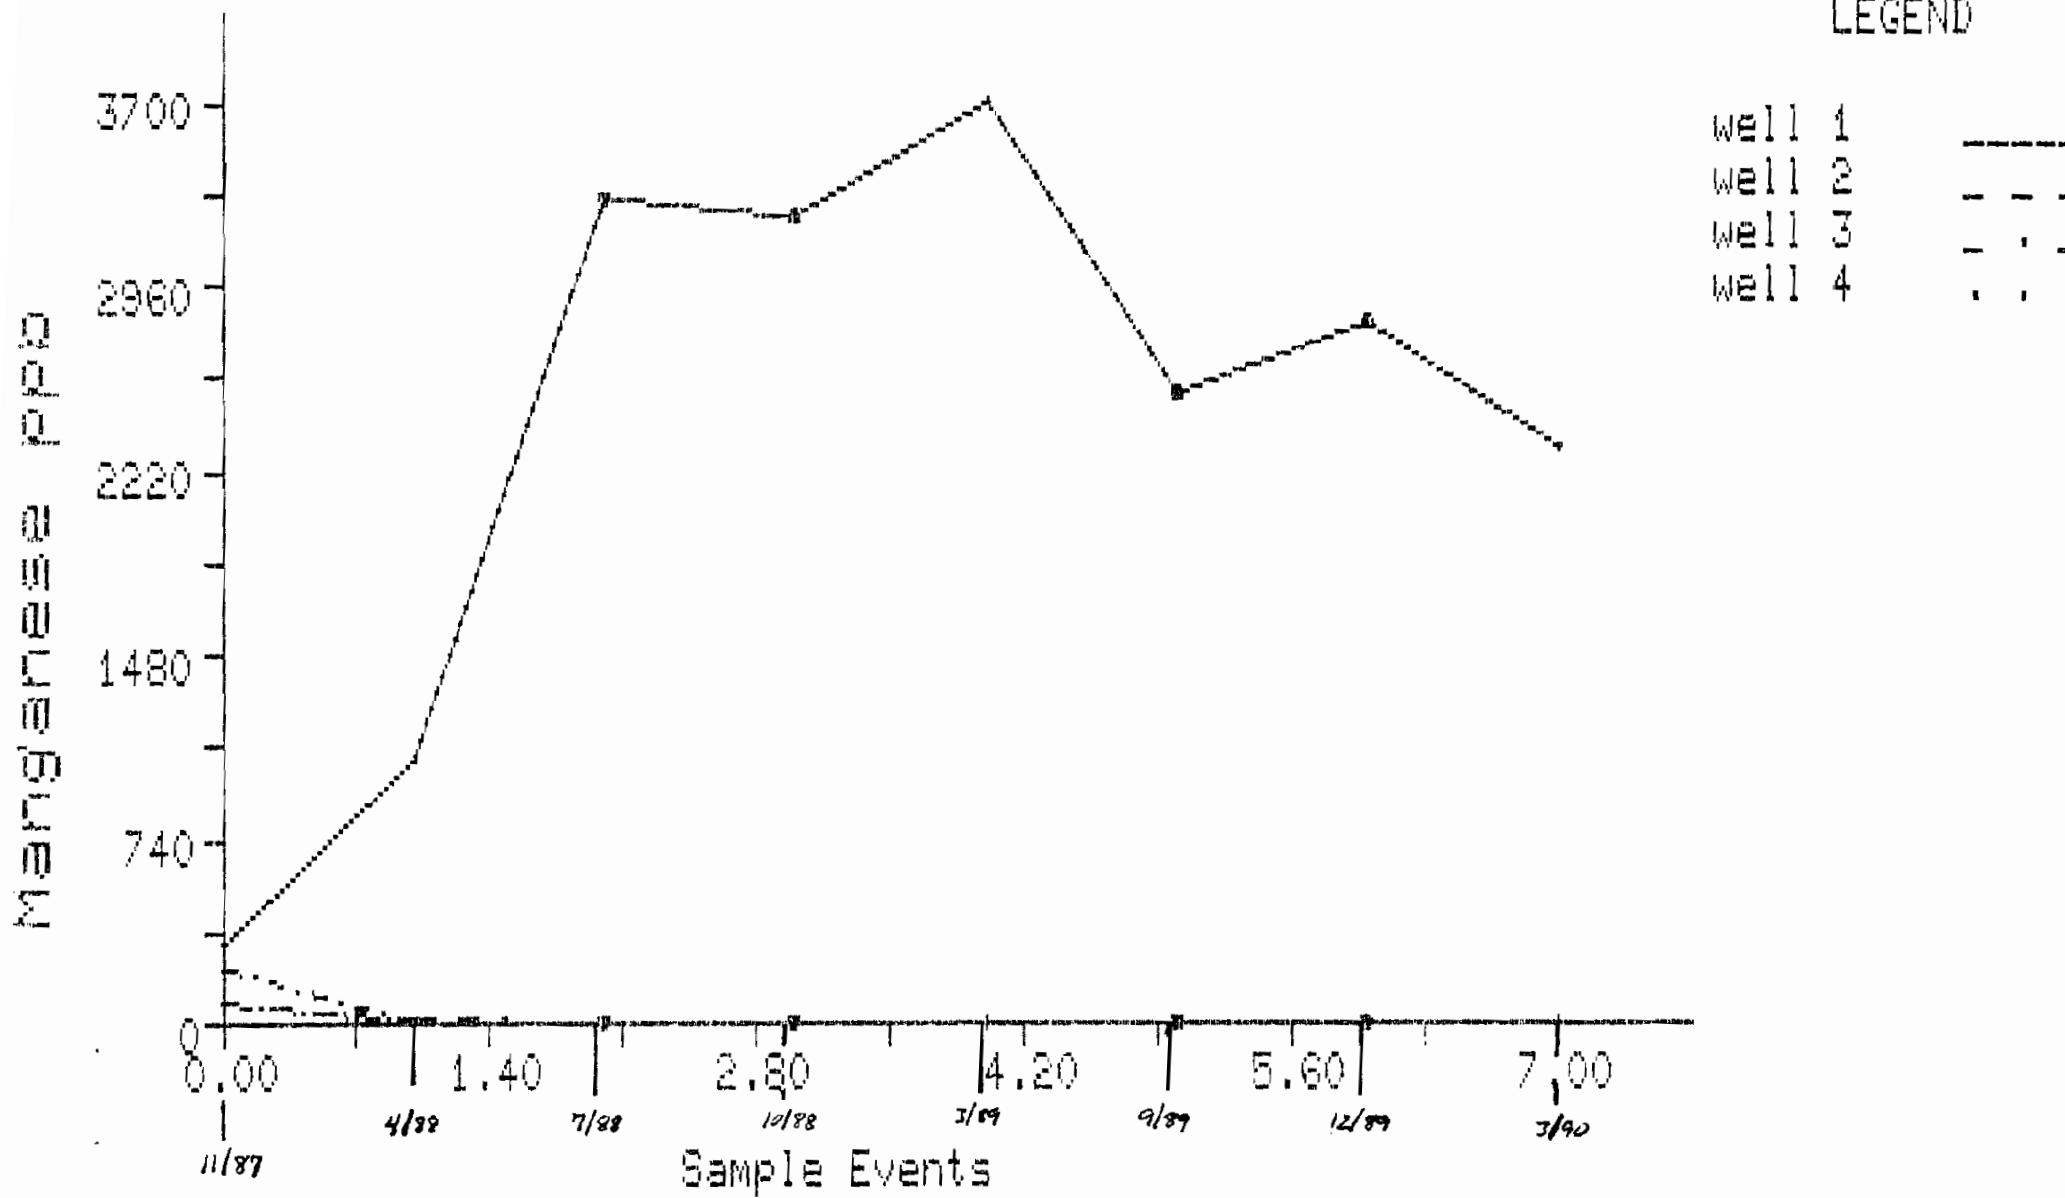
Manganese SR3

Secondary drinking water standard 50 ppb

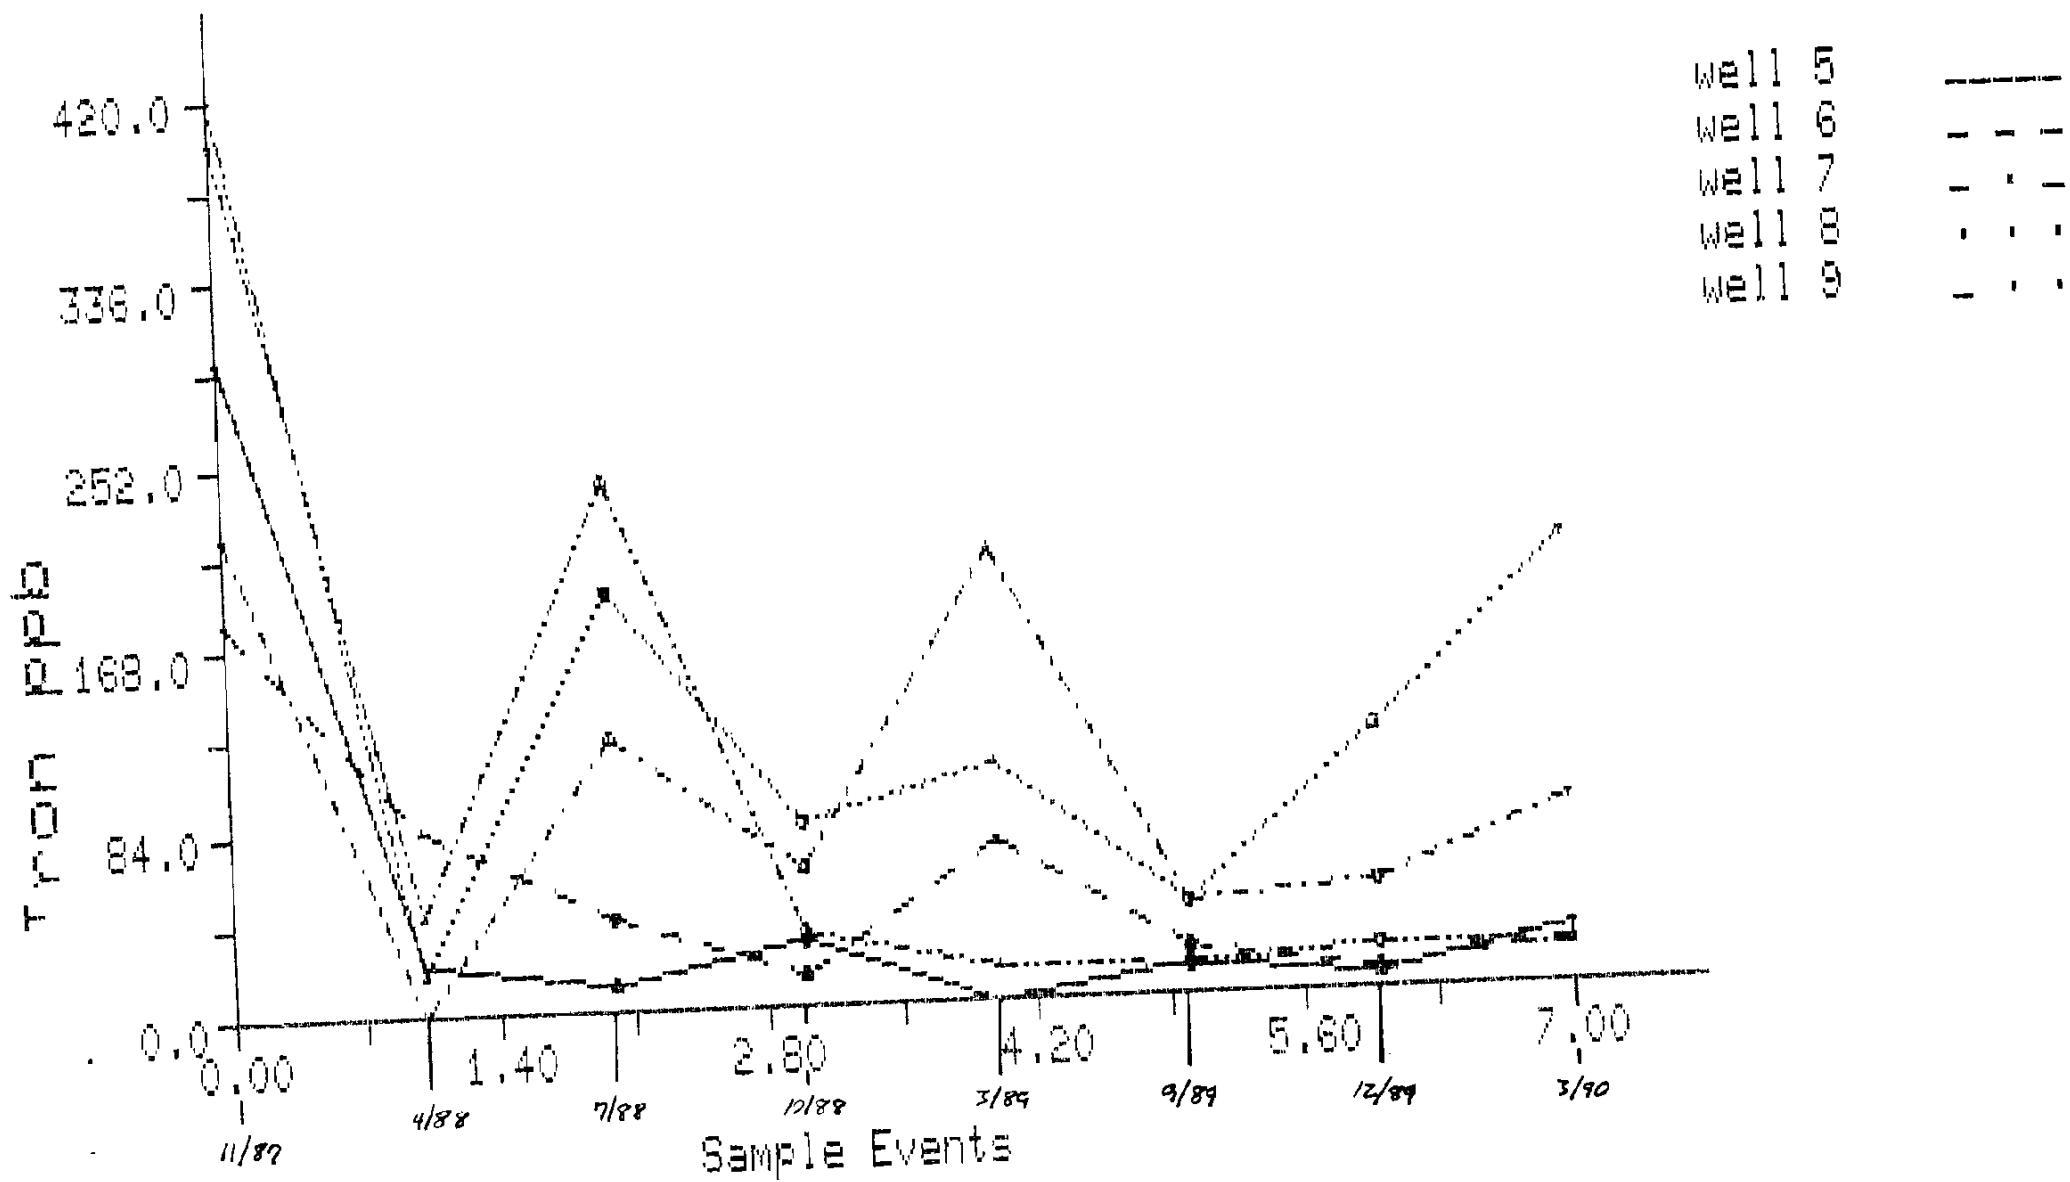
Iron SR4

Secondary drinking water standard 300 ppb
