## MEMORANDUM

**SUBJECT:** Summary of Site Visit of Damco, Inc. Facility  
Mountain Home, AR  
FTN No. 050

**April 25, 2016 Site Visit Photo Log**

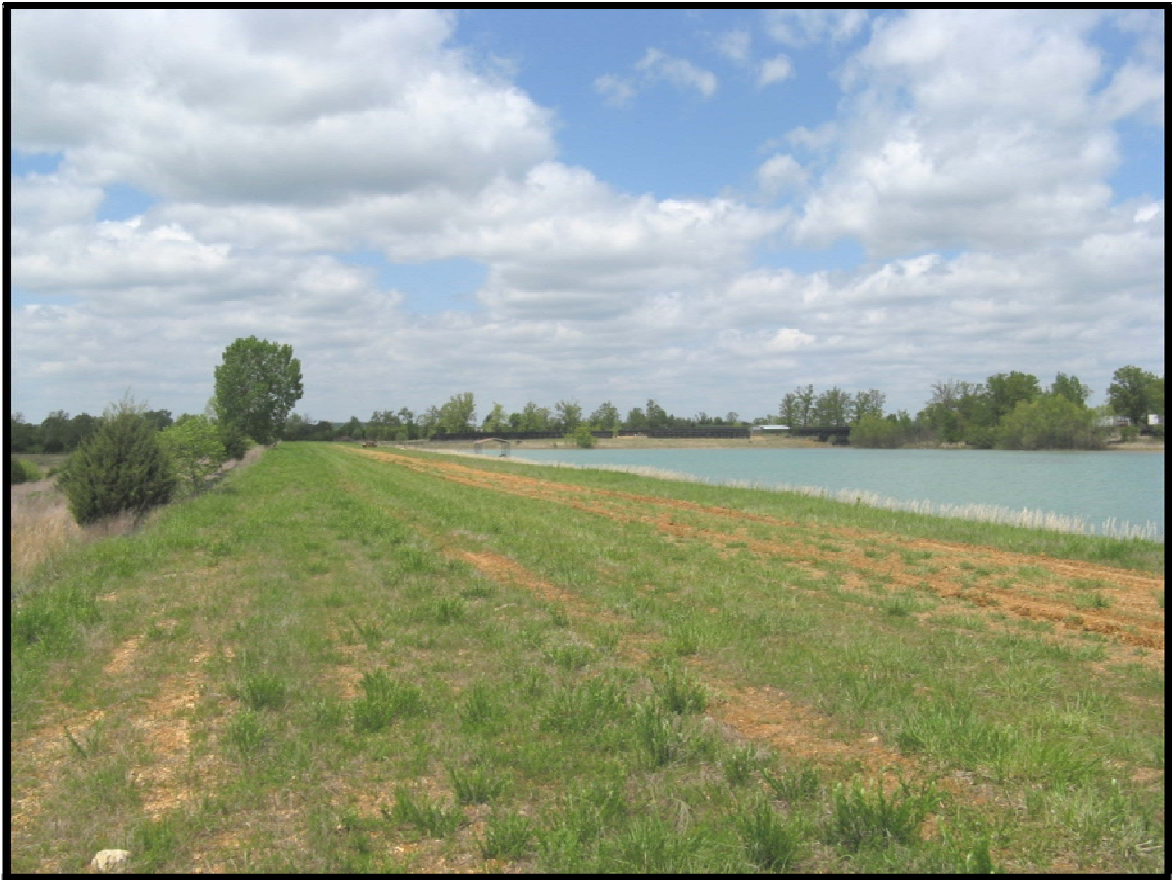
2. The top (crest) of the dam is approximately the same width (40 ft) as shown on the original design plans. However, the crest is longer than designed (approximately 1,350 ft versus 900 ft). The surface of crest of the dam did not show any signs of settlement or rutting (see Photo 1; Attachment 2)

Photo 1: Looking northwest at crest of dam.

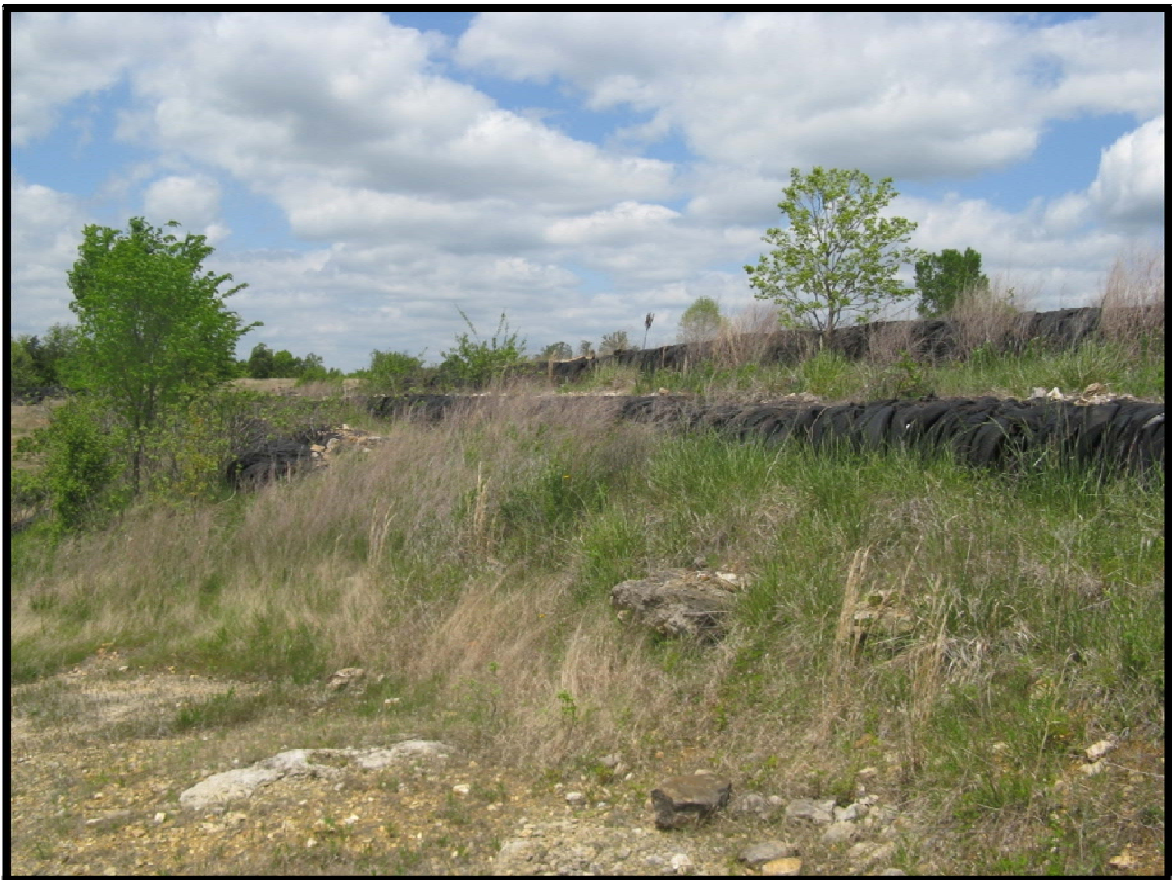
3. According to the design plans, the downstream side of the dam was supposed to have been constructed at a slope of 3H:1V and was to be approximately 72 ft (horizontal) from crest to toe. However, the downstream side has three benches (terraces) and the slope is much longer than originally designed (approximately 380 ft including benches and slopes between benches). The upper bench is about 100 ft wide and is about five rows of tire bales high (about 15 ft). The middle bench is about 180 ft wide and about nine rows of tire bales high (about 27 ft). The lower bench is approximately 50 ft wide and about two rows of tire bales high (6 ft). Photos 2 through 5 present terraced downstream side of dam.

4. The downstream side of each of the three benches is not covered with dirt and the stacked baled waste tires are exposed (see Photos 2, 3, 4, 5, and 7)

Photo 2: Looking north at western edge of upper bench; note exposed baled tires.

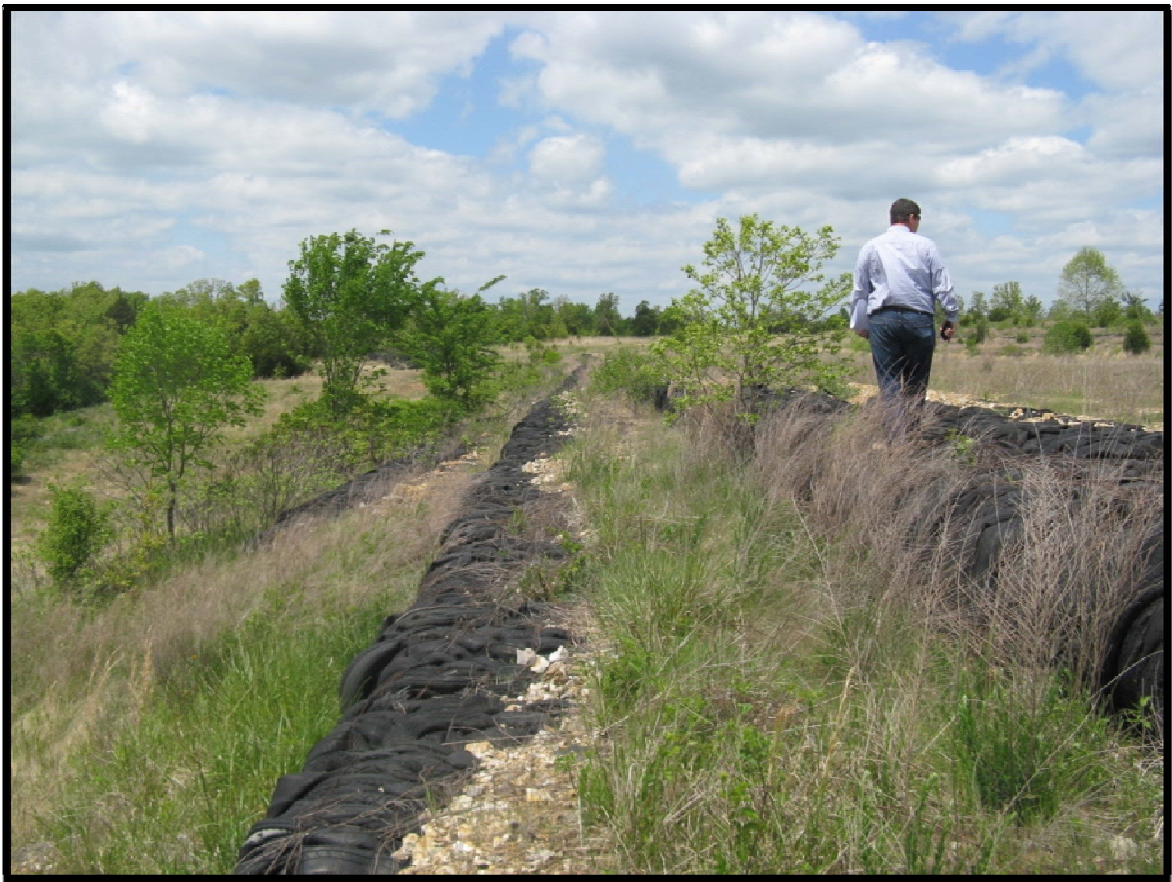
Photo 3: Looking northwest at western edge of middle bench; note exposed baled tires.

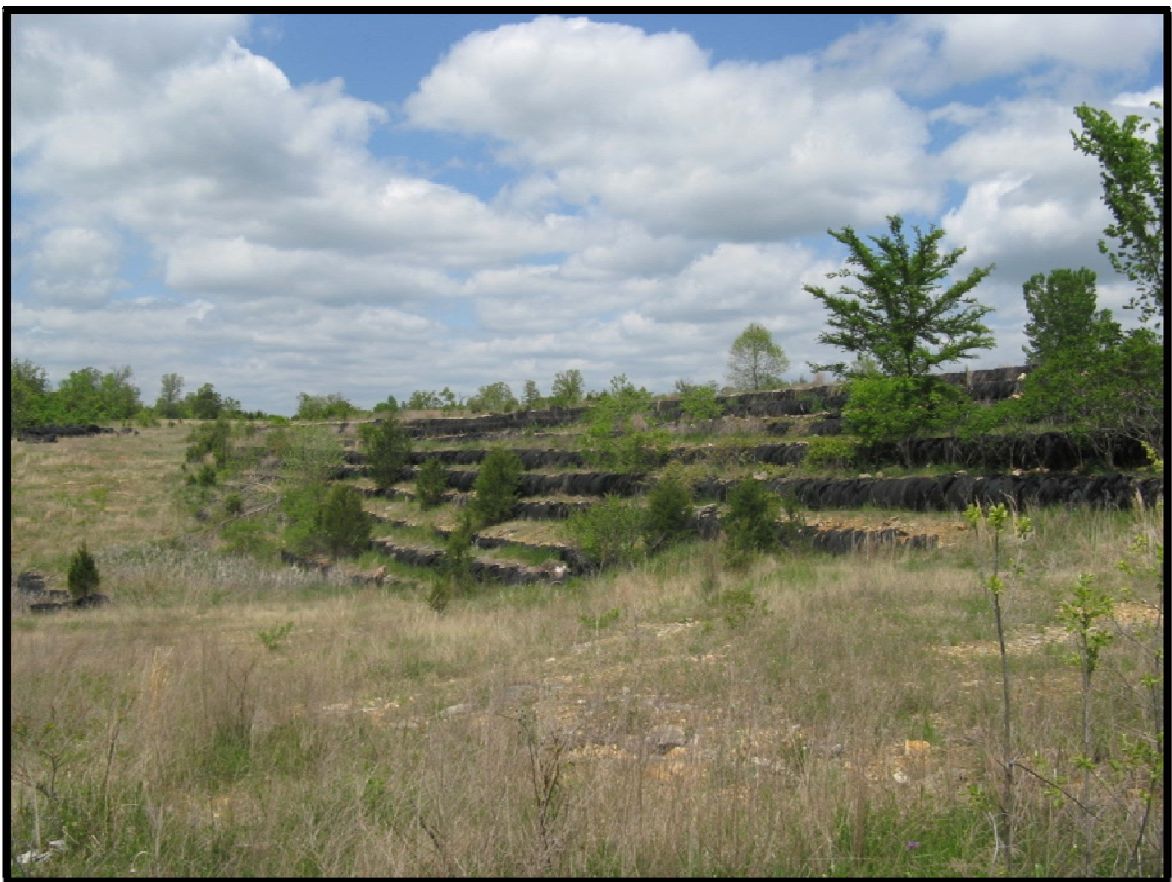
Photo 4: Looking north at western edge of middle bench on right and lower bench on the left; note exposed baled tires.

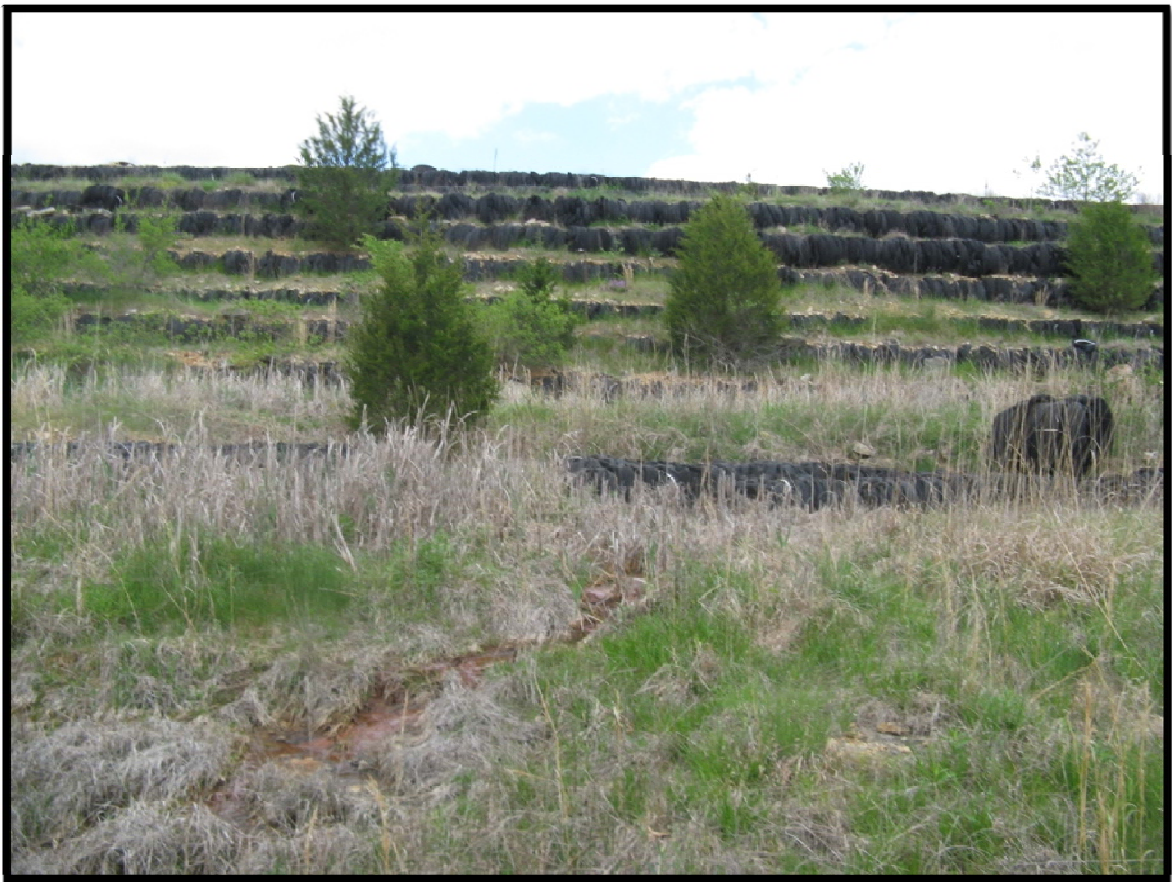
6. There were many seeps noted at the toe of the slope which may be from the pond, stormwater infiltration, or natural seeps from the bedrock adjacent to the waste tire slope (see Photos 5 and 6).

Photo 5: Looking east at western slope of dam; middle bench is at top of photo and lower bench is in middle of photo; note seepage (orange staining) in foreground.

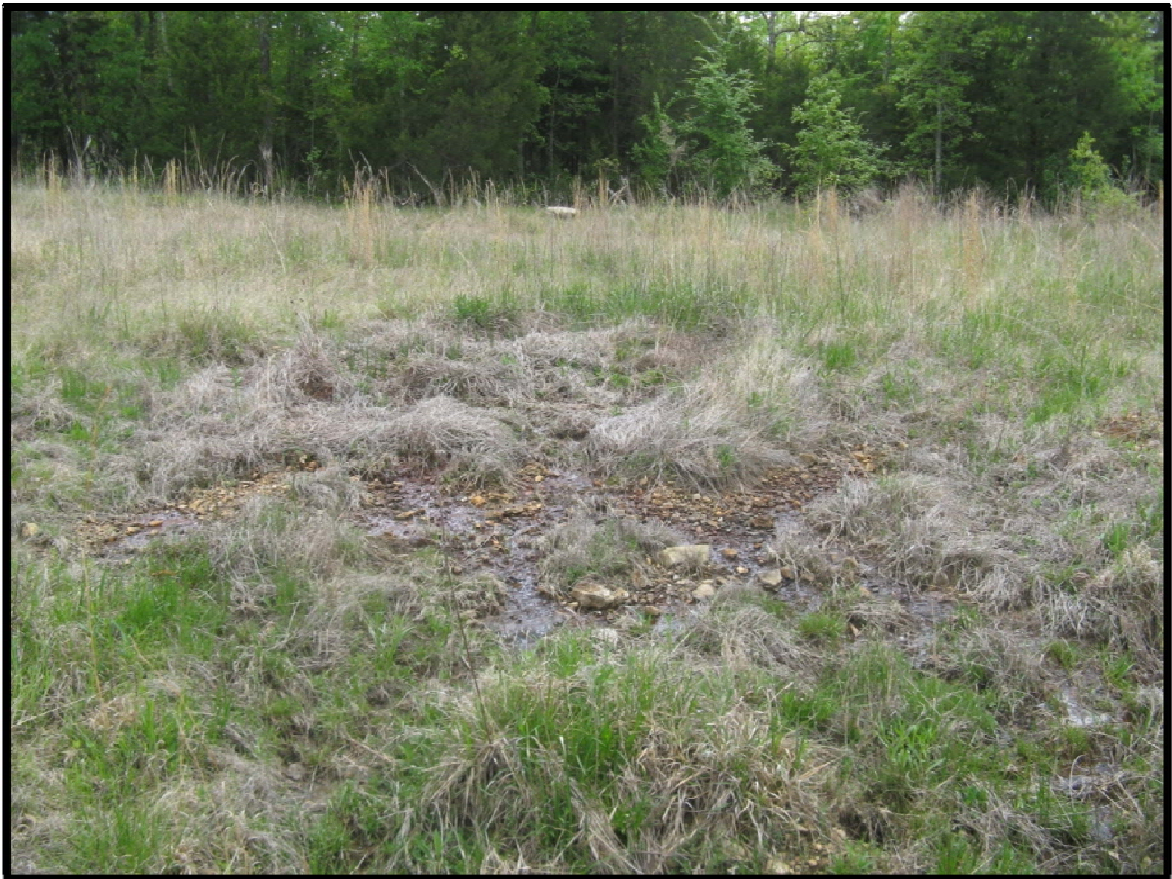
Photo 6: Seepage flowing west from toe of slope.

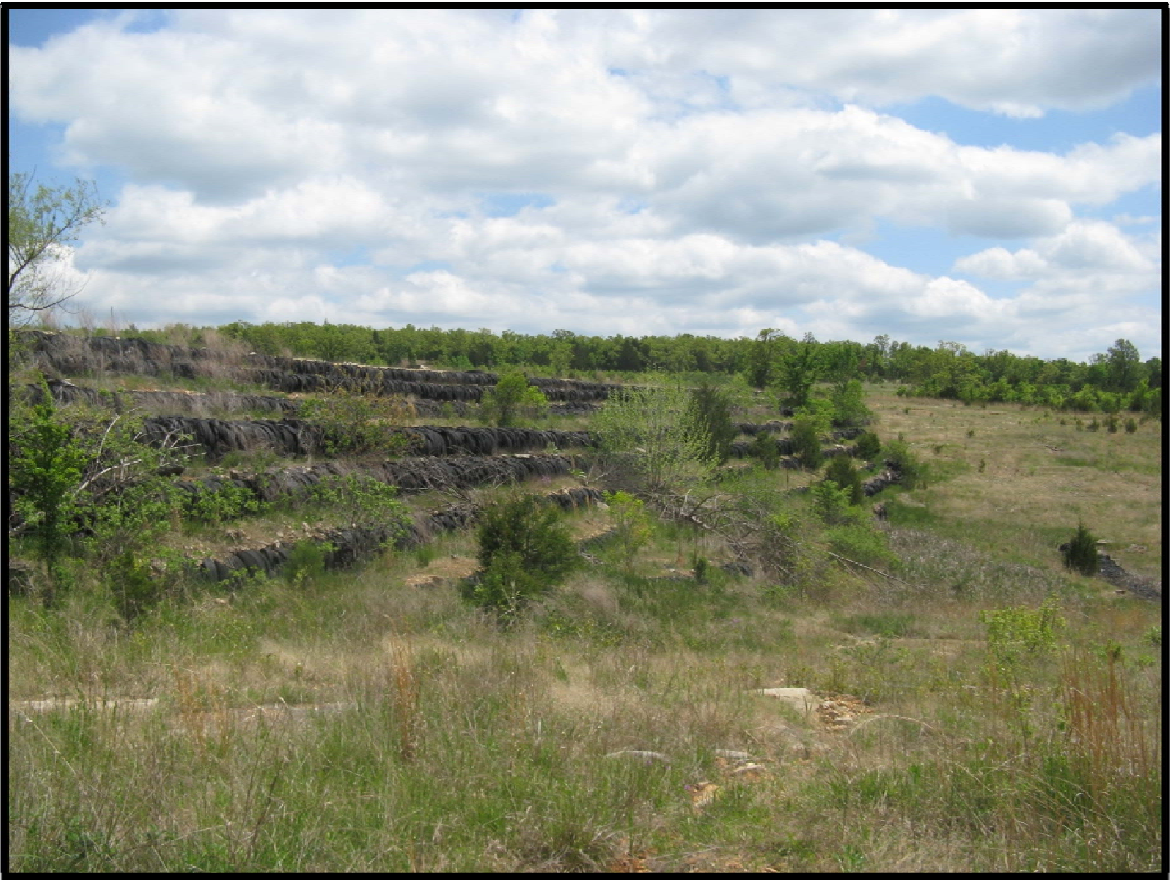
Photo 7: Looking southeast at western slope of dam; middle bench is at upper surface of exposed baled tires.

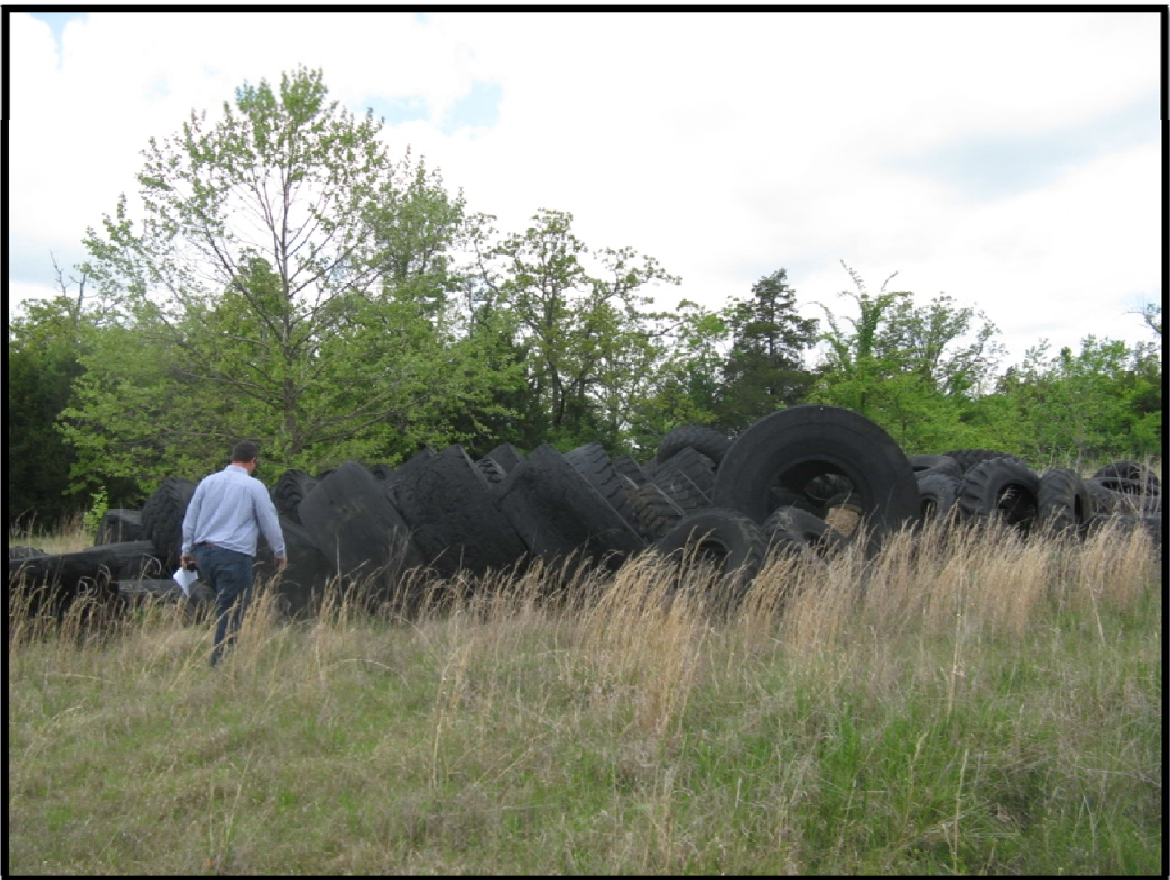
10. Most of the tires not placed in the dam are baled and stacked two to four bales high. There are unbaled waste tires scattered throughout the site, with some in wooded areas northeast of the pond (see Photos 8 through 11).

Photo 8: Unbaled tractor trailer tires located northwest of dam.

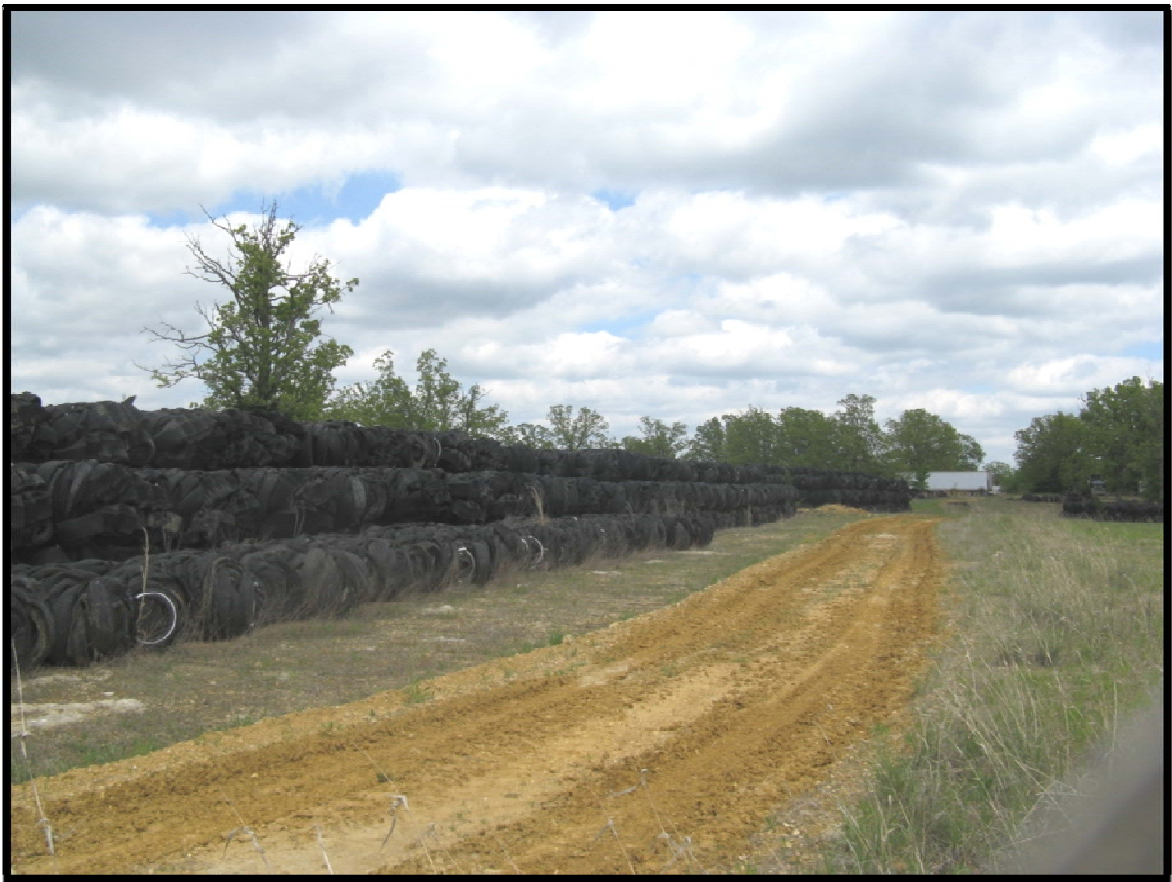
Photo 9: Stacked baled tires located north of dam near old baling area.

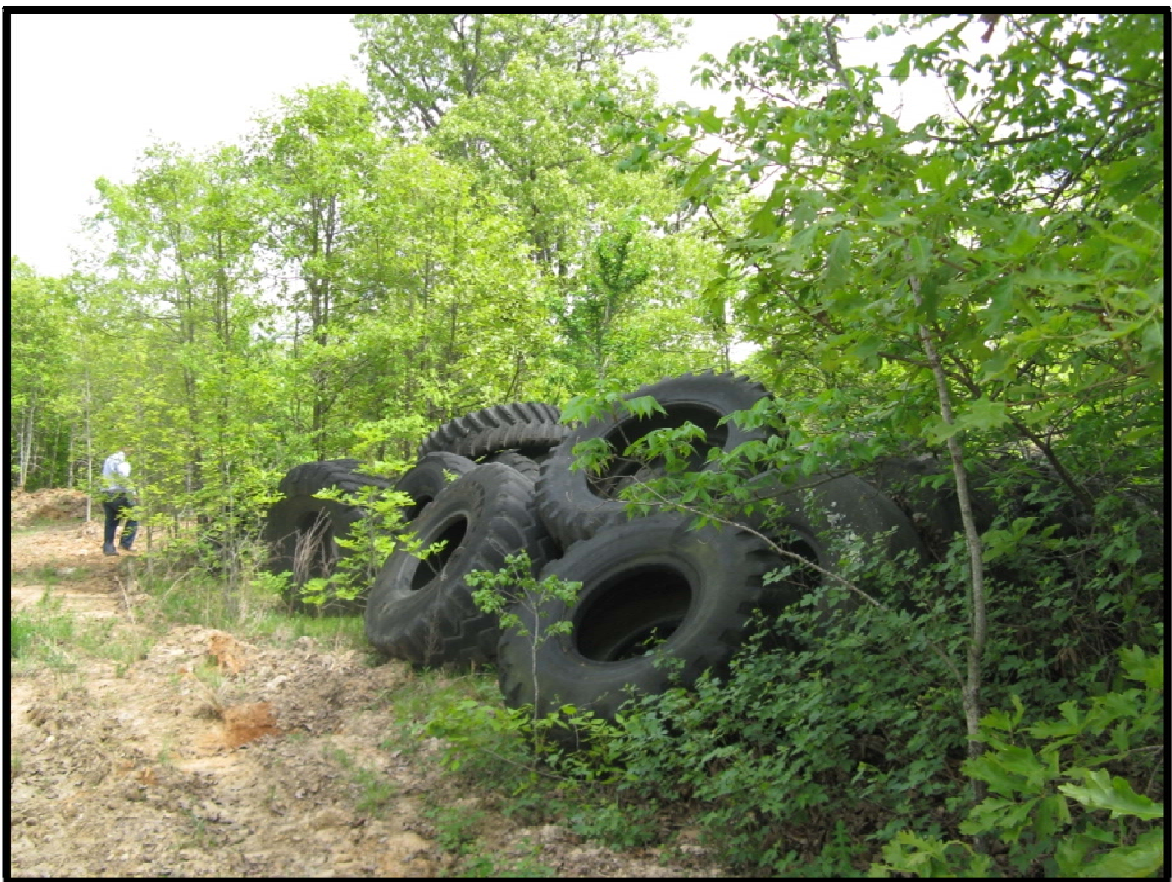
Photo 10: Large unbaled tires located in wooded area east of old baling area.

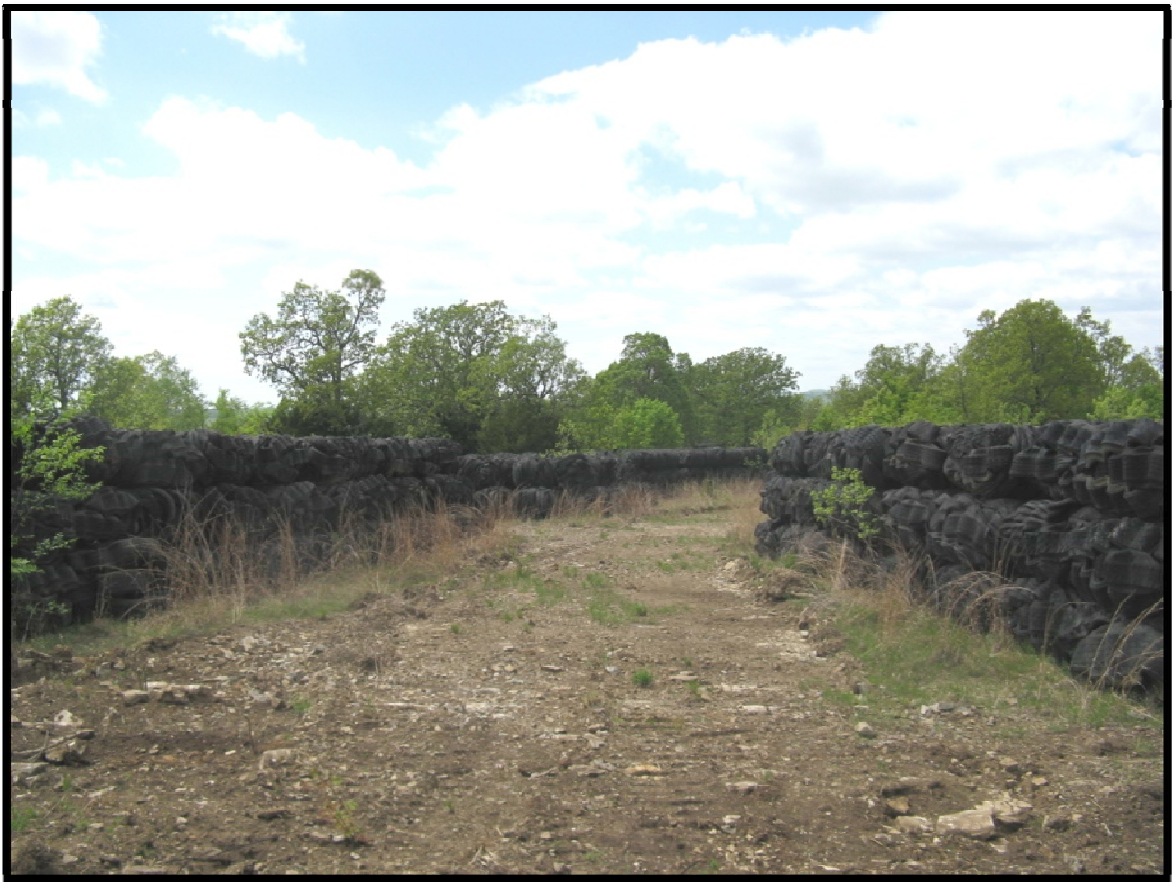
Photo 11: Baled and stacked tires located east of dam and old baling area.
