RE: Response to ADEQ Review of Report for Extending and Repairs to Monitoring Wells MW-3, MW-NAB-2, MW-NAB-8, MW-NAB-4, and CAO-2 at the NABORS Class 1 Landfill AFIN: 0249-S1-R2 Permit No. 03-00051

Subject: Report for Extending and Repairs to Monitoring Wells MW-3, MW-NAB-2, MW-

NAB-8, MW-NAB-4, and CAO-2 at the NABORS Class 1 Landfill.

AFIN: 03-00051; Permit No. 0249-S1-R2

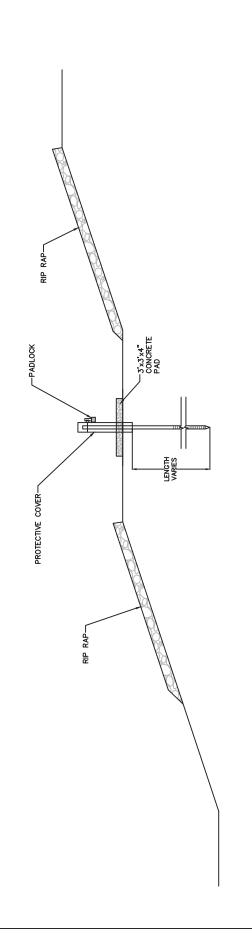
A WELL REPAIR DETAIL
1 NOT TO SCALE

Since MW-NAB-2, MW-NAB-4, MW-3, and CAO-2 are located on a 2:1 slope, riprap was placed above and below the concrete pad for stormwater diversion to prevent slope failure around the newly installed concrete pad. **Attachment 1** depicts the design of the stormwater diversion structure at these locations. **Attachment 2** is a photo log of each of these locations.

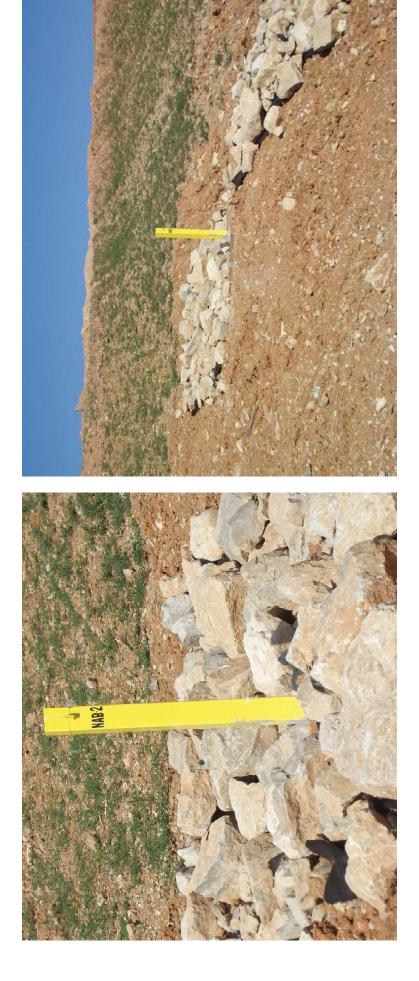
NAB-2 looking Southeast

During the placement of dirt around MW-NAB-2 and MW-3, the PVC well casing was damaged and therefore the wells could not be sampled. To repair the damage, the surrounding fill dirt was excavated until the damage to the PVC casing was located. The pipe was then repaired by adding a new section of PVC casing. The new casing was joined with the old casing via rubber boot with stainless steel bands. In addition, rebar was placed along two sides of the pipe. The rebar was secured with two stainless steel bands above and two bands below the joint to prevent movement in the PVC casing during placement of the dirt around the newly repaired casing. Fill dirt was then placed around the pipe until the desired elevation was reached. A new protective cover and pad were installed to complete each well at the new ground surface.
