FROM: Thomas Huetter, P.G., Harbor

DATE: January 21, 2019

RE: Well Lock Survey
NABORS Landfill
Mountain Home, AR

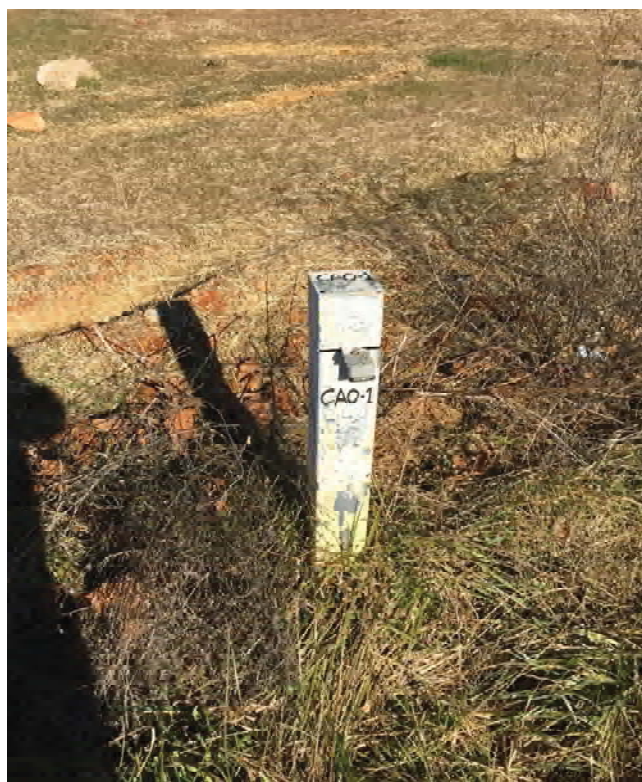
Photograph 1: Groundwater monitoring well CAO-1 - locked.

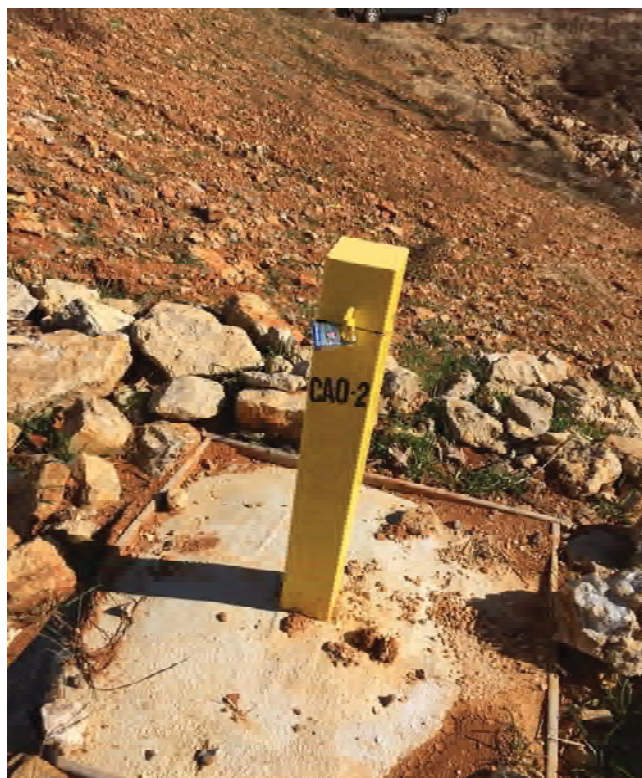
Photograph 2: Extended groundwater monitoring well CAO-2 - new lock has been added.

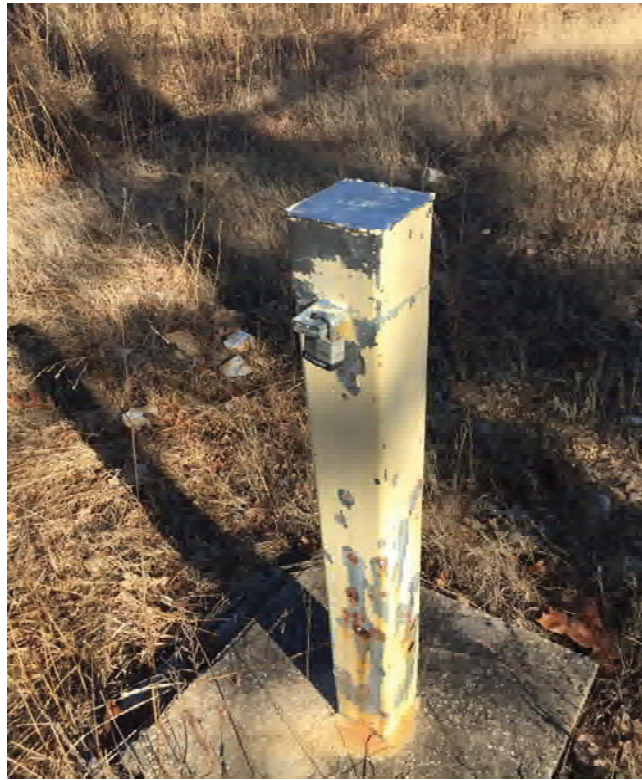
Photograph 3: Groundwater monitoring well CAO-3 - locked.

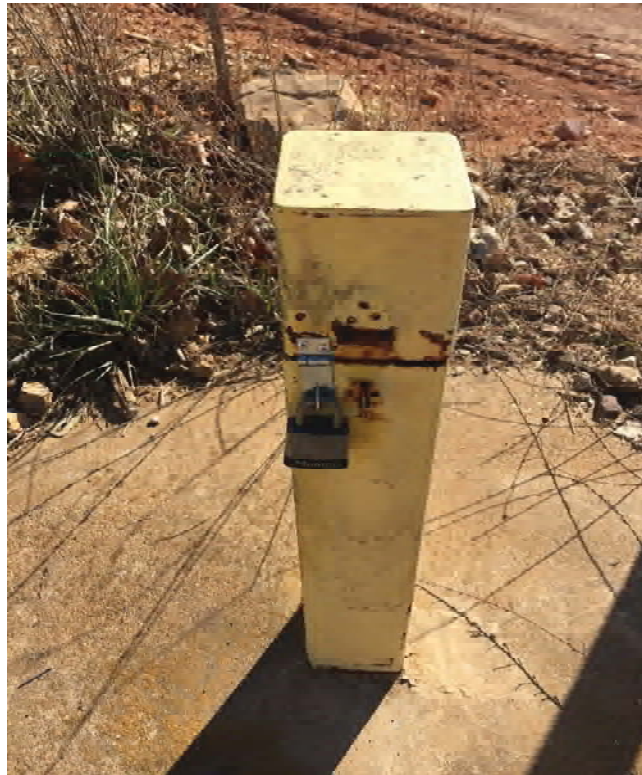
Photograph 4: Groundwater monitoring well MW-1 - new hasp has been added and well locked.

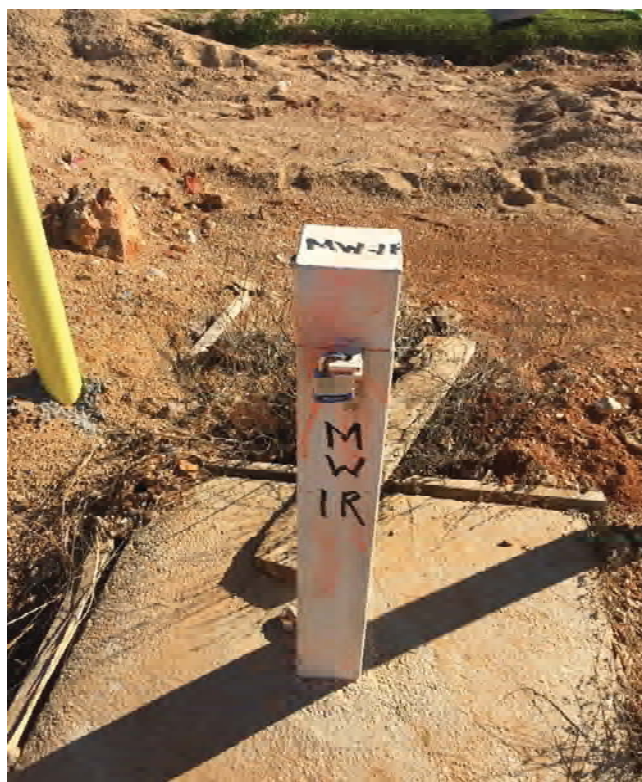
Photograph 5: Groundwater monitoring well MW-1R - locked.

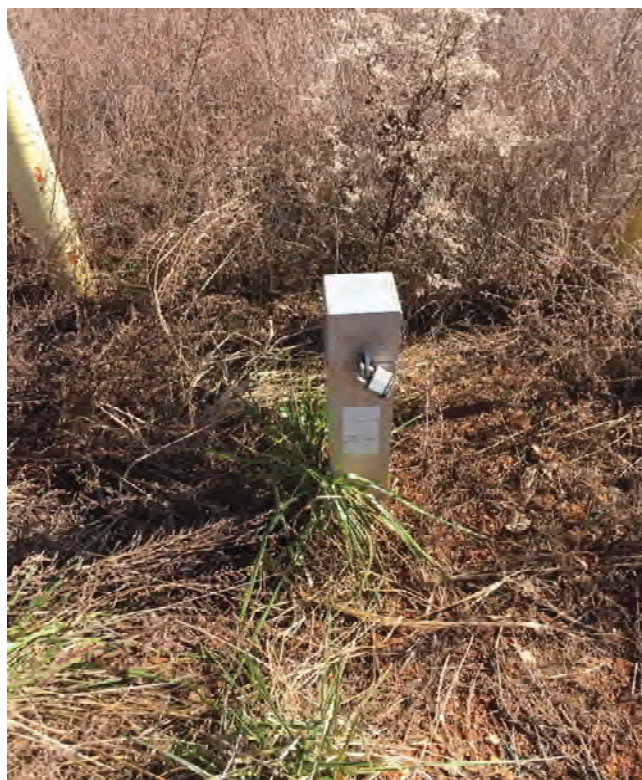
Photograph 6: Groundwater monitoring well MW-2 - locked.

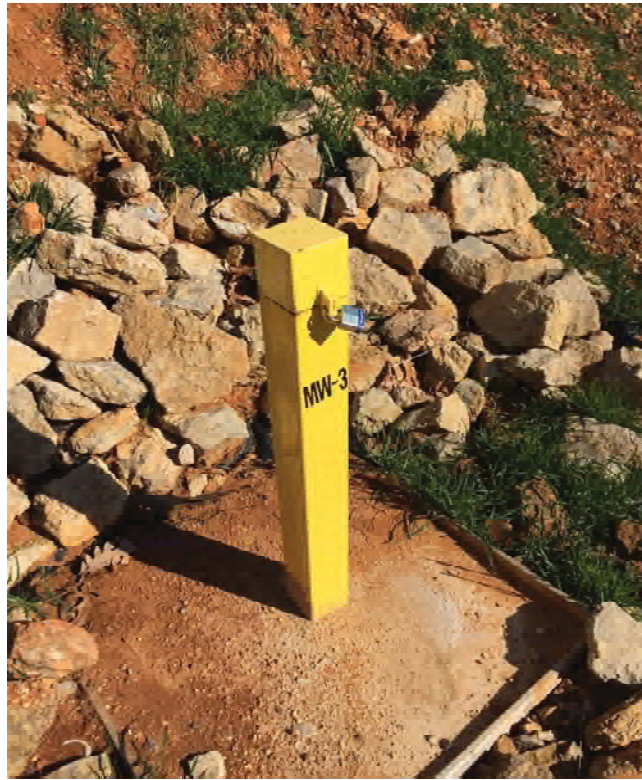
Photograph 7: Extended groundwater monitoring well MW-3 - new lock has been added.

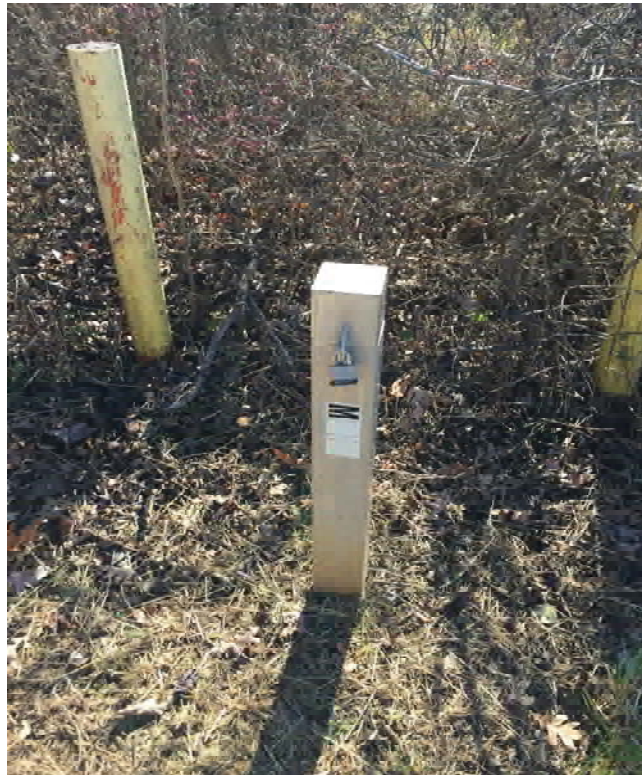
Photograph 8: Groundwater monitoring well MW-4 - locked.

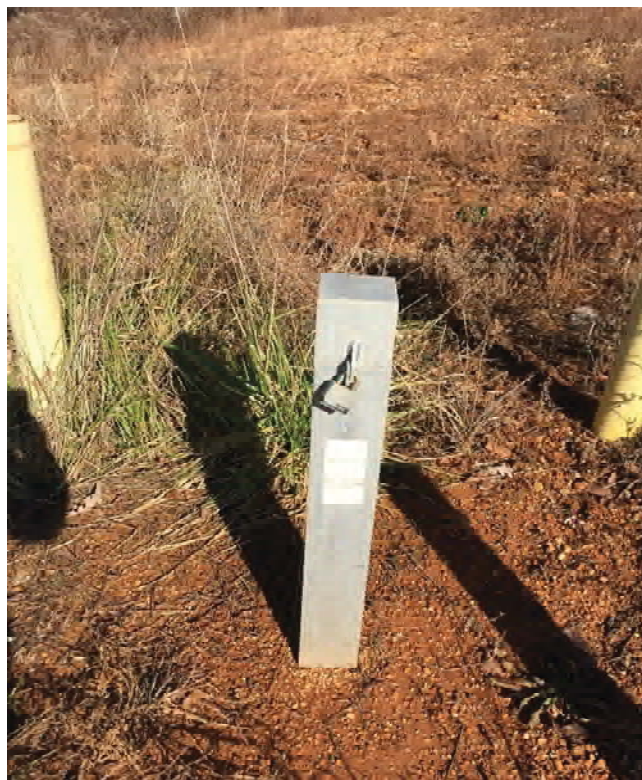
Photograph 9: Groundwater monitoring well MW-5 - locked.

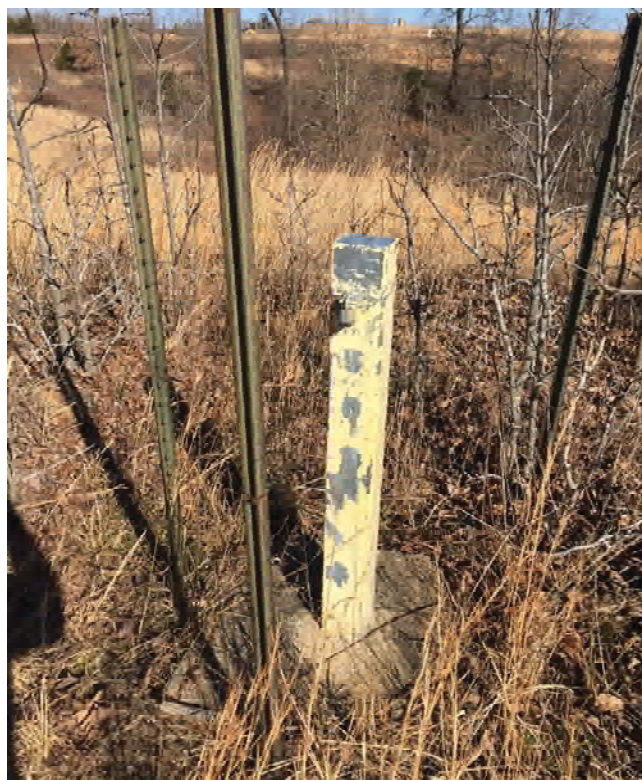
Photograph 10: Groundwater monitoring well MW-6 - locked.

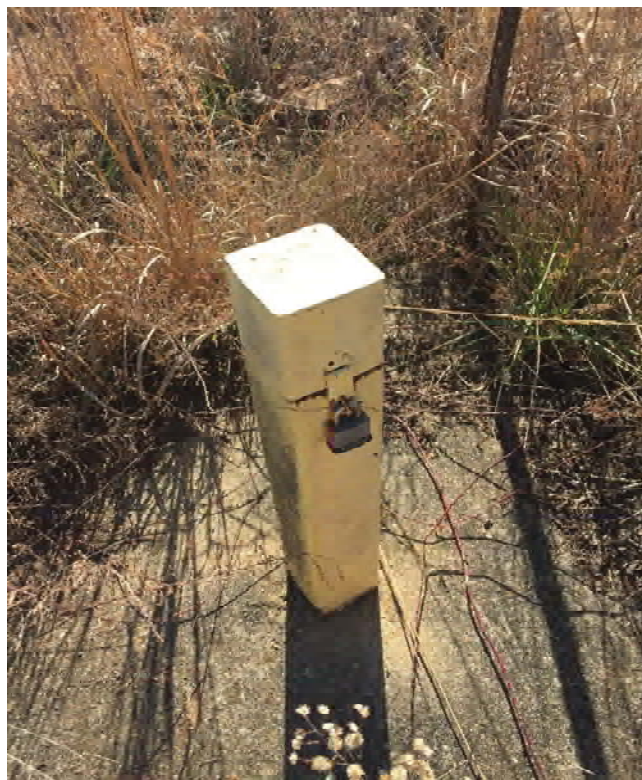
Photograph 11: Groundwater monitoring well MW-7 - locked.

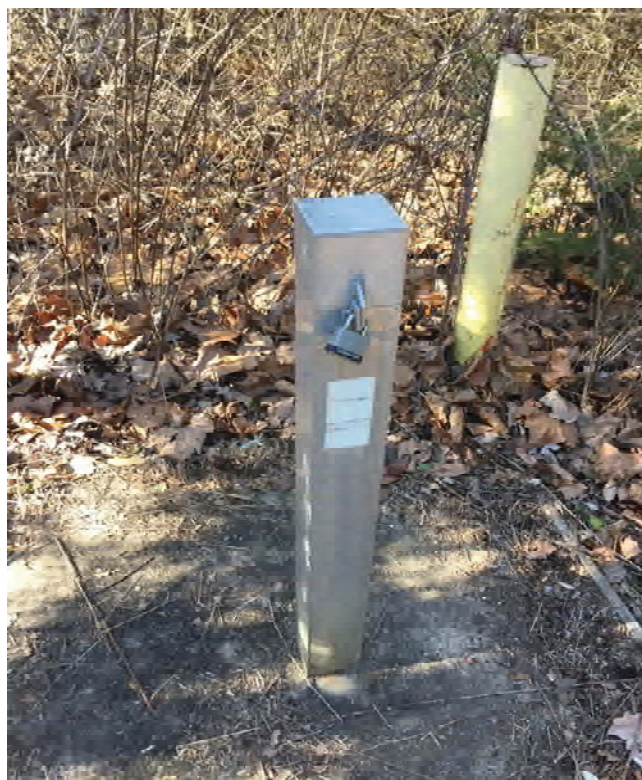
Photograph 12: Groundwater monitoring well MW-509 - locked.

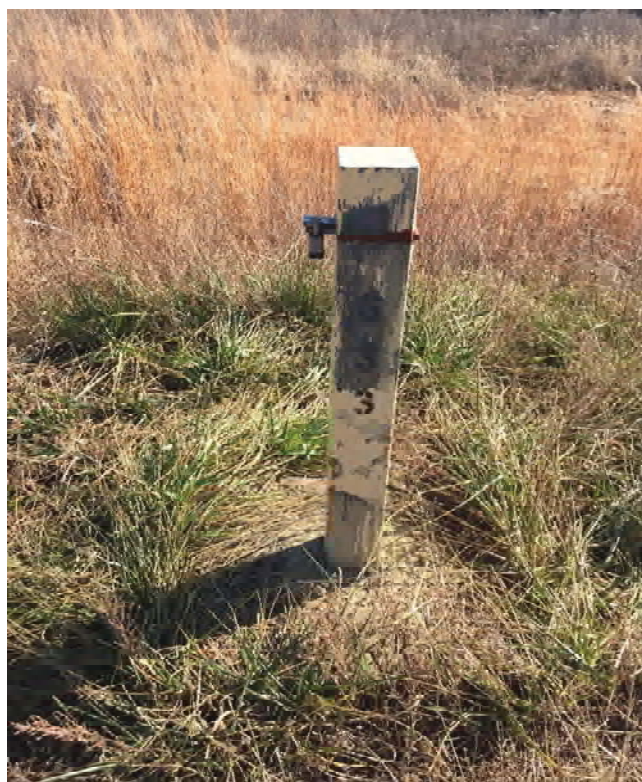
Photograph 13: Groundwater monitoring well MW-577 - locked.

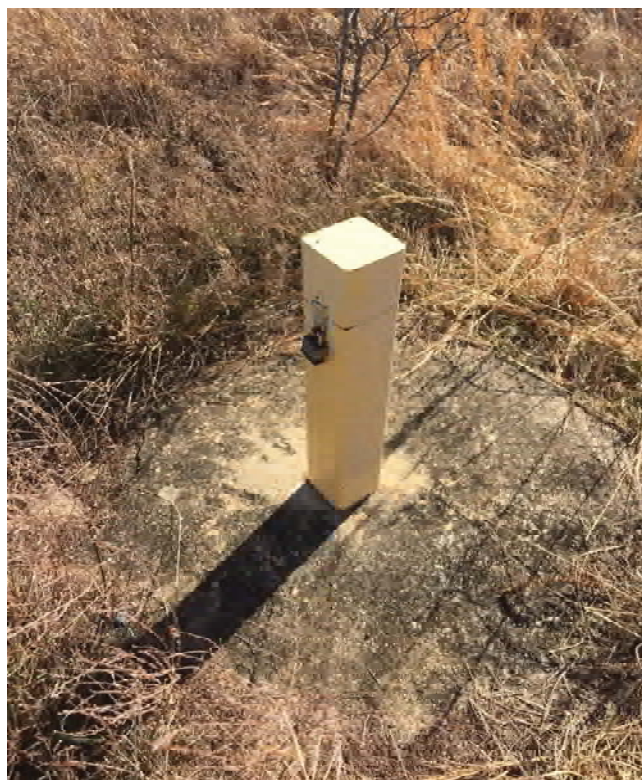
Photograph 14: Groundwater monitoring well MW-633 - locked.

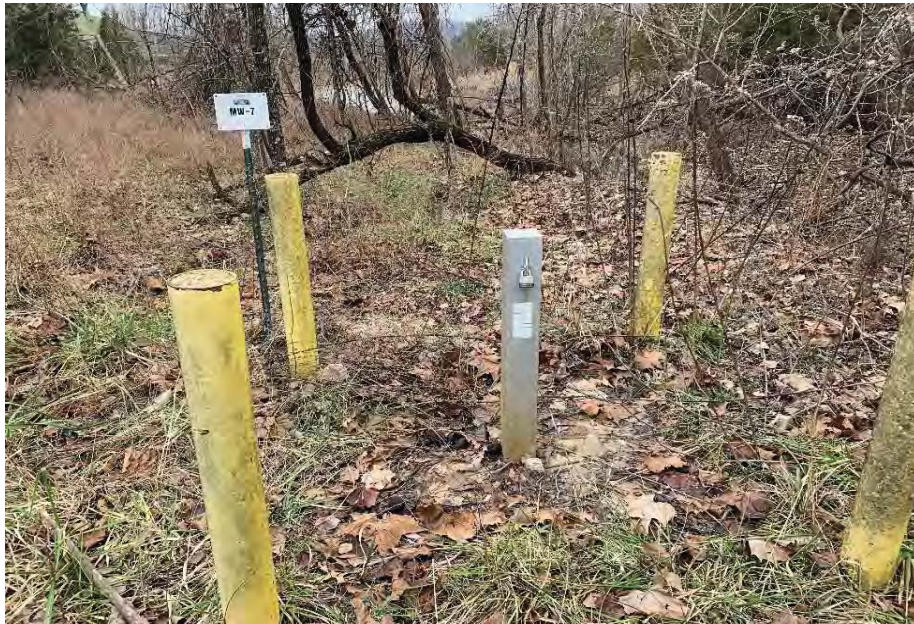
Photograph 15: Groundwater monitoring well MW-689 - locked.

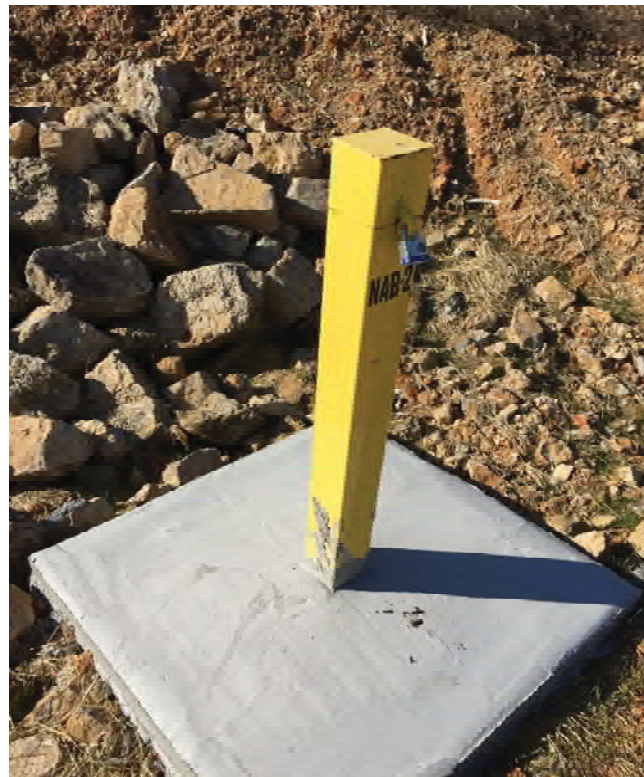
Photograph 16: Extended groundwater monitoring well NAB-2 - new lock has been added.

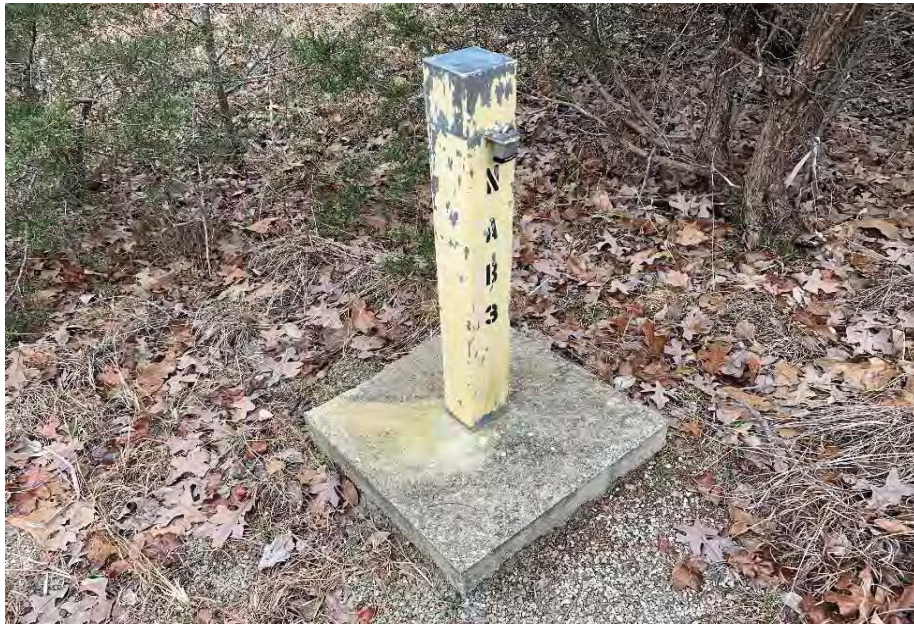
Photograph 17: Groundwater monitoring well NAB-3 - locked.

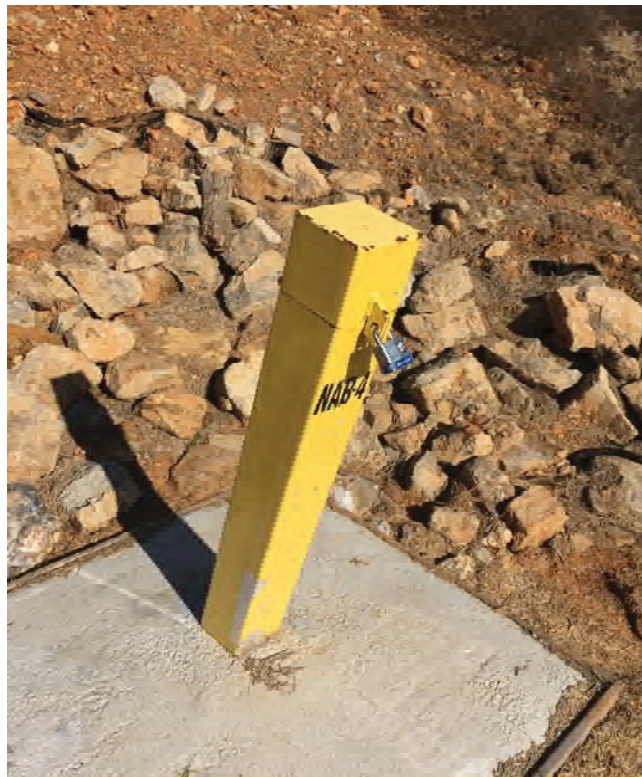
Photograph 18: Extended groundwater monitoring well NAB-4 - new lock has been added.

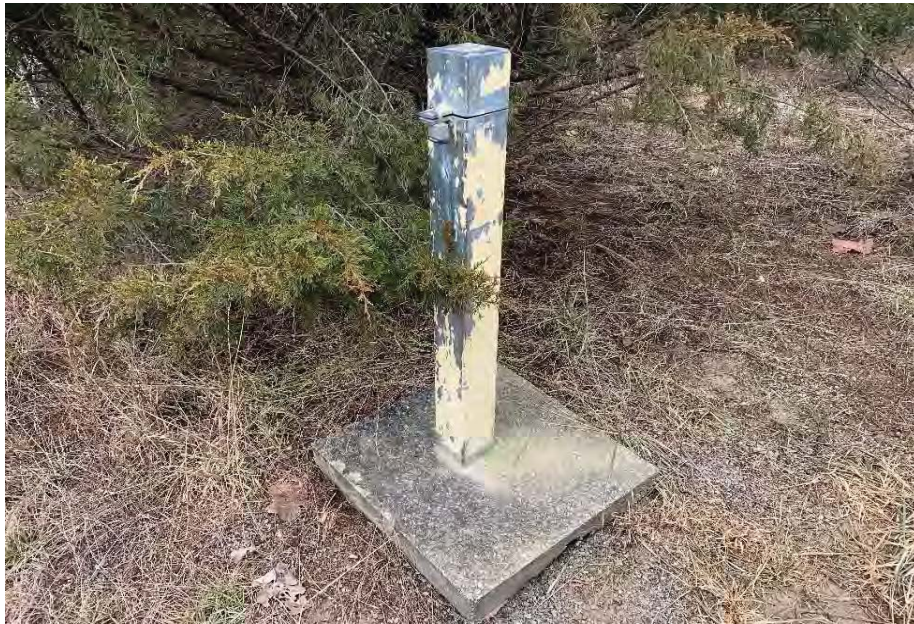
Photograph 19: Groundwater monitoring well NAB-7 - locked.

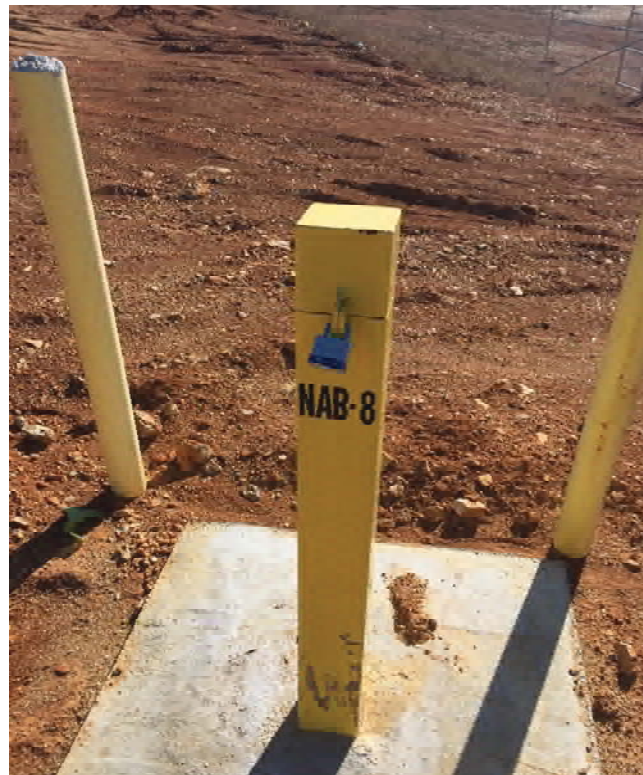
Photograph 20: Extended groundwater monitoring well NAB-8 - new lock has been added.

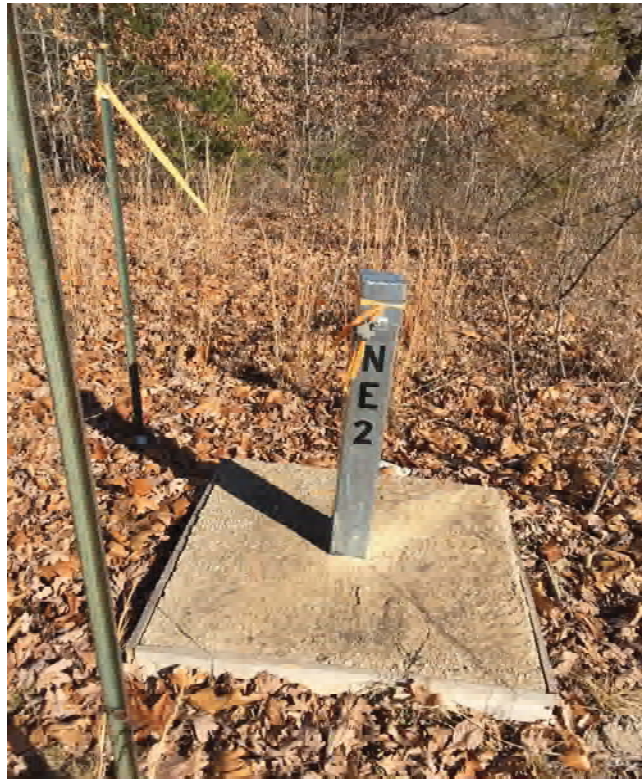
Photograph 21: Groundwater monitoring well NE-2 - locked.

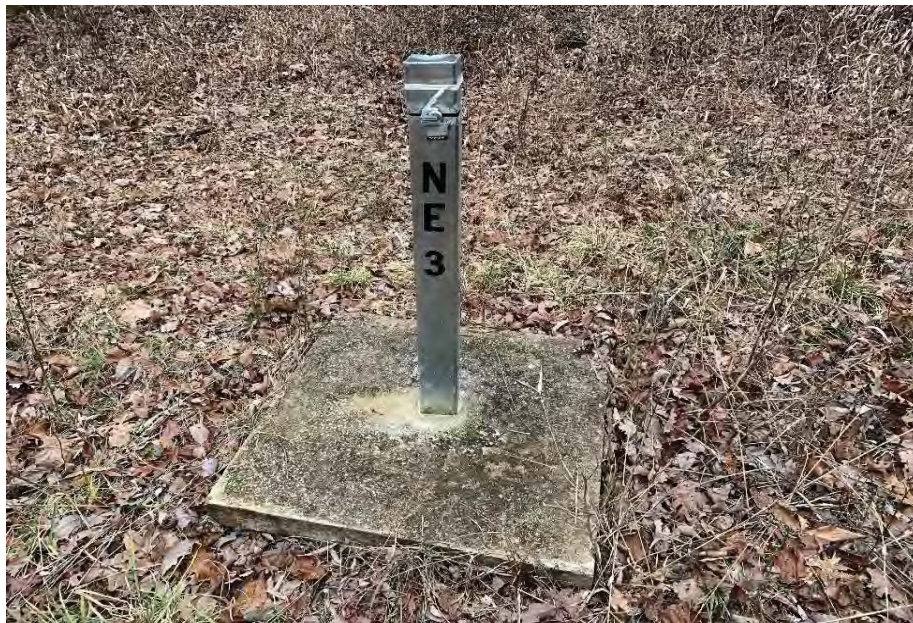
Photograph 22: Groundwater monitoring well NE-3 - locked.

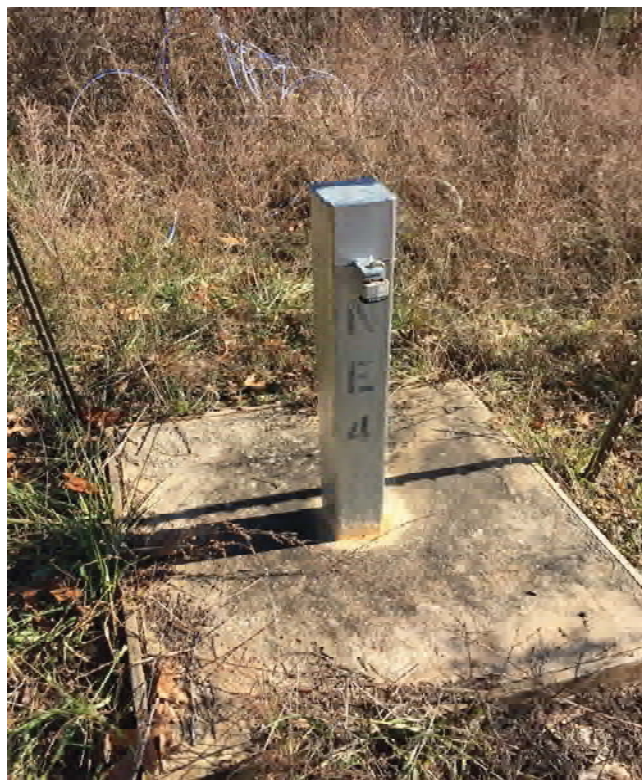
Photograph 23: Groundwater monitoring well NE-4 - locked.

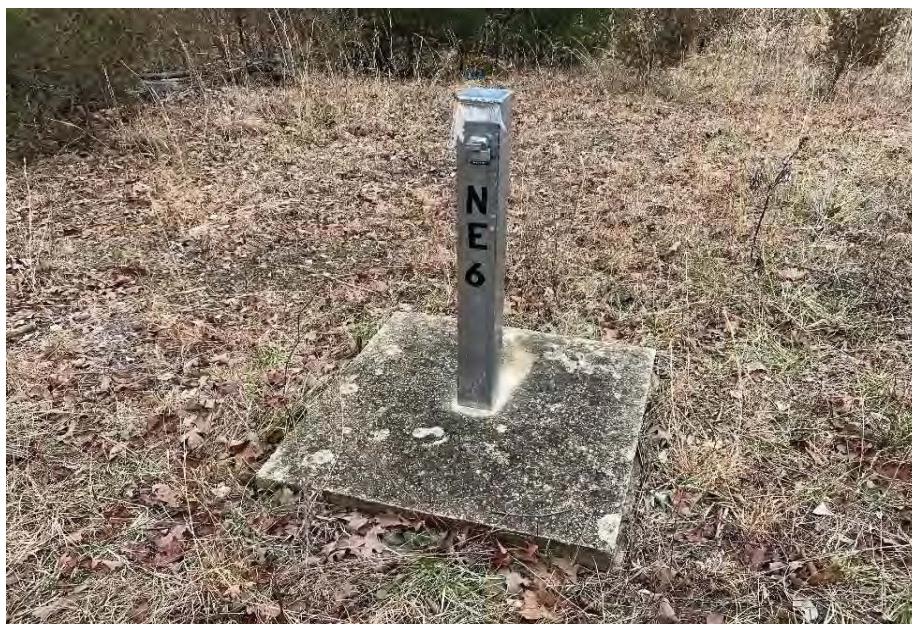
Photograph 24: Groundwater monitoring well NE-6 - locked.

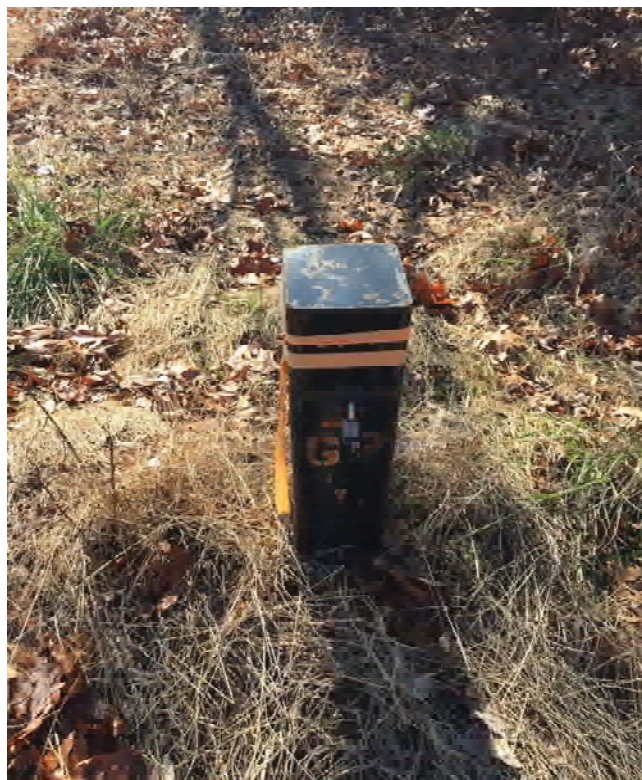
Photograph 1: Gas probe GP-1 - locked.

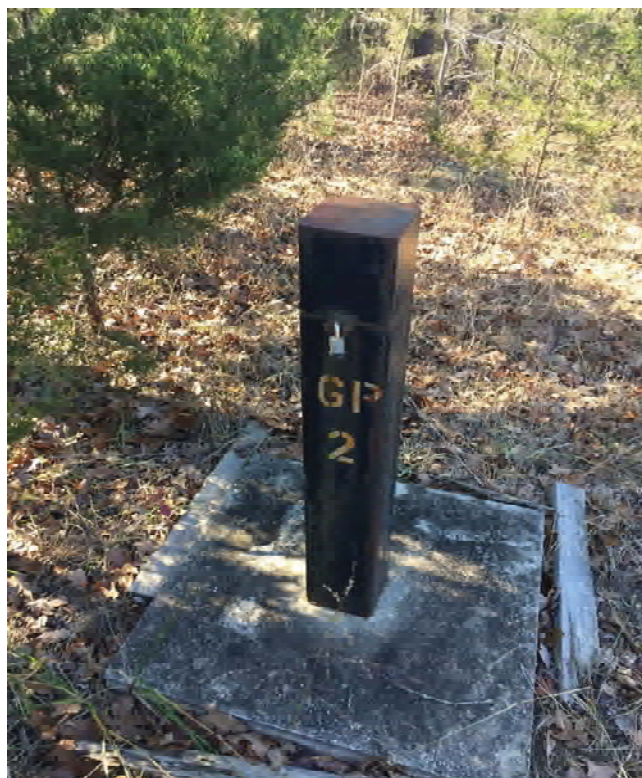
Photograph 2: Gas probe GP-2 - locked.

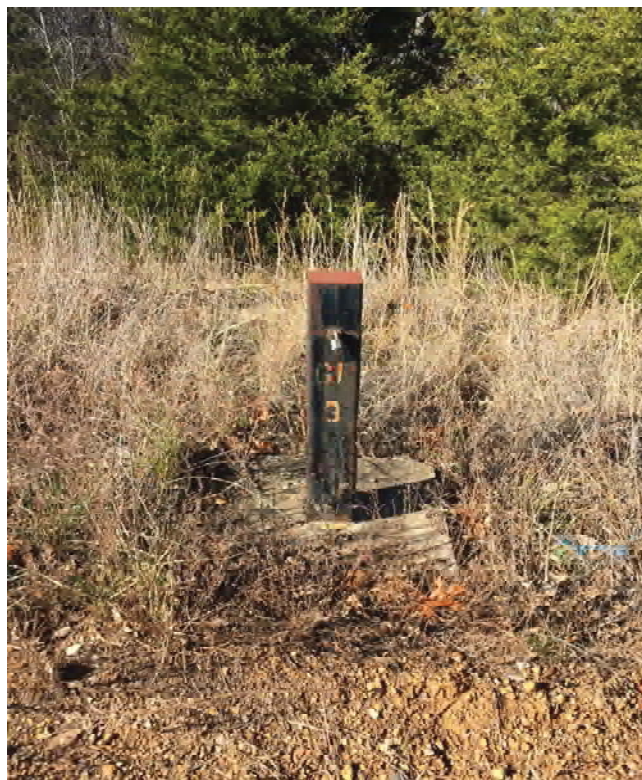
Photograph 3: Gas probe GP-3 - locked.

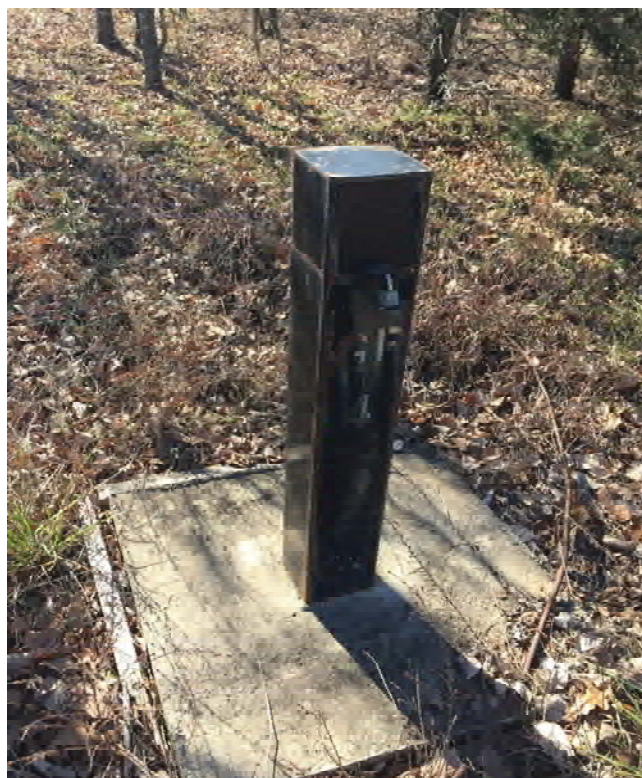
Photograph 4: Gas probe GP-4 - locked.

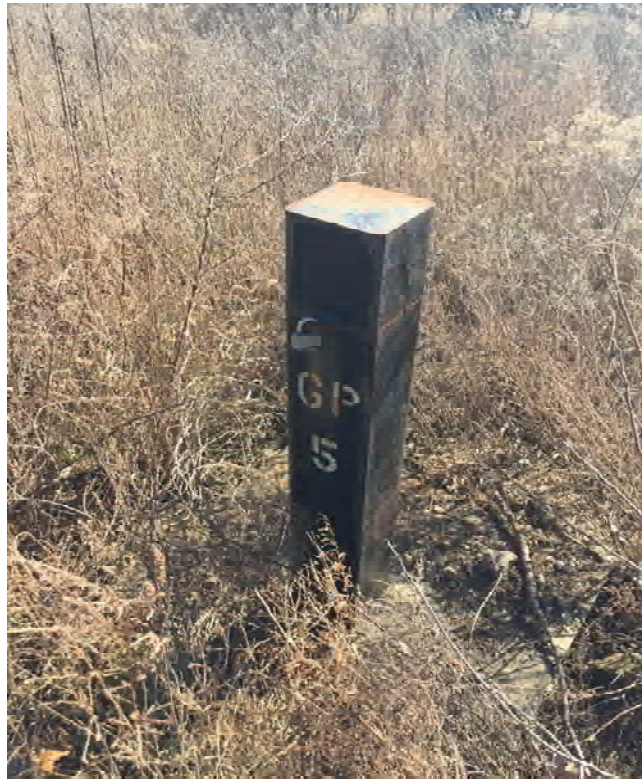
Photograph 5: Gas probe GP-5 - locked.

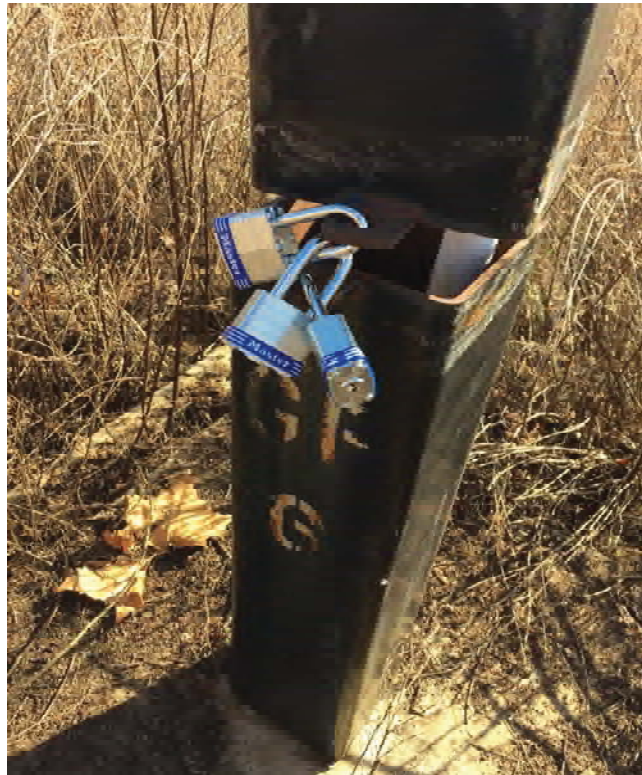
Photograph 6: Gas probe GP-6 - new daisy-chained locks added.
Outer casing will not close properly due to extended inner well pipe.

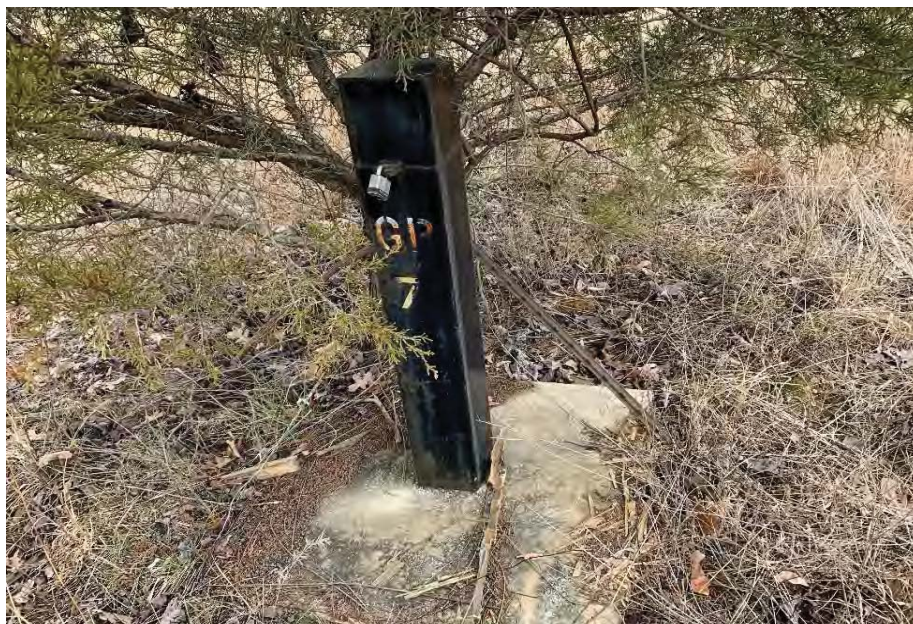
Photograph 7: Gas probe GP-7 - locked.

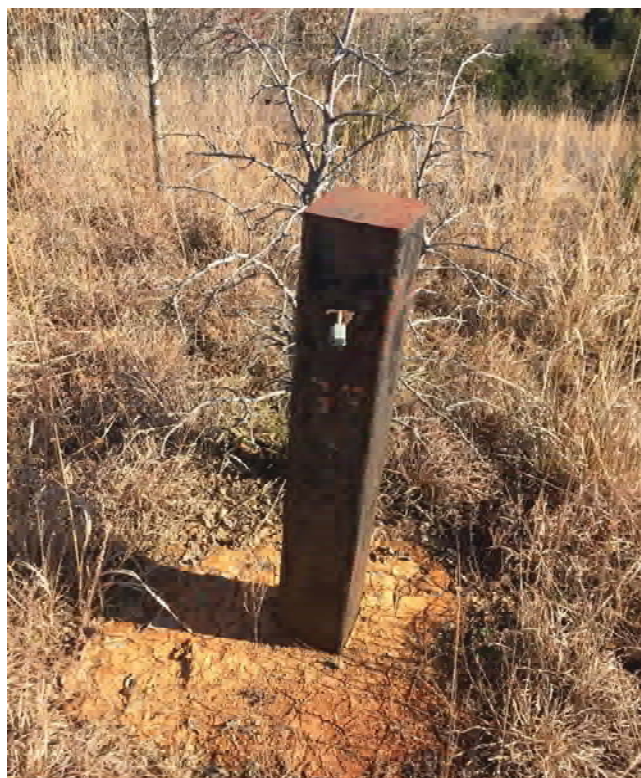
Photograph 8: Gas probe GP-8 - locked.

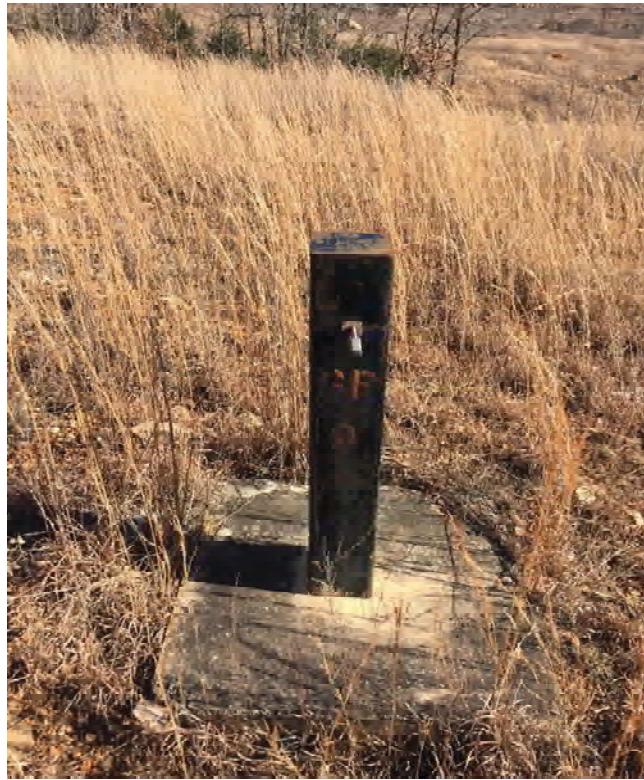
Photograph 9: Gas probe GP-9 - locked.

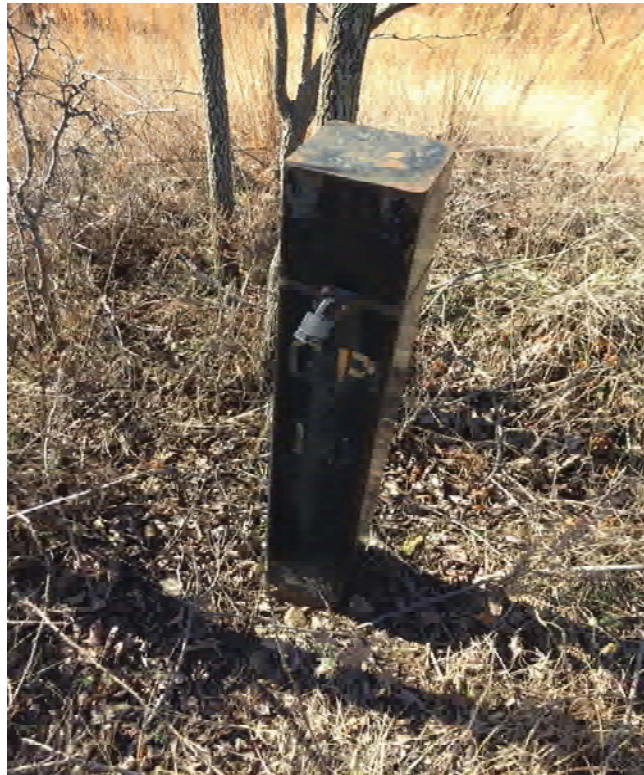
Photograph 10: Gas probe GP-10 - locked.

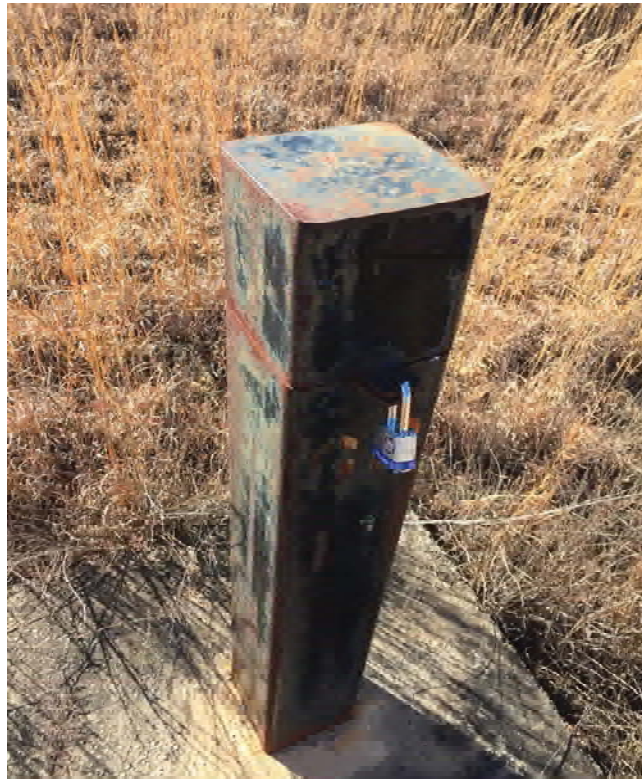
Photograph 11: Gas probe GP-11 - no lock was present. Added new lock.

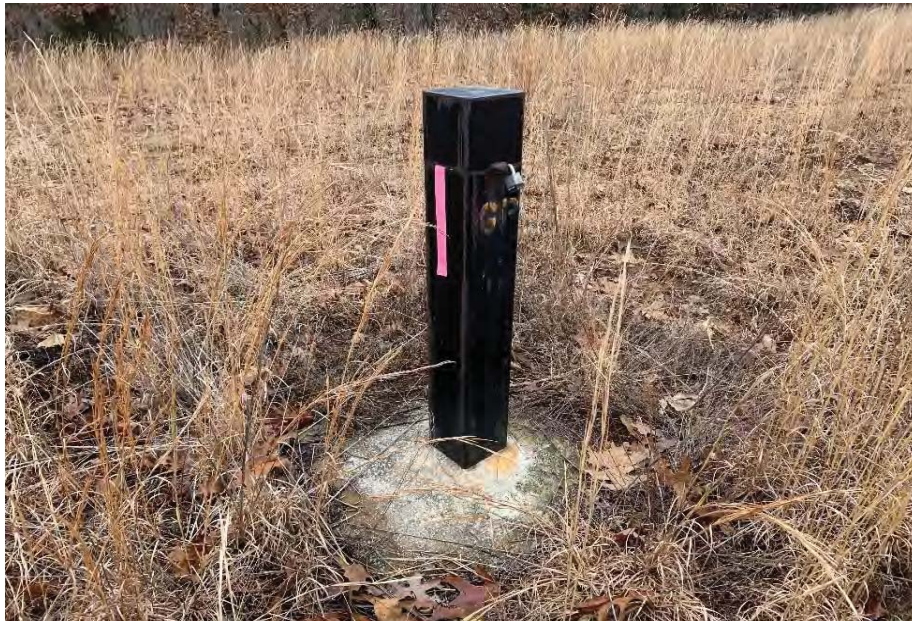
Photograph 12: Gas probe GP-12 - locked.

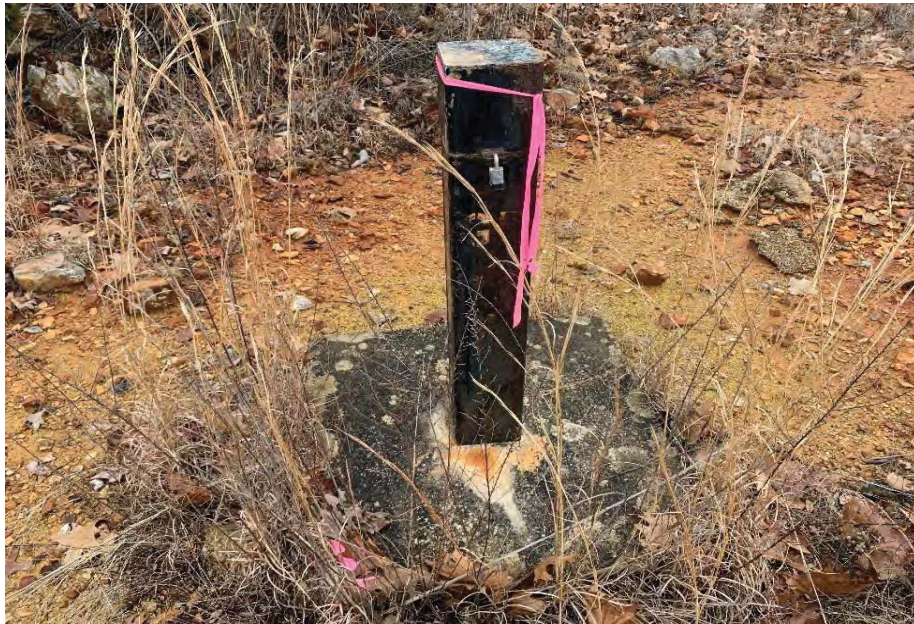
Photograph 13: Gas probe GP-13 - locked.

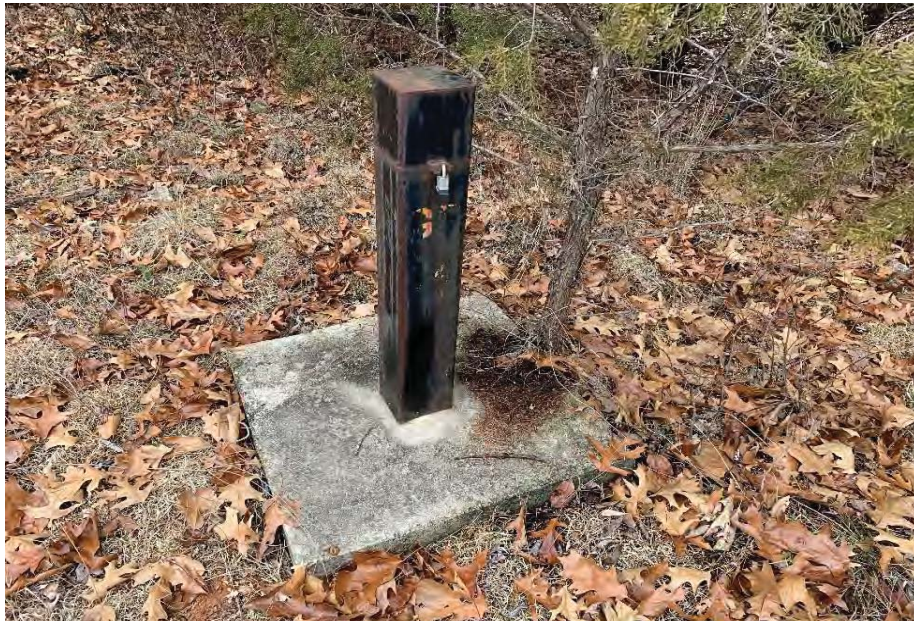
Photograph 14: Gas probe GP-14 - locked.

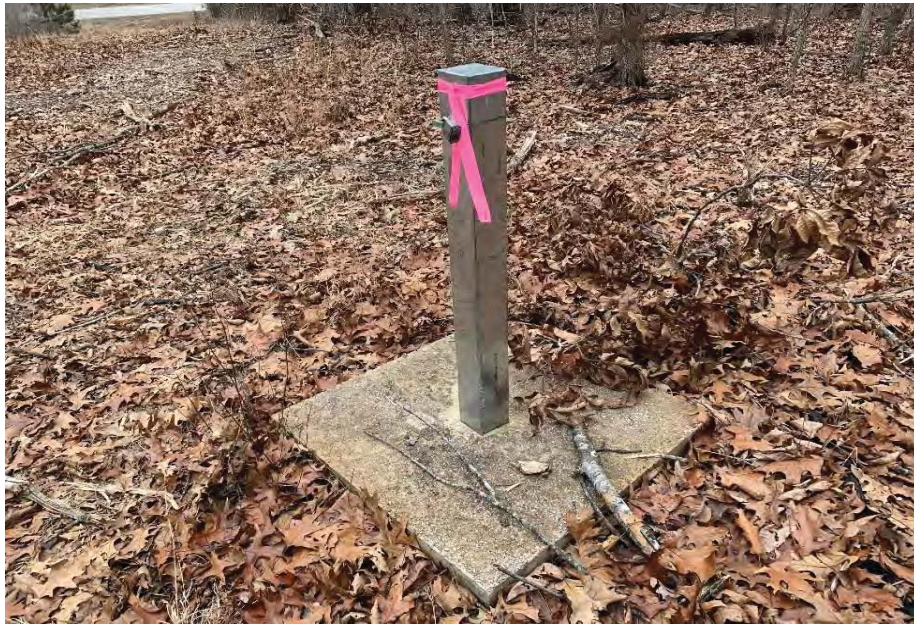
Photograph 15: Gas probe GP-14R - locked.

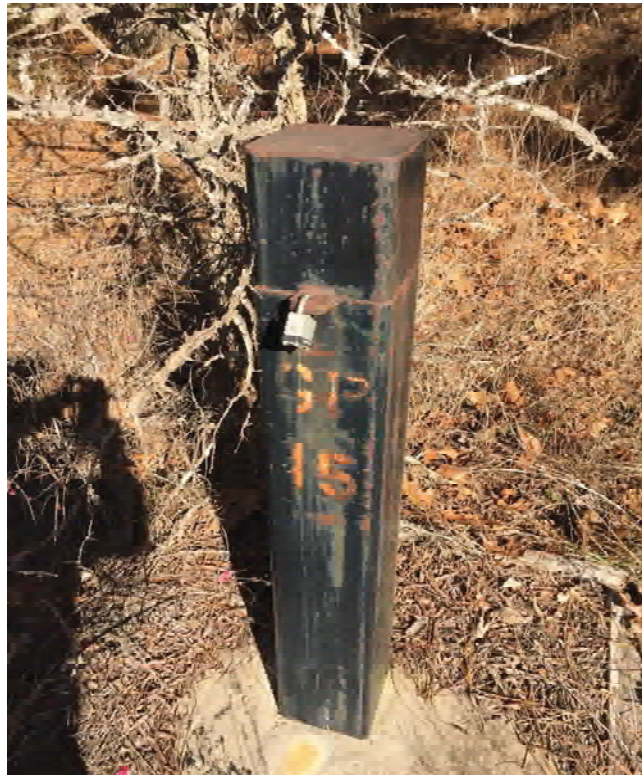
Photograph 16: Gas probe GP-15 - locked.

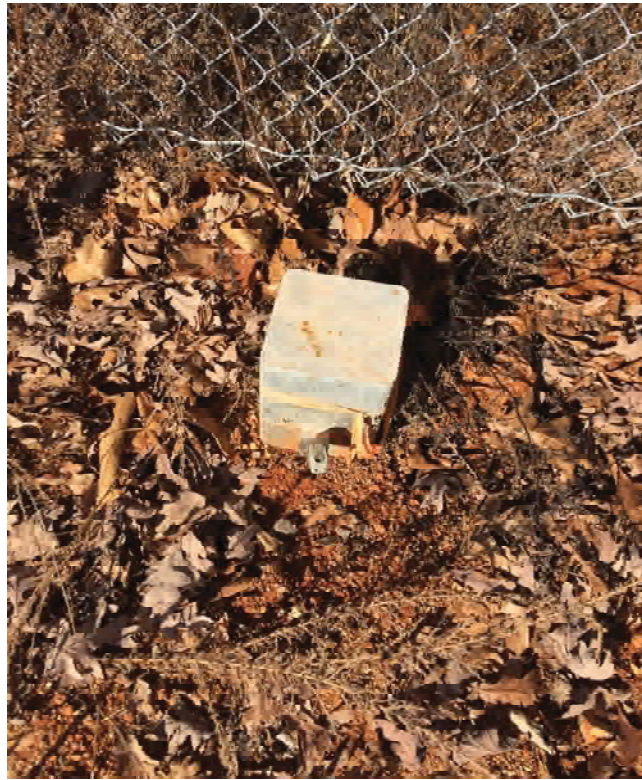
Photograph 17: Gas probe GP-16 - locked.

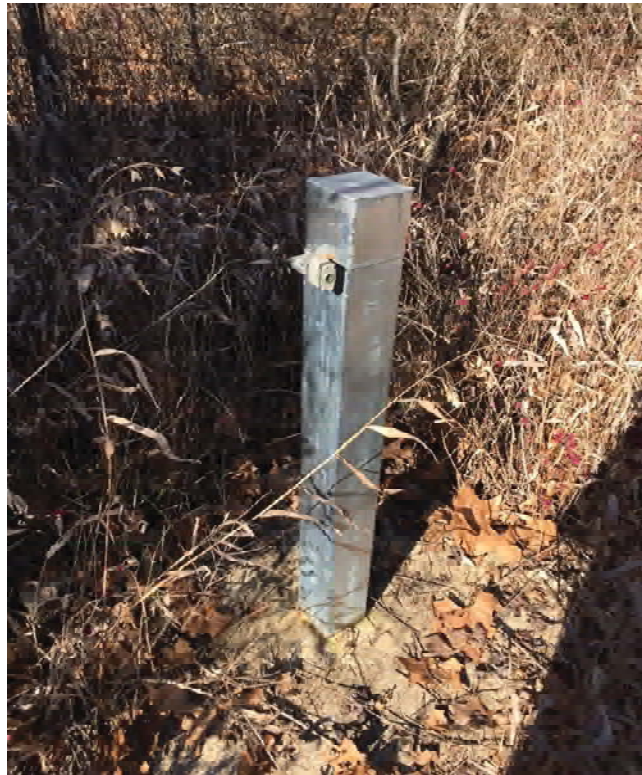
Photograph 18: Gas probe GP-16R - locked.

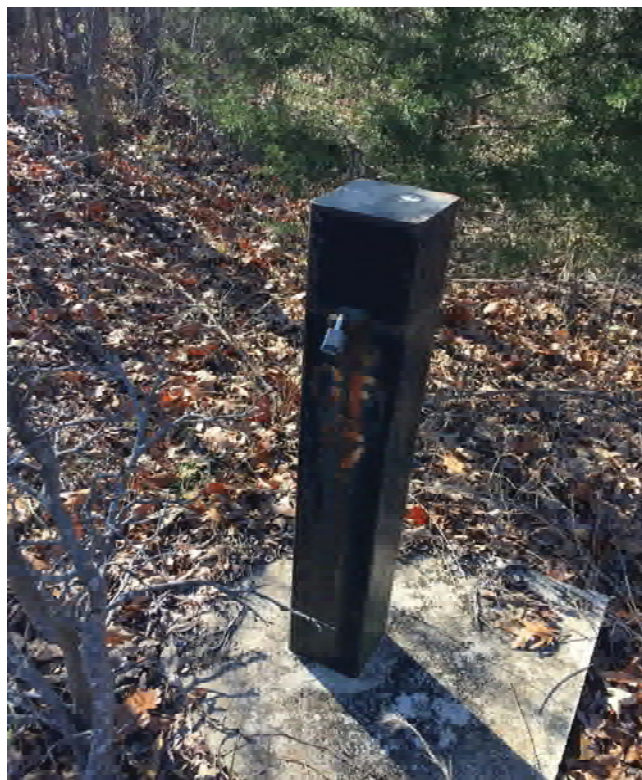
Photograph 19: Gas probe GP-17 - locked.
