FROM: Thomas Huetter, P.G., Harbor

DATE: January 21, 2019

RE: Well Lock Survey
NABORS Landfill
Mountain Home, AR

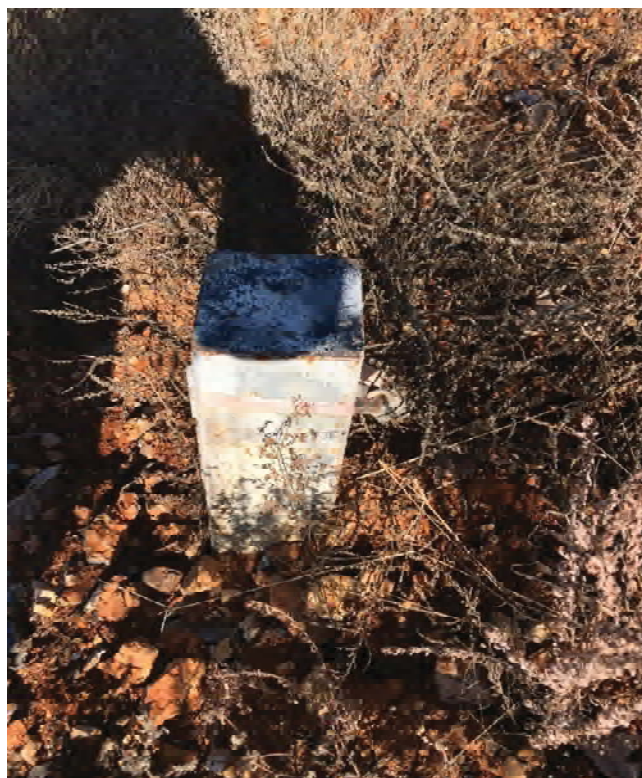
Gas Well	Status	Condition	Date Inspected
GP-18	Locked	Outer casing nearly covered with soil	12/11/2018
GP-18R	Locked	Good	12/11/2018

Photograph 20: Gas probe GP-18 - locked.

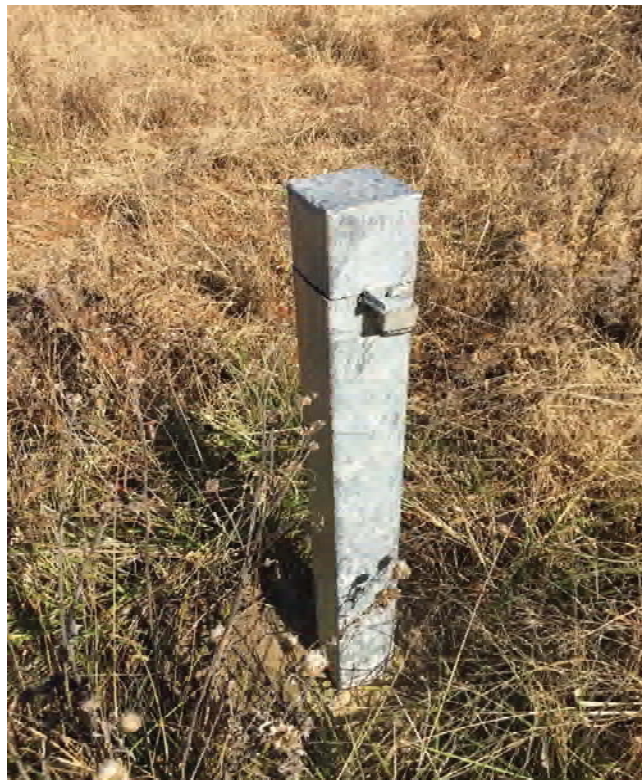
Photograph 21: Gas probe GP-18R - locked.
