Subject: RE: NABORS Bi-weekly Site Inspection

RE: Bi-weekly Site Inspection
NABORS Landfill
Mountain Home, AR

Harbor visited the NABORS landfill in Mountain Home, Arkansas on November 4, 2022, to conduct the bi-weekly landfill inspection. Findings and observations from the landfill inspection are summarized below:

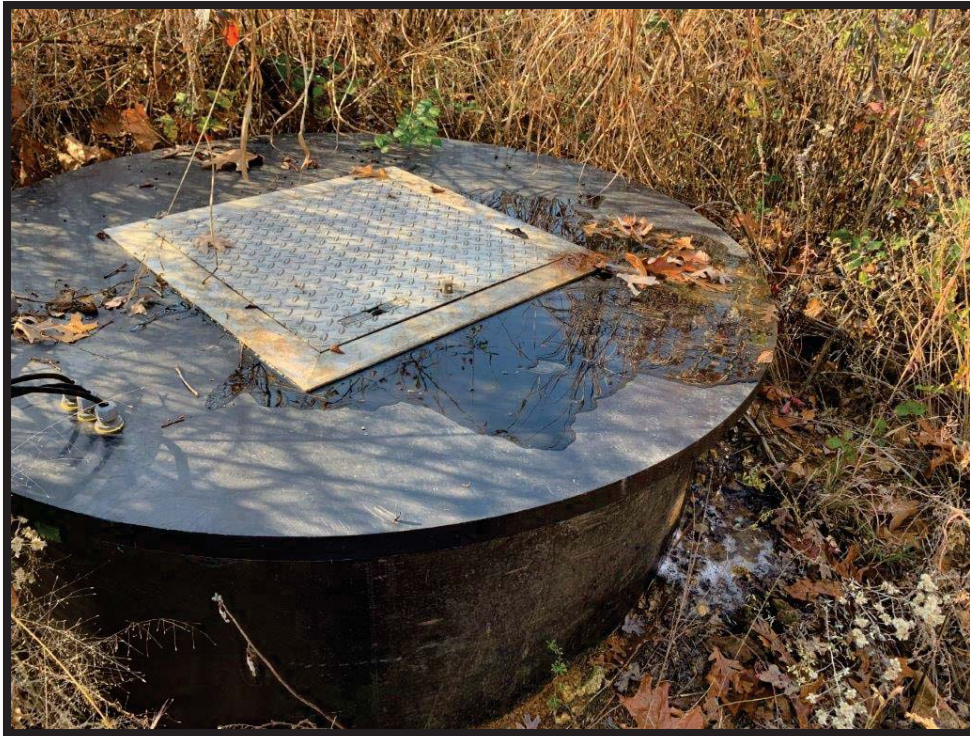
- The red strobe was not activated at VLCS-2, but the sump has exceeded its capacity. VLCS-1 appeared to be functioning correctly; however, vegetation is heavily overgrown at both locations (see photograph 1).

Photograph 1: View of VLCS-2 at capacity.

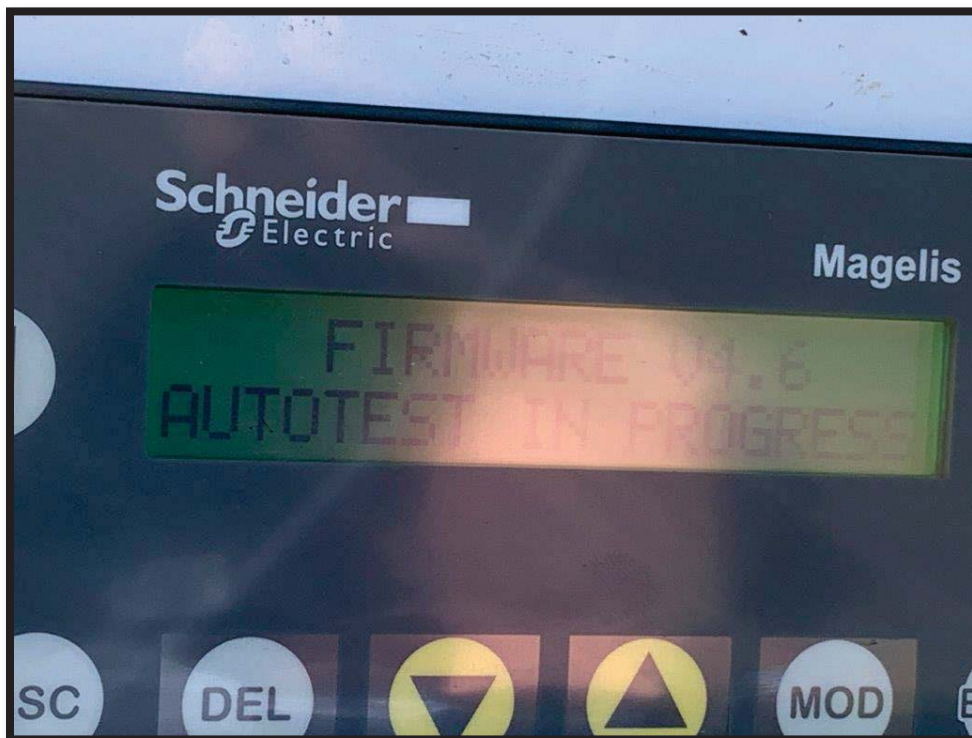
- LCS-1 displayed "FIRMWARE V4.6 AUTOTEST IN PROGRESS" and would not allow keypad navigation (see photograph 2). The green strobe came on when placed in "hand" mode, but it is undetermined whether this point is functioning correctly.

Photograph 2: View of "autotest in progress" message on panel at LCS-1.

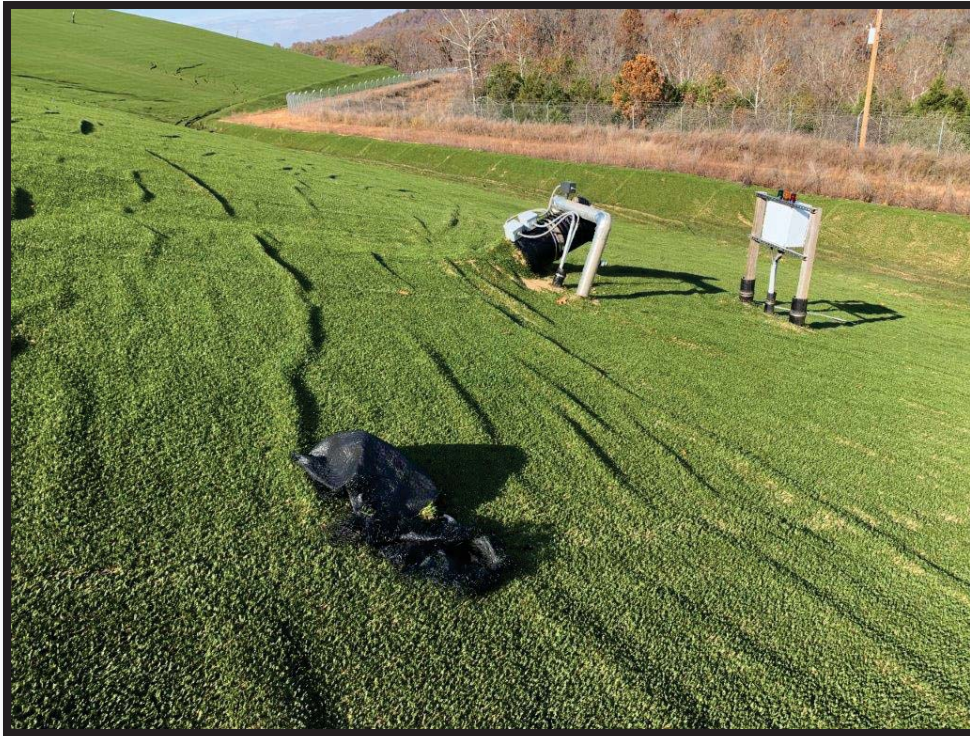
- A piece of torn closure turf and a damaged vent pipe were observed near LCS-1 (see photographs 3 - 5). A turbine vent remains detached (see photograph 6) near LCS-6.

Photograph 3: View west of torn liner piece near LCS-1.

AFT has been contacted to schedule the remaining repairs. Photographs are included in Attachment A. A copy of the field notes and the leachate collection system status form are included in Attachment B.

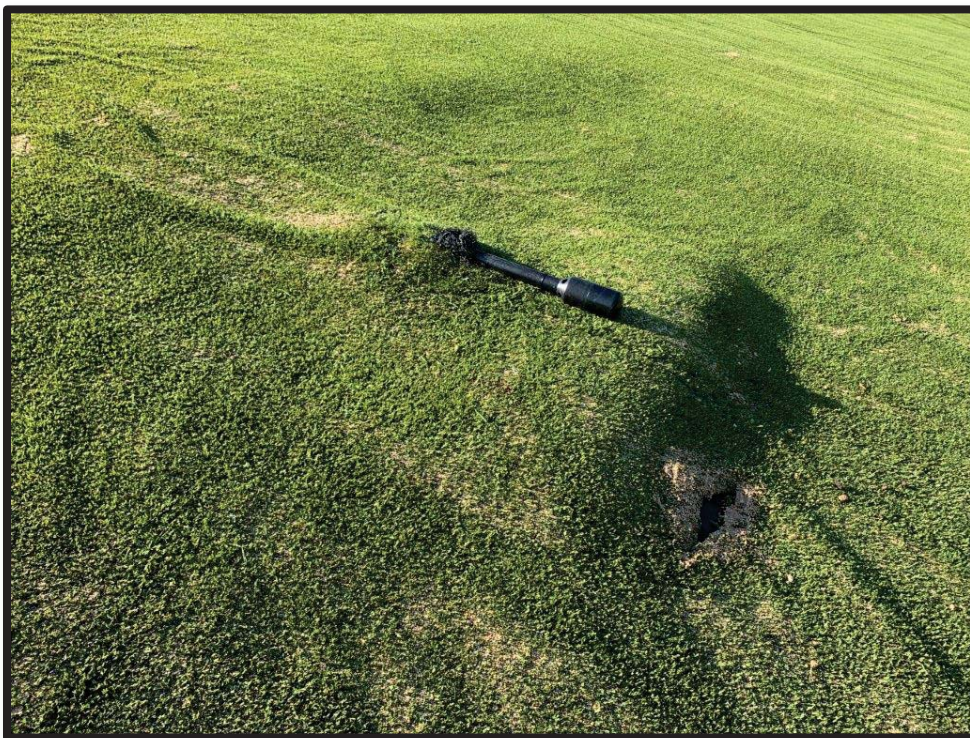
Photograph 4: View southwest of damaged vent pipe near LCS-1.

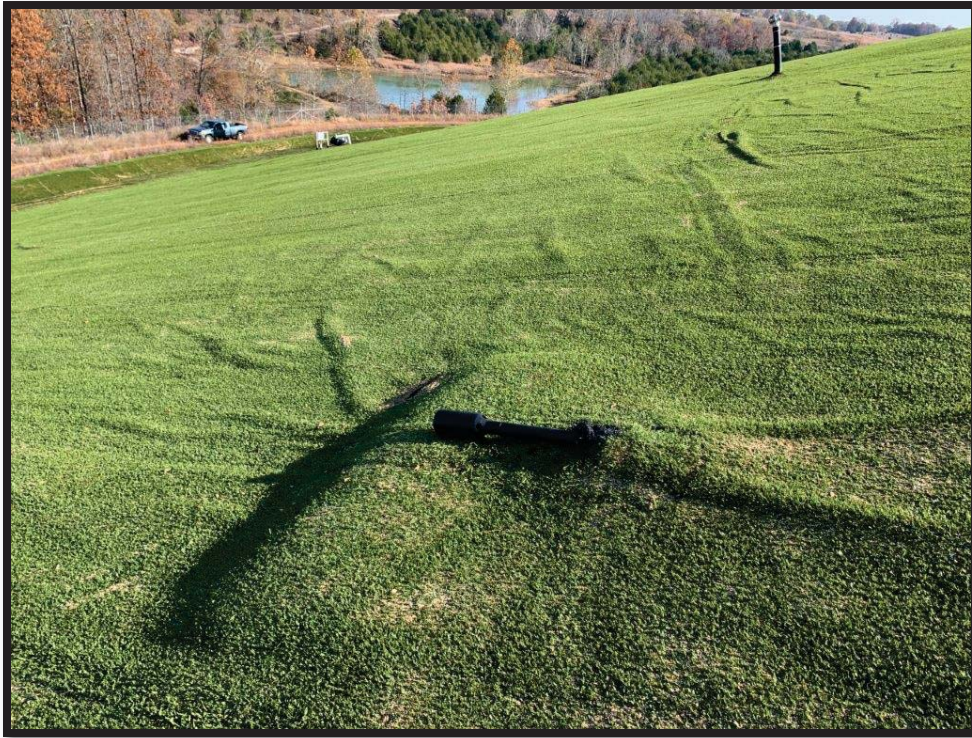
Photograph 5: View northeast of damaged vent pipe near LCS-1 (visible in distance).

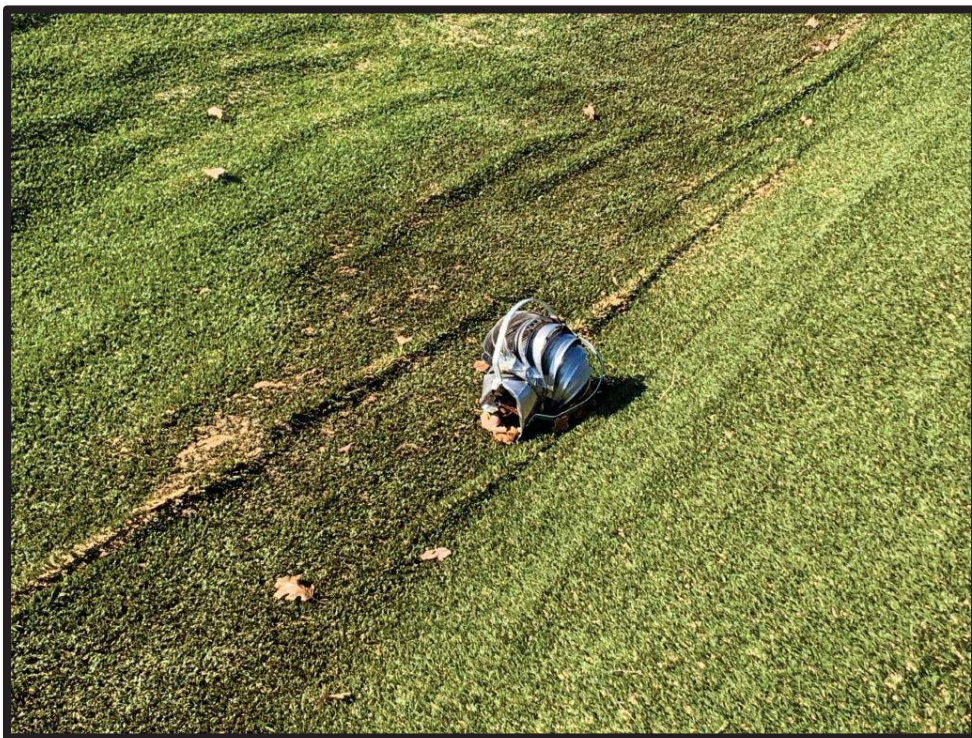
Photograph 6: View of turbine vent near LCS-6 on east side of Area 1-3 cell.
