**FROM:** Caleb Gourley, Project Manager, Harbor

**RE:** Bi-weekly Site Inspection  
NABORS Landfill  
Mountain Home, AR

**AFIN:** 03-00051

**PMT#:** 0249-S1-R2

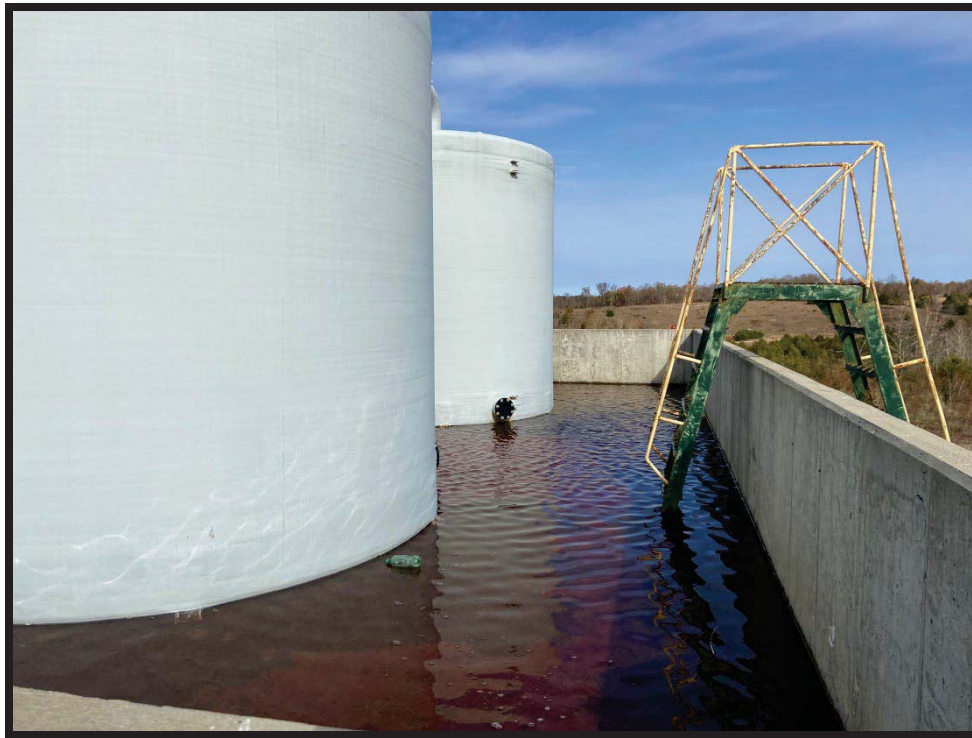
- There were approximately 3.75 inches of stormwater observed in the tank containment. The pH was measured at 8.42, and approximately 1.5 inches of stormwater was released while Harbor was on site (see photographs 1-2).

**Photograph 1:** View north of stormwater in leachate tank containment.

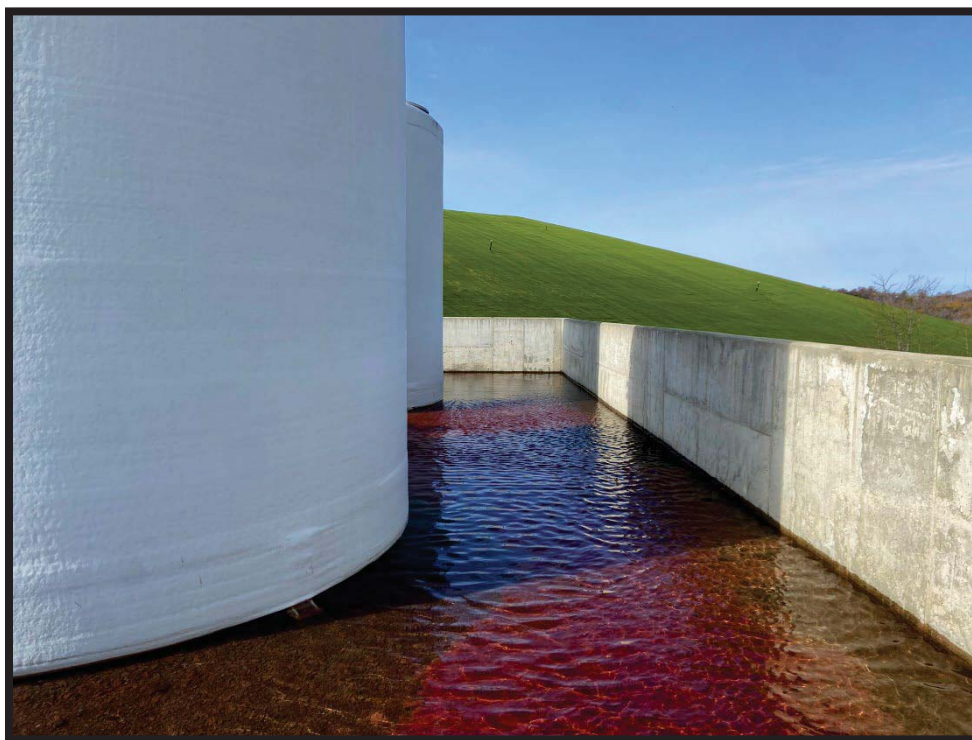
**Photograph 2:** View west of stormwater in leachate tank containment.

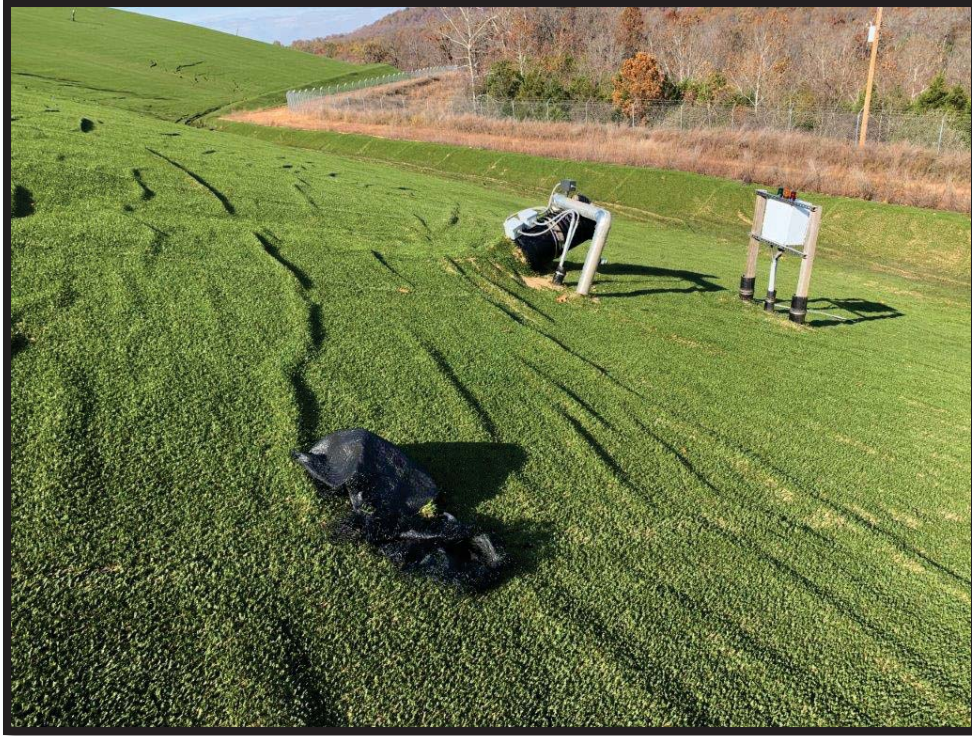
- LCS-6 had a high alarm, while LCS-8 had a low alarm.
- A piece of torn closure turf and a damaged vent pipe were observed near LCS-1 (see photographs 3 - 5). A turbine vent remains detached (see photograph 6) near LCS-6.

**Photograph 3:** View west of torn liner piece near LCS-1.

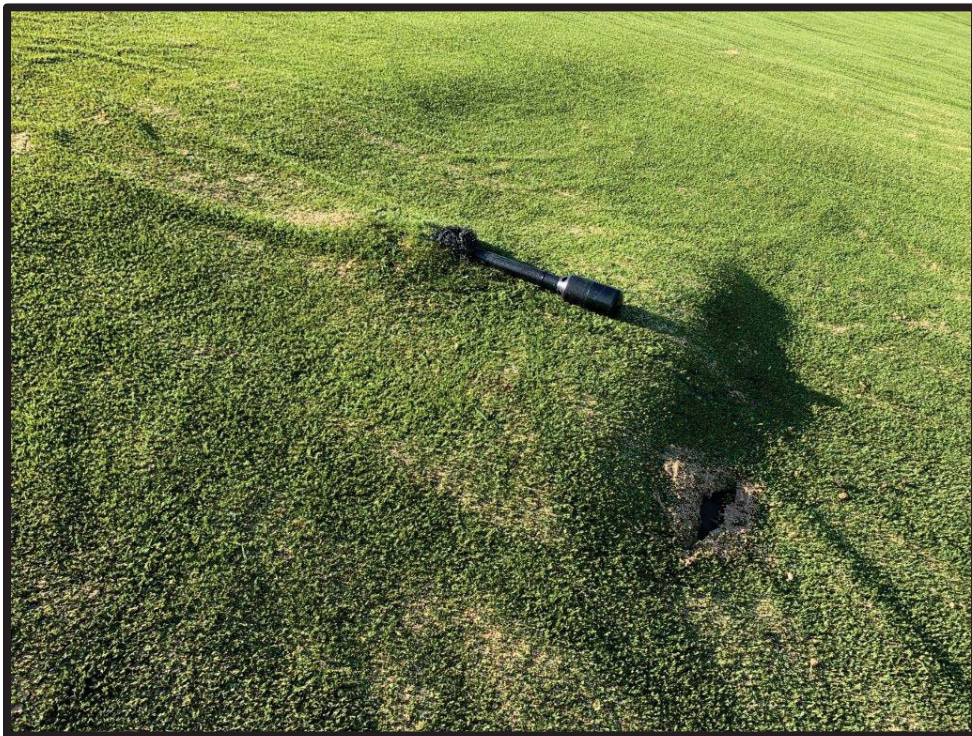
**Photograph 4:** View southwest of damaged vent pipe near LCS-1.

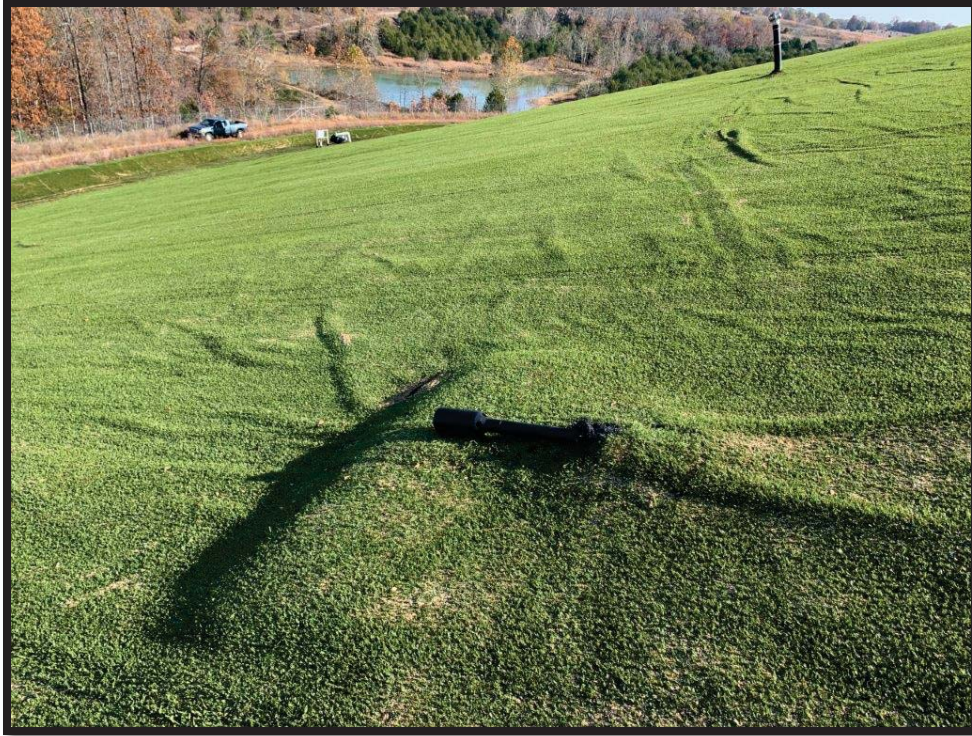
**Photograph 5:** View northeast of damaged vent pipe near LCS-1 (visible in distance).

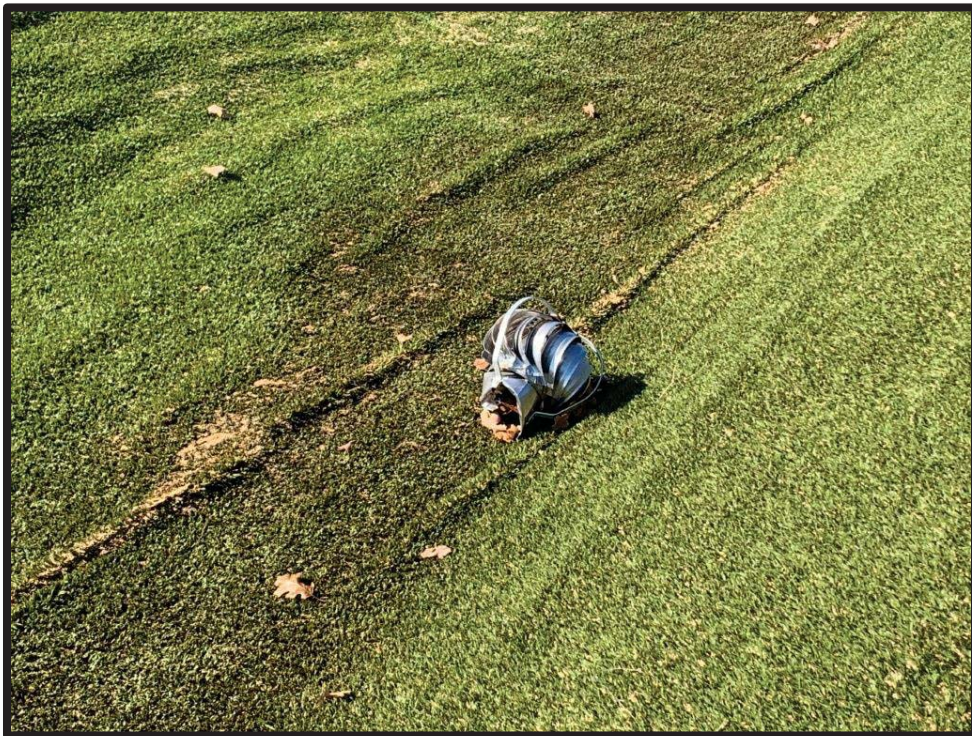
**Photograph 6:** View of turbine vent near LCS-6 on east side of Area 1-3 cell.
