**Subject:** RE: NABORS Landfill Bi-Weekly Inspection

**DATE:** December 5, 2022

**RE:** Bi-weekly Site Inspection  
NABORS Landfill  
Mountain Home, AR

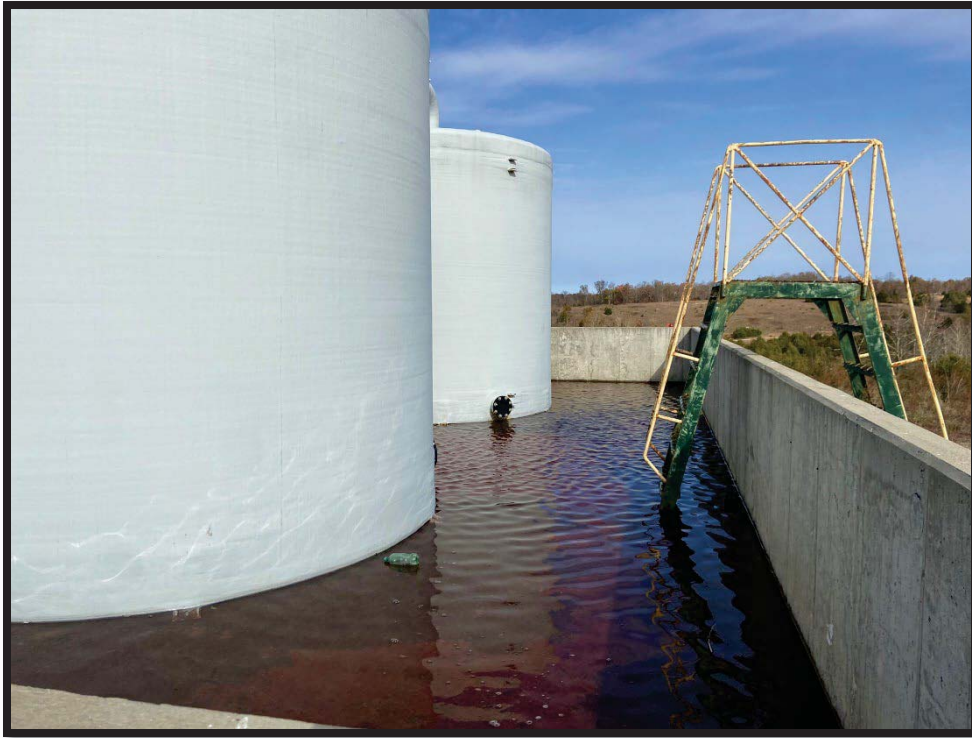
- There were approximately 5.75 inches of stormwater observed in the tank containment. The pH was measured at 8.65, and approximately 2.0 inches of stormwater was released while Harbor was on site (see photographs 1-2).

**Photograph 1:** View north of stormwater in leachate tank containment.

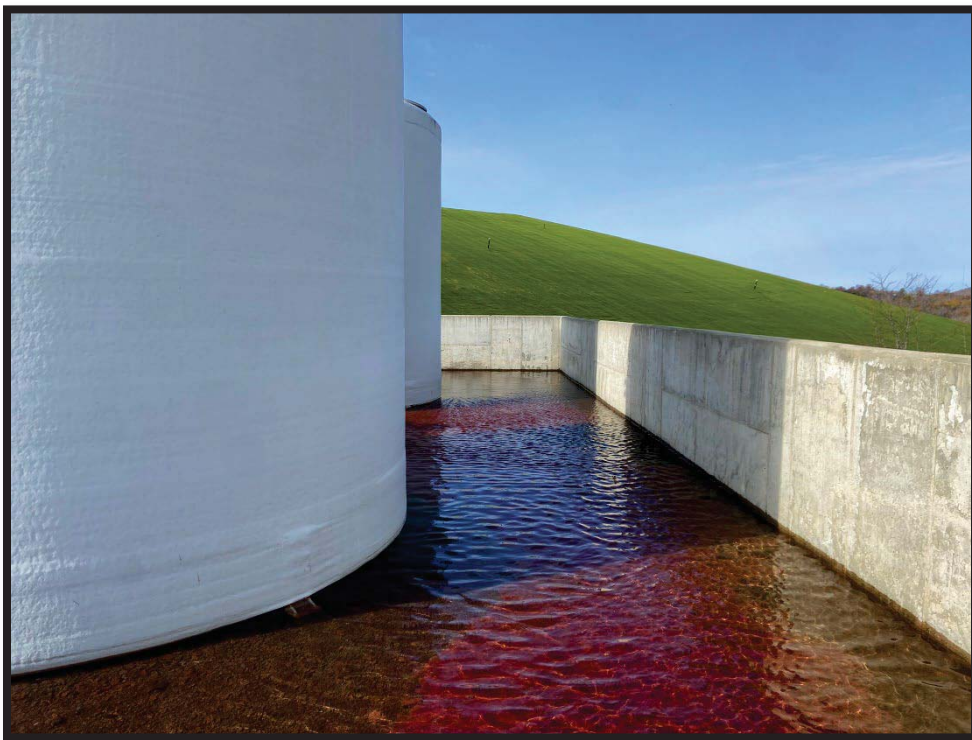
**Photograph 2:** View west of stormwater in leachate tank containment.

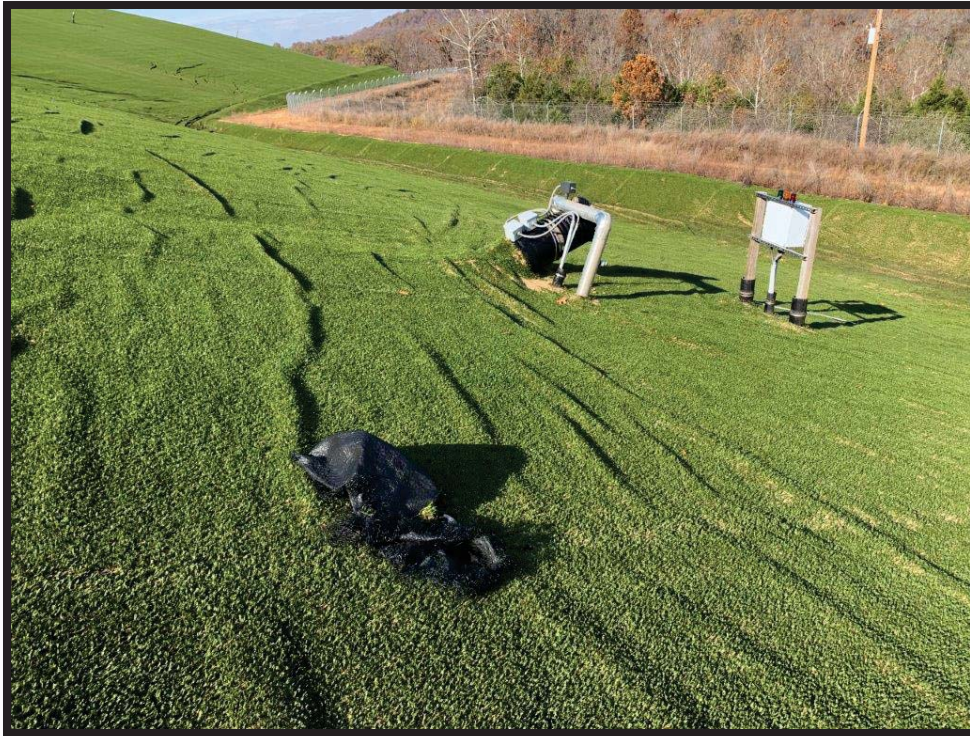
- A piece of torn closure turf and a damaged vent pipe were observed near LCS-1 (see photographs 3 - 5). A turbine vent remains detached (see photograph 6) near LCS-6.

**Photograph 3:** View west of torn liner piece near LCS-1.

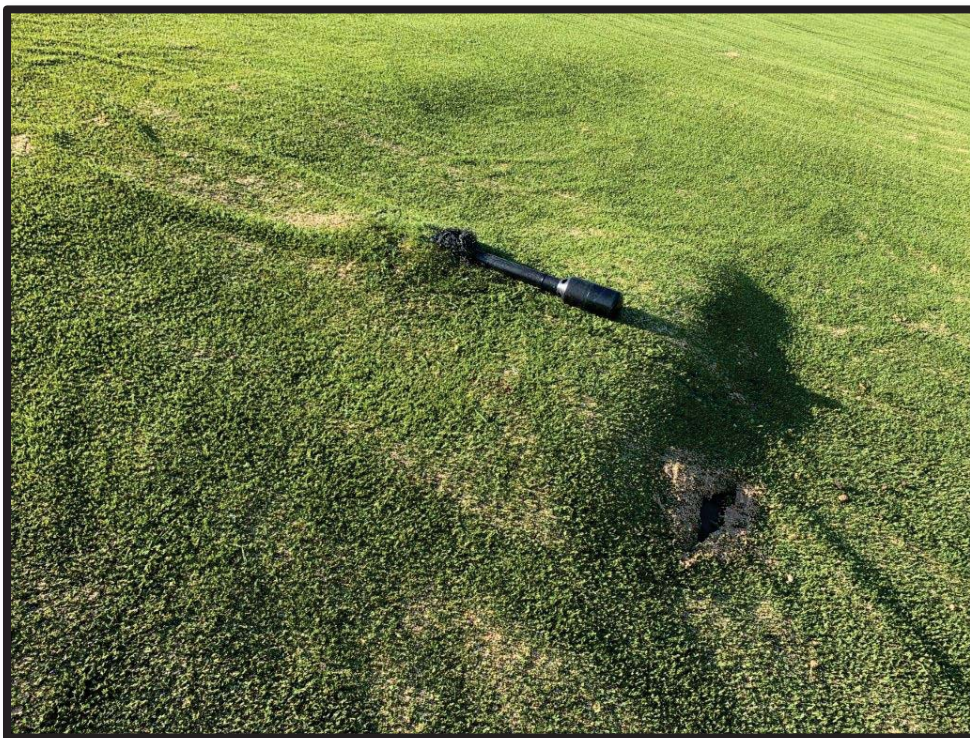
**Photograph 4:** View southwest of damaged vent pipe near LCS-1.

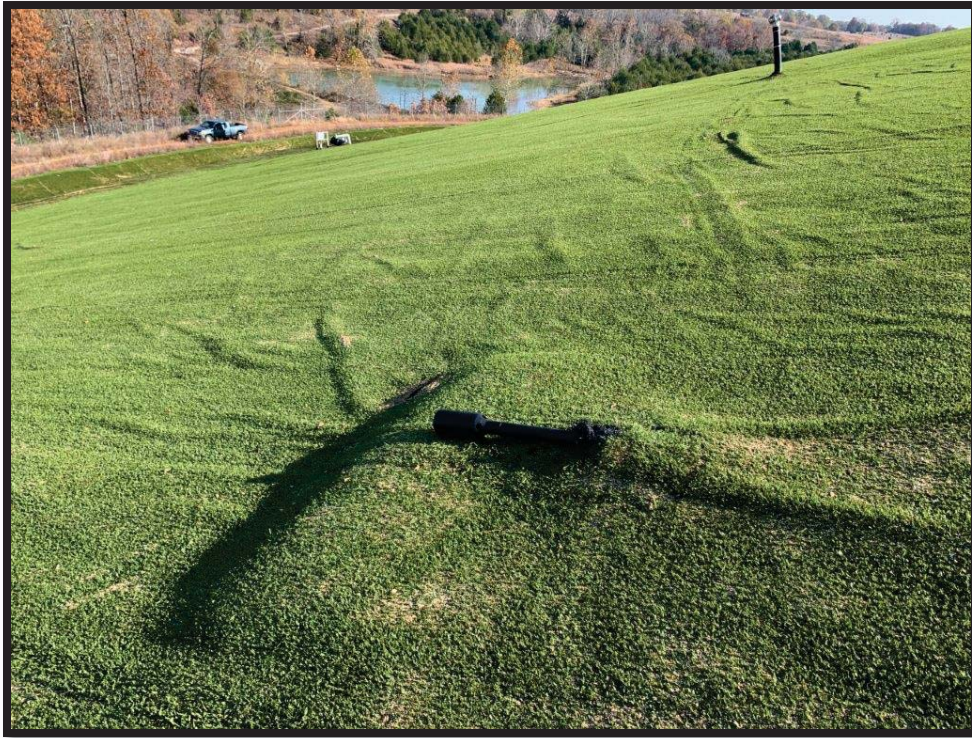
**Photograph 5:** View northeast of damaged vent pipe near LCS-1 (visible in distance).

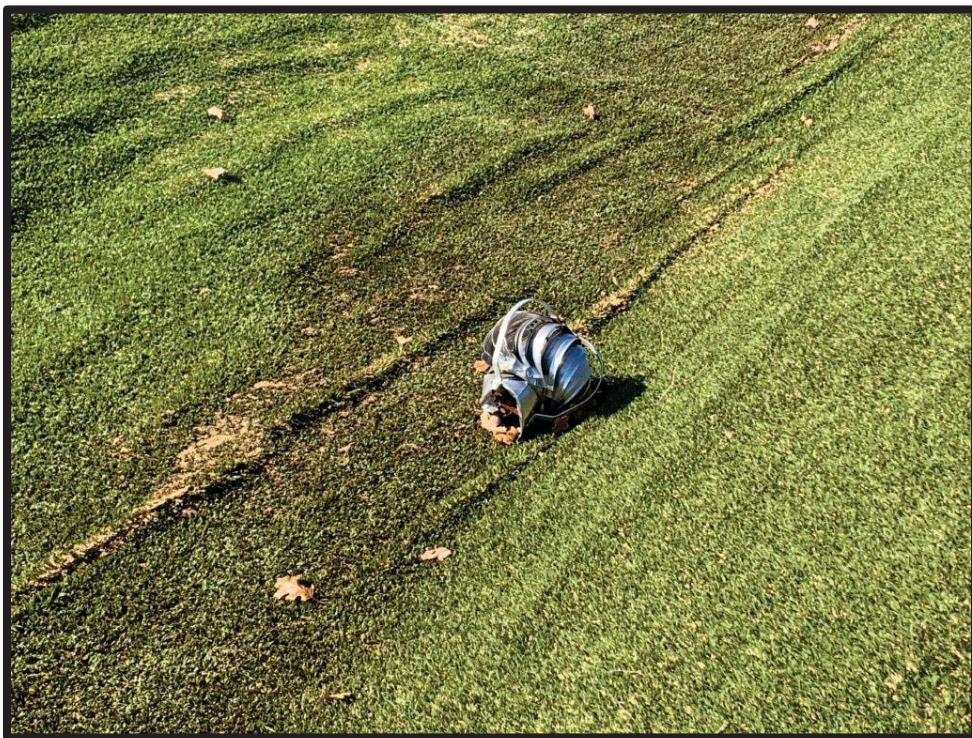
**Photograph 6:** View of turbine vent near LCS-6 on east side of Area 1-3 cell.
