**DATE:** January 16, 2023

**RE:** Bi-weekly Site Inspection  
NABORS Landfill  
Mountain Home, AR

**Attachment A**  
**Site Photographs**

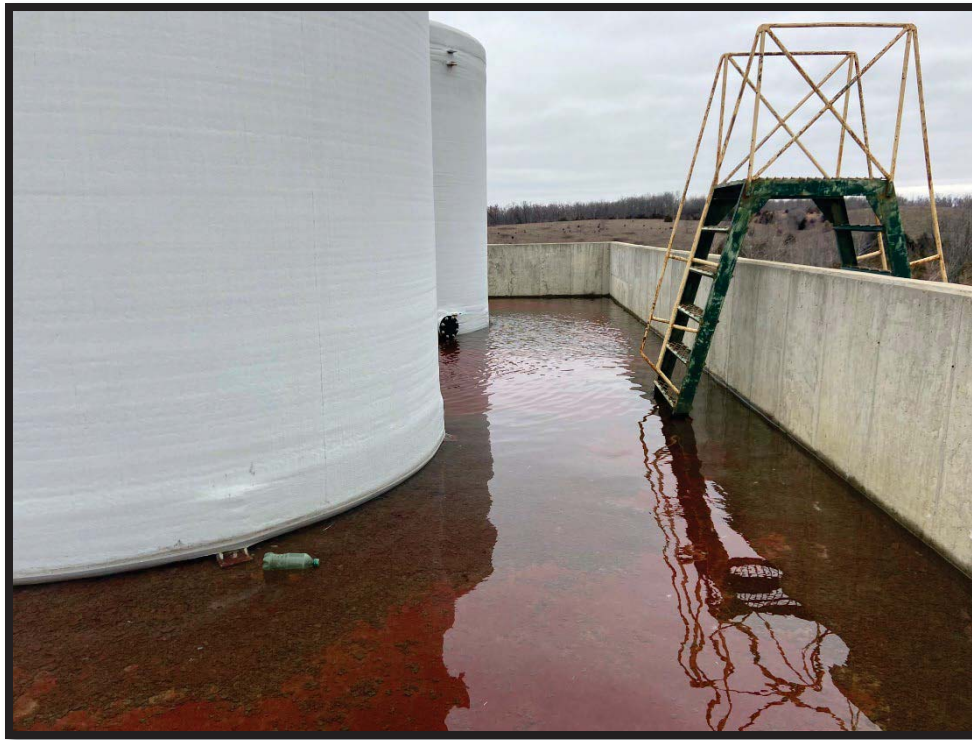
**Photograph 1:** View north of leachate tank containment.

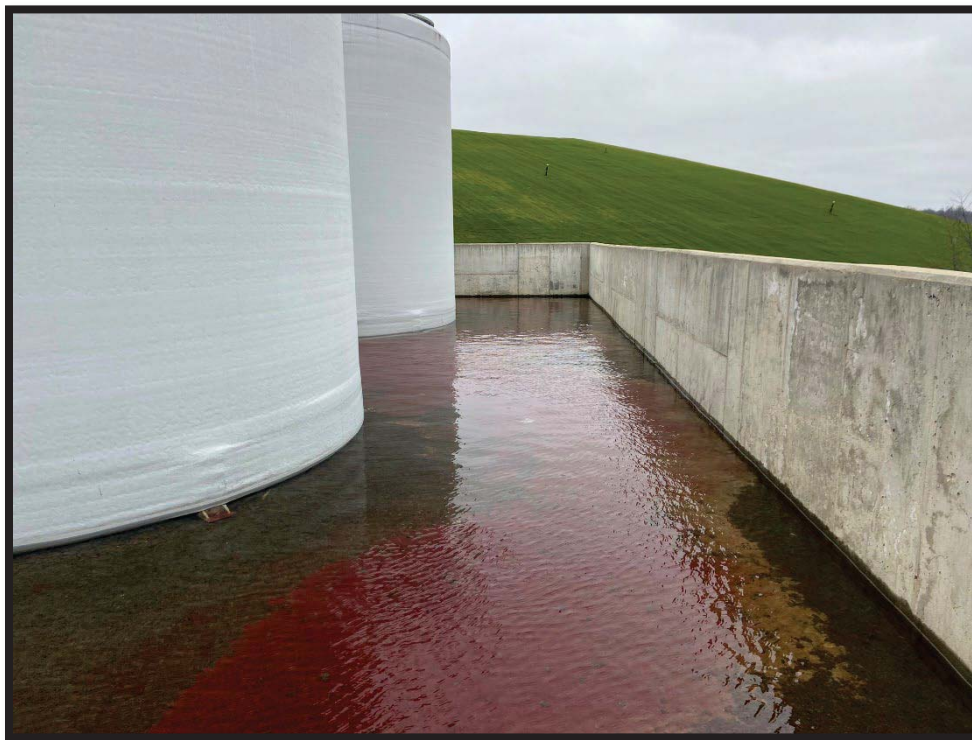
**Photograph 2:** View west of leachate tank containment.

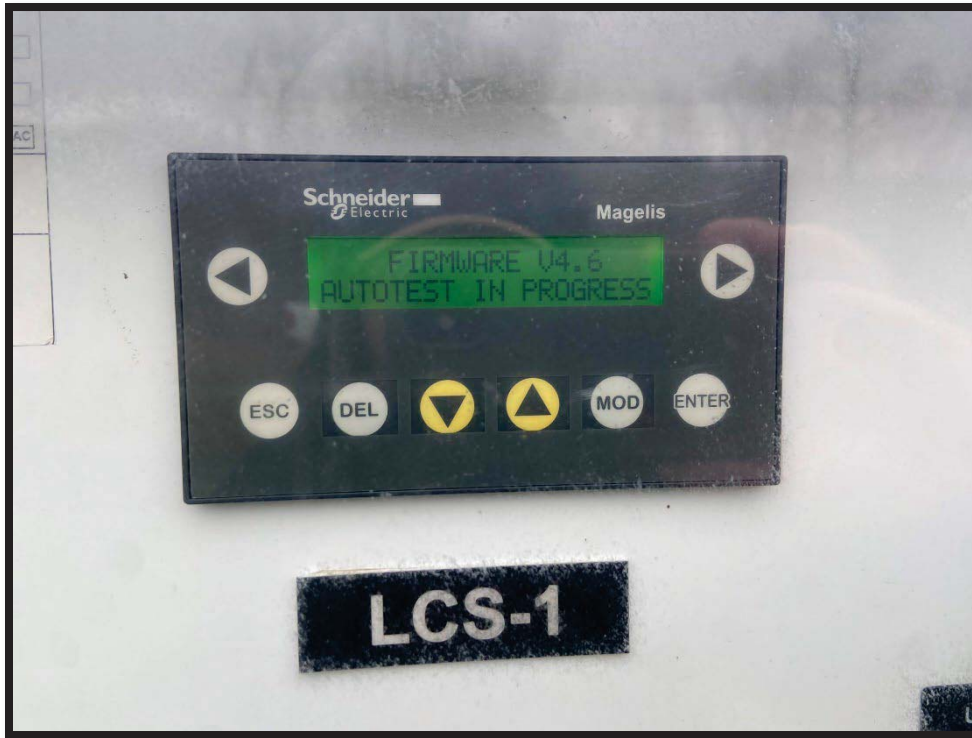
**Photograph 3:** View of LCS-1 error message.

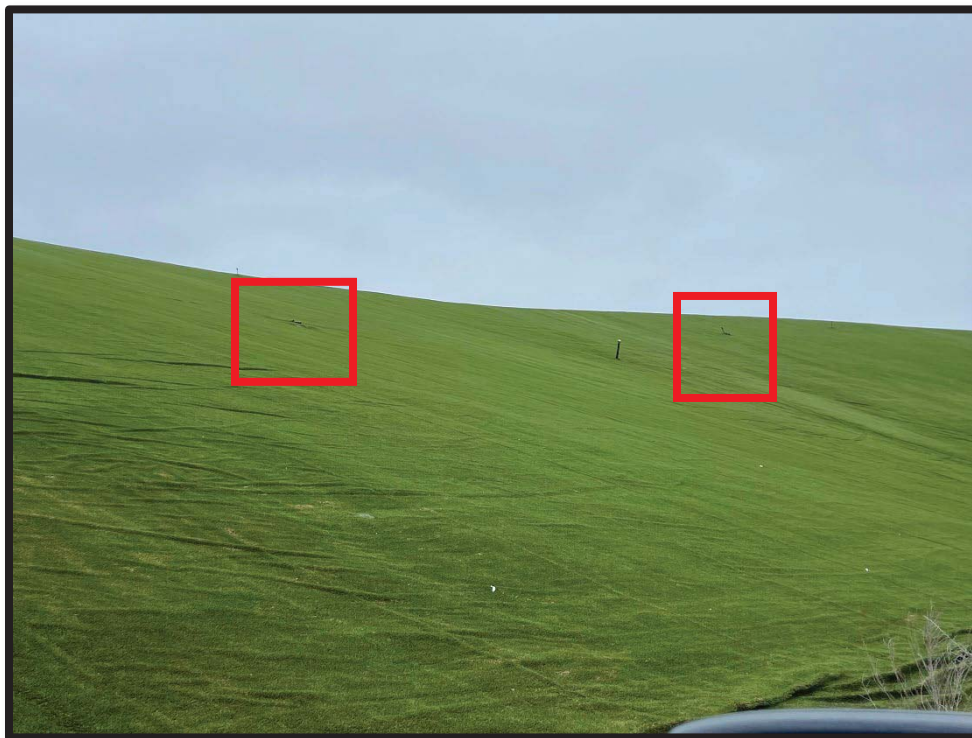
**Photograph 4:** View of damaged vent pipes near LCS-1.

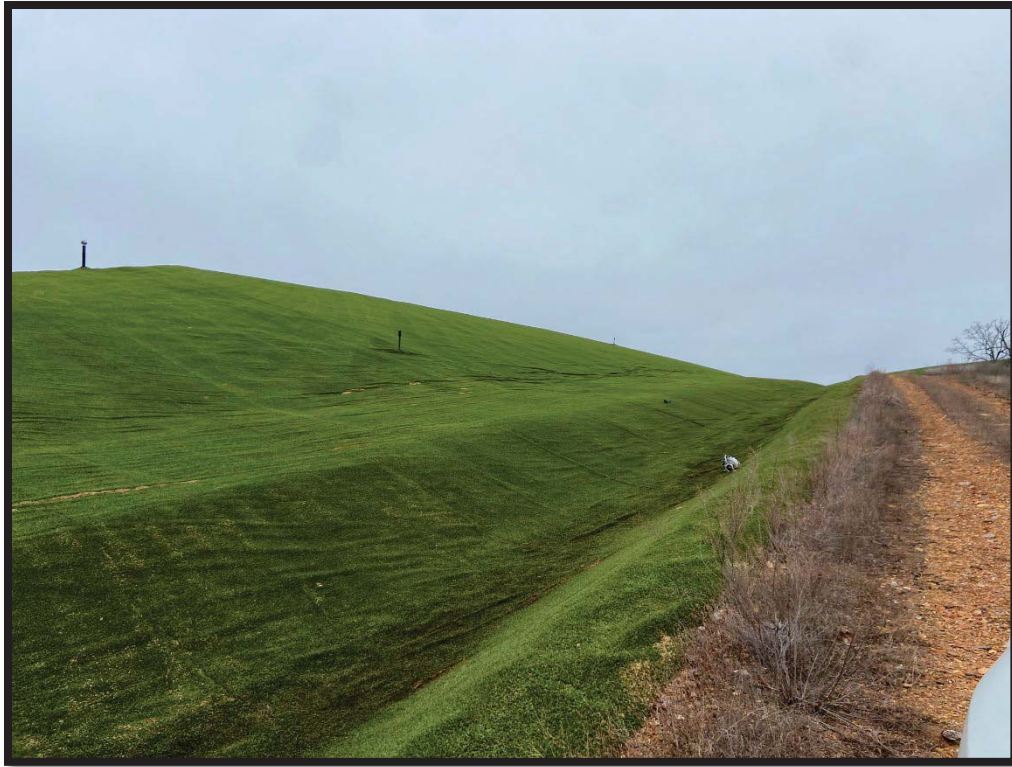
**Photograph 5:** View of damages turbine vent near LCS-6
