Subject: Nabors landfill site visit

DATE: January 26, 2023

RE: Bi-weekly Site Inspection
NABORS Landfill
Mountain Home, AR

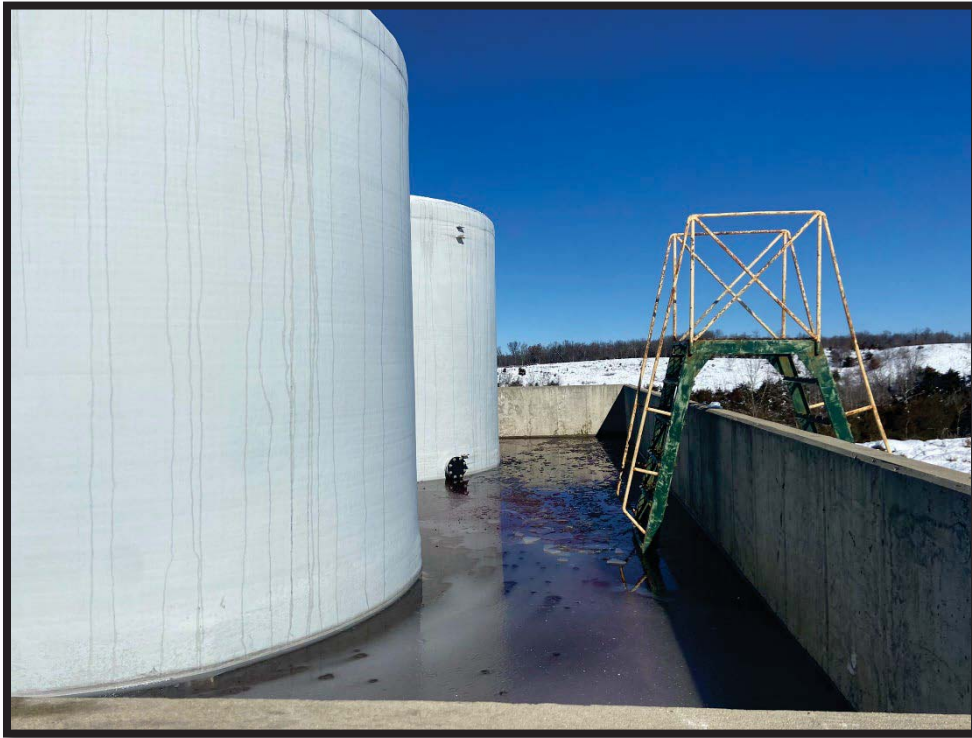
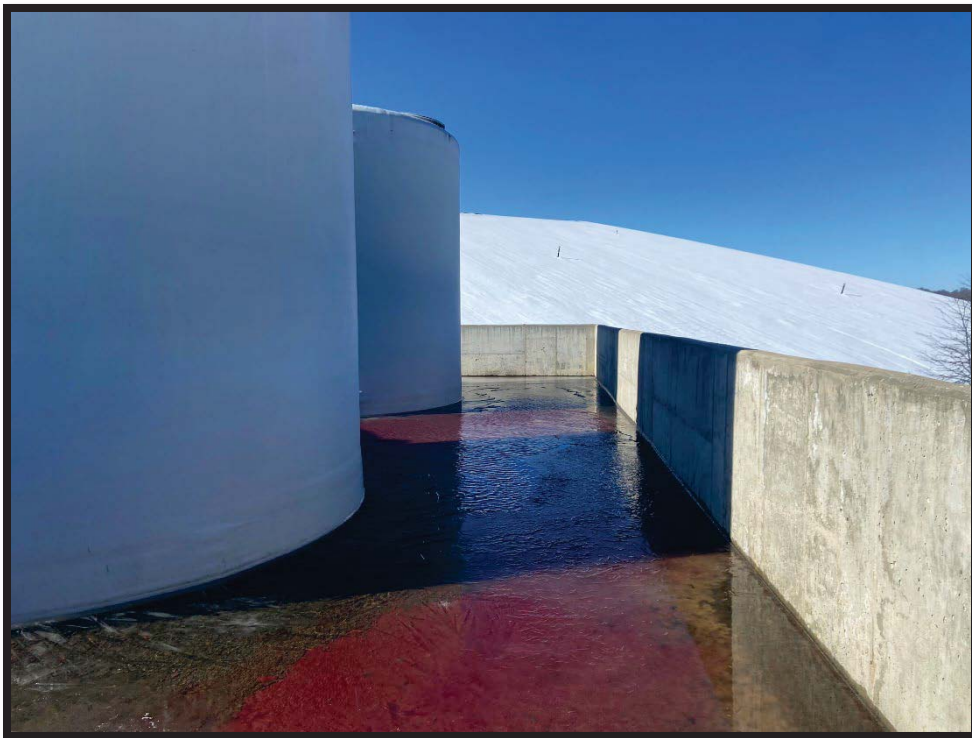
- There were approximately 6.0 inches of stormwater observed in the tank containment. The pH was measured at 8.78, and approximately 2.0 inches of stormwater was released while Harbor was on site (see photographs 1-2).
- The leachate tank level gauge was not operational, mostly like caused by a power outage in the area.
- VLCS-1 has reached its capacity and is overflowing (see photograph 3). VLCS-2 appears to be functioning correctly.
- LCS-1 appeared to be functioning correctly.
- All other stations were not operational. This appears to be due to a power outage in the area.
- A piece of torn closure turf and a damaged vent pipe were observed near LCS-1. A turbine vent remains detached near LCS-6. A new turbine vent has become detached near LCS-8 (see photograph 4).

Photograph 1: View north of leachate tank containment.

Photograph 2: View west of leachate tank containment.

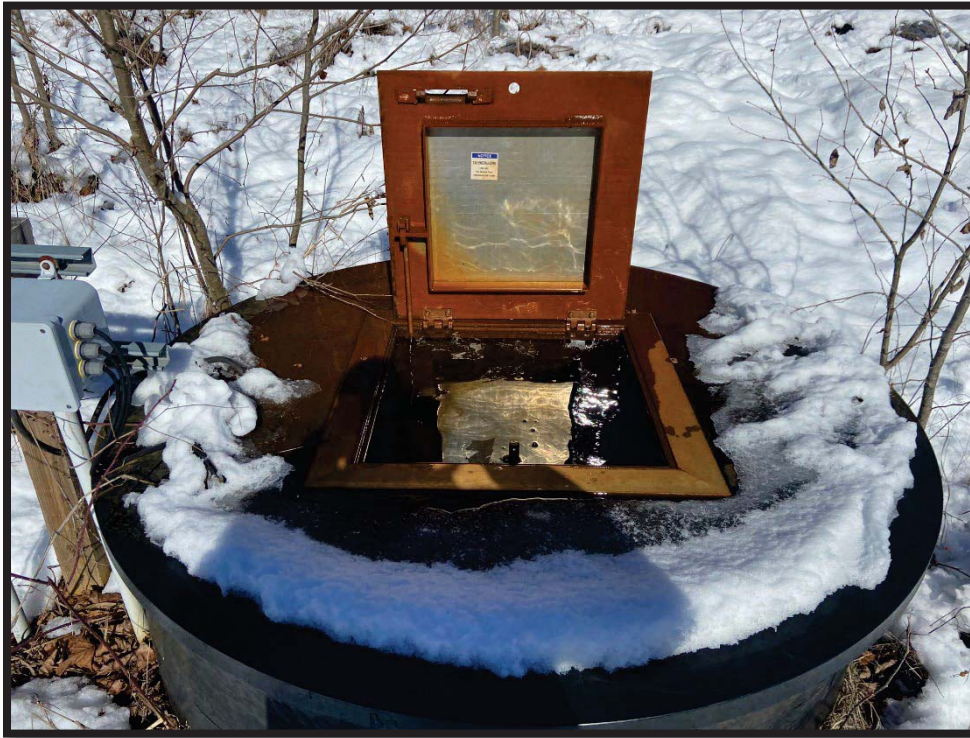
Photograph 3: View of VLCS-1 at capacity.

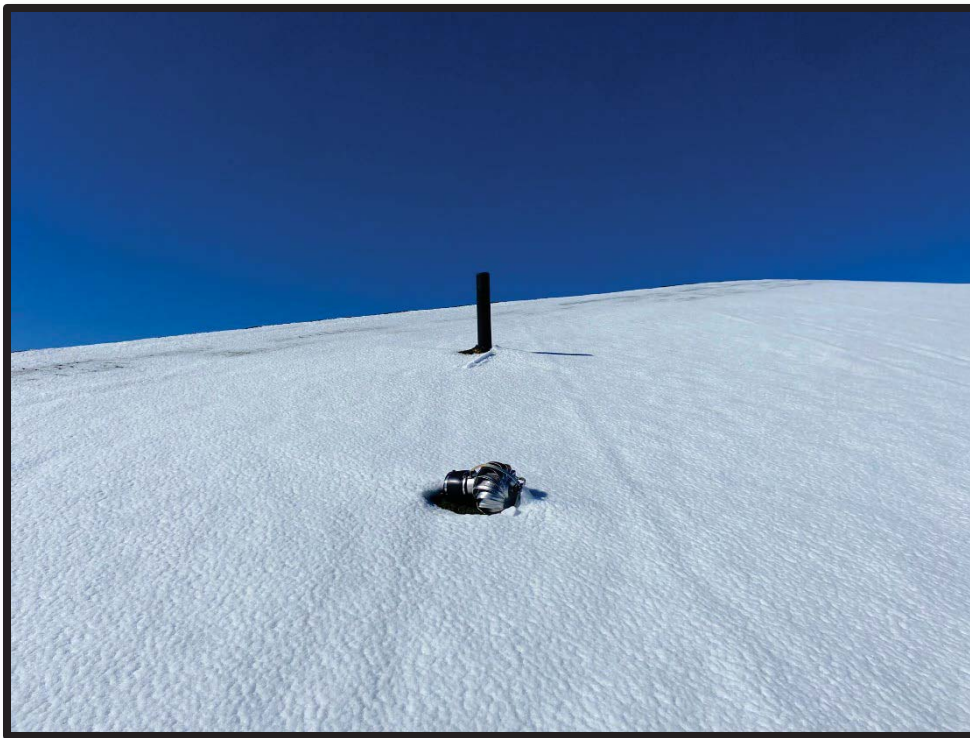
Attached is the inspection memo from the site visit conducted at Nabors Landfill today. There was a power outage from the winter storm that hit the area causing the entire system to go down. There is also another turbine vent detached near LCS-8.

Photograph 4: View of damaged turbine vent near LCS-8.
