DATE: February 13, 2023

FROM: Caleb Gourley, Project Manager, Harbor

RE: Bi-weekly Site Inspection
NABORS Landfill
Mountain Home, AR

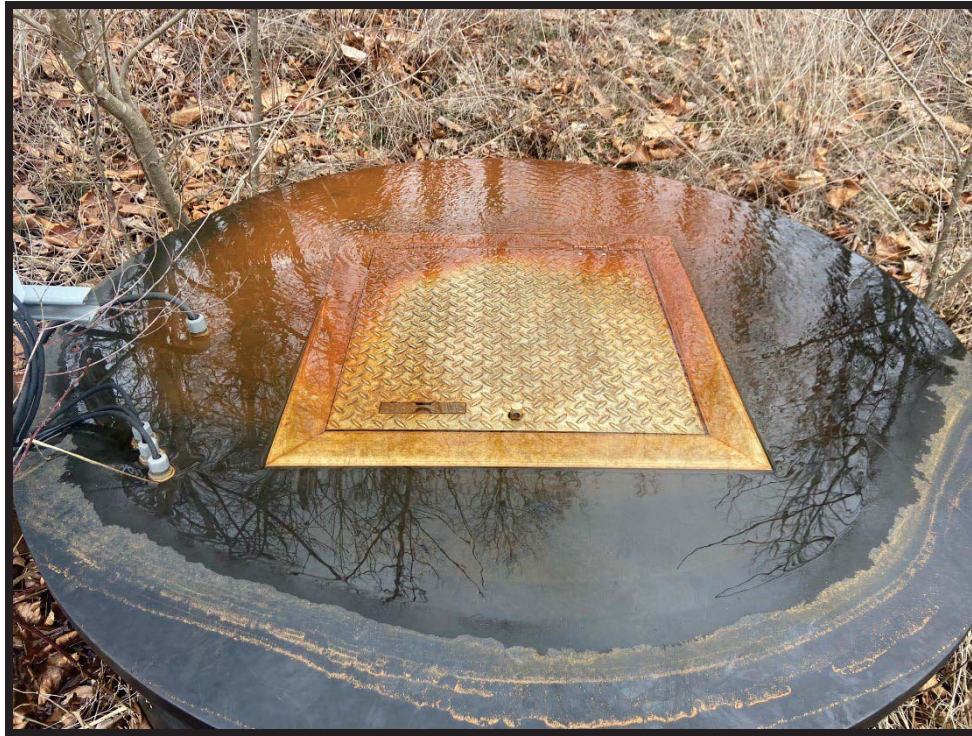
- VLCS-1 has reached its capacity and is overflowing (see photograph 1). VLCS-2 appears to be functioning correctly.
- LCS-1 had a dialogue on its display that read “Autotest in Progress” (see photograph 2).

Photograph 1: View of VLCS-1 at capacity.

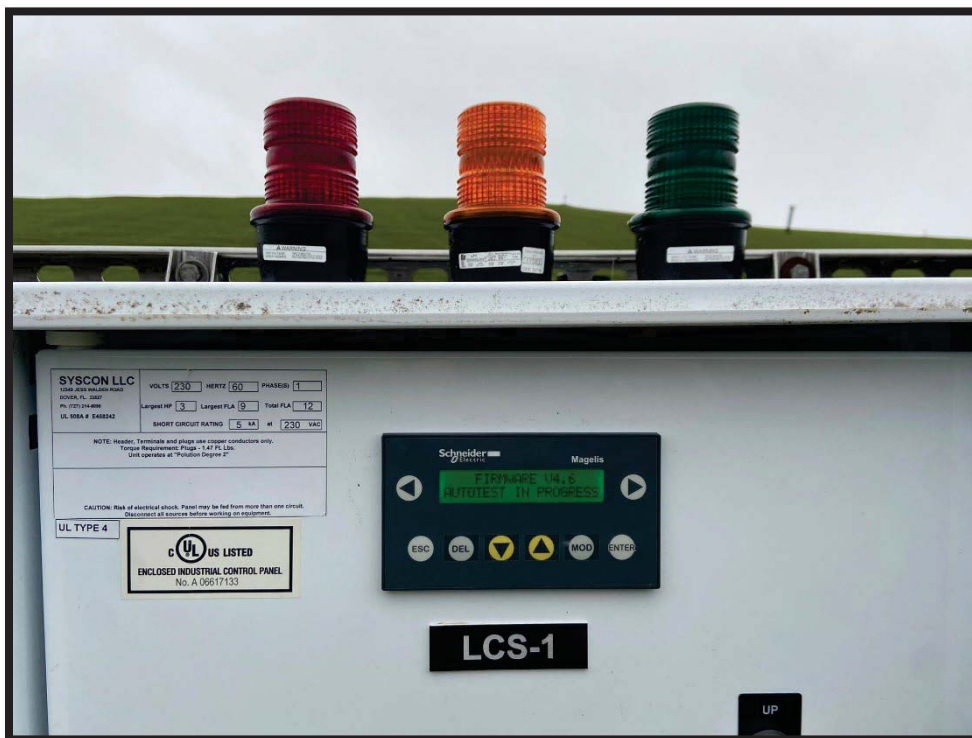
Photograph 2: View of dialogue on LCS-1 display.

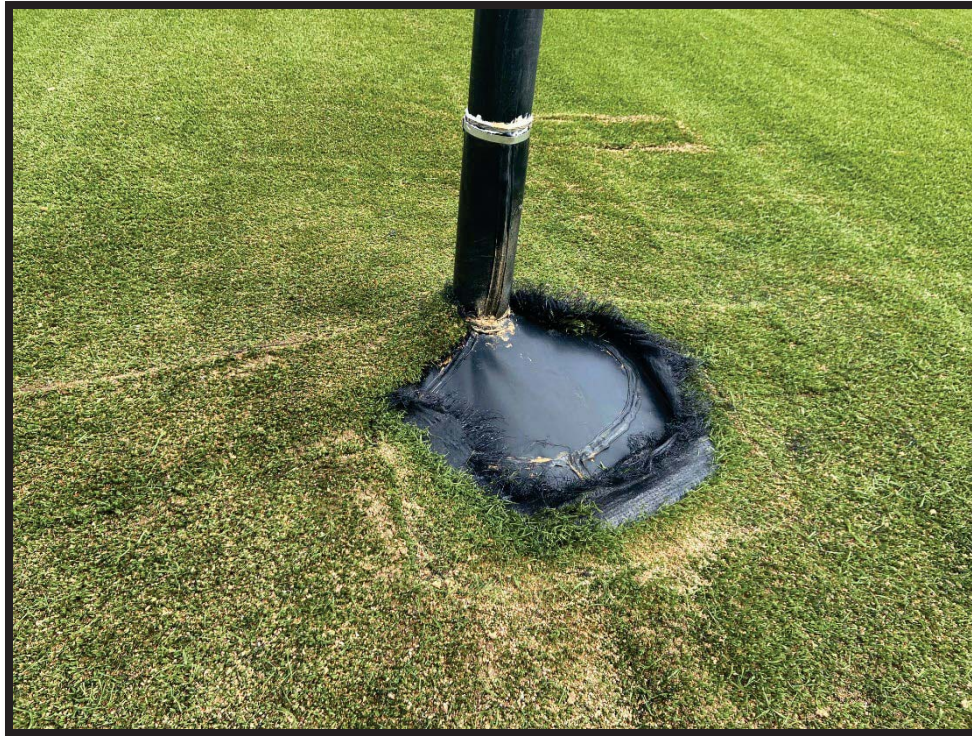
- LCS-3 and LCS-8 had high alarms.
- LCS-4, LCS-6, LCS-7, and LCS-9 appeared to be functioning correctly.
- LCS-5 had a pump fault.
- A piece of torn closure turf and a damaged vent pipe were observed near LCS-1. A turbine vent remains detached near LCS-6. Closure turf is torn in several areas near LCS-4. A new turbine vent has become detached near LCS-8 (see photograph 3-5).

Photograph 3: View of damaged closure turf near LCS-4.

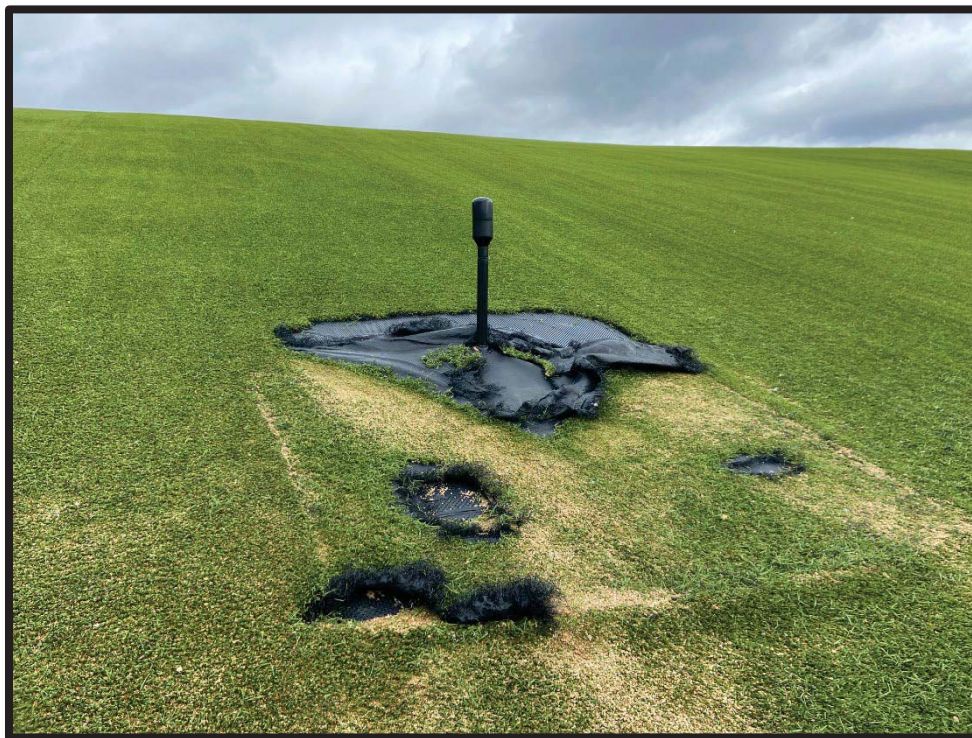
Photograph 4: View of damaged closure turf near LCS-4.

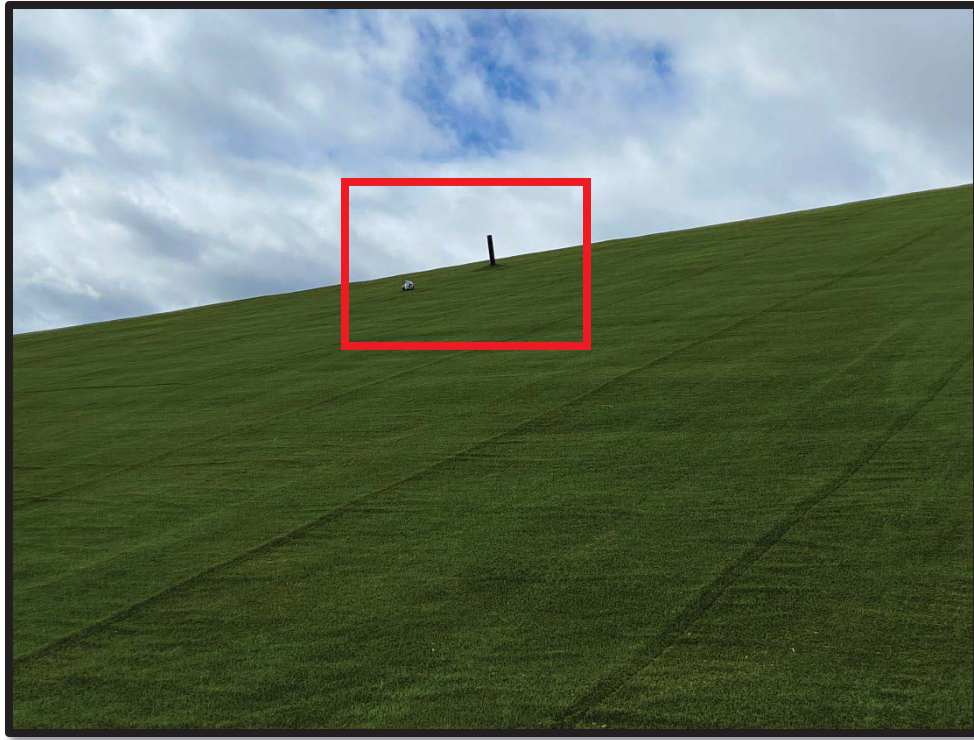
Photograph 5: View of detached turbine vent near LCS-8.
