DATE: February 24, 2023

TO: Clay McDaniel, Project Manager, DEQ - Office of Land Resources

FROM: Caleb Gourley, Project Manager, Harbor

RE: Bi-weekly Site Inspection
NABORS Landfill
Mountain Home, AR

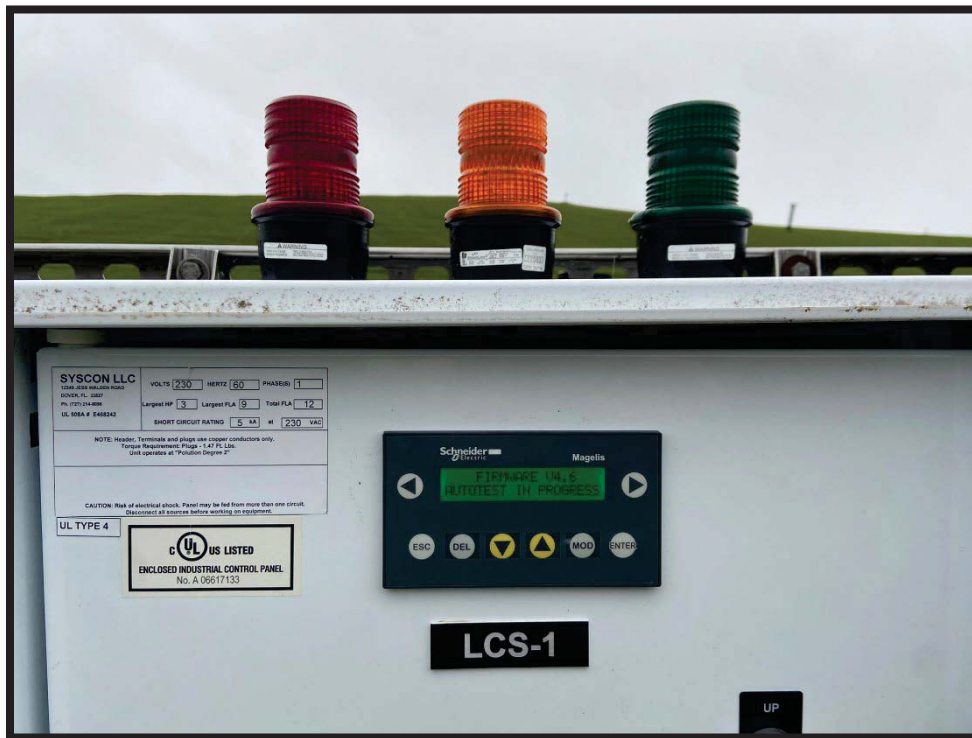
- LCS-1 had a dialogue on its display that read “Autotest in Progress” (see photograph 1).
- LCS-2 had a high alarm. The station appears to not be functioning correctly. The “pump-on”, “pump-off”, “high-alarm, and “low-alarm” functions of the sump are all set at 0.0”. These settings are causing a malfunction.

Photograph 1: View of dialogue on LCS-1 display.

| Panel Number | Display Functioning (Yes/No) | Leachate Level (inches) | Green Flashing? (Yes/No) | Amber Flashing? (Yes/No) | Red Flashing? (Yes/No) | Working in Hand? (Yes/No) | Working in Auto? (Yes/No) | VFD Status | Hours | Alarm | Comments |
|---|---|---|---|---|---|---|---|---|---|---|---|
| LCS-1 | Y | - | N | N | N | - | - | - | - | - | "Autotest in progress" |

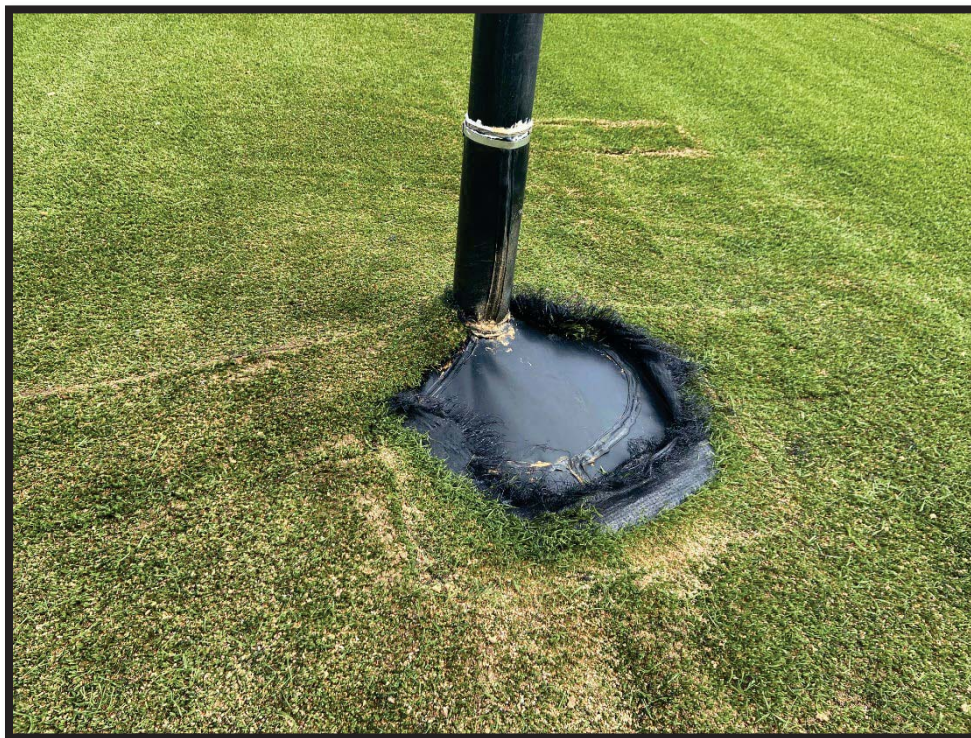
- A piece of torn closure turf and a damaged vent pipe were observed near LCS-1. A turbine vent remains detached near LCS-6. Closure turf is torn in several areas near LCS-4. A new turbine vent has become detached near LCS-8 (see photographs 2 - 4).

Photograph 2: View of damaged closure turf near LCS-4.

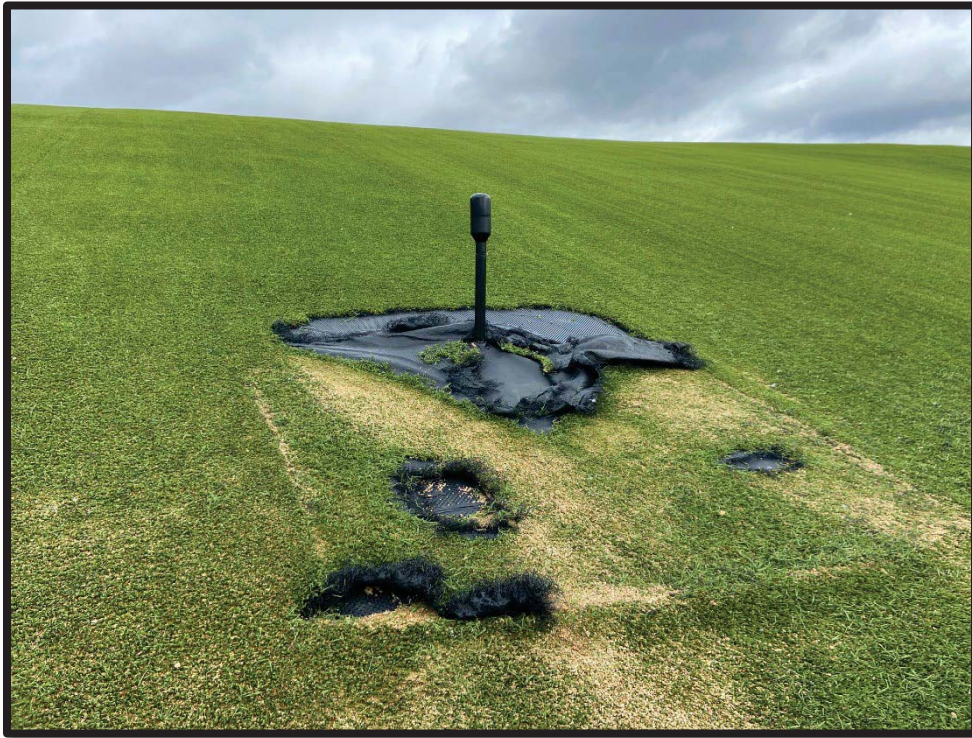
Photograph 3: View of damaged closure turf near LCS-4.

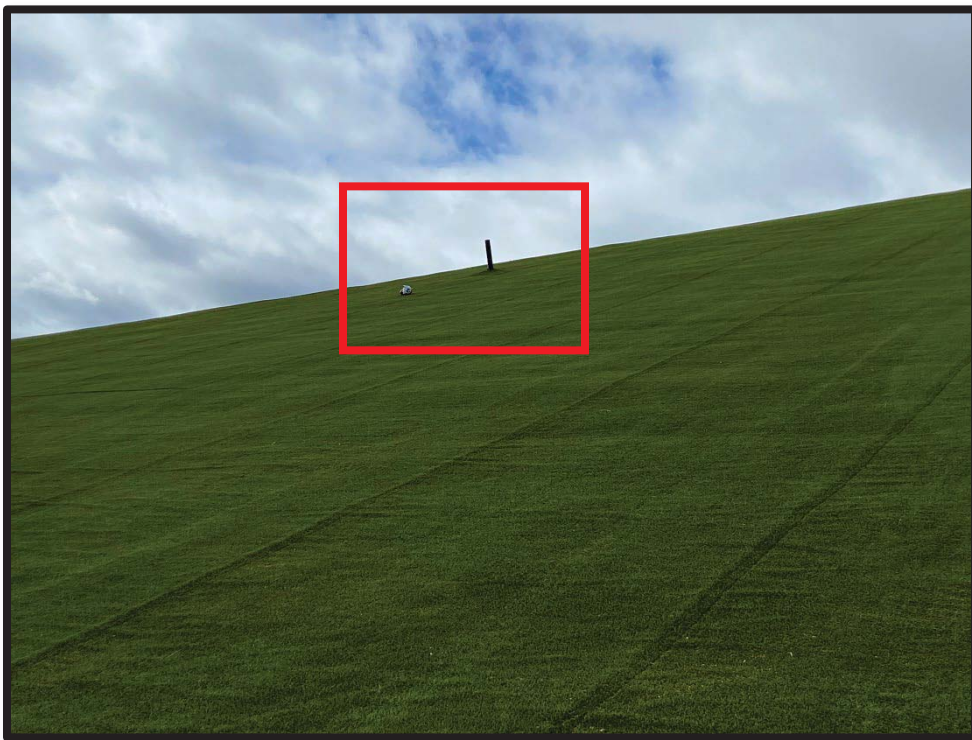
Photograph 4: View of detached turbine vent near LCS-8.
