DATE: March 8, 2023

TO: Clay McDaniel, Project Manager, DEQ - Office of Land Resources

FROM: Caleb Gourley, Project Manager, Harbor

RE: Bi-weekly Site Inspection
NABORS Landfill
Mountain Home, AR

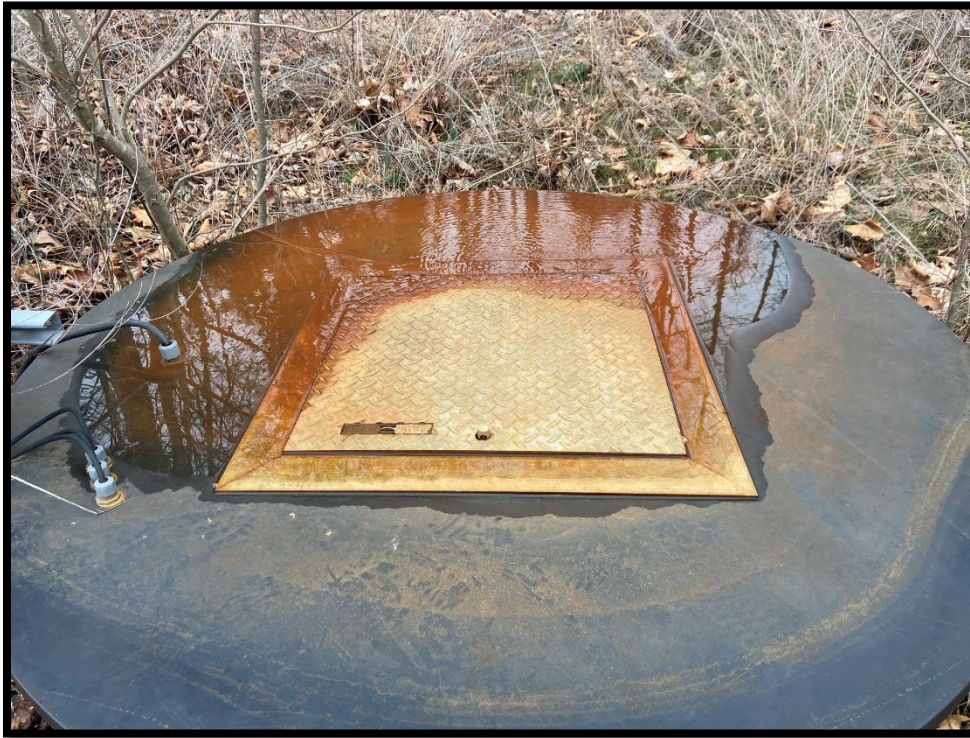
- VLCS-1 was at capacity and overflowing (see photograph 1). VLCS-2 appeared to be functioning correctly.
- LCS-1, LCS-2, LCS-4, LCS-7, and LCS-8 had a pump fault.

Photograph 1: View of VLCS-1 at capacity.

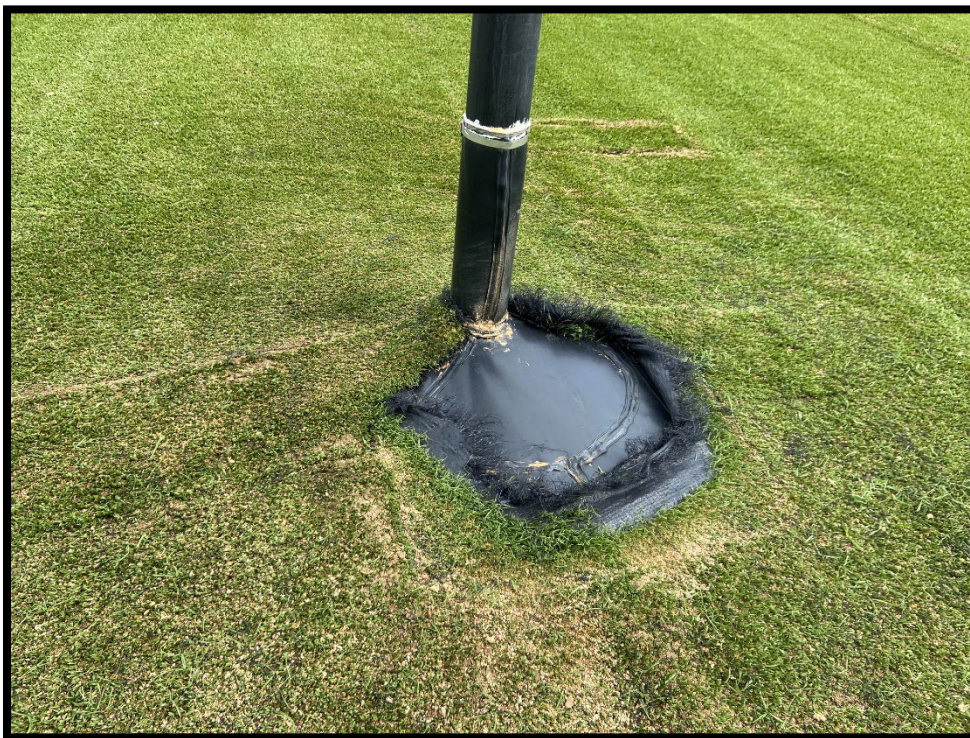
Photograph 2: View of damaged closure turf near LCS-4.

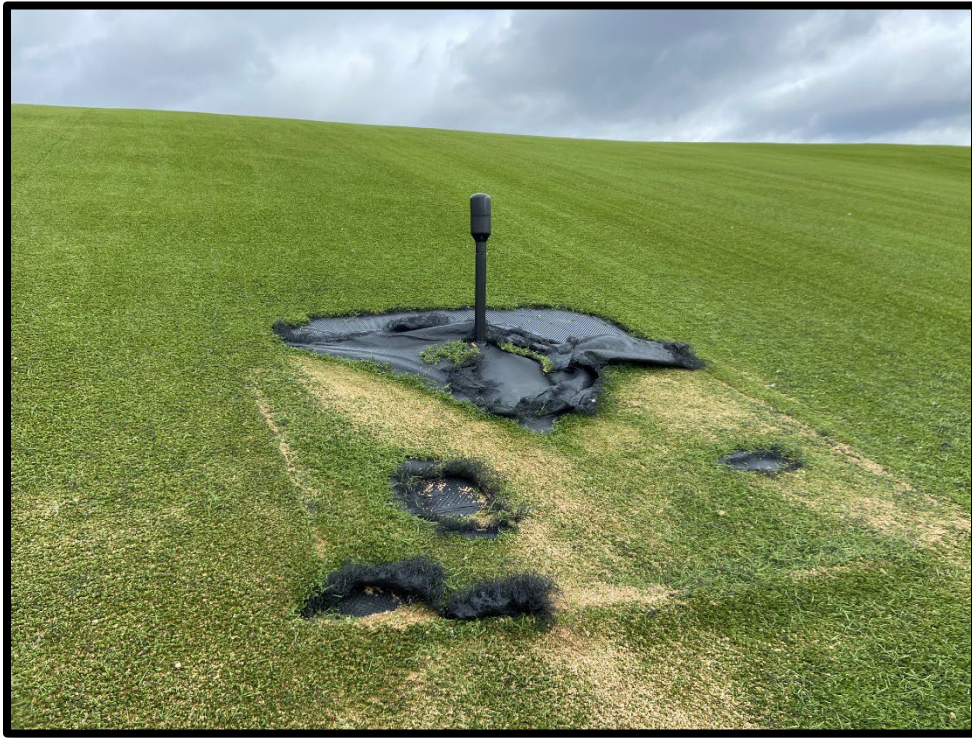
Photograph 3: View of damaged closure turf near LCS-4.

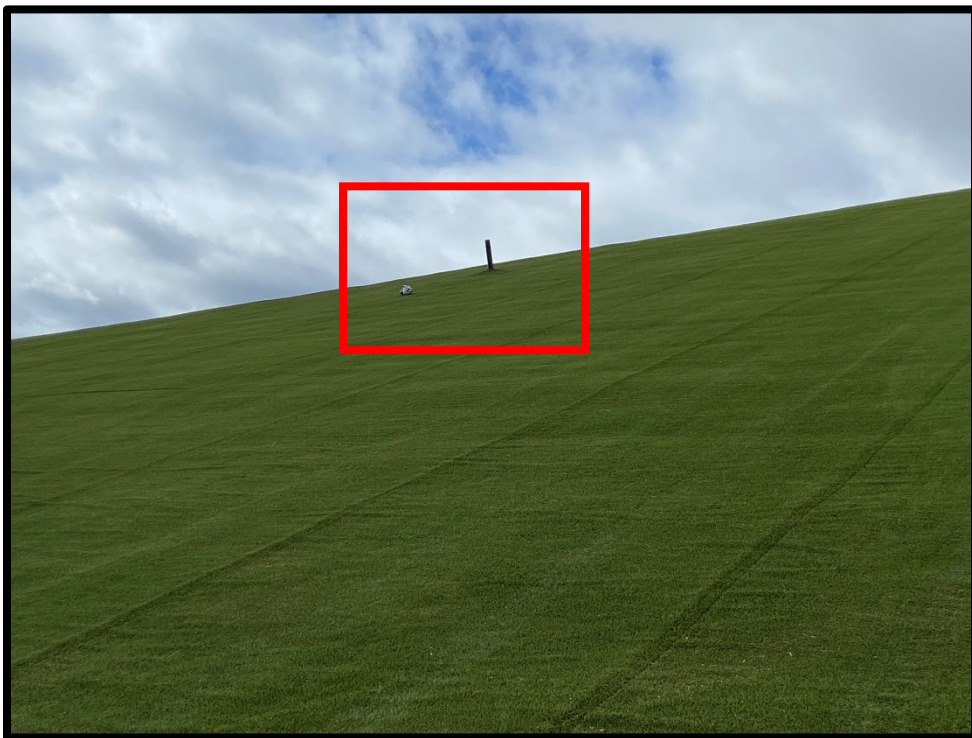
Photograph 4: View of detached turbine vent near LCS-8.
