**RE:** Bi-weekly Site Inspection  
NABORS Landfill  
Mountain Home, AR

<b>AFIN:</b> 03-00051
<b>PMT#:</b> 0249-S1-R2
<b>Received</b> By Karen Blue at 4:36 pm, Mar 27, 2023
<b>DOC ID#:</b> 83681
<b>TO:</b> MM>FILE <KMB

Harbor visited the NABORS landfill in Mountain Home, Arkansas on March 22, 2023, to conduct the bi-weekly landfill inspection. Findings and observations from the landfill inspection are summarized below:

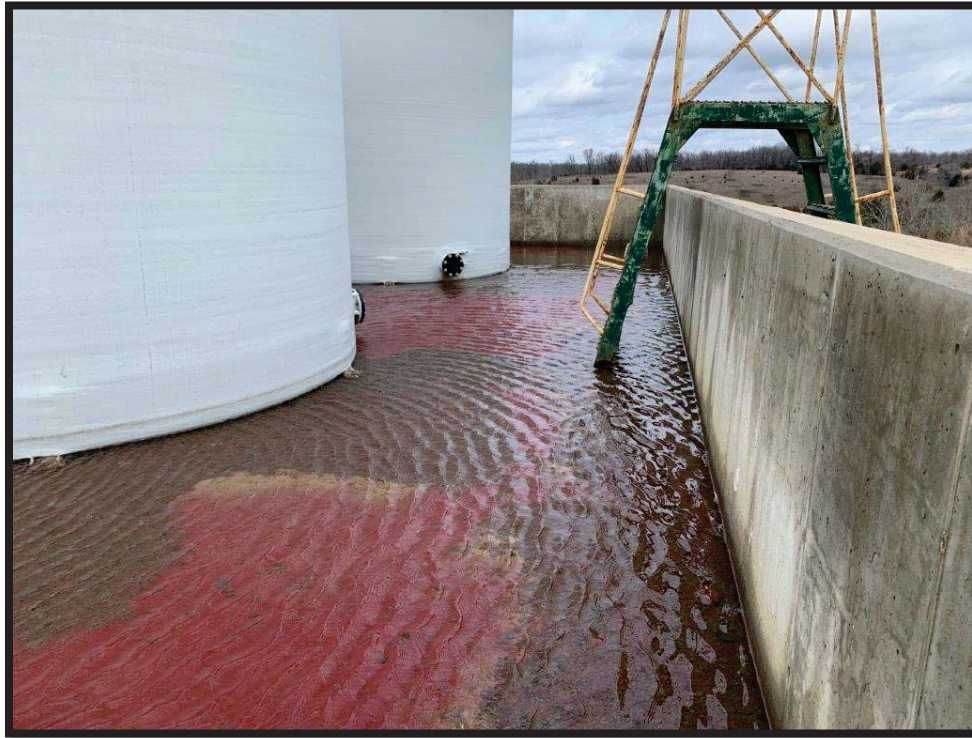
- Approximately 2.5 inches of stormwater was observed in the tank containment. The pH of the stormwater was measured at 8.32 SU. Approximately 1.5 inches of stormwater were released from the containment while Harbor was onsite (see photographs 1-2). The level of leachate in the tanks was measured at 19.8”.

**Photograph 1:** View of stormwater in leachate tank containment.

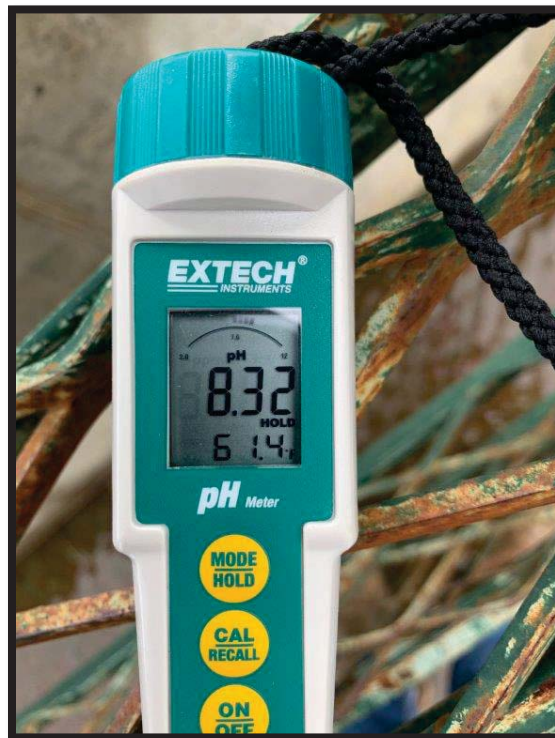
**Photograph 2:** Stormwater pH measurement.

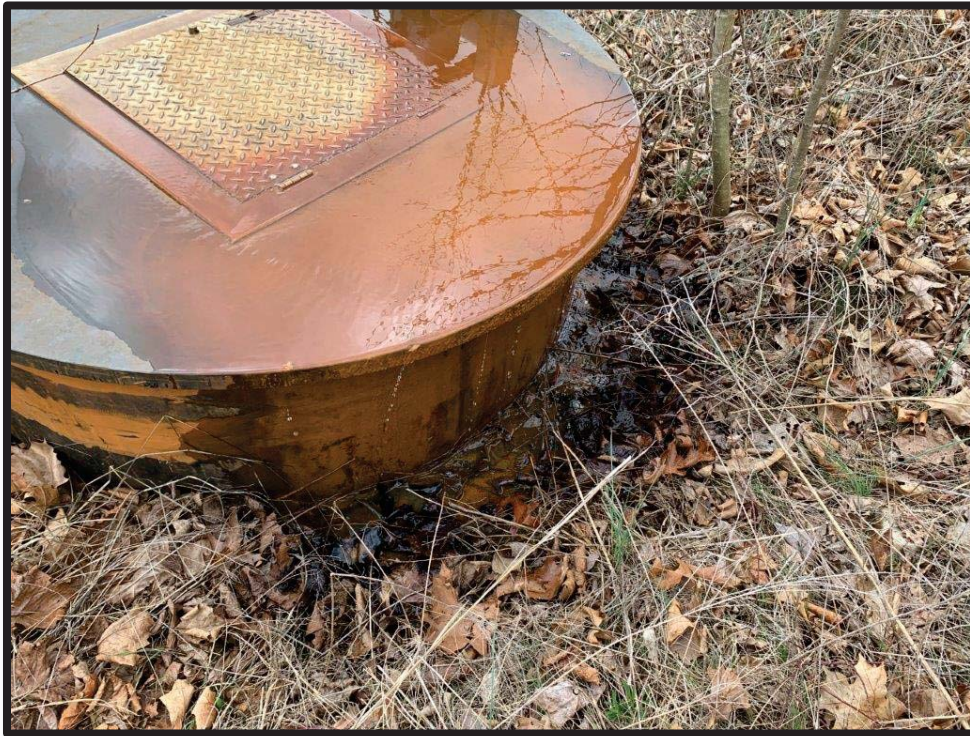
- VLCS-1 was at capacity and overflowing (see photographs 3-4). VLCS-2 appeared to be functioning correctly.
- The LCS-1, LCS-2, LCS-4, LCS-7, and LCS-8 main panel displays indicated a pump fault. All points were powered down then restarted and the pump fault remained.

**Photograph 3:** View of VLCS-1 at full capacity and overflowing.

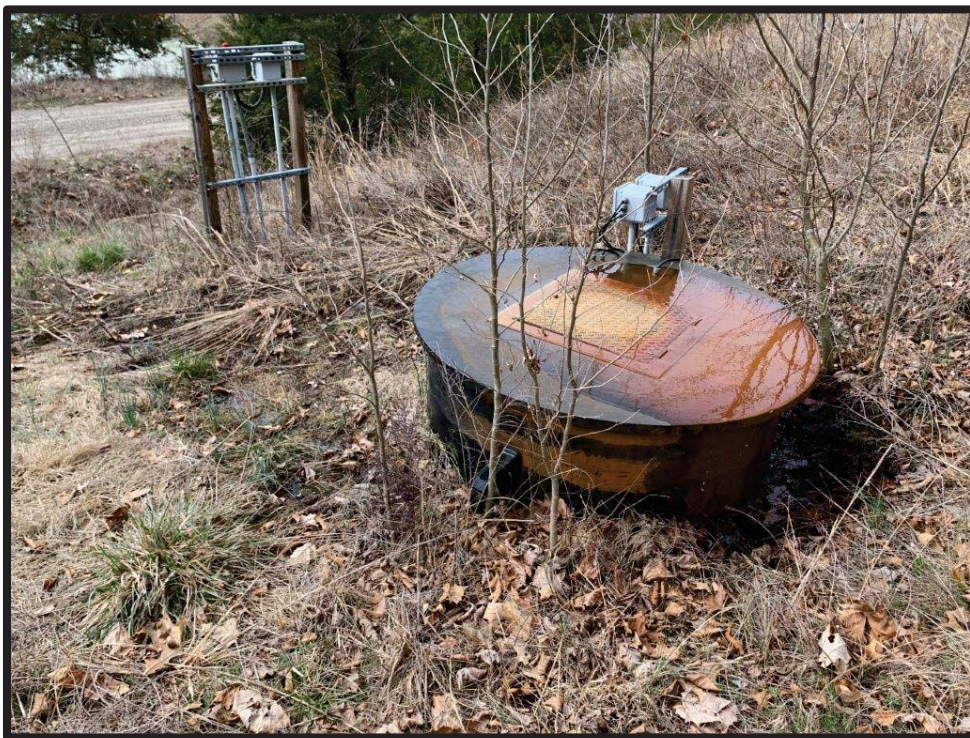
**Photograph 4:** Additional view of VLCS-1 at full capacity and overflowing.
