**Subject:** RE: Nabors Bi-weekly Site Visit

**RE:** Bi-weekly Site Inspection  
NABORS Landfill  
Mountain Home, AR

Harbor visited the NABORS landfill in Mountain Home, Arkansas on April 20, 2023, to conduct the bi-weekly landfill inspection. Findings and observations from the landfill inspection are summarized below:

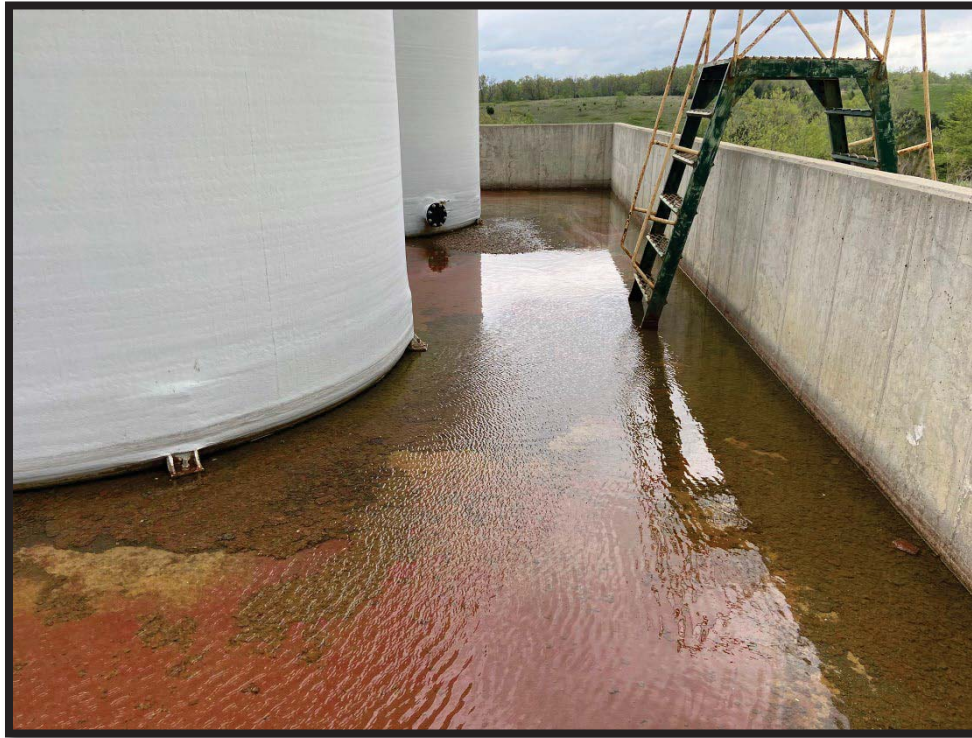
- Approximately one inch of stormwater was observed in the tank containment. The pH of the stormwater was measured at 8.98 and approximately 0.5 inches of stormwater was released from containment while Harbor was onsite (see photograph 1). The level of leachate in the tanks was measured at 20.2”.

**Photograph 1:** View of stormwater in leachate tank containment.

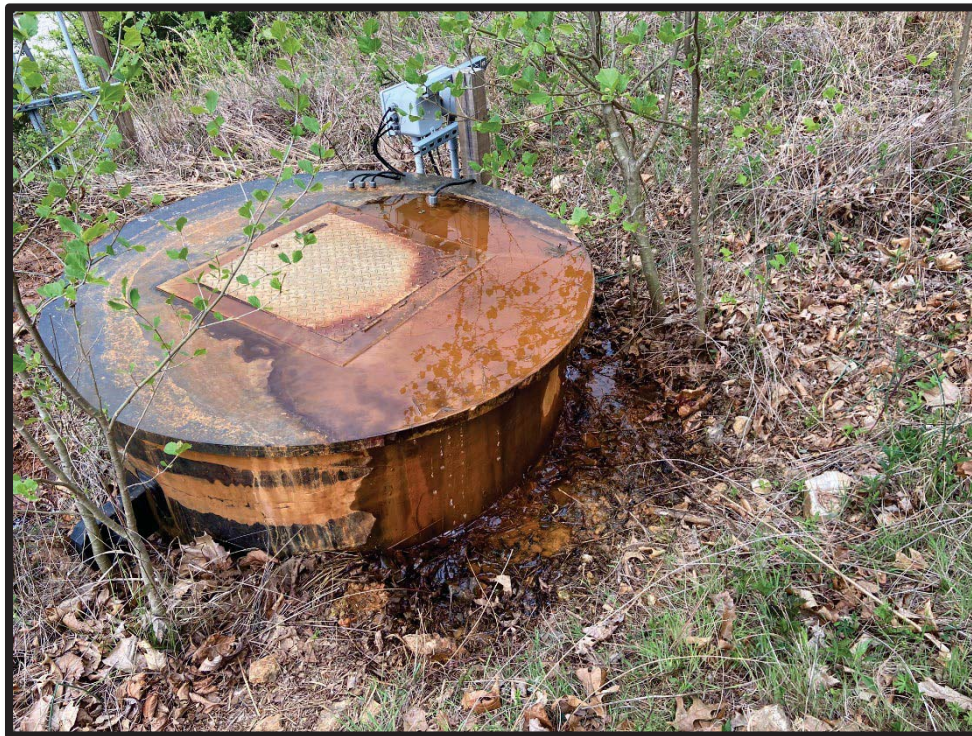
- VLCS-1 was at capacity and overflowing (see photographs 2-3). VLCS-2 appeared to be functioning correctly.
- LCS-1 had a message on its display that read, “Firmware V4.6 Autotest in Progress.” The station was reset, and the normal display was activated. The station has a pump fault.

**Photograph 2:** View of VLCS-1 at full capacity and overflowing.

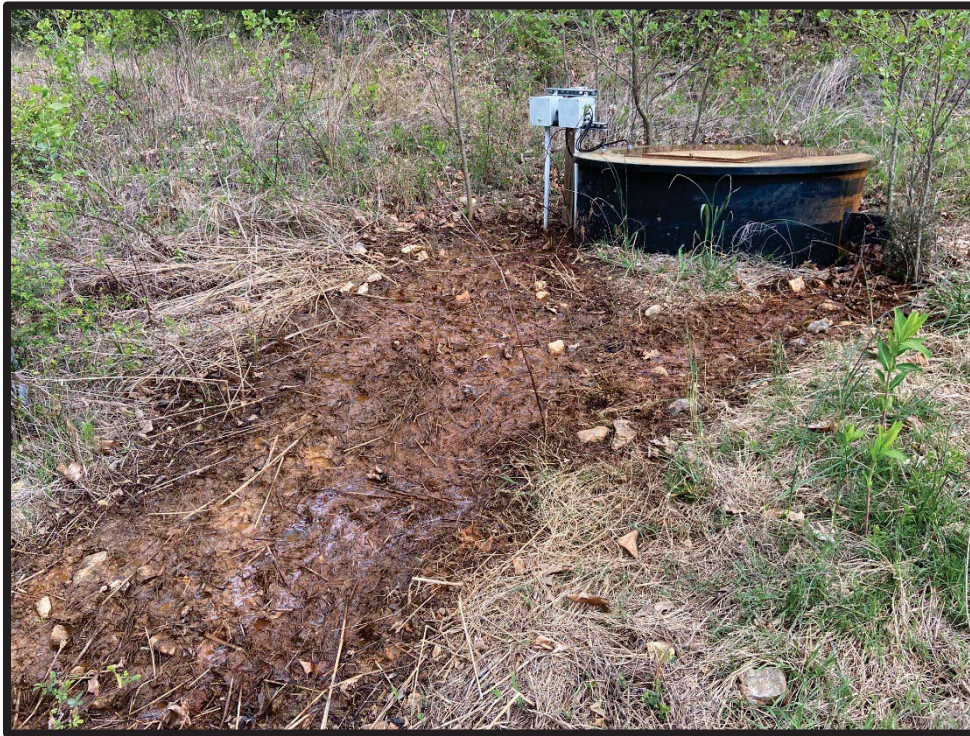
**Photograph 3:** View of stressed vegetation from VLCS-1 overflow.

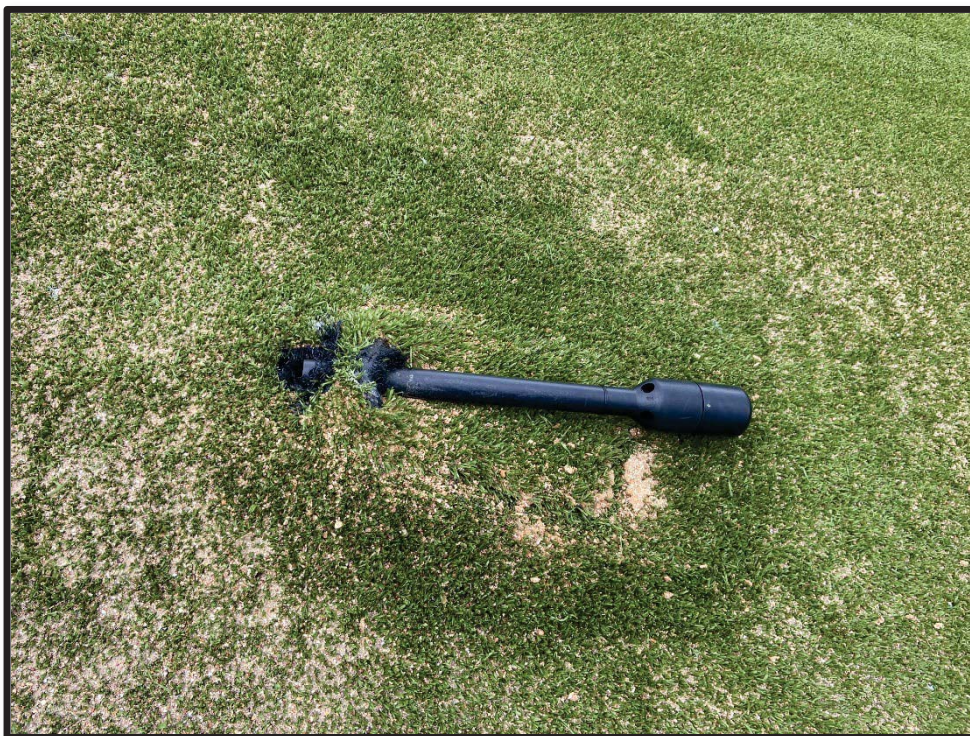
**Photograph 4:** Broken PRV on the east side of Area 1-2.

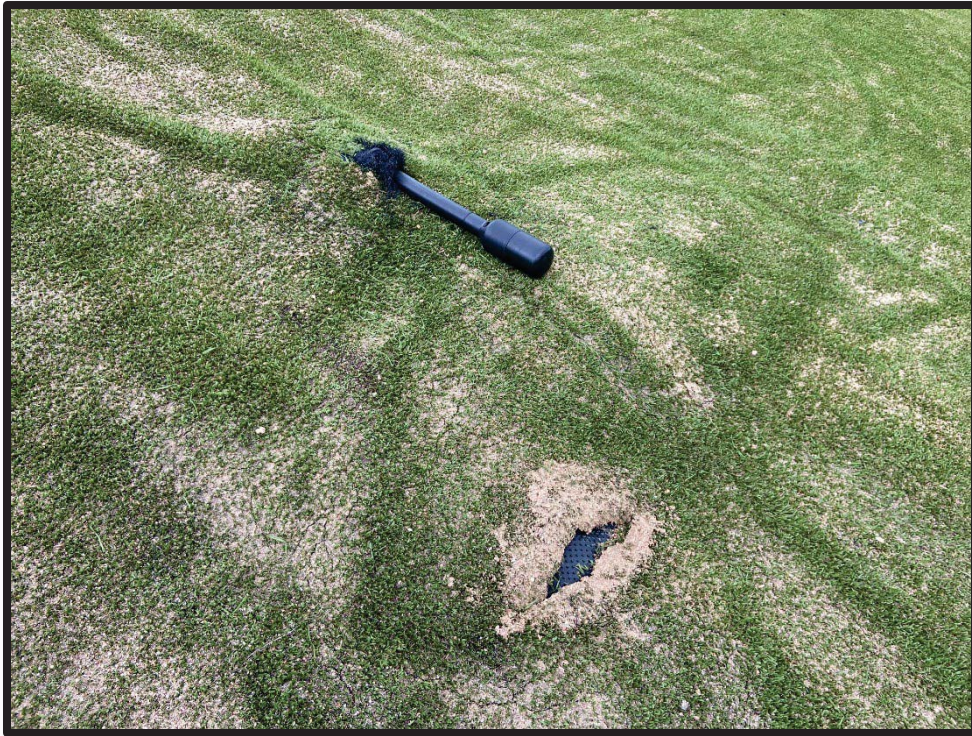
**Photograph 5:** Broken PRV and closure turf tear on the north side of Area 1-2, near LCS-1.

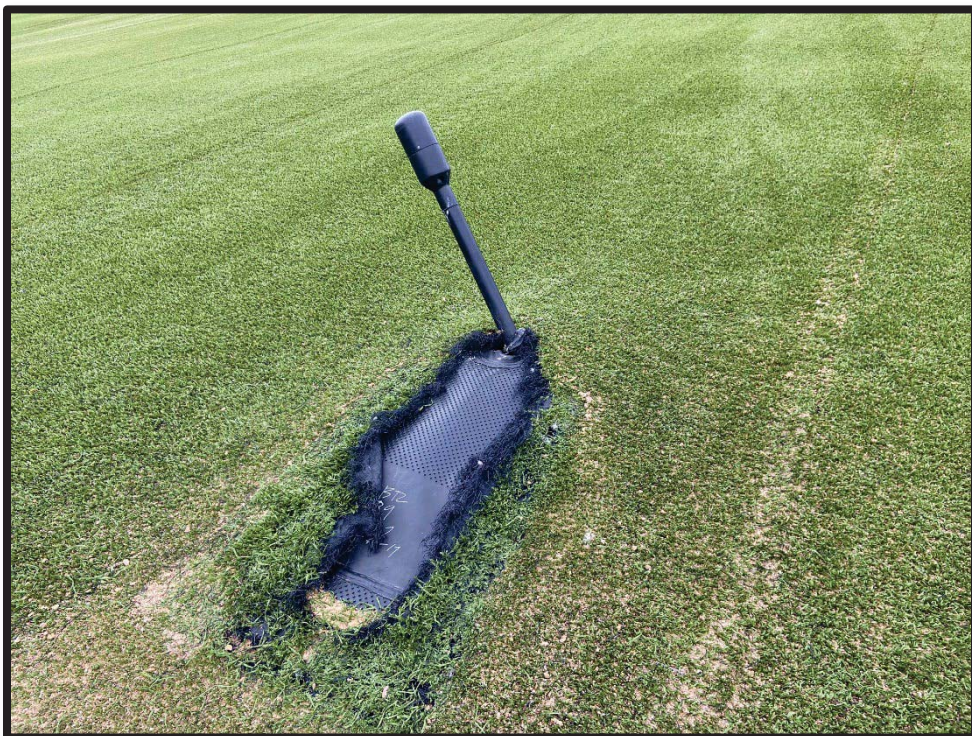
**Photograph 6:** Bent PRV and closure turf tear on north side of Area 1-2, near LCS-1.

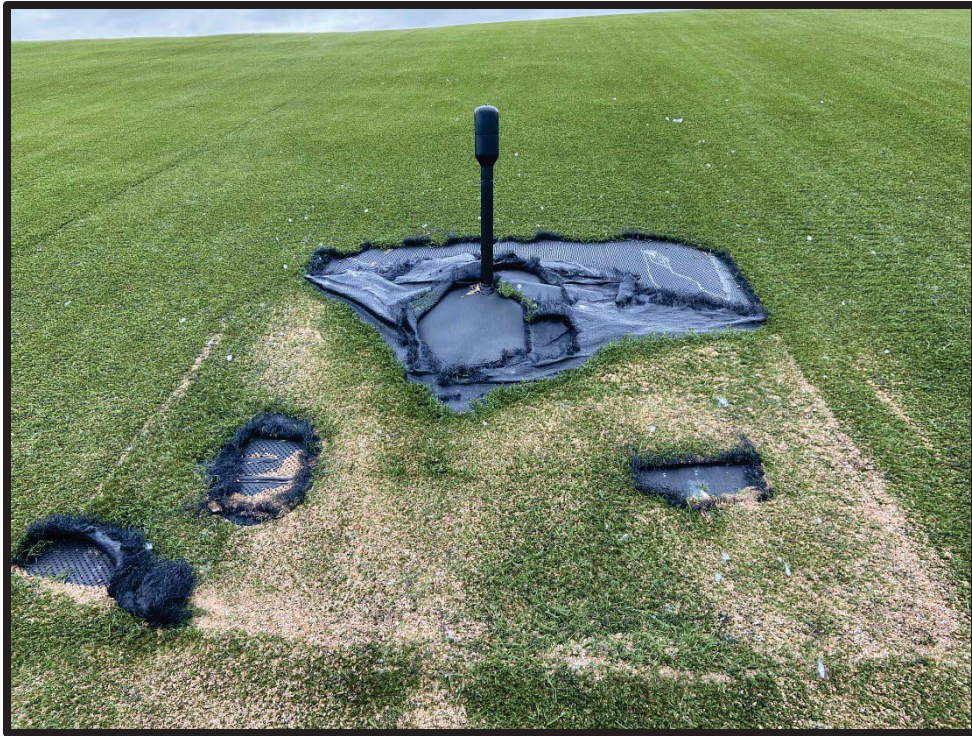
**Photograph 7:** Torn closure turf on south side of Area 1-2, near LCS-4.

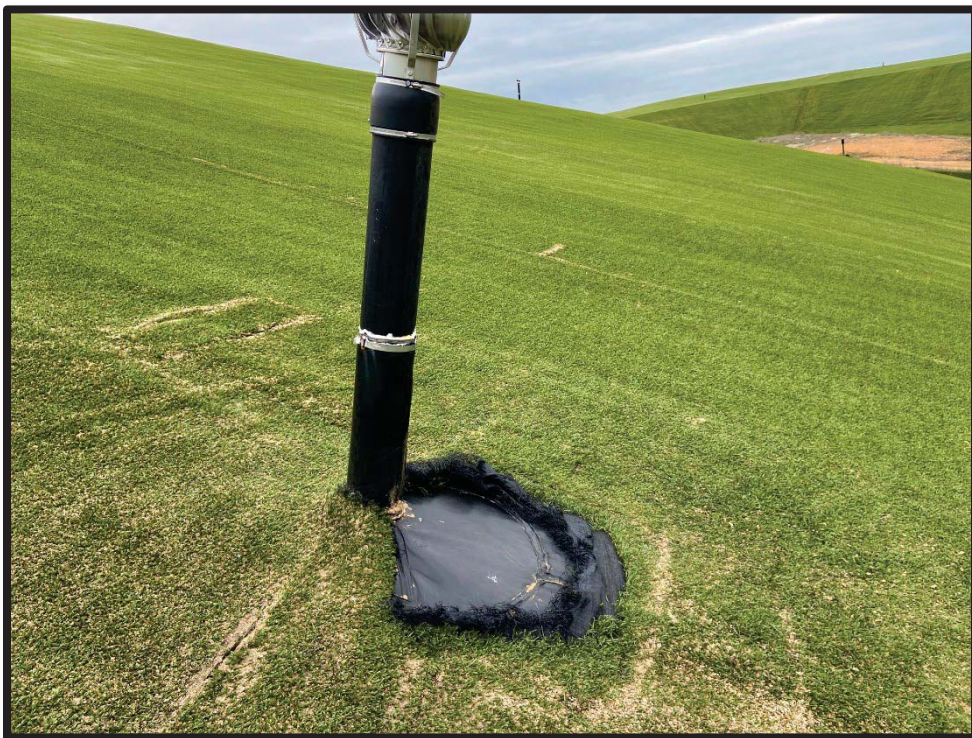
**Photograph 8:** Torn closure turf on south side of Area 1-2, near LCS-4.

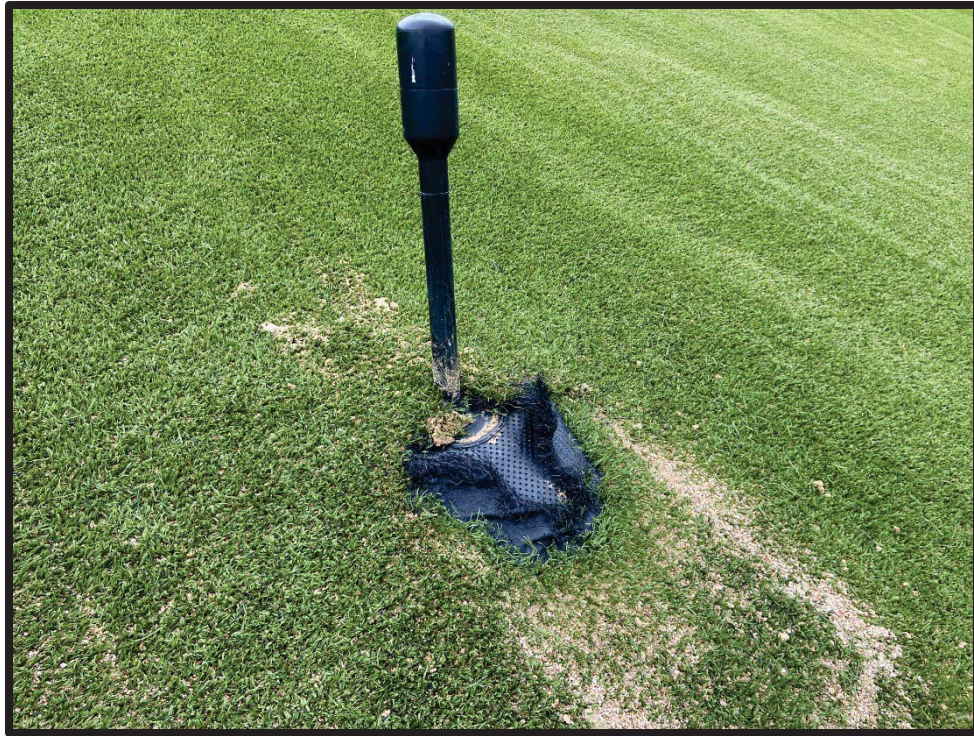
**Photograph 9:** Closure turf tear around PRV on Area 1-2, near LCS-4.

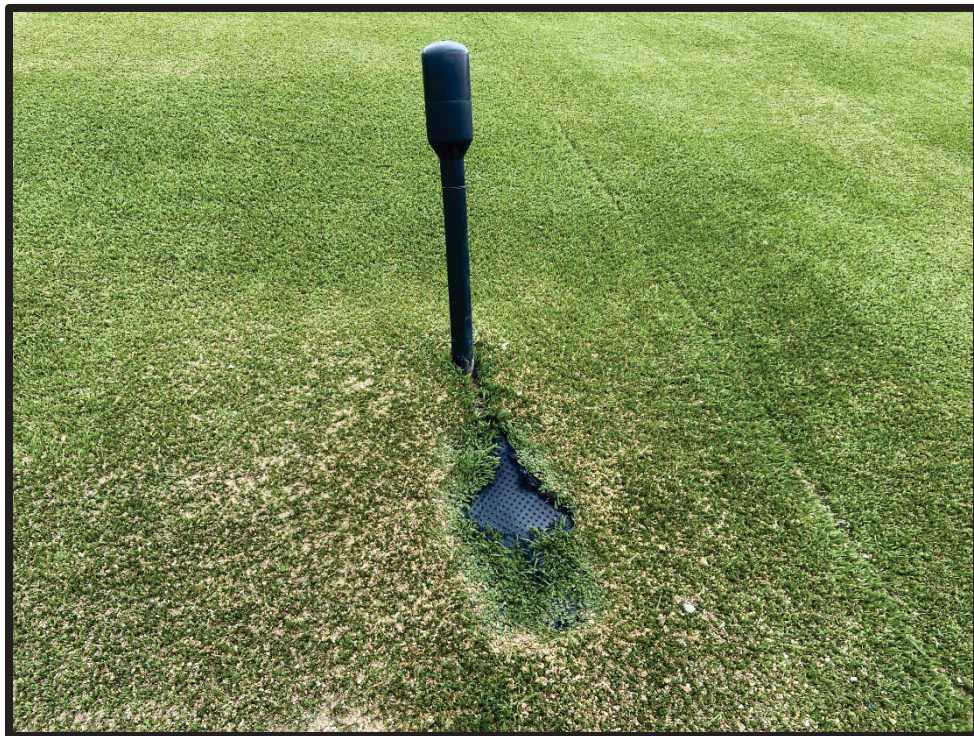
**Photograph 10:** Torn closure turf around PRV on south side of Area 1-3.

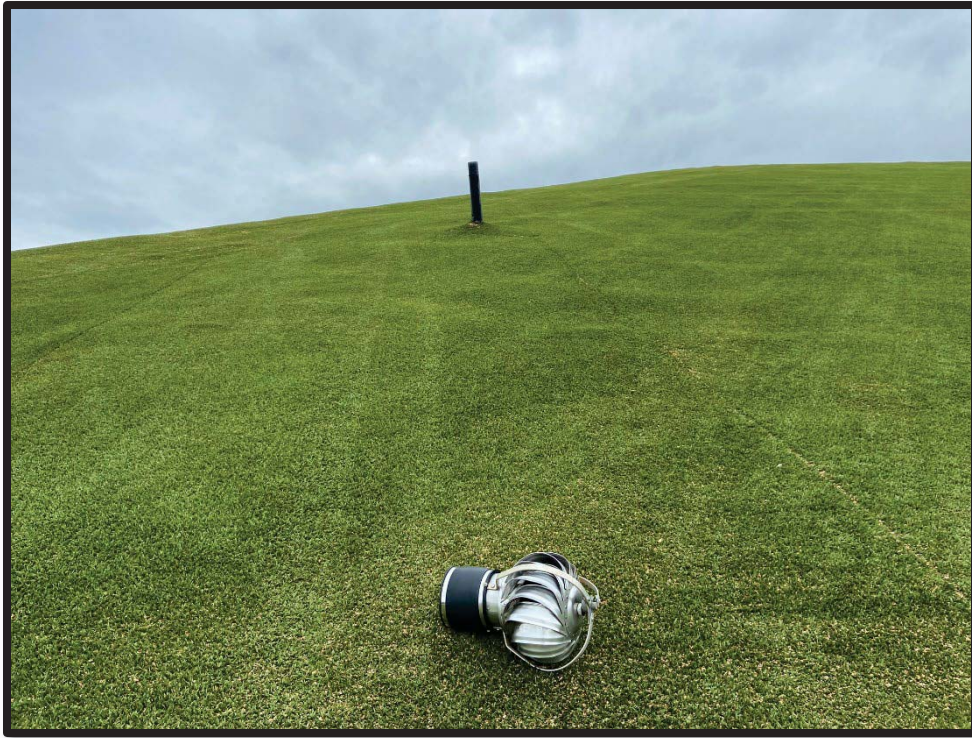
**Photograph 11:** Damaged turbine vent on Area 1-3, near LCS-8.

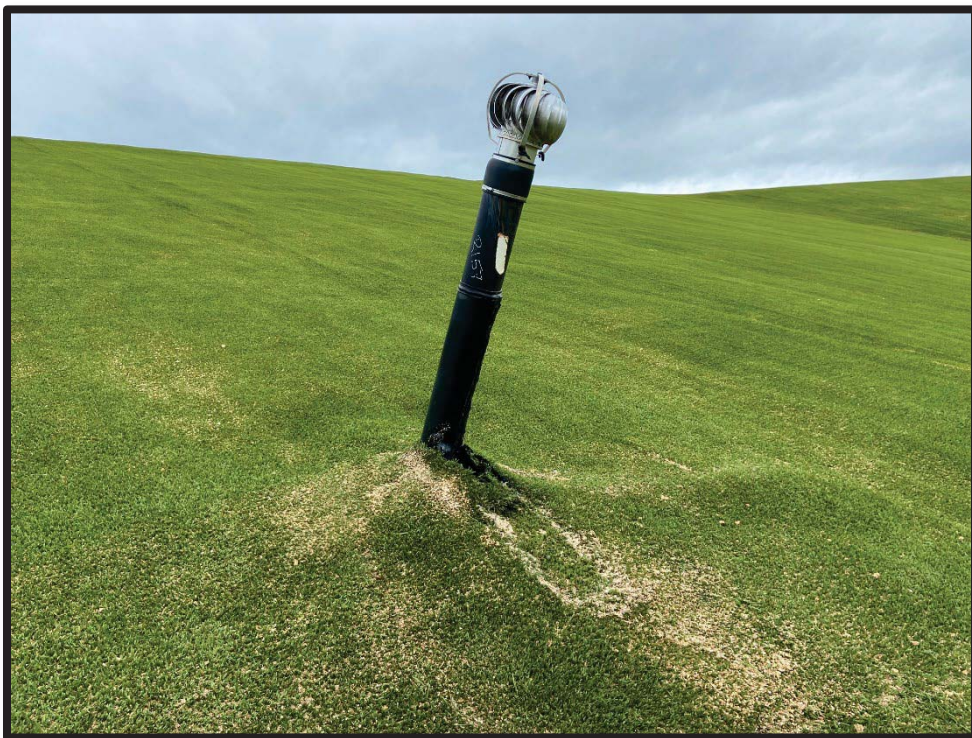
**Photograph 12:** Torn closure turf around turbine vent on Area 1-3, near LCS-7.

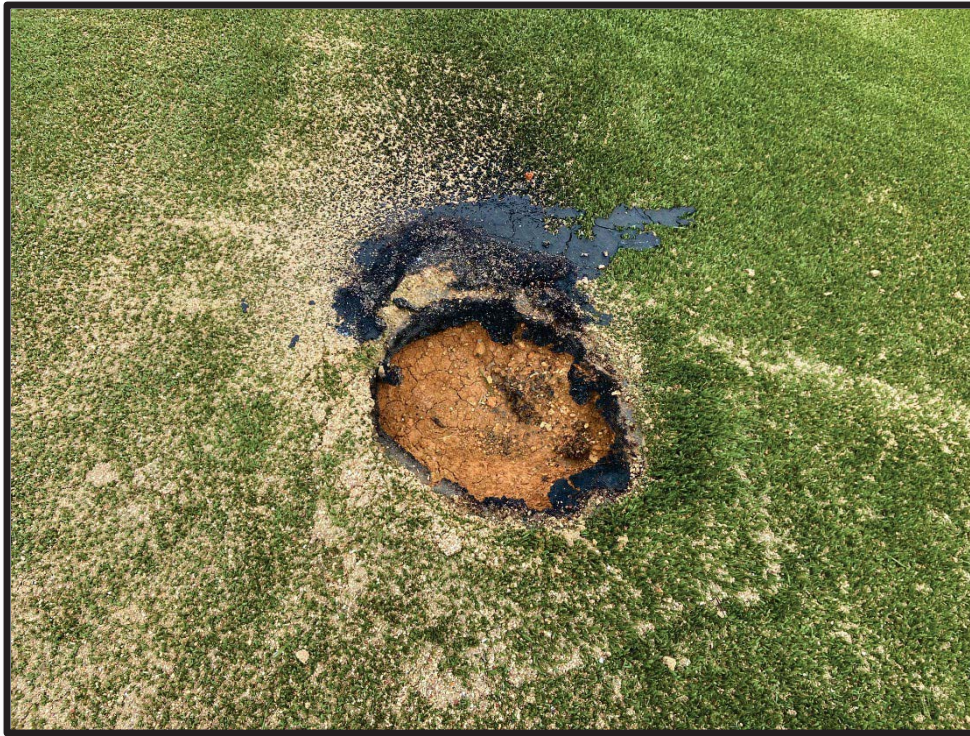
**Photograph 13:** Torn closure turf where vent was on Area 1-3, near LCS-6.

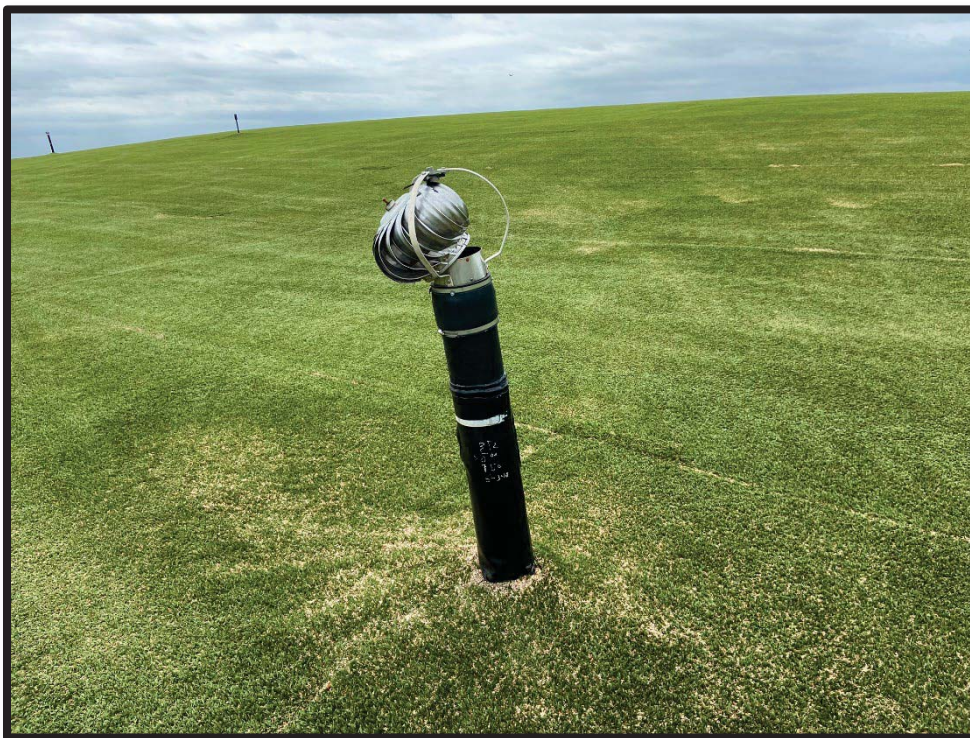
**Photograph 14:** Damaged turbine vent atop Area 1-3.
