**DATE:** May 8, 2023

**RE:** Bi-weekly Site Inspection  
NABORS Landfill  
Mountain Home, AR  
*Harbor Project No: ADEQ-22340*

**Attachment A**  
**Site Photographs**

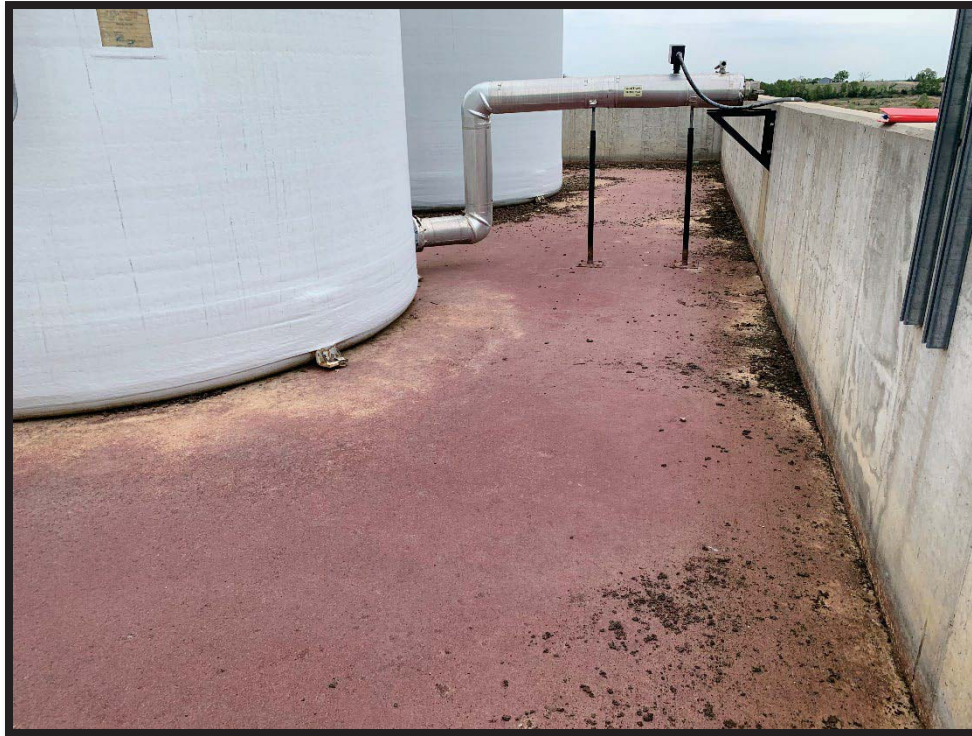
- No stormwater was observed in the tank battery secondary containment (see photographs 1-2). The drain plug was observed in the discharge pipe. The level of leachate in the tanks was measured at 39.6".

**Photograph 1:** View of dry conditions in leachate tank secondary containment.

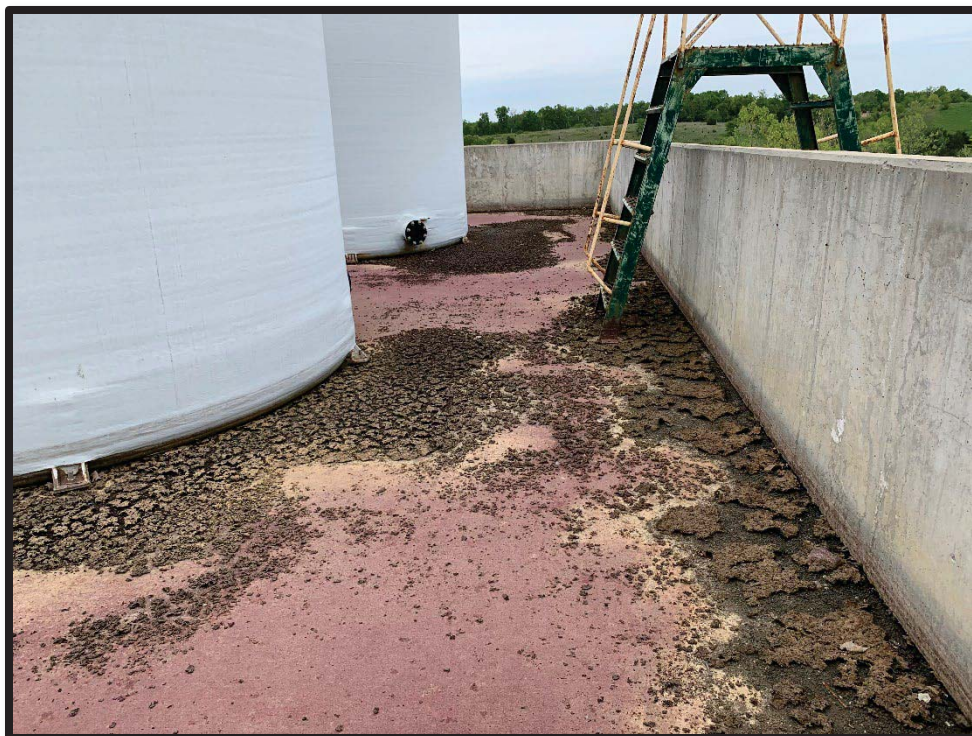
**Photograph 2:** View of dry conditions in leachate tank secondary containment.

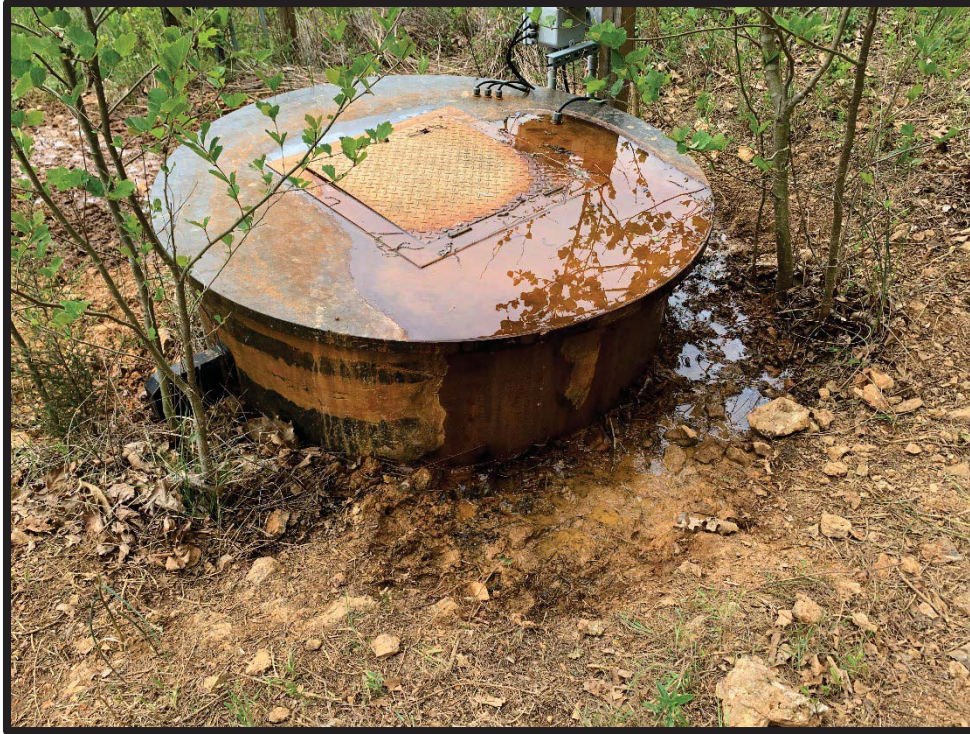
- VLCS-1 was at capacity and overflowing (see photographs 3-4). A large area of wet soil caused by the overflow appears to be attracting deer as evidenced by an abundance of deer tracks.

**Photograph 3:** View of VLCS-1 at full capacity and overflowing.

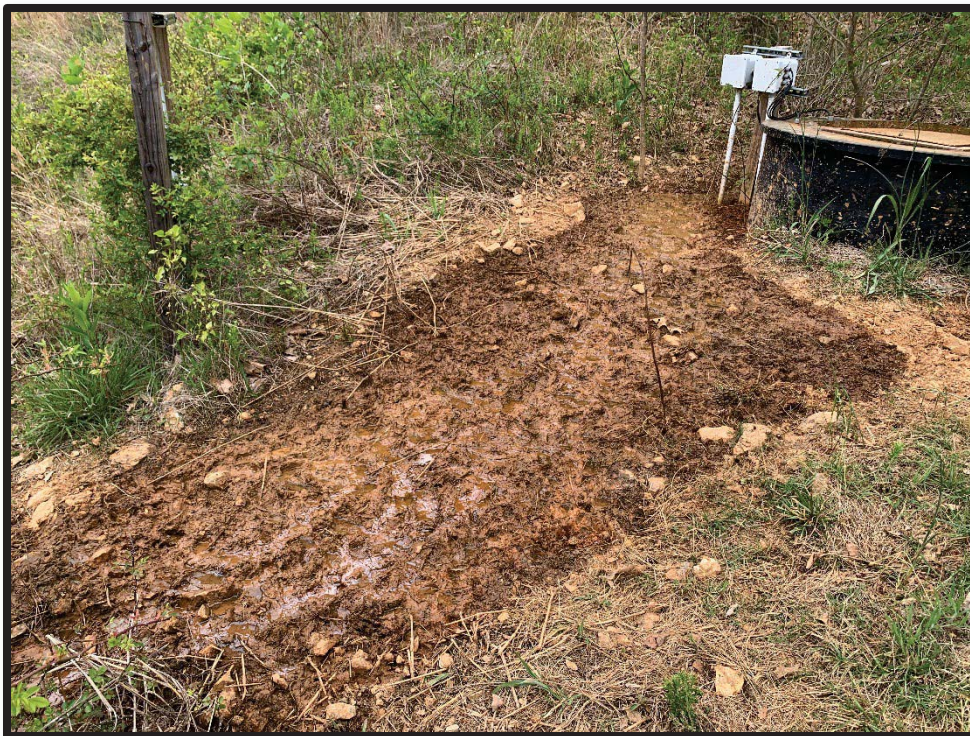
**Photograph 4:** View of stressed vegetation from VLCS-1 overflow. Abundant deer tracks visible in mud.

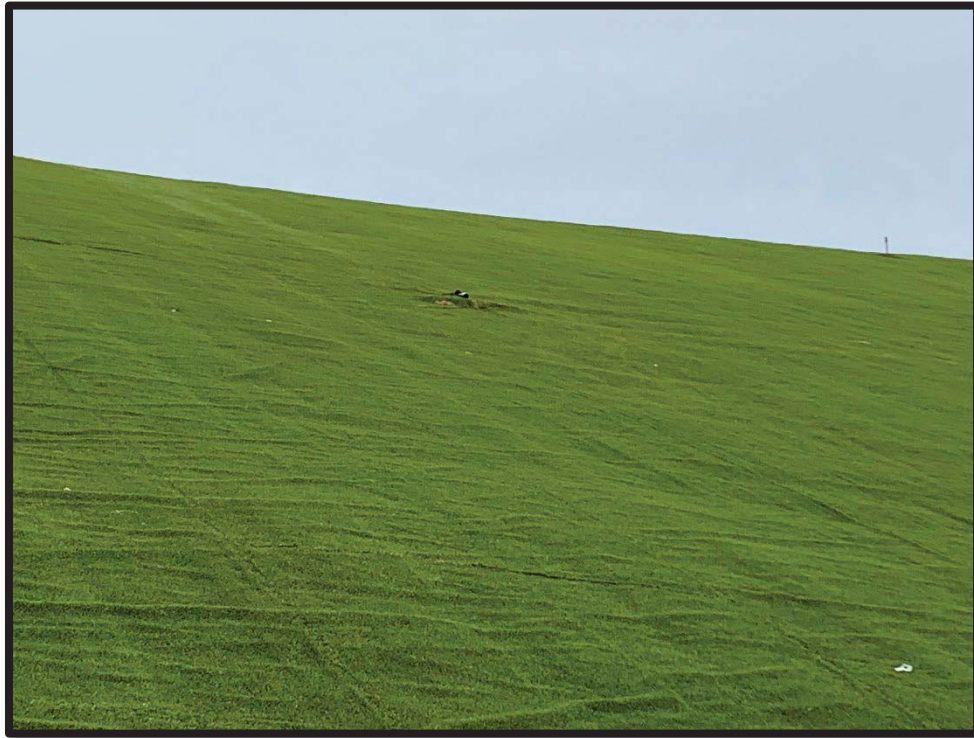
- Repairs to the closure turf and vents appears largely complete; although one vent pipe near LCS-1 appeared to still need repair (see photo 5).

**Photograph 5:** Broken PRV and closure turf tear on the north side of Area 1-2, near LCS-1.

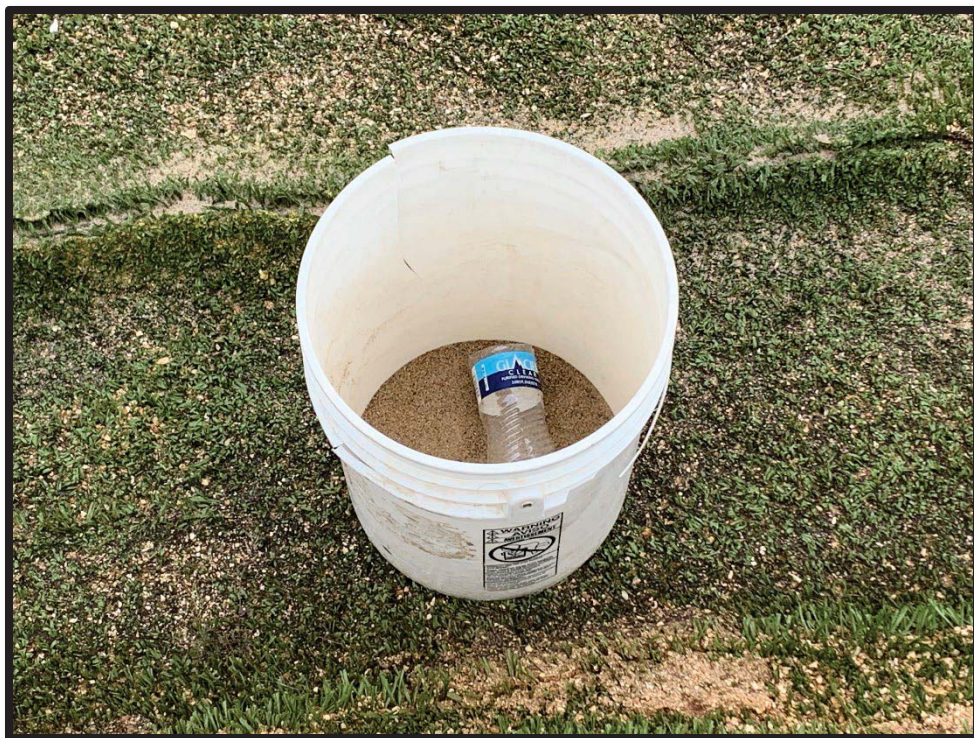
**Photograph 6:** Discarded five-gallon bucket with sand left over from liner repairs.
