Subject: RE: Nabors Bi-weekly Site Visit

DATE: May 19, 2023

RE: Bi-weekly Site Inspection
NABORS Landfill
Mountain Home, AR
Harbor Project No: ADEQ-22340

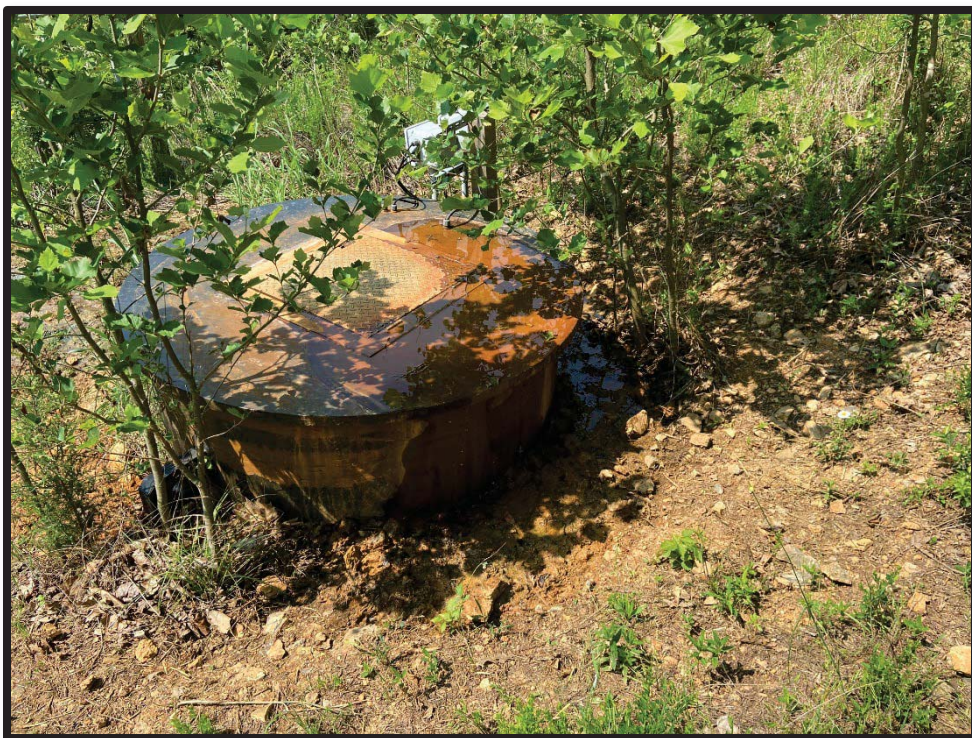
- Minimal stormwater was observed in the tank battery secondary containment. As such, no stormwater was released. The level of leachate in the tanks was measured at 48.3”.
- VLCS-1 was at capacity and overflowing (see photographs 1-2). A large area of wet soil caused by the overflow appears to be attracting deer as evidenced by an abundance of deer tracks.
- VLCS-2 appeared to be functioning correctly.
- LCS-1 has a pump fault.
- The display on LCS-2 is not functioning correctly, but the green strobe was activated.
- LCS-5 is not operational.
- LCS-3 and LCS-6 appeared to be functioning correctly.
- LCS-4, LCS-7, and LCS-8 had pump faults.
- LCS-9 display was working, but level at 0.0” and not working in “hand” mode.
- Closure turf remains torn on Area 1-2 above LCS-4 (see photographs 3-4).

Photograph 2: View of overflow at VLCS-1.

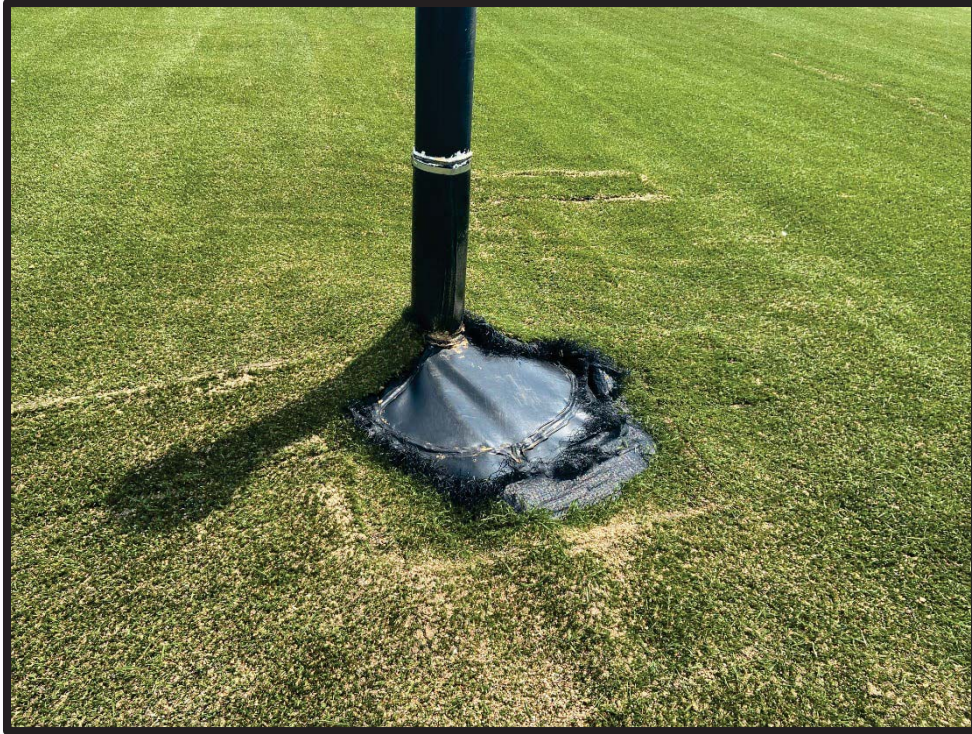
Photograph 3: Closure turf tear around turbine vent on the south side of Area 1-2, near LCS-4.

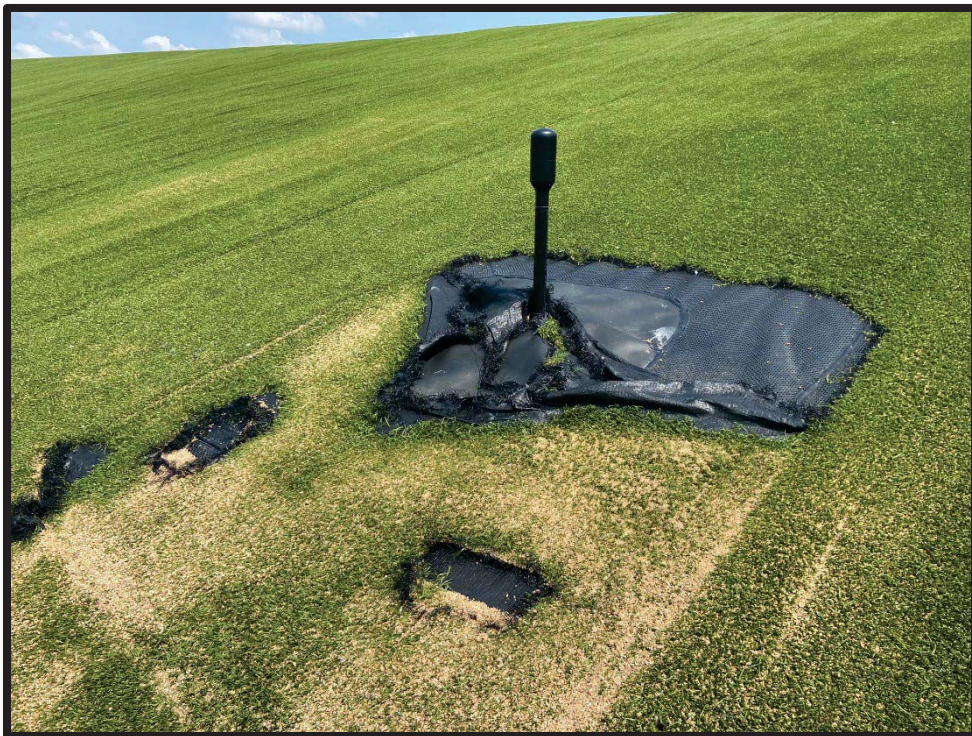
Photograph 4: Closure turf tear around PRV on the south side of Area 1-2, near LCS-4.
