Subject: RE: Nabors Bi-Weekly Site Visit

DATE: June 6, 2023

RE: Bi-weekly Site Inspection
NABORS Landfill
Mountain Home, AR
Harbor Project No: ADEQ-22340

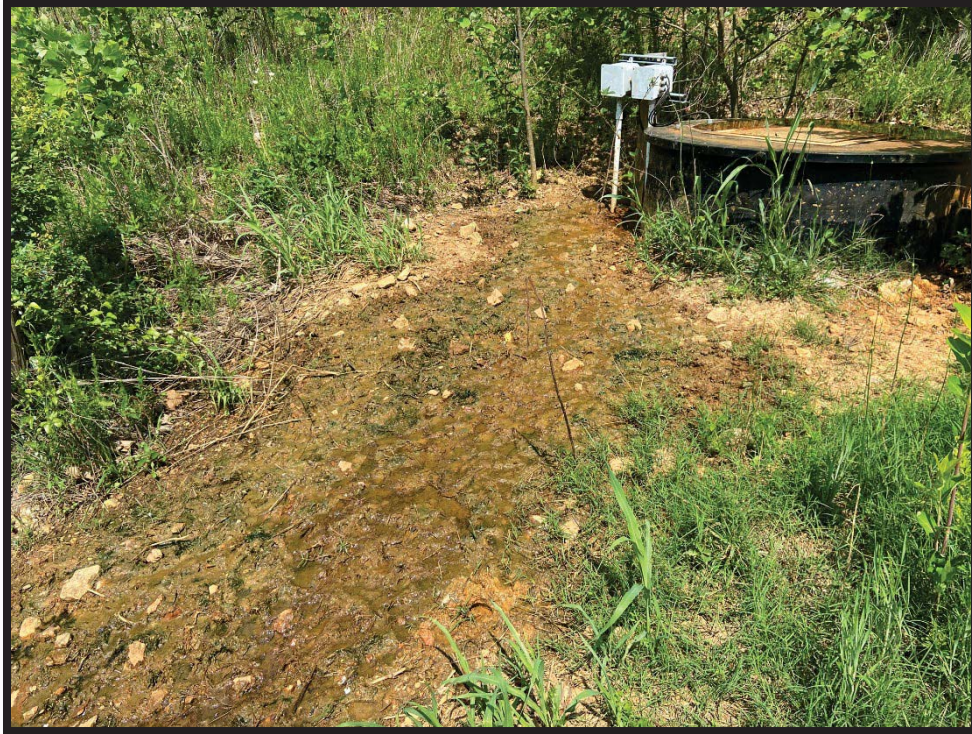
- No stormwater was observed in the tank battery secondary containment. As such, no stormwater was released. The level of leachate in the tanks was measured at 33.1”.
- VLCS-1 was at capacity and overflowing (see photographs 1-2). A large area of wet soil caused by the overflow appears to be attracting deer as evidenced by an abundance of deer tracks.
- VLCS-2 appeared to be functioning correctly.
- LCS-1 displayed a message that read “Autotest in Progress.”
- LCS-3 is functioning in “hand” mode only.
- LCS-2, LCS-5, and LCS-6 are not operational.
- LCS-4, LCS-7, and LCS-8 had pump faults.
- LCS-9 display was working, but level was at 0.0” and not working in “hand” mode.
- Closure turf remains torn on Area 1-2 above LCS-4 (see photographs 3-4).

Photograph 1: View of stressed vegetation from VLCS-1 overflow. Abundant deer tracks visible in mud.

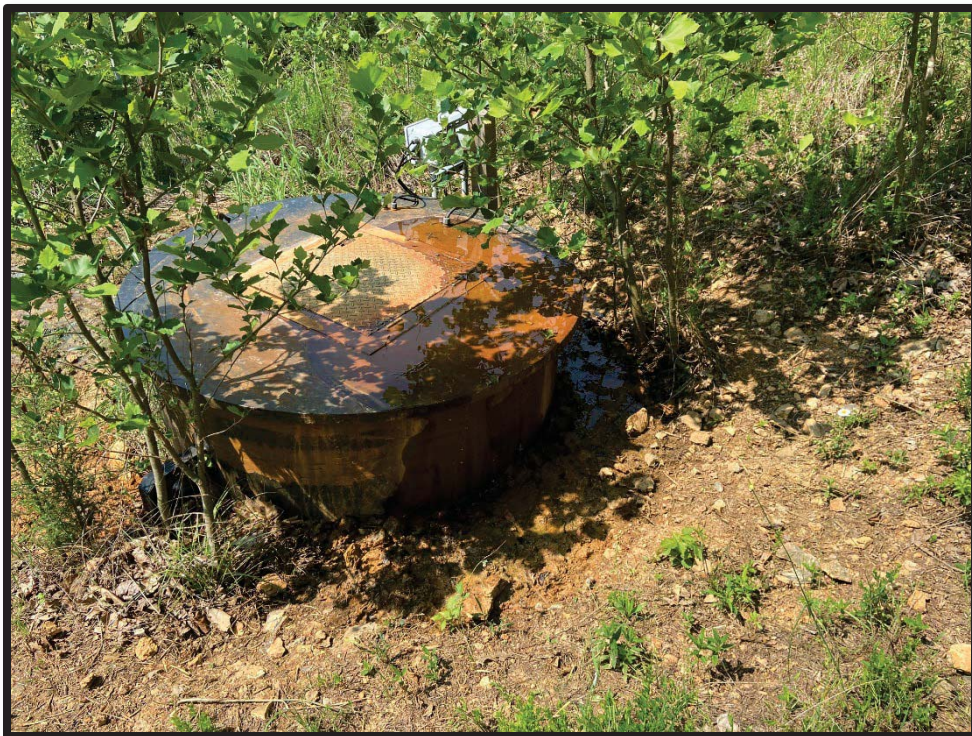
Photograph 2: View of overflow at VLCS-1.

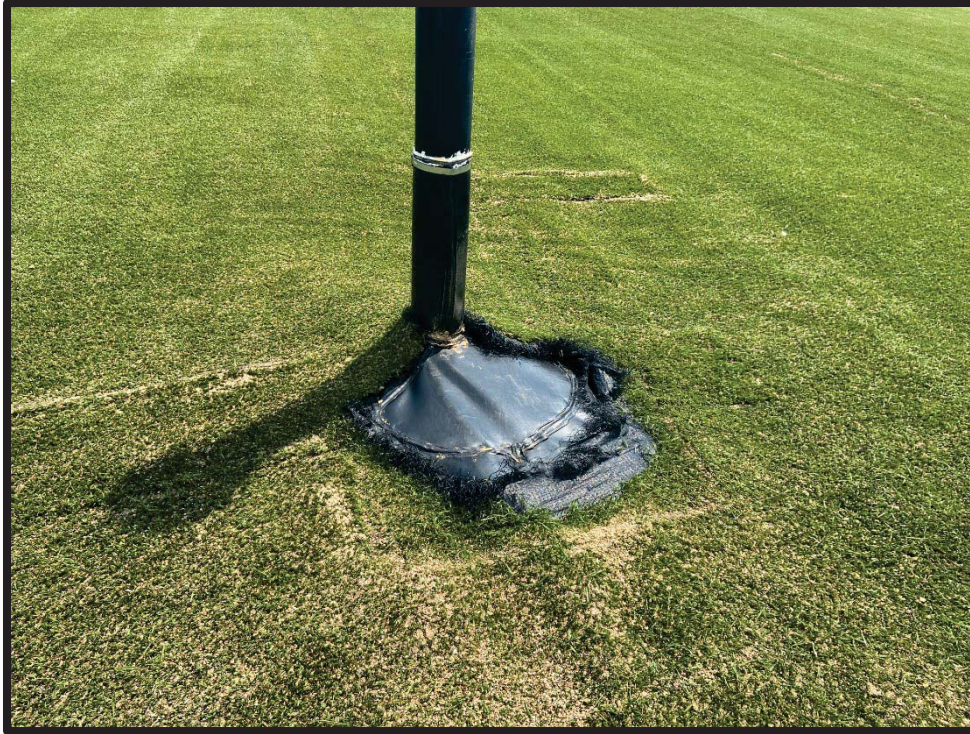
Photograph 3: Closure turf tear around turbine vent on the south side of Area 1-2, near LCS-4.

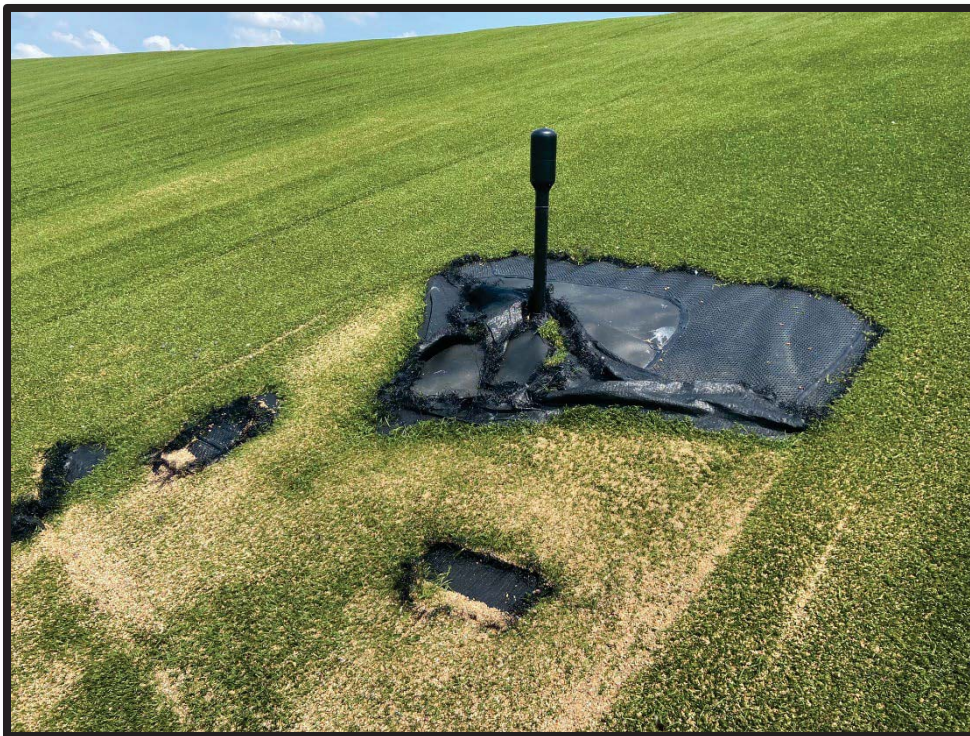
Photograph 4: Closure turf tear around PRV on the south side of Area 1-2, near LCS-4.
