DATE: June 13, 2023

RE: Bi-weekly Site Inspection
NABORS Landfill
Mountain Home, AR
Harbor Project No: ADEQ-22340

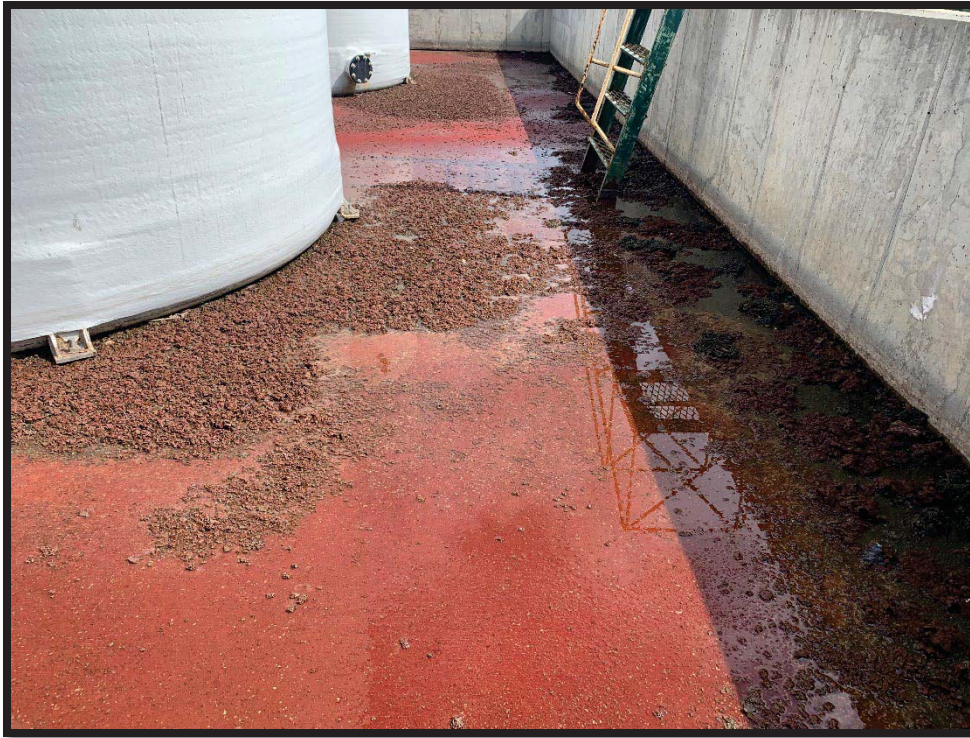
- A trace amount of stormwater was observed in the tank battery secondary containment. As such, no stormwater was released. The level of leachate in the tanks remained at 33.1" (see photographs 1 and 2).

Photograph 1: View north of leachate tank secondary containment. Small pools of water visible from recent rain.

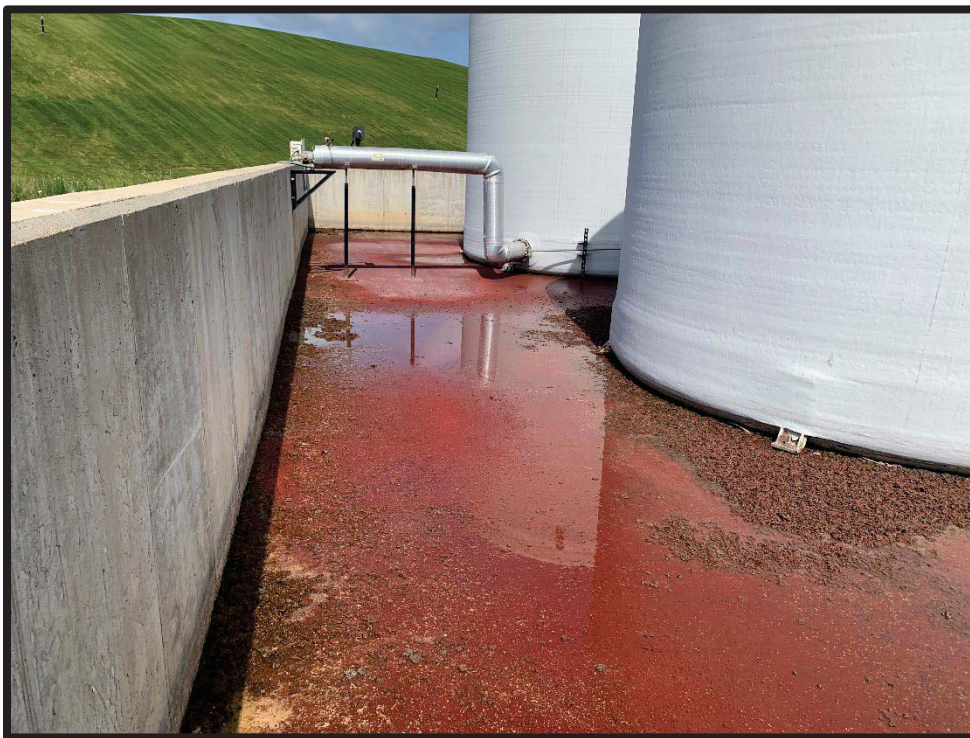
Photograph 2: View north of leachate tank secondary containment.

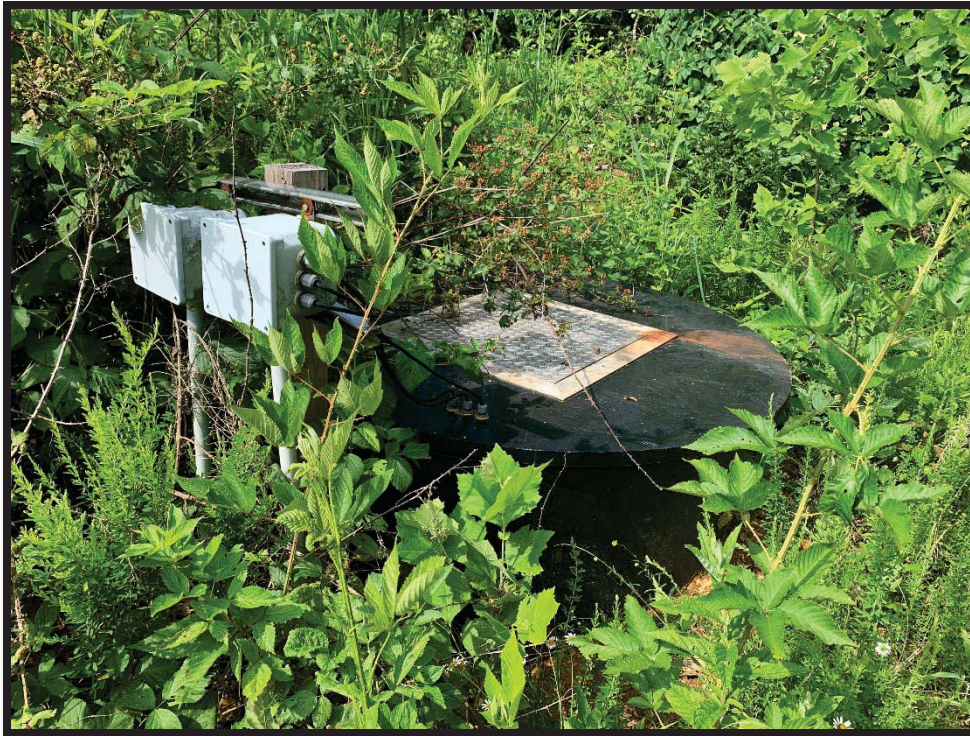
- VLCS-2 appeared to be functioning correctly but is heavily overgrown with vegetation (see photographs 3 and 4).
- VLCS-1 remains at capacity and continues to overflow (see photographs 5 and 6). A large area of wet soil caused by the overflow appears to be attracting deer as evidenced by an abundance of deer tracks.

Photograph 3: View southwest of VLCS-2 sump overgrown with vegetation.

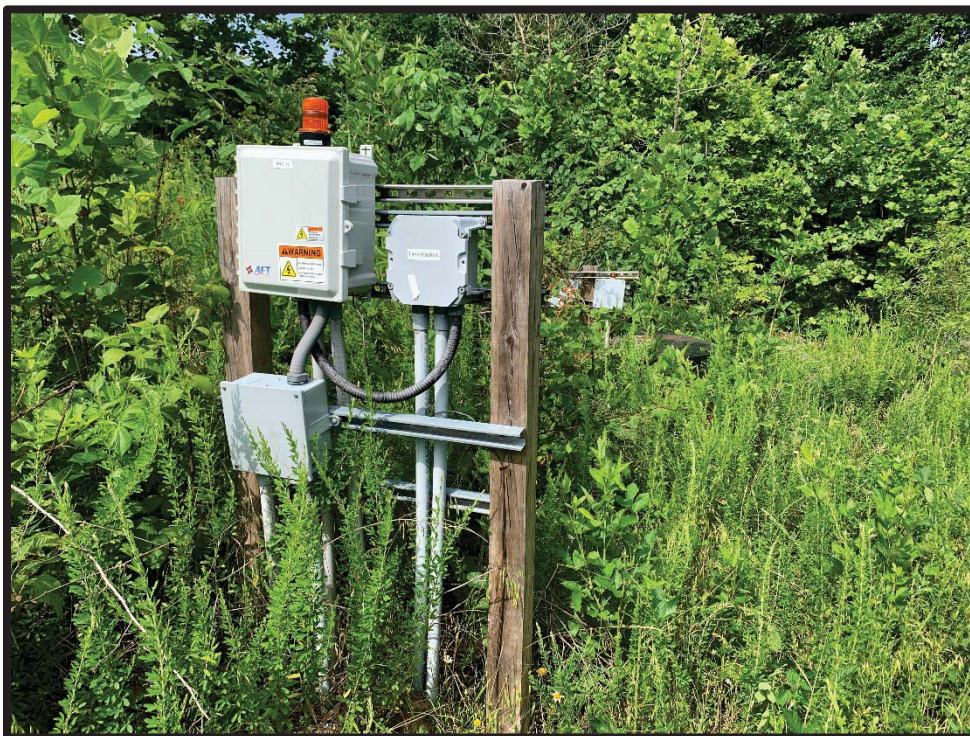
Photograph 4: View southwest of VLCS-2 control panel and overgrown vegetation.

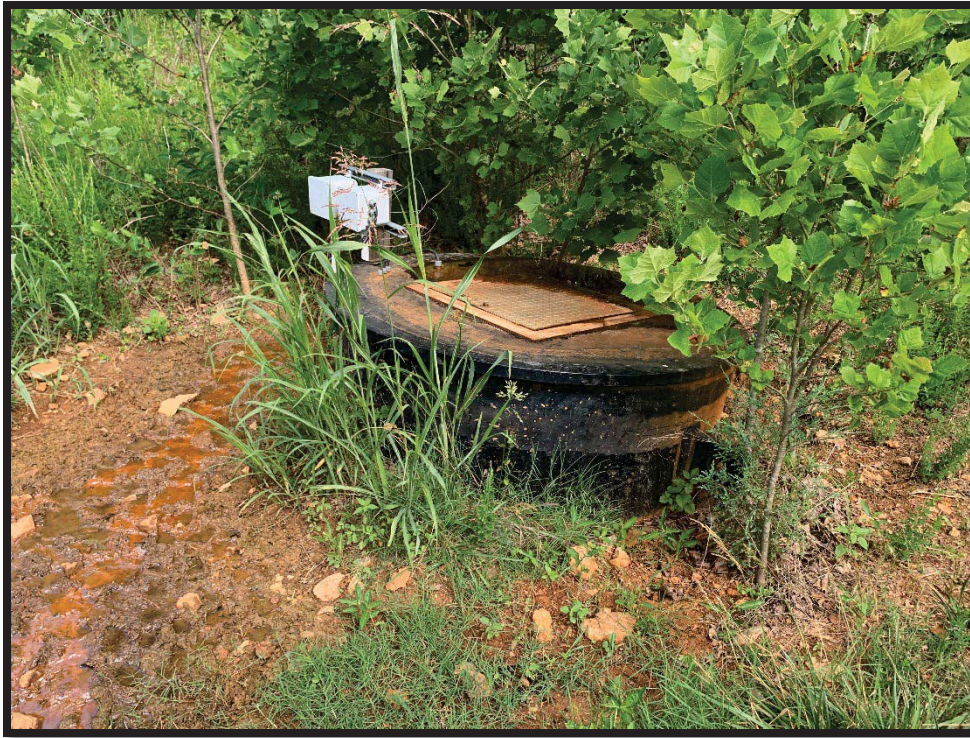
Photograph 5: View of stressed vegetation from VLCS-1 overflow. Abundant deer tracks visible in mud.

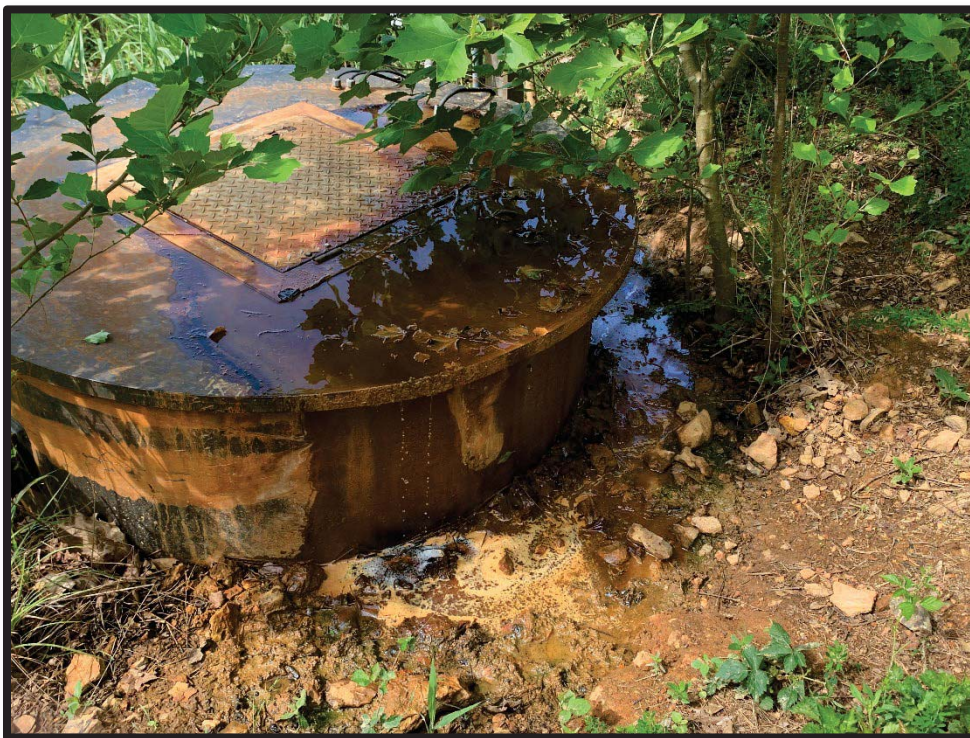
Photograph 6: View of overflow at VLCS-1.

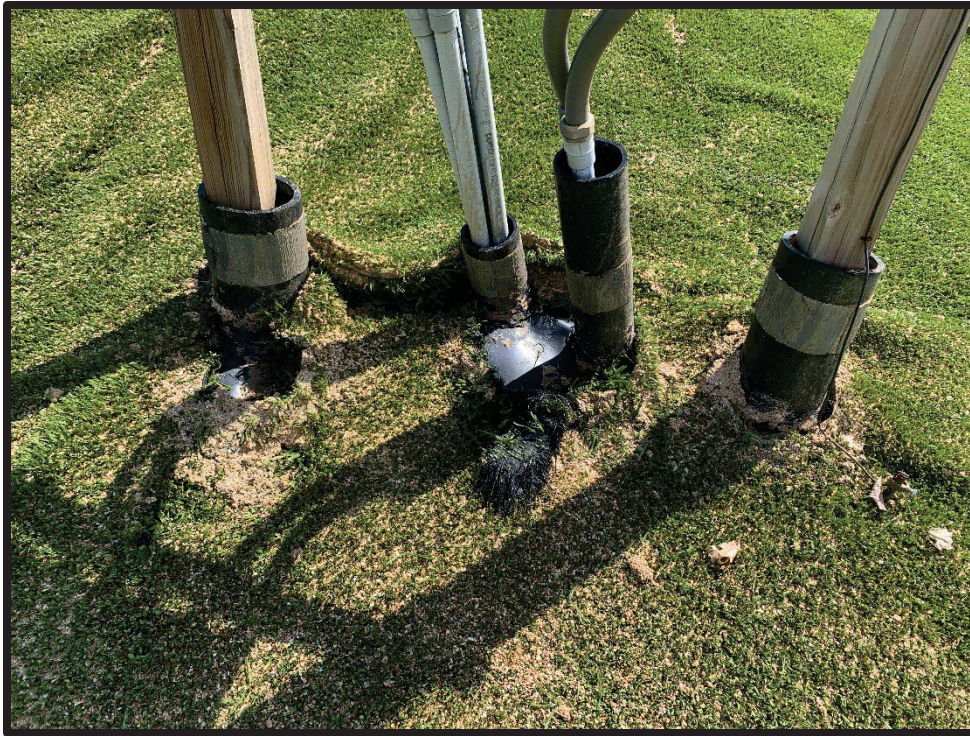
- Closure turf is damaged around the base of LCS-4 (see photograph 7) and remains torn on Area 1-2 above LCS-4. A whirligig vent has detached from the pipe above LCS-8 (see photographs 8 – 10).

Photograph 7: Closure turf damage at base of LCS-4.

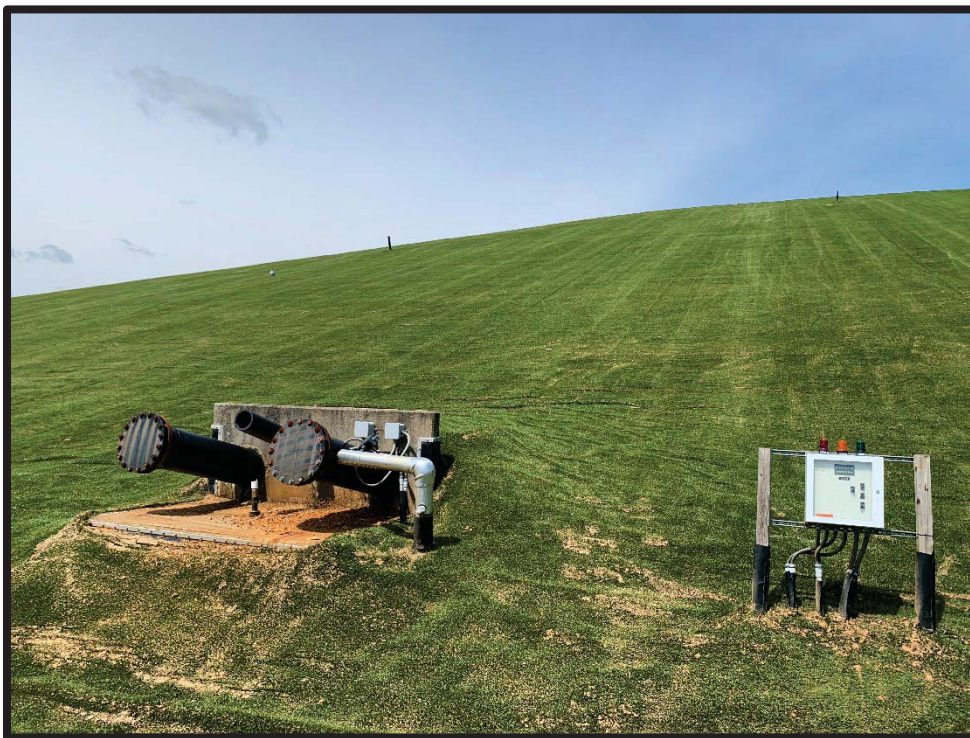
Photograph 8: View southwest of LCS-8. Detached whirligig vent visible in distance.

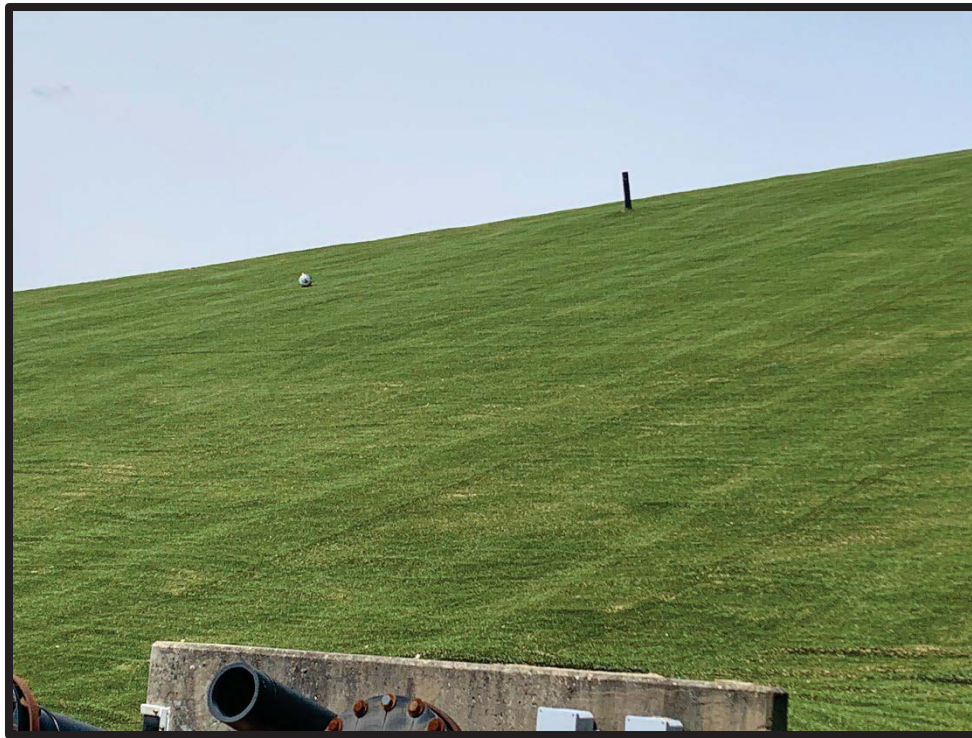
Photograph 9: Closer view of detached whirligig near LCS-8.

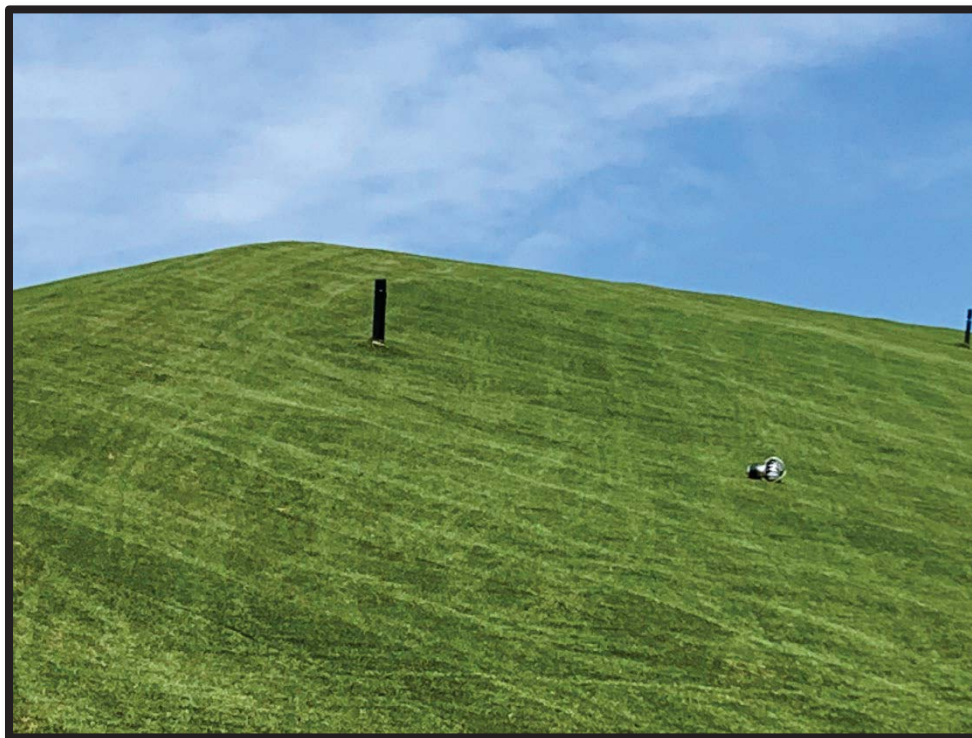
Photograph 10: Secondary view of detached whirligig.
