Subject: RE: Nabors Report

Project Information

Project Name	<u>Nabors Landfill</u>	City, State	<u>Mountain Home, AR</u>
WG Representative	<u>Jeff Albright, Maintenance Mgr.</u>	Report Date	<u>2023-07-27</u>

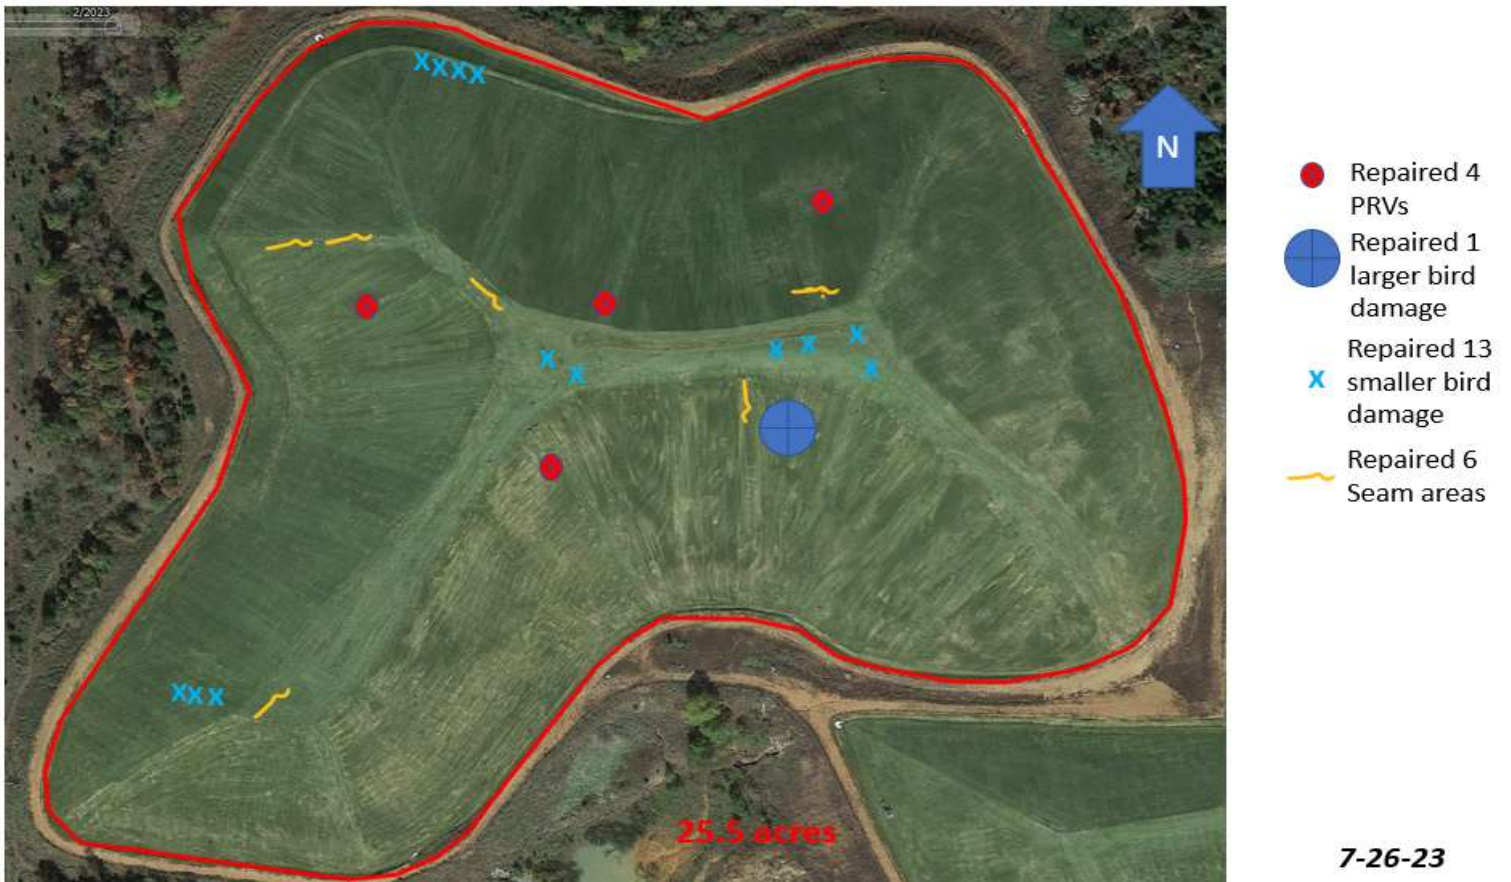
1. Overview of Cell 1-2

PRVs on Cell 1-2 were identified needing repairs. Four PRVs were repaired, using new risers and caps. See 1. Site Overview, and 3. Repaired PRVs.

Cell 1-2: An area surrounding a PRV had turf damage that was repaired. See 1. Site Overview and 4. Large Area of Bird Damage

Cell 1-2: Several smaller areas of bird damage on the top deck of the largest landfill were repaired. See 1. Overview and 5. Top Deck Bird Damage

Several seam areas on Cell 1-2 were repaired. See 1. Overview and 6. Seam Repairs

4 areas of bird damage near the lower bench on northern side were repaired as were 3 areas of bird damage on west slope. See 1. Overview and 7. Bird Damage

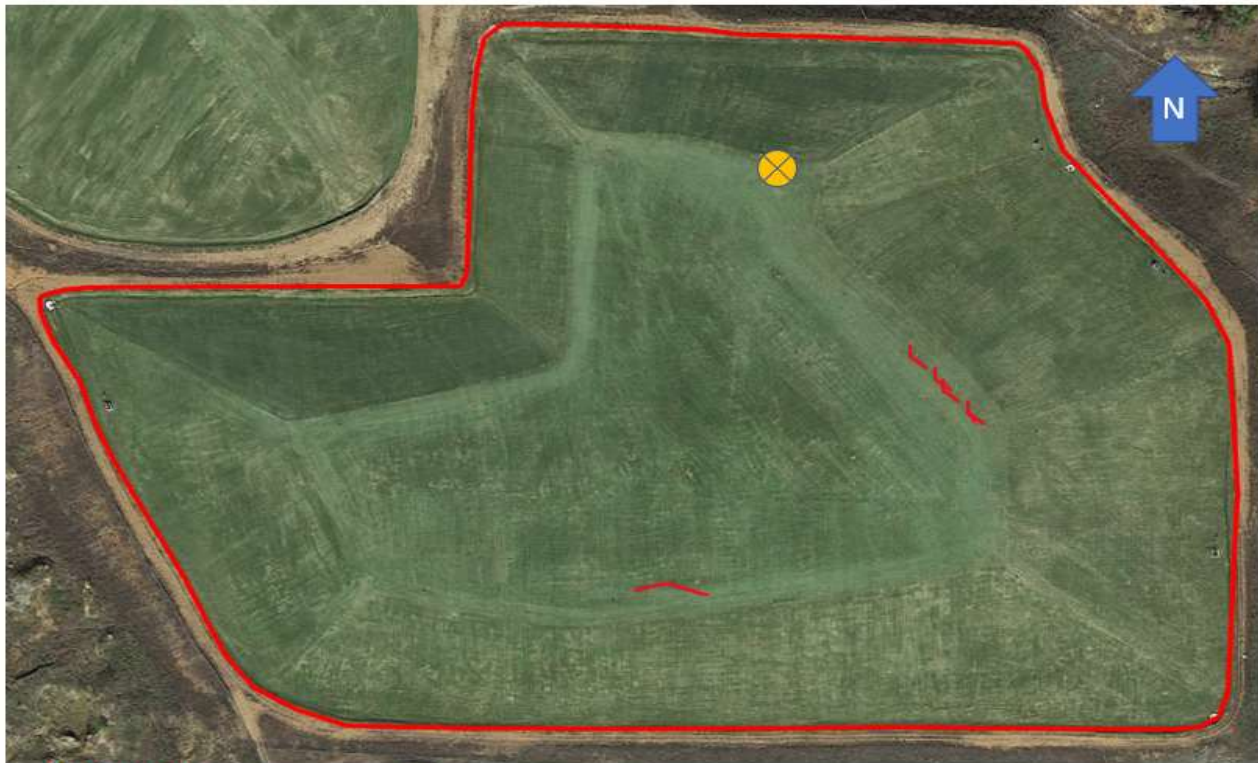
2. Overview of Cell 1-3

Cell 1-3: Three separate seam areas were repaired. See 2. Cell 1-3 Overview and 8. Seam Repair

Cell 1-3: A damaged area of both turf and liner, of an unknown origin, was repaired. See 2. Overview and 9. Turf and Liner Damage

Damaged turf and liner repaired

Seams repaired

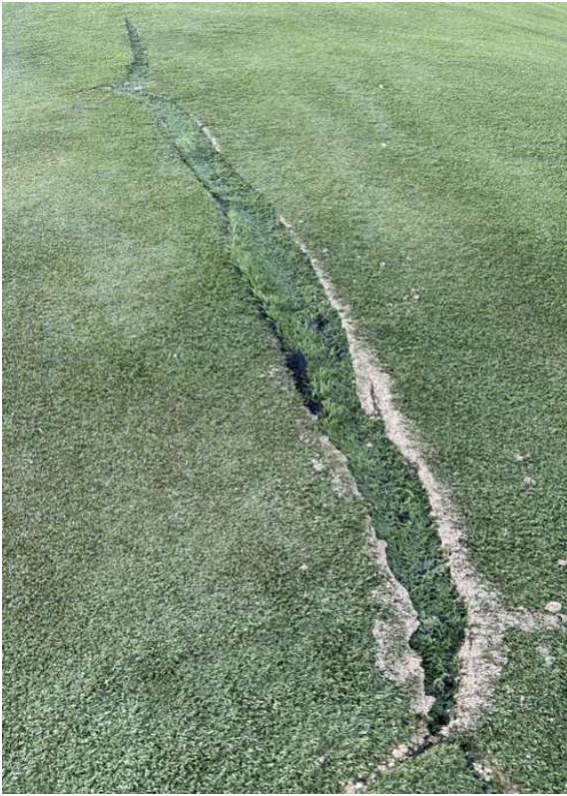
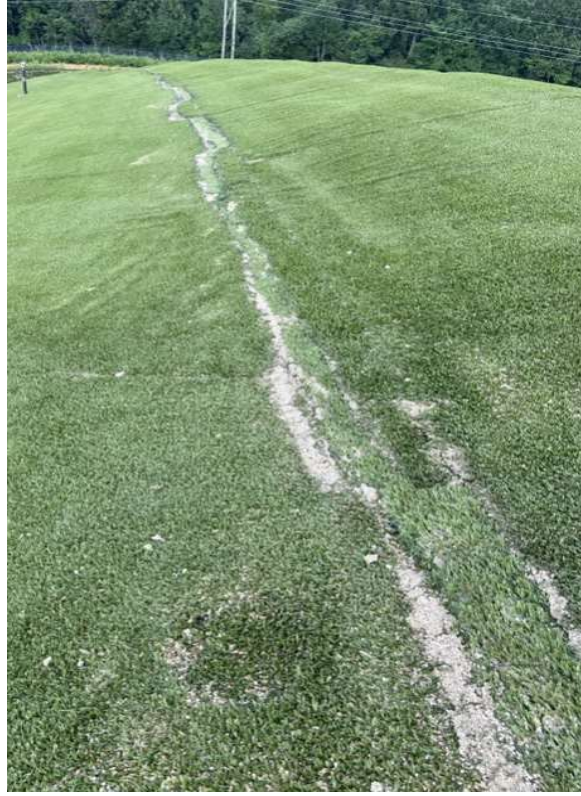
6. Seam Repairs Cell 1-2 (before and after repair)

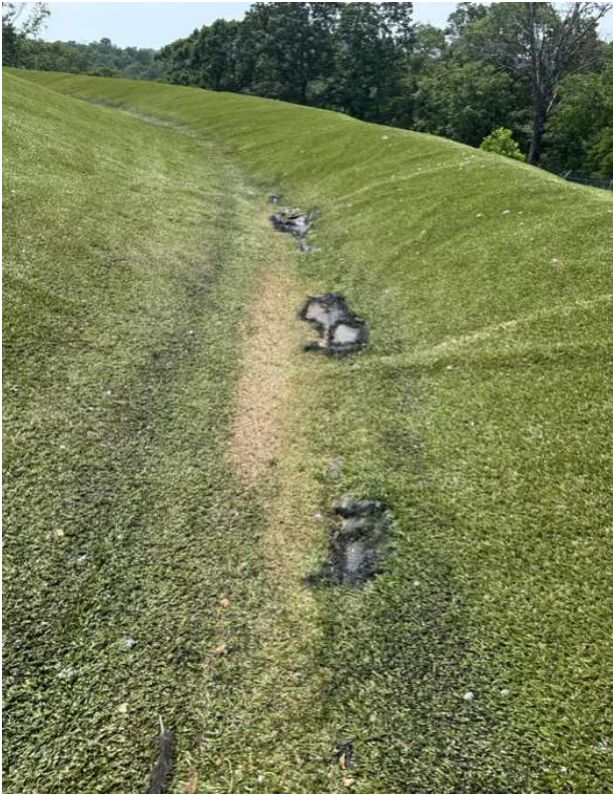
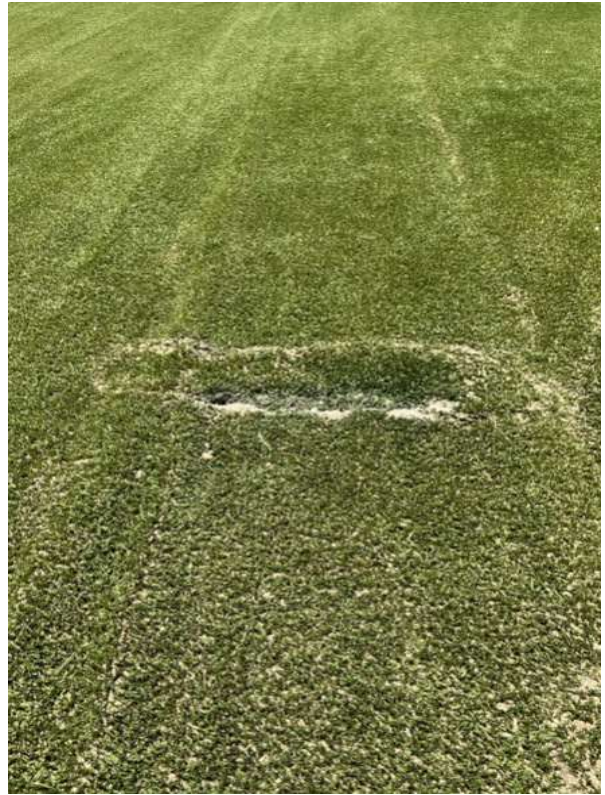
7. Bird Damage (before and after repair)

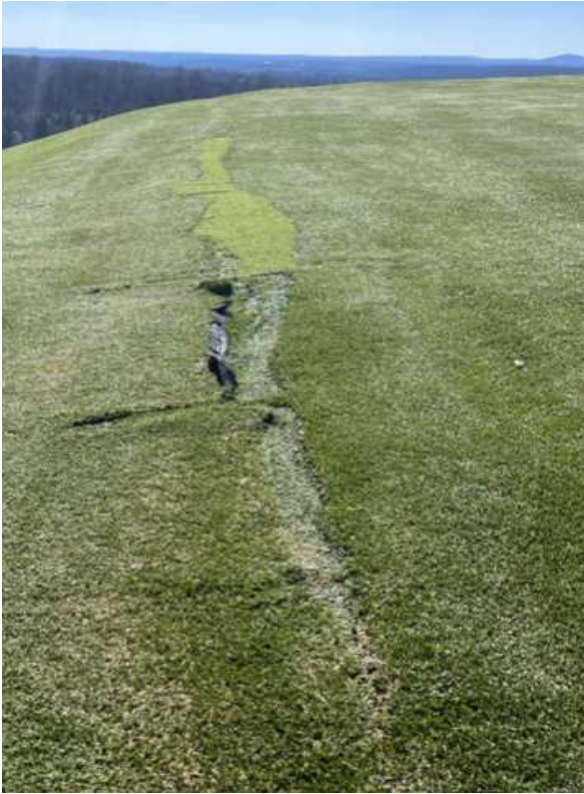
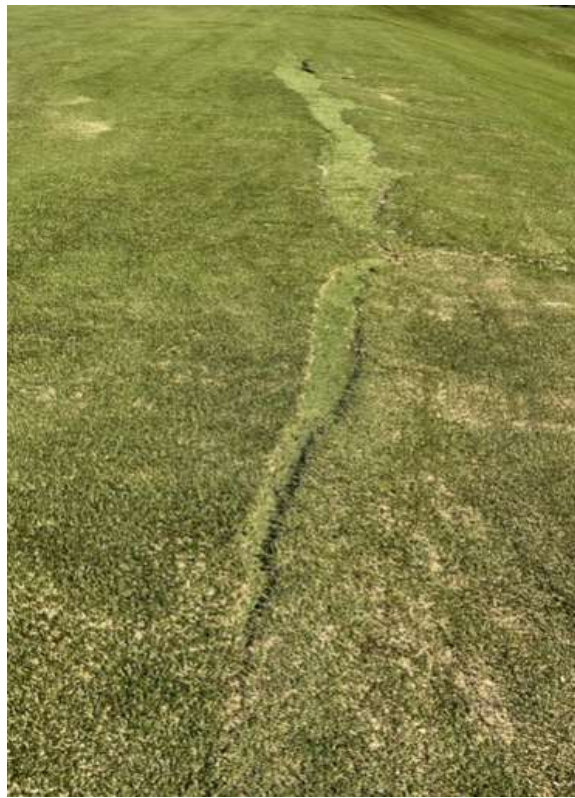
8. Cell 1-3 Seam Repair (before and after repair)

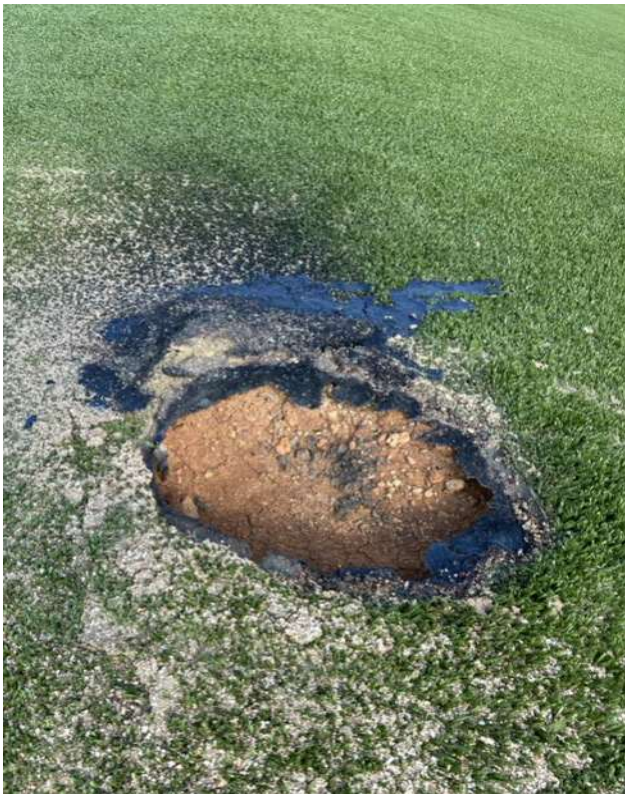
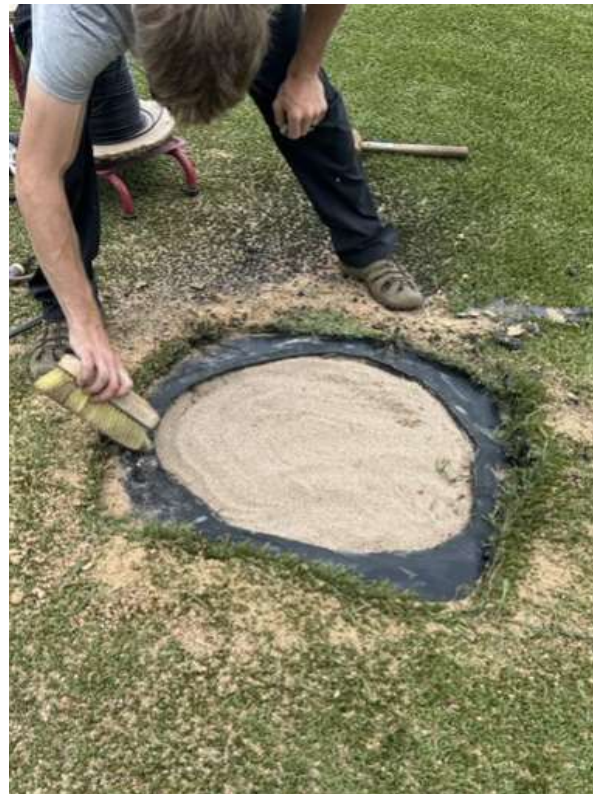
9. Turf and Liner damage (before and during repair)

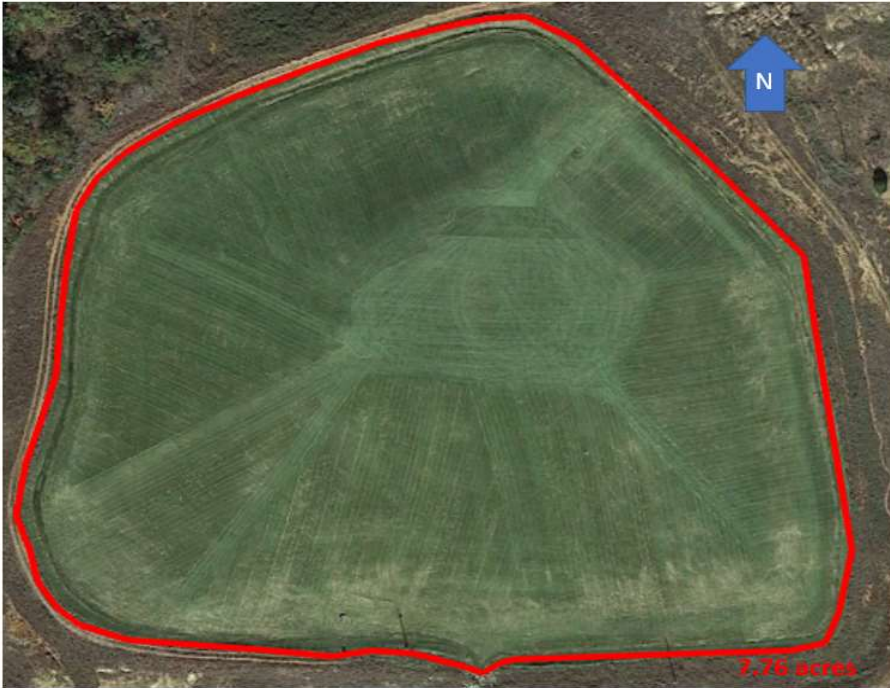
10. Overview Cell 4

No repairs were necessary on Cell 4, the C&D landfill. See 10. Cell 4 Overview
