MEMORANDUM

SUBJECT: Tucker Lumber Company, LLC

Water Division NPDES Photographic Evidence Sheet**Location:** Tucker Lumber Company, LLC**Photographer:** John W. Lamb**Witness:** None**Photo #** 1 **Of** 22**Date:** 3/30/09 **Time:** 12:55**Description:** On Ms. Staten's Property looking onto Tucker Lumber's Wet deck for log storage, sprinkler head within 10 feet of property line.

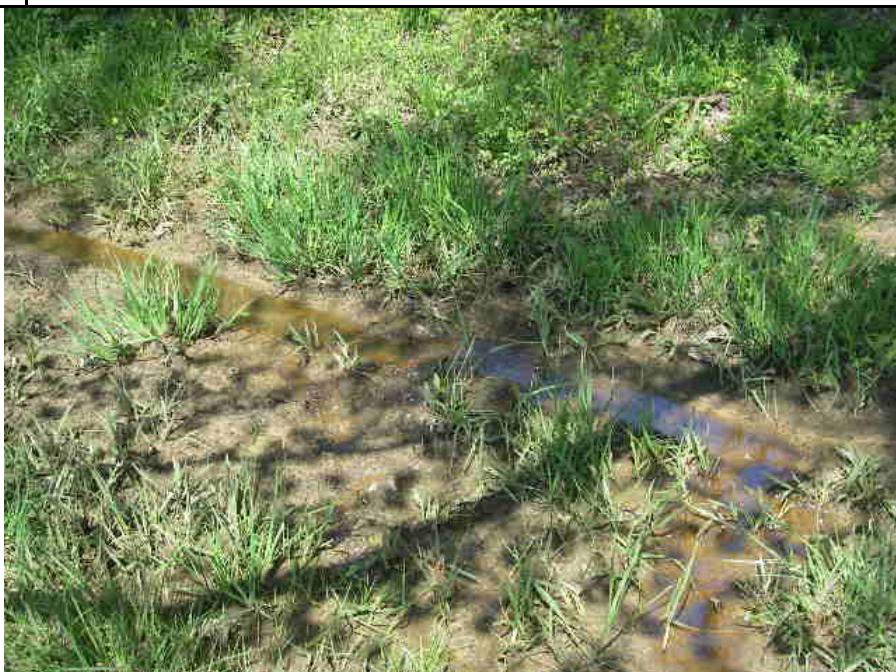
**Photographer:** John W. Lamb**Witness:** None**Photo #** 2 **Of** 22**Date:** 3/30/09 **Time:** 12:55**Description:** On Ms. Staten's property, wet deck overspray running off.

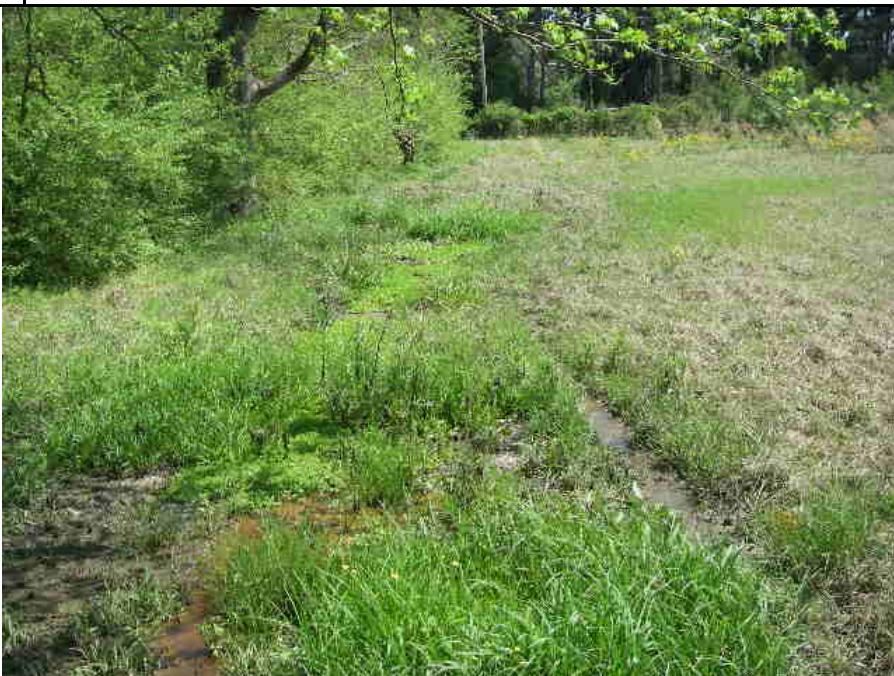
Water Division NPDES Photographic Evidence Sheet**Location:** Tucker Lumber Company, LLC**Photographer:** John W. Lamb**Witness:** None**Photo #** 3 **Of** 22**Date:** 3/30/09 **Time:** 12:55**Description:** On Ms. Staten's Property, looking down to Columbia Road 245, showing run off of Overspray

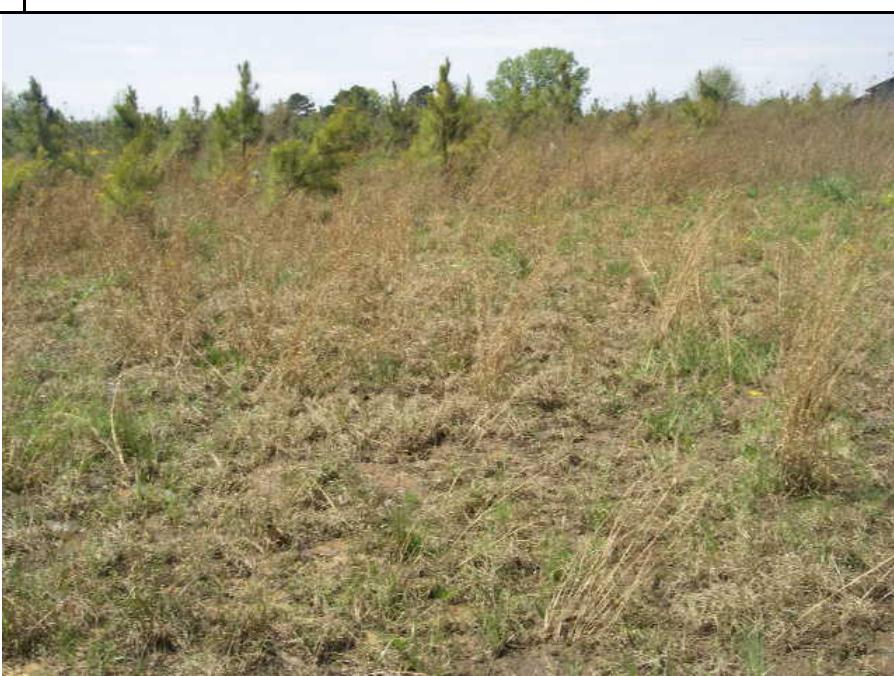
**Photographer:** John W. Lamb**Witness:** None**Photo #** 4 **Of** 22**Date:** 3/30/09 **Time:** 12:55**Description:** Ms. Staten's pine plantation next to Tucker Lumber Company, trees have blown over because of the saturated soil.

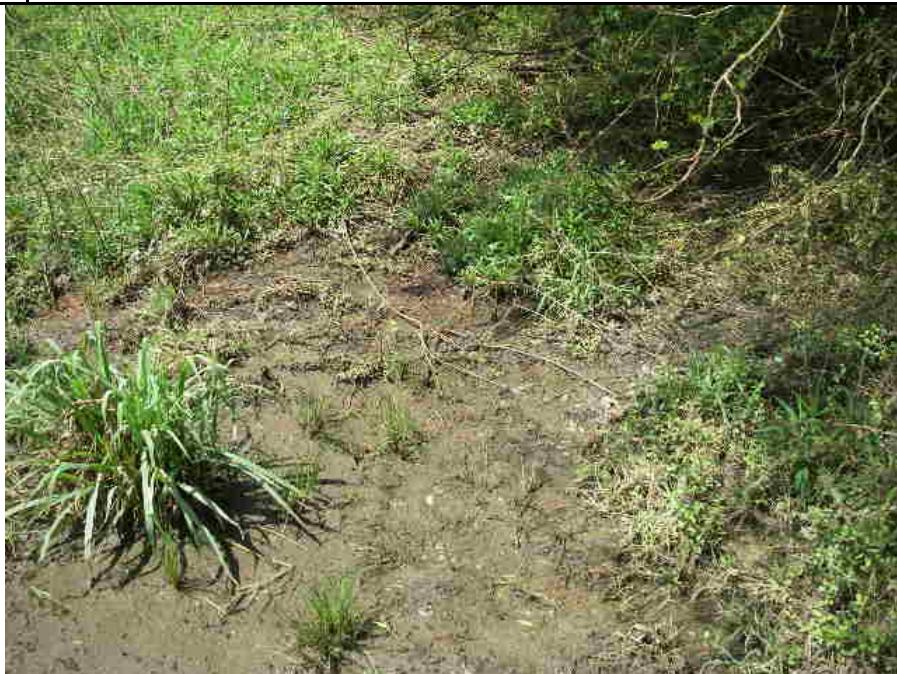
Water Division NPDES Photographic Evidence Sheet**Location:** Tucker Lumber Company, LLC**Photographer:** John W. Lamb **Witness:** None**Photo #** 5 **Of** 22 **Date:** 3/30/09 **Time:** 12:56**Description:** An area on Ms. Staten's property that is extremely boggy due to overspray of wet deck

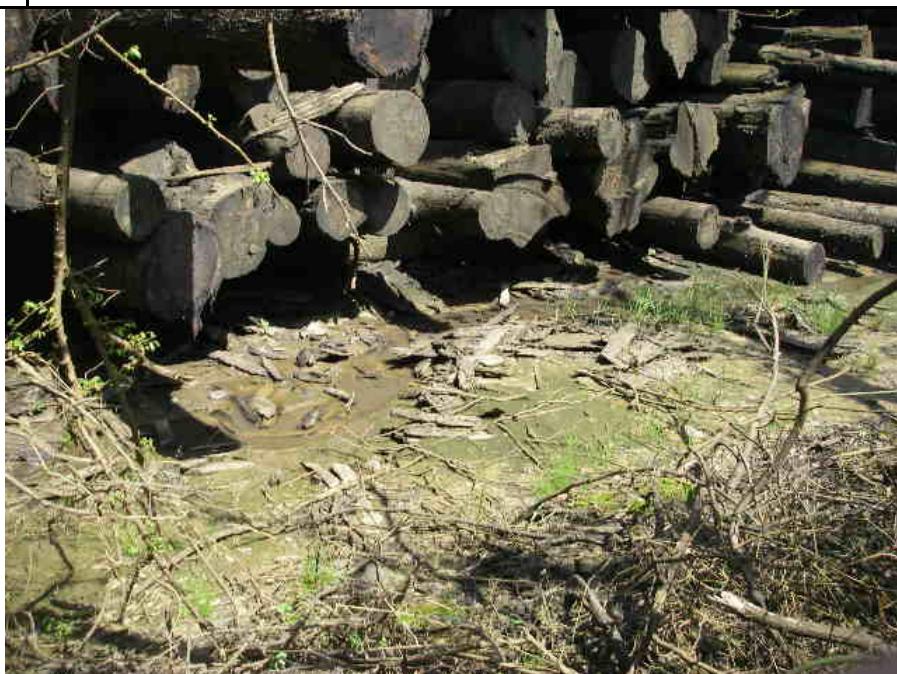
**Photographer:** John W. Lamb **Witness:** None**Photo #** 6 **Of** 22 **Date:** 3/30/09 **Time:** 12:56**Description:** Wet deck logs stacked with 5 or so yards of Ms. Staten's property line

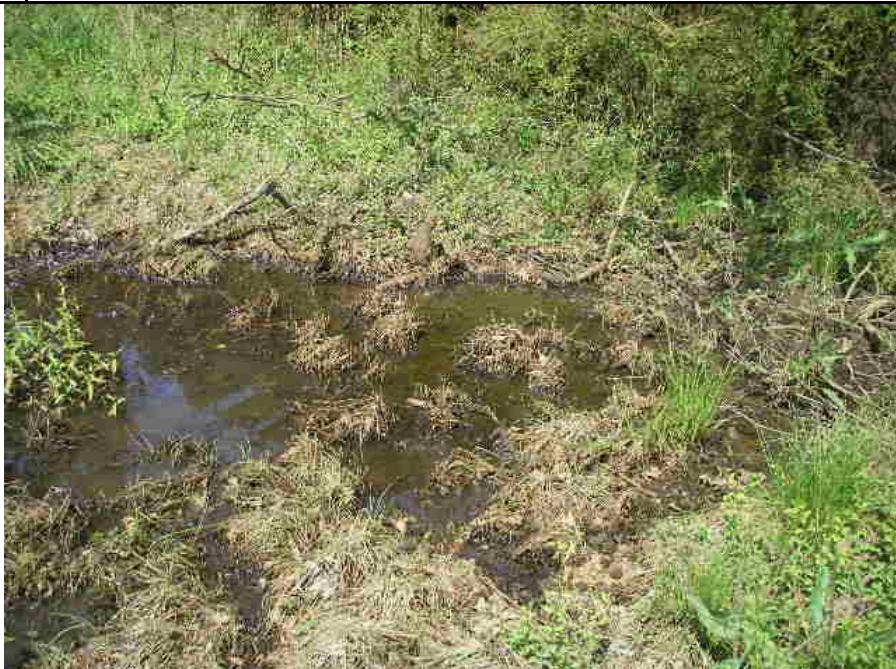
Water Division NPDES Photographic Evidence Sheet**Location:** Tucker Lumber Company, LLC**Photographer:** John W. Lamb **Witness:** None**Photo #** 7 **Of** 22 **Date:** 3/30/09 **Time:** 12:58**Description:** Ms. Staten's property next to Tucker Lumber Company Property line and wet deck

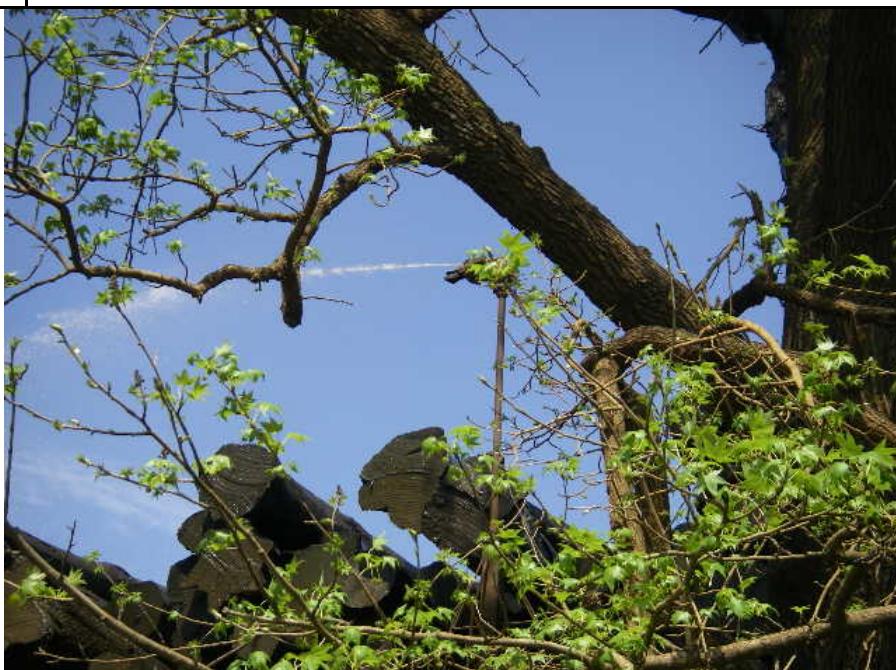
3. The facility was allowing overspray on Ms. Staten's property. This overspray had been going on for some time and the soil was saturated with this overspray water. Dead trees were observed as a result of this overspray. The sprinkler heads which were causing overspray were within 5 foot of Ms. Staten's property and even with a strong south wind, the sprinklers were still spraying off the property.

**Photographer:** John W. Lamb **Witness:** None**Photo #** 8 **Of** 22 **Date:** 3/30/09 **Time:** 12:58**Description:** One of several sprinkler heads next to Ms. Staten's property which allows overspray of wet deck water onto her land.

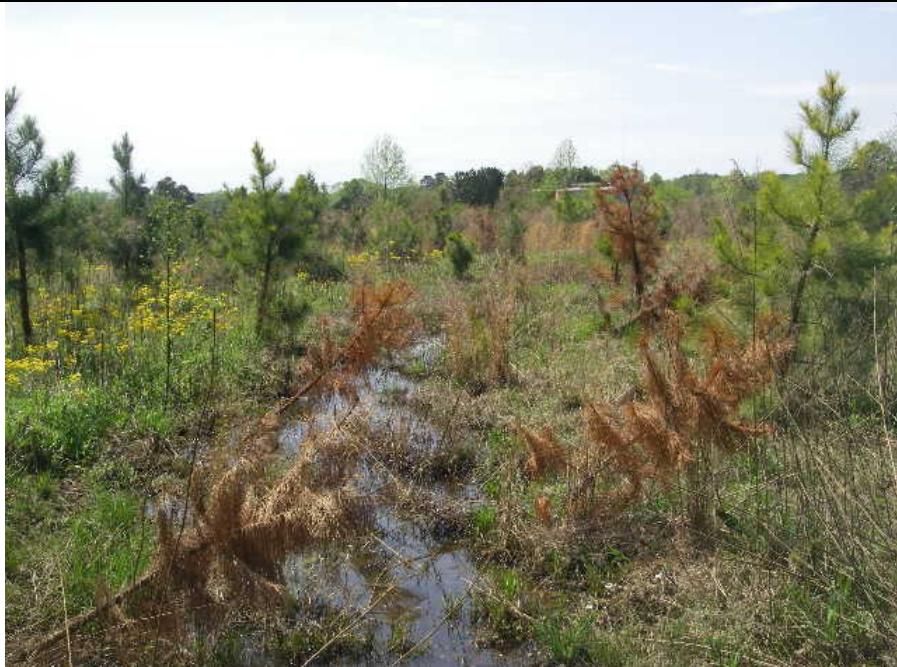
Water Division NPDES Photographic Evidence Sheet**Location:** Tucker Lumber Company, LLC**Photographer:** John W. Lamb **Witness:** None**Photo #** 9 **Of** 22 **Date:** 3/30/09 **Time:** 12:59**Description:** Pine trees on Ms. Staten's property which have died.

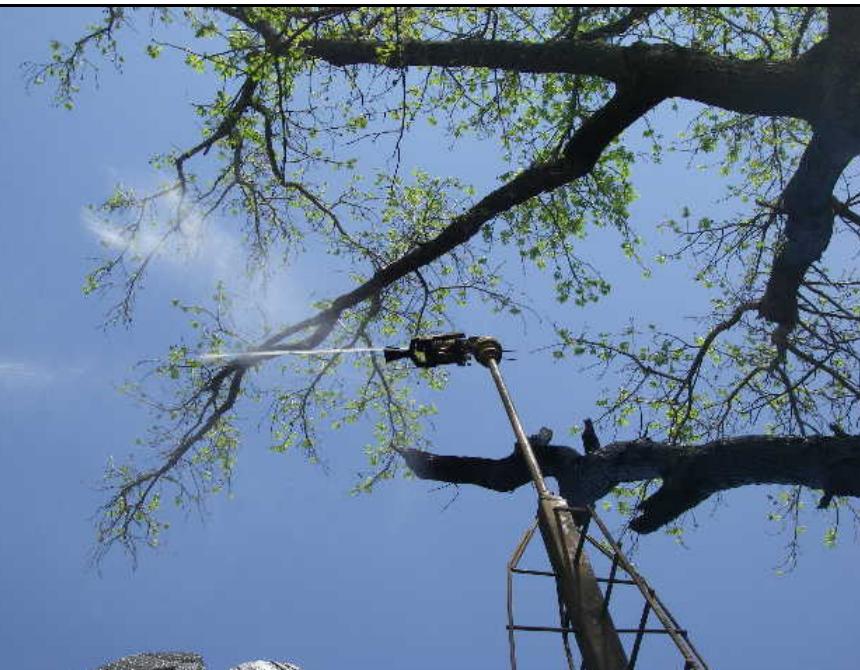
**Photographer:** John W. Lamb **Witness:** None**Photo #** 10 **Of** 22 **Date:** 3/30/09 **Time:** 12:59**Description:** Standing on Ms. Staten's property, overspray falling onto inspector on ground, even with a stiff south wind on the date of investigation.

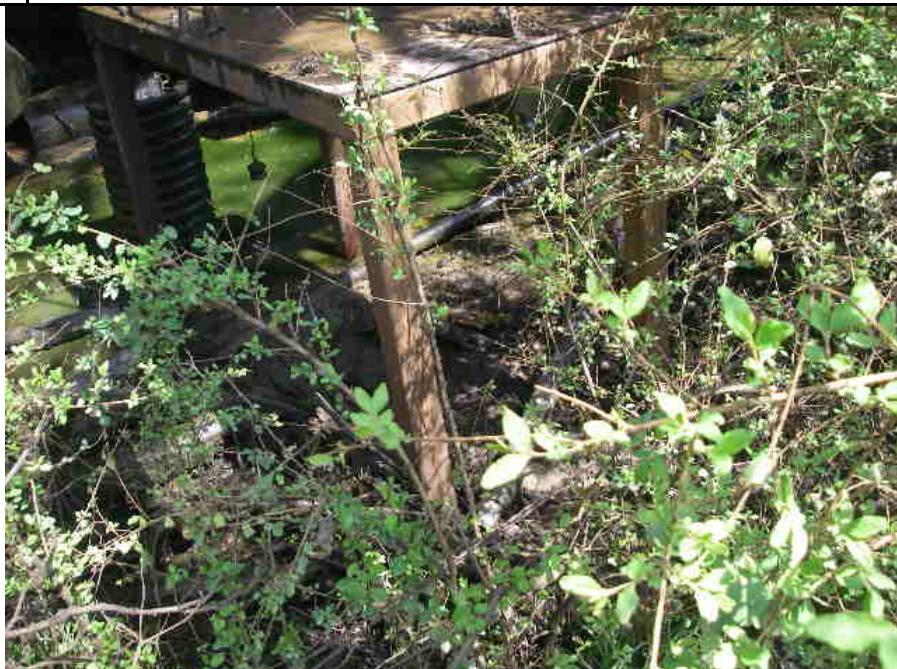
Water Division NPDES Photographic Evidence Sheet**Location:** Tucker Lumber Company, LLC**Photographer:** John W. Lamb **Witness:** None**Photo #** 11 **Of** 22 **Date:** 3/30/09 **Time:** 13:00**Description:** Base of sprinkler platform, some 5 foot from property line.

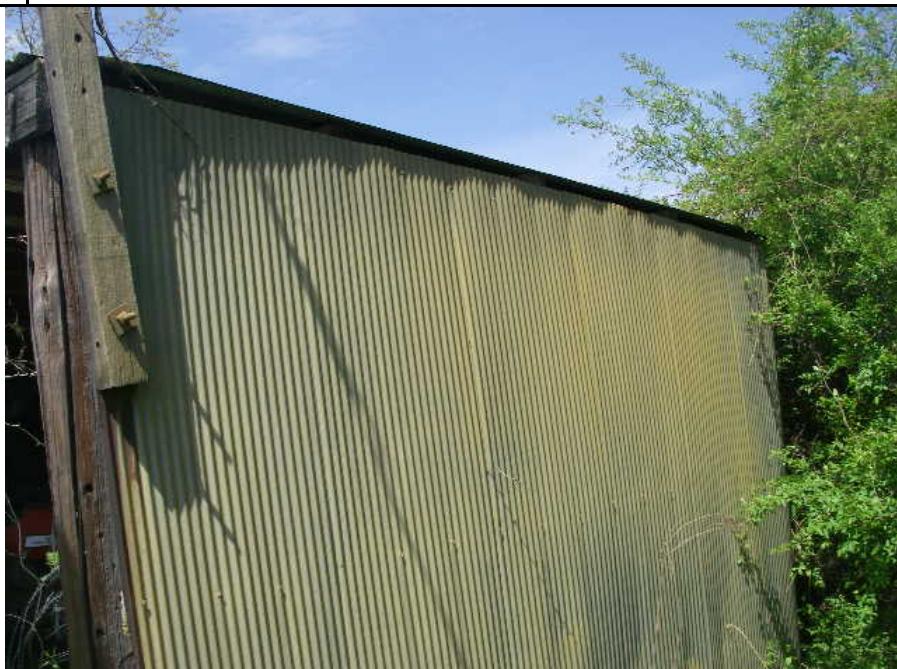
**Photographer:** John W. Lamb **Witness:** None**Photo #** 12 **Of** 22 **Date:** 3/30/09 **Time:** 13:03**Description:** Shed on Ms. Staten's property showing stains from overspray

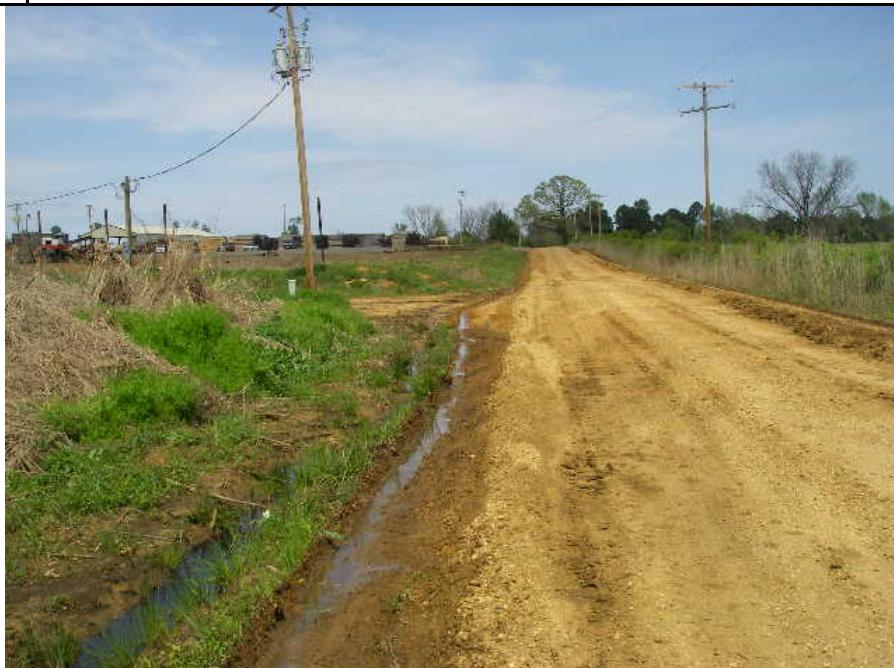
Water Division NPDES Photographic Evidence Sheet**Location:** Tucker Lumber Company, LLC**Photographer:** John W. Lamb **Witness:** None**Photo #** 13 **Of** 22 **Date:** 3/30/09 **Time:** 13:12**Description:** Standing on Columbia Road 245 in front of Tucker Lumber, process water/storm water discharge into road ditch

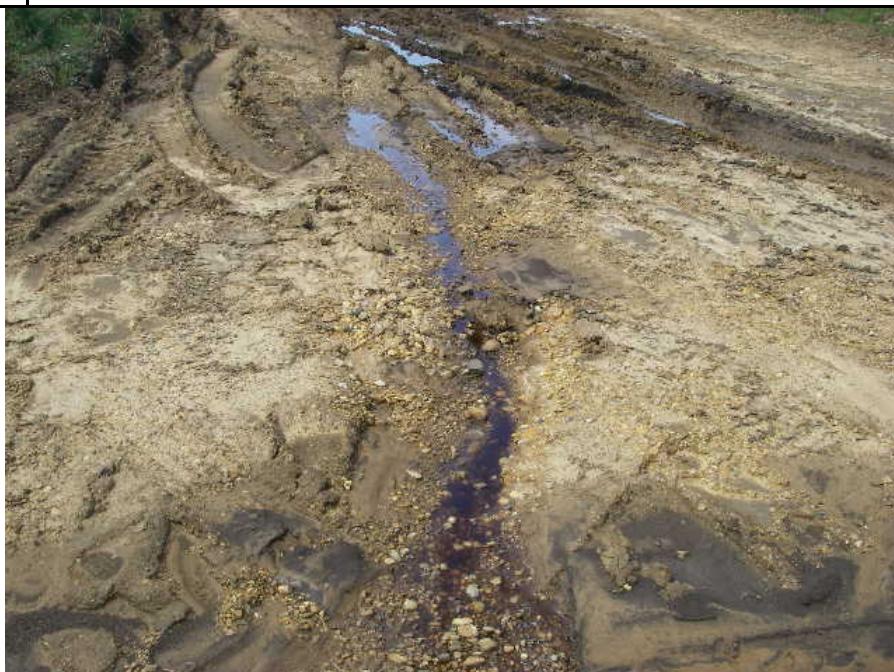
**Photographer:** John W. Lamb **Witness:** None**Photo #** 14 **Of** 22 **Date:** 3/30/09 **Time:** 13:13**Description:** Standing on Columbia 245, looking up drive way onto property, showing process water discharge from a log wet deck

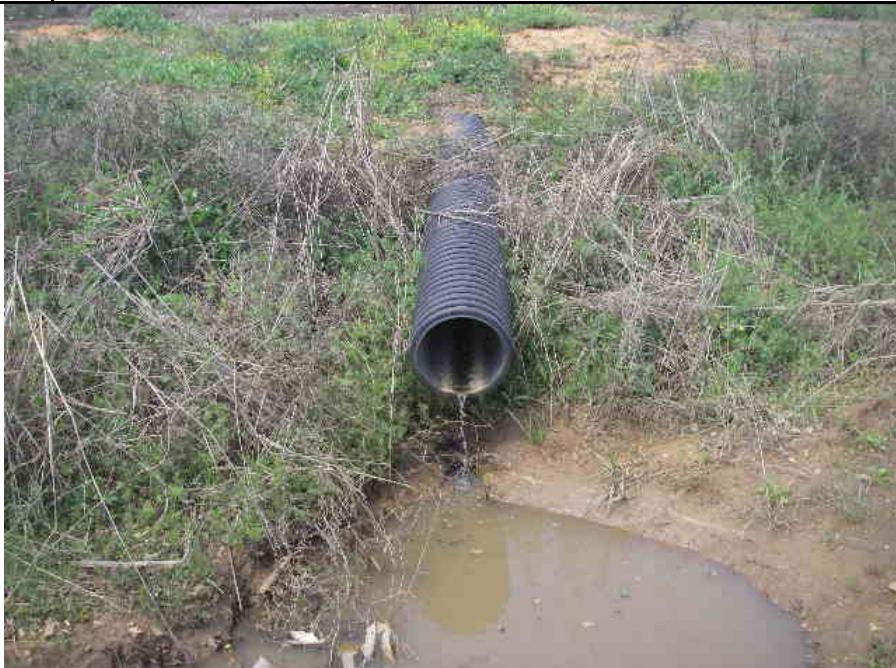
Photographer:	John W. Lamb		Witness:	None	
Photo # 15	Of	22	Date:	3/30/09	Time: 13:13

Description: Discharge of storm water from second pond onsite, no logs were being stored above this pond at this time.

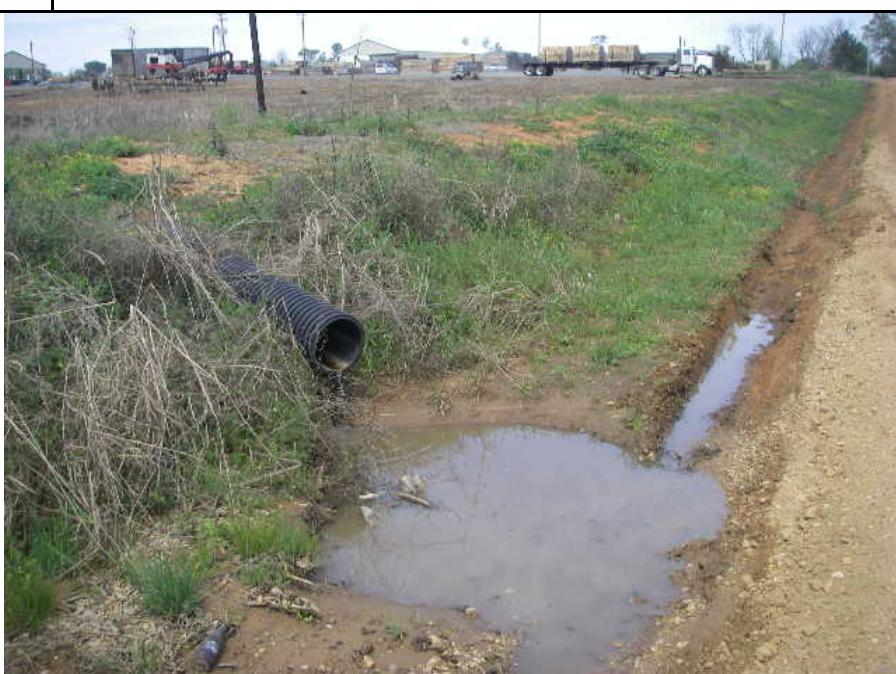
Photographer:	John W. Lamb		Witness:	None	
Photo # 16	Of	22	Date:	3/30/09	Time: 13:13

Description: As above, from Columbia Road 245

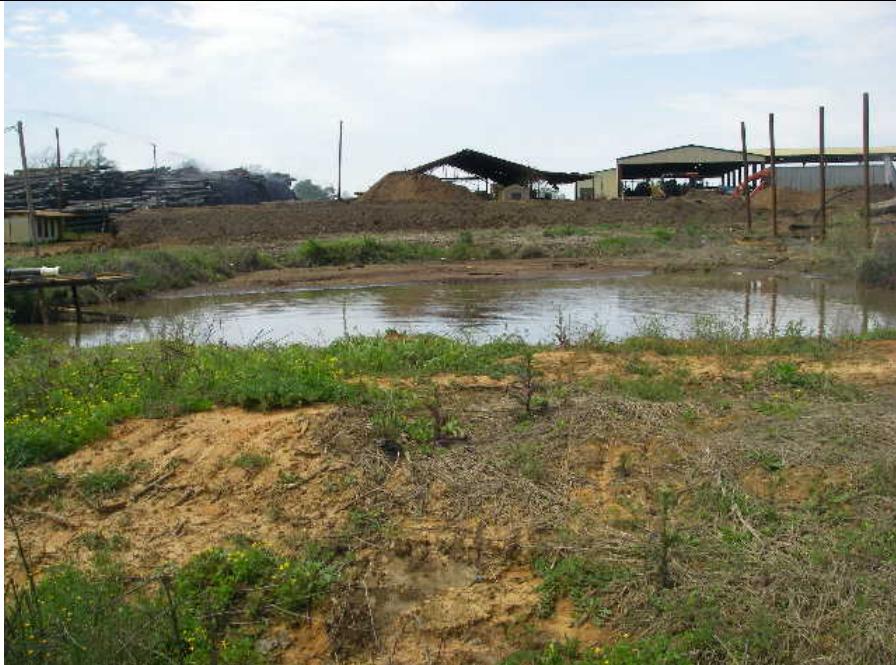
Water Division NPDES Photographic Evidence Sheet**Location:** Tucker Lumber Company, LLC**Photographer:** John W. Lamb **Witness:** None**Photo #** 17 **Of** 22 **Date:** 3/30/09 **Time:** 13:14**Description:** Second pond next to Columbia 245, no logs stored on this pond. Has ability to wet logs from this pond.

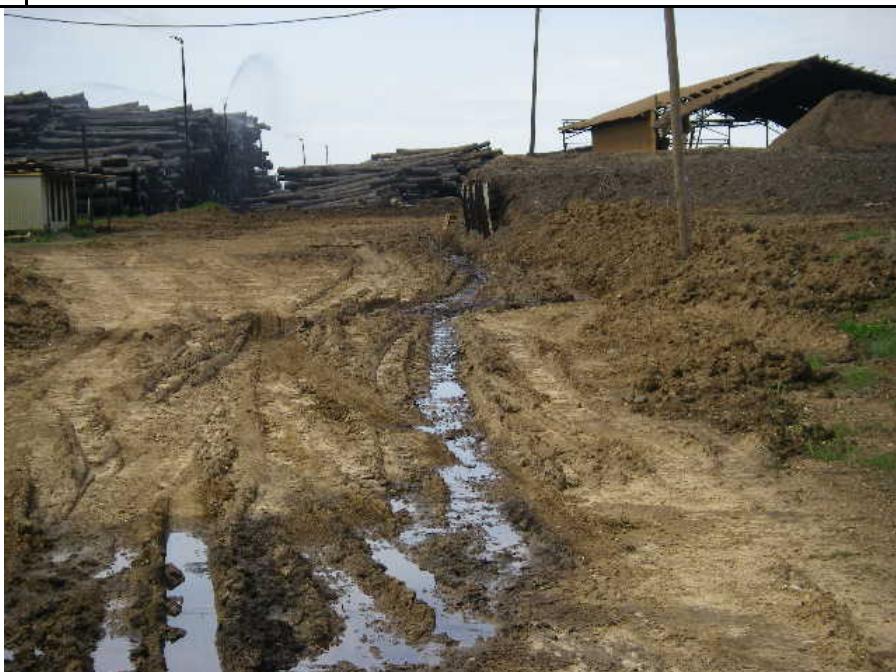
**Photographer:** John W. Lamb **Witness:** None**Photo #** 18 **Of** 22 **Date:** 3/30/09 **Time:** 13:14**Description:** Standing on Columbia Road 245, zoomed into log storage wet deck, showing process water discharging down drive way.

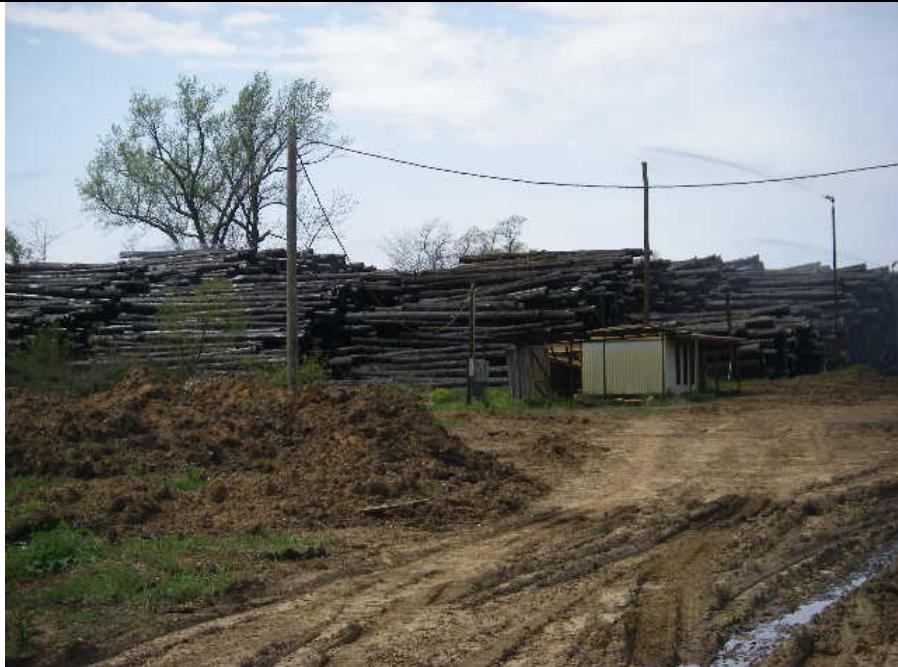
Water Division NPDES Photographic Evidence Sheet**Location:** Tucker Lumber Company, LLC**Photographer:** John W. Lamb **Witness:** None**Photo #** 19 **Of** 22 **Date:** 3/30/09 **Time:** 13:14**Description:** Log storage that is stacked next to Ms. Staten's property.

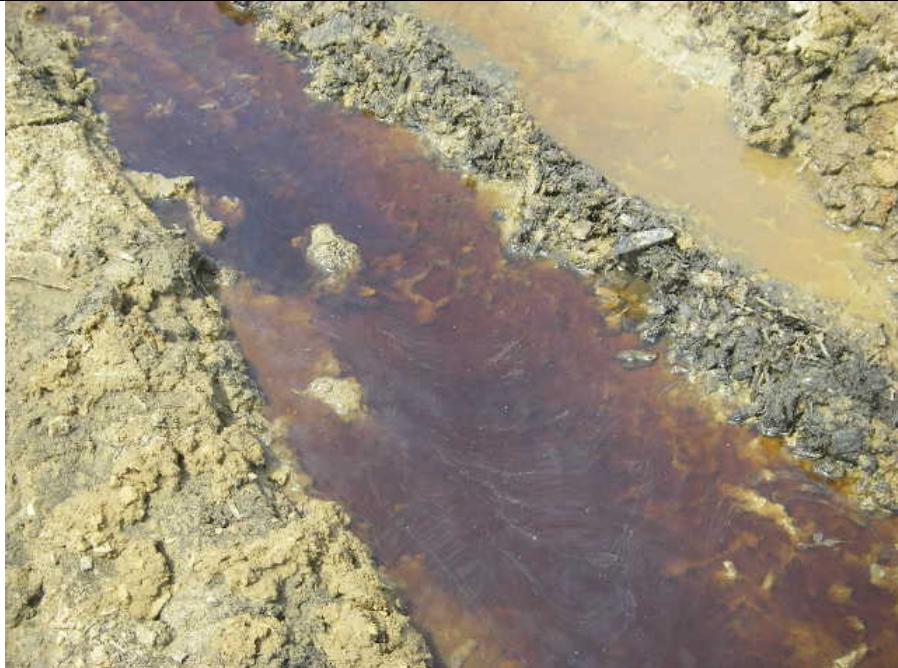
**Photographer:** John W. Lamb **Witness:** None**Photo #** 20 **Of** 22 **Date:** 3/30/09 **Time:** 13:15**Description:** Close up of process water being discharged into Columbia 245 Road ditch

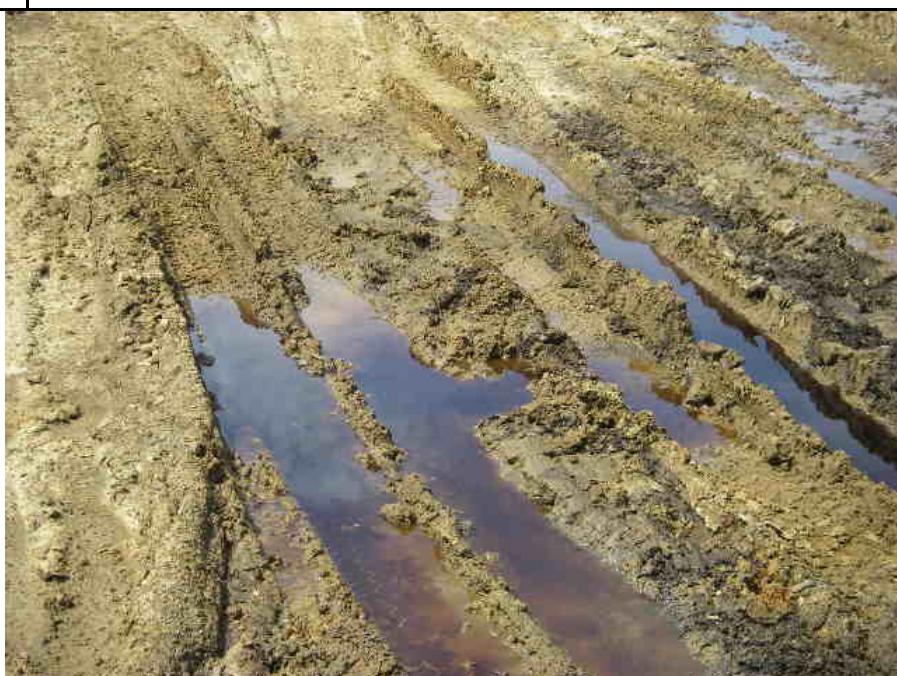
Water Division NPDES Photographic Evidence Sheet**Location:** Tucker Lumber Company, LLC**Photographer:** John W. Lamb **Witness:** None**Photo # 21** Of 22 **Date:** 3/30/09 **Time:** 13:15**Description:** As above
