**ARKANSAS DEPARTMENT OF ENVIRONMENTAL QUALITY**

**STATE SANITARY TREATMENT  
SYSTEM INSPECTION FORM**

Inspection Date: February 6, 2007

1A. Name of Facility: Sunset Bay Subdivision

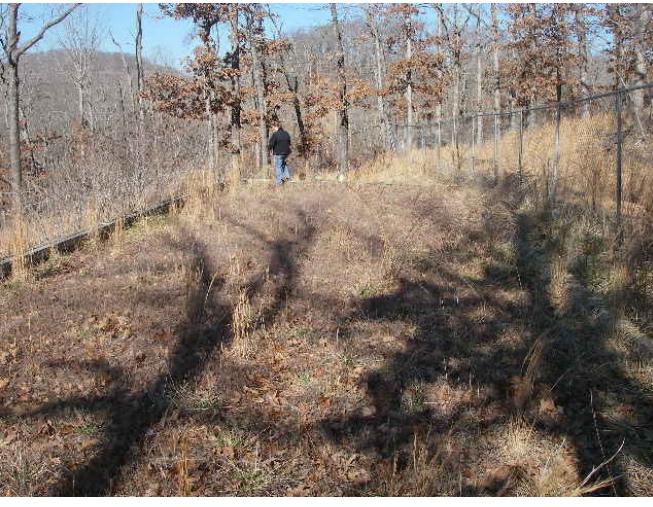
<b>Location:</b>	Sunset Bay Subdivision							
<b>Photographer:</b>	Bruce Kirkpatrick			<b>Witness:</b>	Alison West			
<b>Photo #</b>	1	<b>Of</b>	16		<b>Date:</b>	2-6-07	<b>Time:</b>	10:39 a.m.
<b>Description:</b>	IMGP0529. Weeds growing in recirculating sand filter #3.

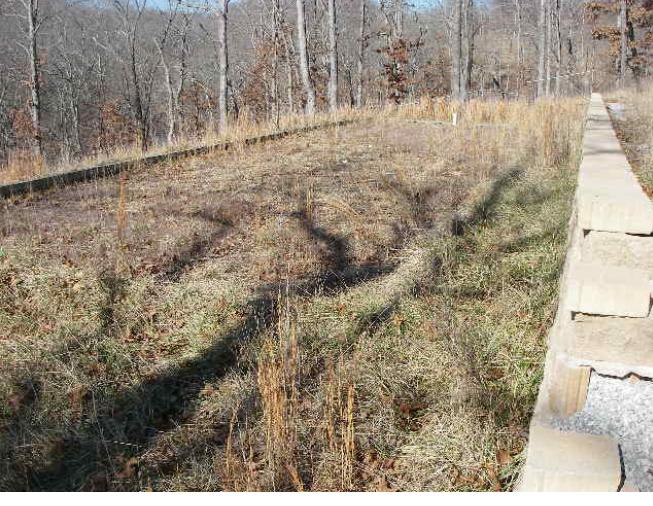
<b>Photographer:</b>	Bruce Kirkpatrick			<b>Witness:</b>	Alison West			
<b>Photo #</b>	2	<b>Of</b>	16		<b>Date:</b>	2-6-07	<b>Time:</b>	10:39 a.m.
<b>Description:</b>	IMGP0530. Weeds growing in recirculating sand filter #3.

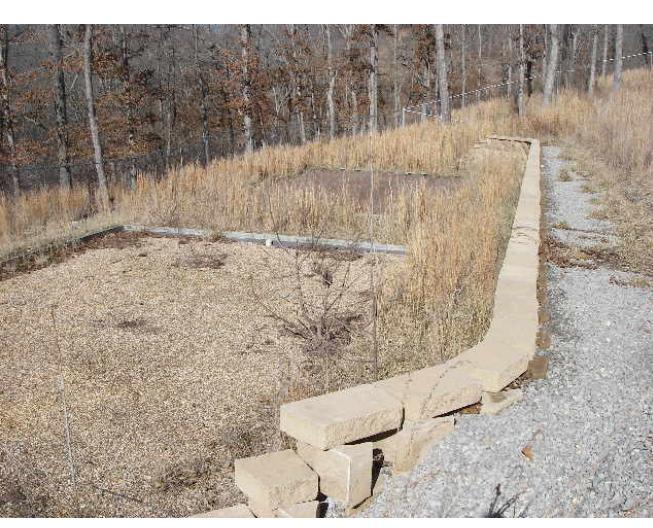
<b>Location:</b>	Sunset Bay Subdivision							
<b>Photographer:</b>	Bruce Kirkpatrick			<b>Witness:</b>	Alison West			
<b>Photo #</b>	3	<b>Of</b>	16		<b>Date:</b>	2-6-07	<b>Time:</b>	10:40 a.m.
<b>Description:</b>	IMGP0531. Weeds growing in recirculating sand filter #4.

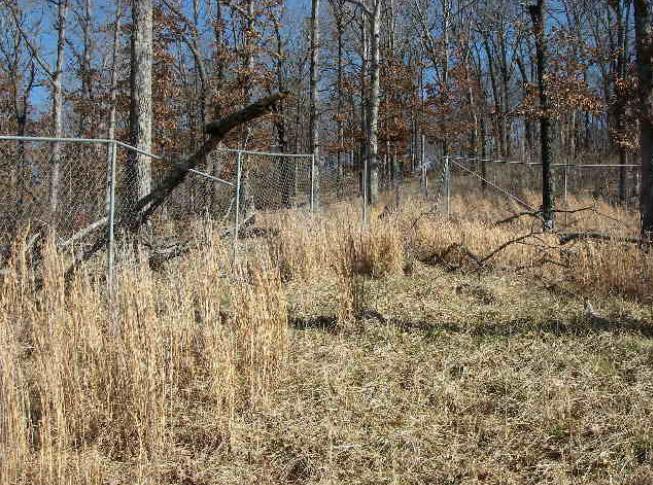
<b>Photographer:</b>	Bruce Kirkpatrick			<b>Witness:</b>	Alison West			
<b>Photo #</b>	4	<b>Of</b>	16		<b>Date:</b>	2-6-07	<b>Time:</b>	10:44 a.m.
<b>Description:</b>	IMGP0532. Fence not being maintained around recirculating sand filter #3 and 4.

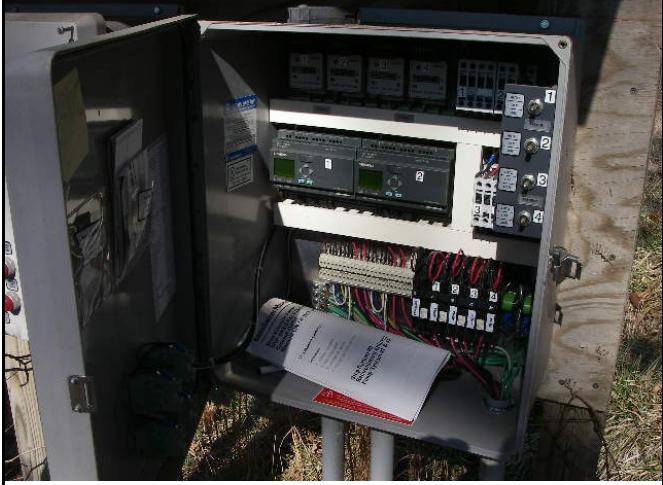
If no, what units are out and why? Recirculating Sand Filter #5 had collapsed. The control panels were in the off position at recirculating sand filter 3 & 4. The electrical meter at recirc 3 & 4 showed 0 kw. The control panel at recirculating sand filter 1 and 2 was in the auto position; but, it did not appear to be working.

<b>Location:</b>	Sunset Bay Subdivision							
<b>Photographer:</b>		Bruce Kirkpatrick			<b>Witness:</b>	Alison West		
<b>Photo #</b>	5	<b>Of</b>	16		<b>Date:</b>	2-6-07	<b>Time:</b>	10:51 a.m.
<b>Description:</b>		IMGP0533. One of the control panels at recirculating sand filter #3 and 4. Switches are turned to the "off" position.

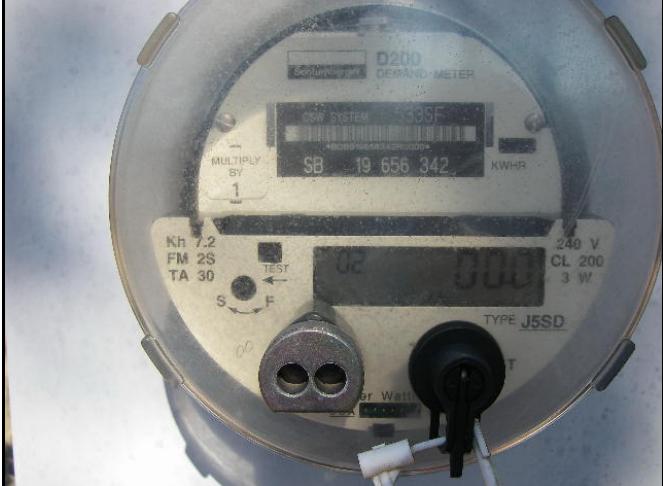
<b>Photographer:</b>		Bruce Kirkpatrick			<b>Witness:</b>	Alison West		
<b>Photo #</b>	6	<b>Of</b>	16		<b>Date:</b>	2-6-07	<b>Time:</b>	10:52 a.m.
<b>Description:</b>		IMGP0534. Electrical meter reading 0 kw near control panel at recirculating sand filter #3 and 4.

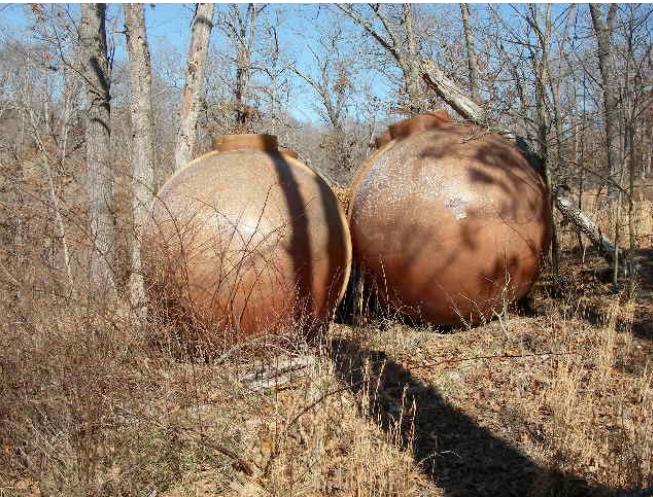
<b>Location:</b>	Sunset Bay Subdivision							
<b>Photographer:</b>	Bruce Kirkpatrick			<b>Witness:</b>	Alison West			
<b>Photo #</b>	7	<b>Of</b>	16		<b>Date:</b>	2-6-07	<b>Time:</b>	11:00 a.m.
<b>Description:</b>		IMGP0537. 2-6000 gallon tanks near recirculating sand filter #3 and 4.

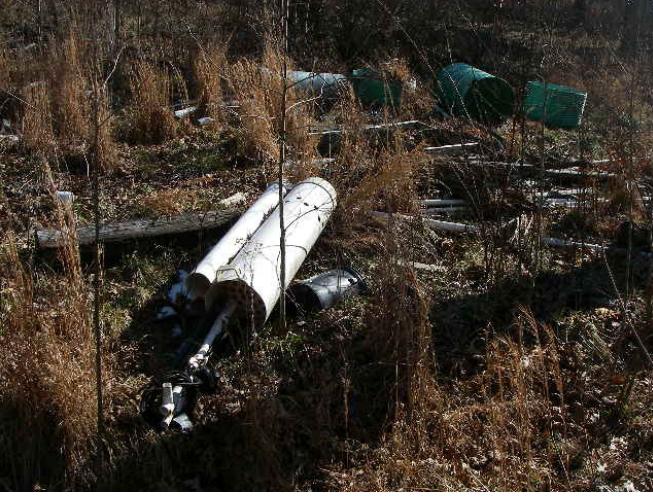
<b>Photographer:</b>		Bruce Kirkpatrick			<b>Witness:</b>	Alison West		
<b>Photo #</b>	8	<b>Of</b>	16		<b>Date:</b>	2-6-07	<b>Time:</b>	11:04 a.m.
<b>Description:</b>		IMGP0538. Pump vaults and parts on the ground near recirculating sand filter #5.

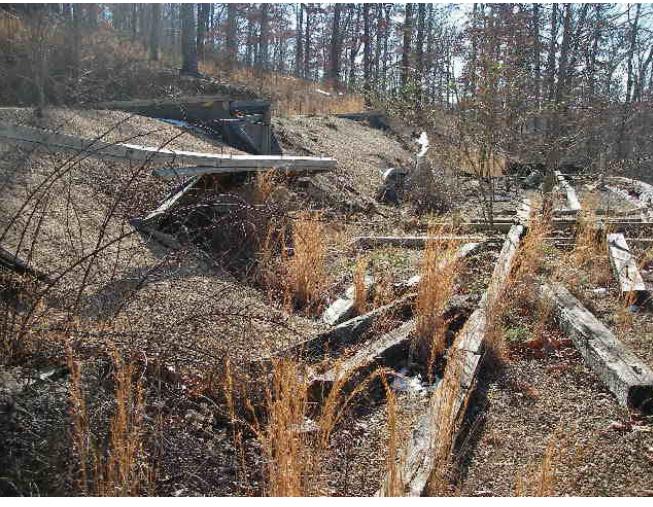
<b>Location:</b>	Sunset Bay Subdivision							
<b>Photographer:</b>		Bruce Kirkpatrick			<b>Witness:</b>		Alison West	
<b>Photo #</b>	11	<b>Of</b>	16		<b>Date:</b>	2-6-07	<b>Time:</b>	11:08 a.m.
<b>Description:</b>		IMGP0541. Recirculating sand filter #5 collapsed.

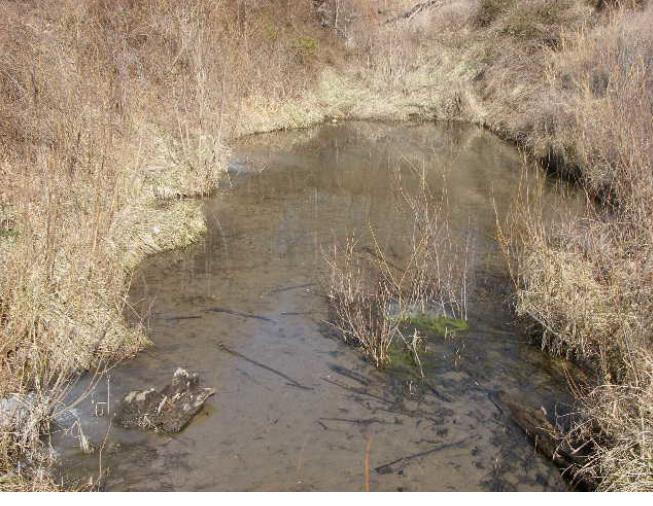
<b>Photographer:</b>		Bruce Kirkpatrick			<b>Witness:</b>		Alison West	
<b>Photo #</b>	12	<b>Of</b>	16		<b>Date:</b>	2-6-07	<b>Time:</b>	11:11 a.m.
<b>Description:</b>		IMGP0542. Drainage near recirculating sand filters # 1 and 2.

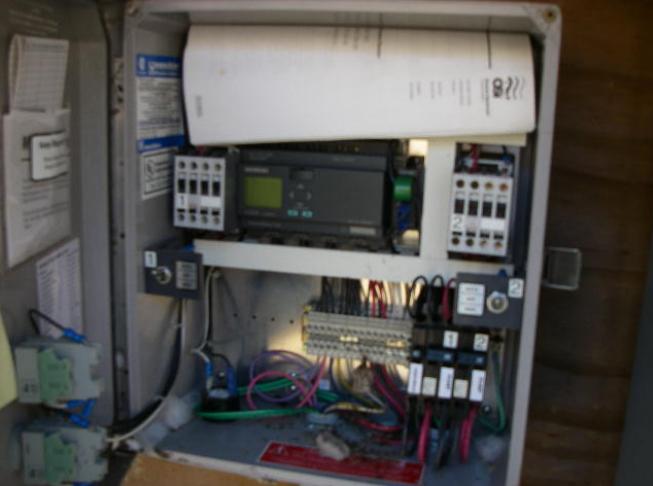
<b>Location:</b>	Sunset Bay Subdivision							
<b>Photographer:</b>		Bruce Kirkpatrick			<b>Witness:</b>	Alison West		
<b>Photo #</b>	13	<b>Of</b>	16		<b>Date:</b>	2-6-07	<b>Time:</b>	11:15 a.m.
<b>Description:</b>		IMGP0543. Control panel turned to "auto" at recirculating sand filter #1 and 2. Nothing on the display.

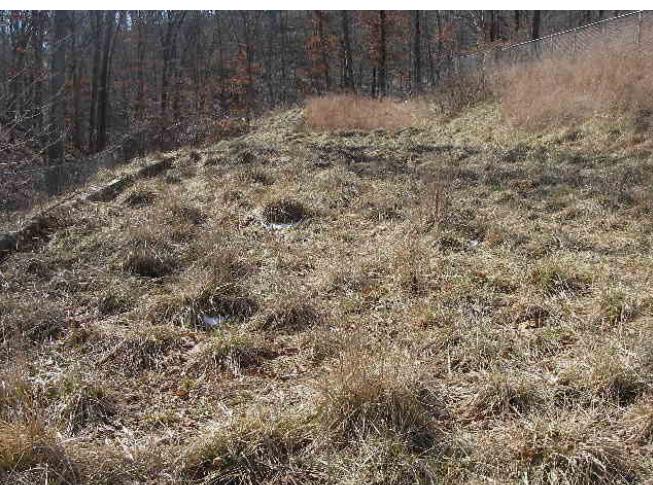
<b>Photographer:</b>		Bruce Kirkpatrick			<b>Witness:</b>	Alison West		
<b>Photo #</b>	14	<b>Of</b>	16		<b>Date:</b>	2-6-07	<b>Time:</b>	11:16 a.m.
<b>Description:</b>		IMGP0544. Weeds growing in recirculating sand filter #1 and 2.

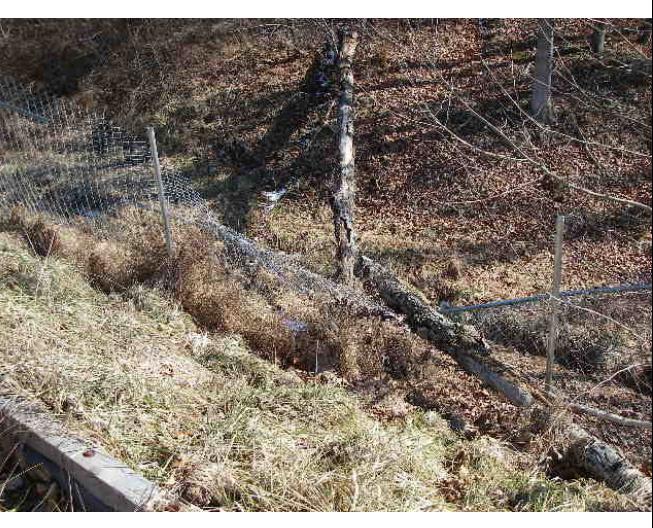
<b>Location:</b>	Sunset Bay Subdivision							
<b>Photographer:</b>	Bruce Kirkpatrick			<b>Witness:</b>	Alison West			
<b>Photo #</b>	15	<b>Of</b>	16		<b>Date:</b>	2-6-07	<b>Time:</b>	11:16 a.m.
<b>Description:</b>		IMGP0545. Fence down at recirculating sand filter #1 and 2.

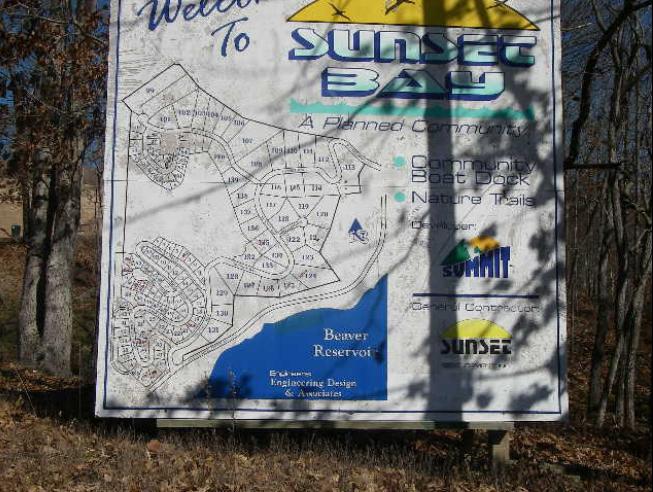
<b>Photographer:</b>	Bruce Kirkpatrick			<b>Witness:</b>	Alison West			
<b>Photo #</b>	16	<b>Of</b>	16		<b>Date:</b>	2-6-07	<b>Time:</b>	12:02 p.m.
<b>Description:</b>		IMGP0549. Sign at entrance of Sunset Bay Subdivision.
