RE: Storm Water Inspection

AFIN: None NPDES Permit No.: None

Water Division NPDES Photographic Evidence Sheet							
Location: On the south side of Greers Ferry, Arkansas on Highway #16 (Cleburne County)							
Photographer: Mike Kennedy Witness: None

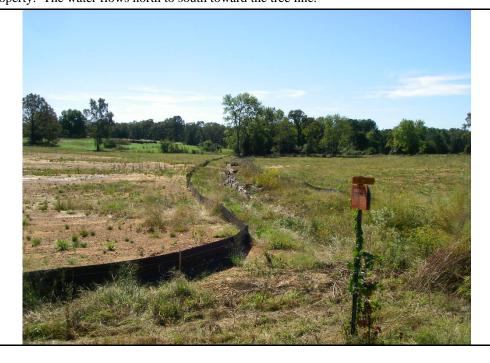
Photo #
 2
 Of
 8
 Date:
 10-10-07
 Time:
 1206

Description: This view is looking south from the north side of the property. A branch runs through almost the middle of the property. The water flows north to south toward the tree line.

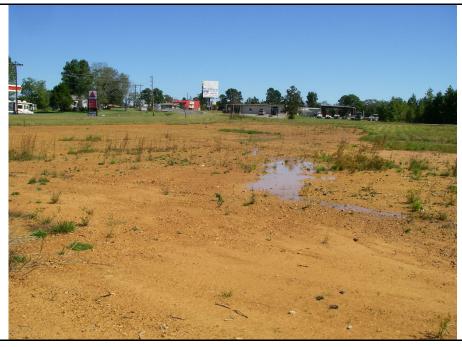
I also noted that you have an area of bare ground with no vegetative cover that is approximately 1 acre in size. Vegetative cover needs to be established as soon as possible. A suggestion might be to put out mulch or hay to cover the ground before the fall and winter rains.

Water Division NPDES Photographic Evidence Sheet									
Location:	Location: On the south side of Greers Ferry, Arkansas on Highway #16 (Cleburne County)								
Photographer:	apher: Mike Kennedy Witness: None								
Photo #	3	3	Of	8		Date:	10-10-07	Time:	1217
Description: Note the bare ground located on the East side of the branch with a wet weather stream running through the bar The bare area covers approx. more than 1 acre.									ugh the bare ground.

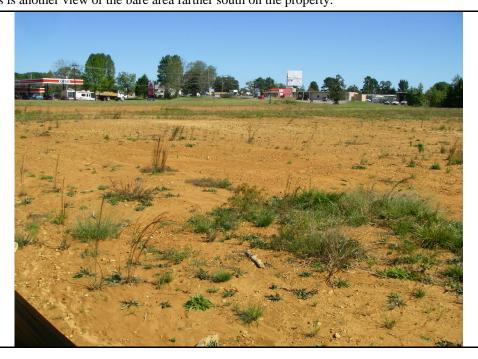
Photographer:		Mike Ke	nnedy		Witness:	None	None		
Photo #	4	Of	8		Date:	10-10-07	10-10-07 Time: 1215		
Description: This is another view of the bare area farther south					n the property.

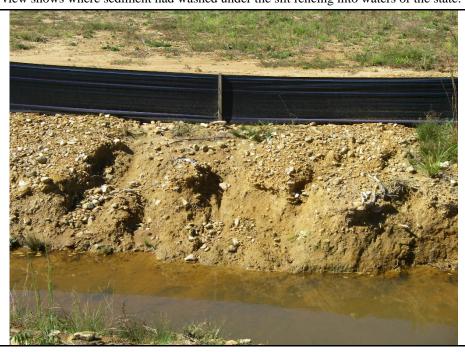
Sediment from the site had washed into waters of the state from several areas. This is a violation of the Arkansas Water and Air Pollution Control Act (8-4-217) a, 2. The sediment had washed under silt fencing installed on the property. The silt fencing needs repairing.

Water Division NPDES Photographic Evidence Sheet									
Location:	Location: On the south side of Greers Ferry, Arkansas on Highway #16 (Cleburne County)								
Photographer :	:	Mike Ke	nnedy	Witness: None					
Photo #	5	Of	Of 8 Date: 10-10-07 Time: 1216						
Description:	Description: This view shows where sediment had washed under the silt fencing into waters of the state

Gresponse to your letter daled Nov 16, 2007 I have purchased a truck load of 3" to 4" washed white stone that will be placed along the needed areas of the selt fencing and in the areas "in The ditch" where the Hay Bales Continue to be washed away from large rains. Also, I have Durchased and rec 20 addetional Hay Bales to be squad and placed on the have area, as you indicated, We will plant seed before placing & dist. the Hay. The Botone has been delivered, and should be placed this next week, as it was too muddy tweet for placement. The Hay well be spread as soon as we finish the Rock work.

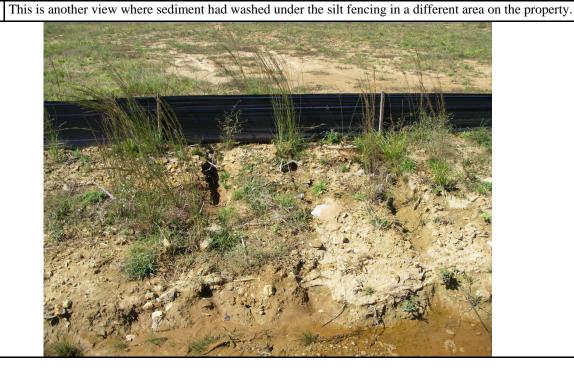
Photographer:		Mike Ke	Mike Kennedy Witness: None						
Photo #	6	Of	8		Date:	10-10-07	10-10-07 Time: 1216		
Description:	Cription: This is another view where sediment had washed under the silt fencing in a different area on the property.							operty.

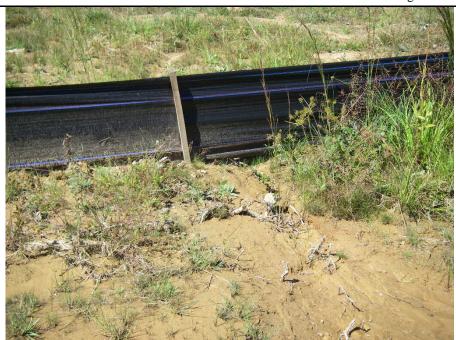
Photo #
 7
 Of
 8
 Date:
 10-10-07
 Time:
 1211

Description: This view shows a different area where sediment had washed under the silt fencing into the branch.

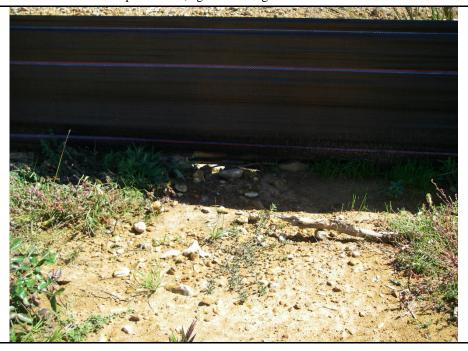
Photo #
 8
 Of
 8
 Date:
 10-10-07
 Time:
 1208

Description: This view is a little farther up the fence, again showing where sediment had washed into the branch from the property.

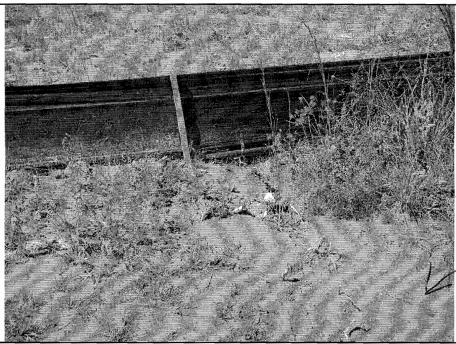
This view shows a different area where sediment had washed under the silt fencing into the branch.

Rockalse
Where the
Hay Bales
Run accross
the Detch
to Slow down
the Water Flow

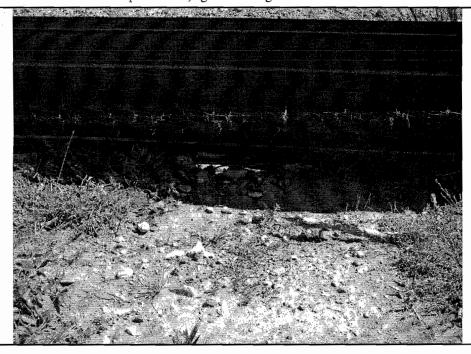
ographer	:	M	ike Ke	nnedy		Witness:	None			
o #	8	ì	Of	8		Date:	10-10-07	10-10-07 Time:		
ription:		Tl	nis viev	w is a litt	e farther up the fence, again show	ving where sed	iment had washed	into the branch	from the property.
