April 1, 2009

RE: Bull Shoals Wastewater Facility
AFIN: 45-00020; NPDES Permit No.: AR0037028

NPDES Compliance Inspection Report

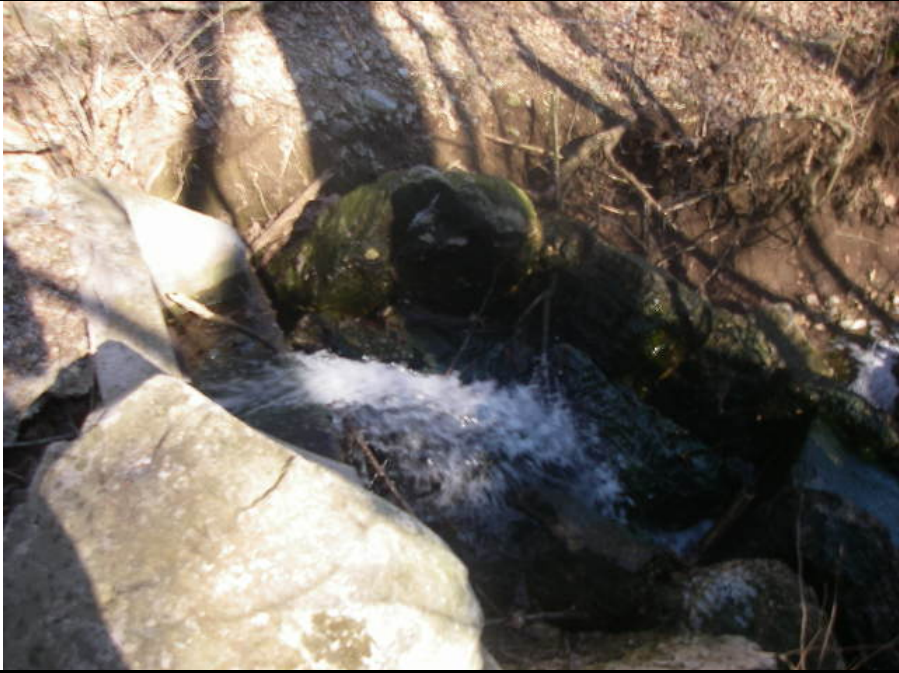
Photo # 1 **of** 1 **Date:** 2-4-09 **Time:** 1442

Description: Photo of Outfall 001 showing clear effluent
