RE: Complaint Investigation and Compliance Inspection

AFIN: 12-00000 NPDES Permit No.: ARR150000

On September 16, 2009, I performed a complaint investigation along with a compliance inspection of your facility. The complaint alleged that sediment was washing from the site onto neighboring property and into waters of the state. The inspection was conducted in accordance with the provisions of the Federal Clean Water Act, the Arkansas Water and Air Pollution Control Act, and the regulations promulgated thereunder.

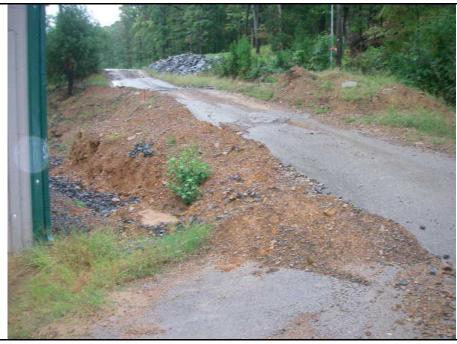
Water Division NPDES Photographic Evidence Sheet												
Location:	ocation: Robert Pennington construction site												
Photographer: Bruce Kirkpatrick Witness: none													
Photo #	Photo # 1 Of 16 Date: 9/16/09 Time: 1721 h4s												
Description:	Description: Photo of road below permittee's site and corner of complainant's shed

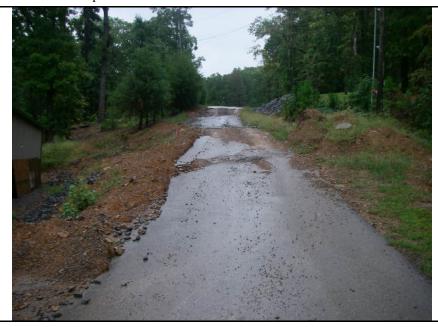
Photo #
 2
 Of
 16
 Date:
 9/16/09
 Time:
 1722

Description: Photo of road below permittee's site

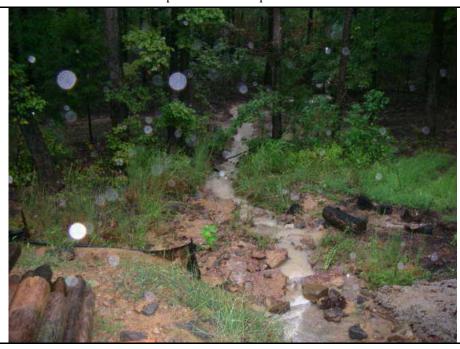
Water Division NPDES Photographic Evidence Sheet												
Location:													
Photographer	:	Bruce K	irkpatrick		Witness:	none	none						
Photo #	Photo # 3 Of 16 Date: 9/16/09 Time: 1722												
Description:	Description: Photo of turbid water and soil deposits below complainant's shed

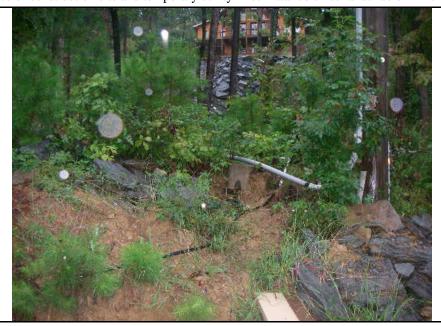
Photo #
 4
 Of
 16
 Date:
 9/16/09
 Time:
 1723

Description: Photo of construction site and temporary utility lines installed since landslide on 4-27-09

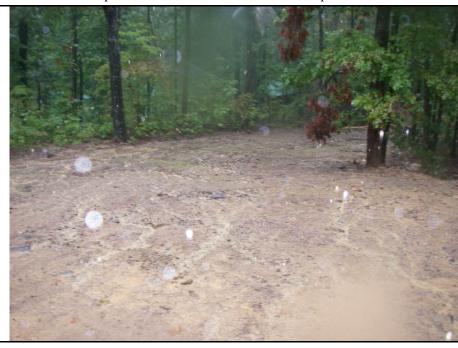
Water Division NPDES Photographic Evidence Sheet												
Location:	ocation: Robert Pennington construction site												
Photographer	Photographer: Bruce Kirkpatrick Witness: none												
Photo #	hoto # 5 Of 16 Date: 9/16/09 Time: 1739												
Description:	Description: Photo of site where spoiled soil from construction site was deposited. Soils were not stabilized.

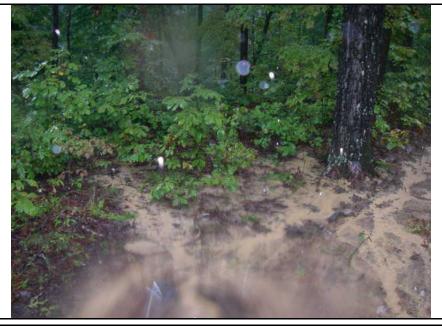
Photo #
 6
 Of
 16
 Date:
 9/16/09
 Time:
 1741

Description: Run-off from soil spoils deposit with no sediment controls

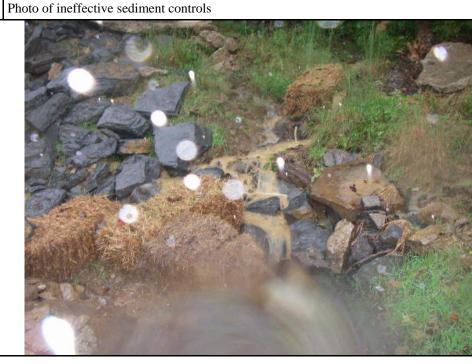
Water Division NPDES Photographic Evidence Sheet												
Location:	ocation: Robert Pennington construction site												
Photographer: Bruce Kirkpatrick Witness: none													
Photo #	hoto # 7 Of 16 Date: 9/16/09 Time: 1742												
Description:	Description: Photo of ineffective sediment controls

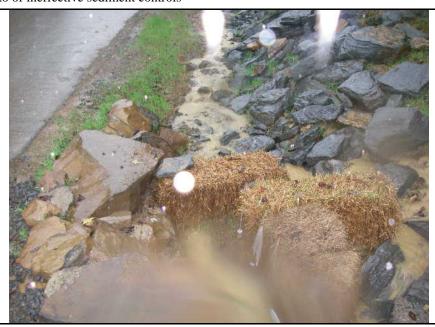
Photographer:			irkpatrick	Witness:	none		
Photo #	8	Of	16	Date:	9/16/09	Time:	1742

Description: Photo of ineffective sediment controls

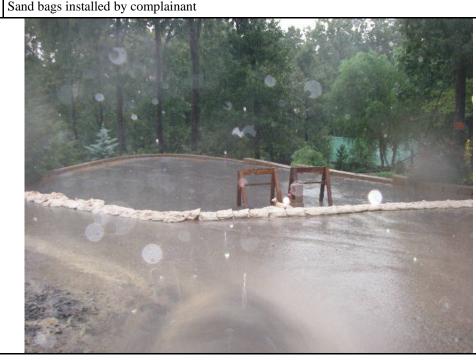
Water Division NPDES Photographic Evidence Sheet												
Location:	ocation: Robert Pennington construction site												
Photographer	:	Bruce K	irkpatrick		Witness: none								
Photo #	hoto# 9 Of 16 Date: 9/16/09 Time: 1742												
Description:	Description: Sand bags installed by complainant

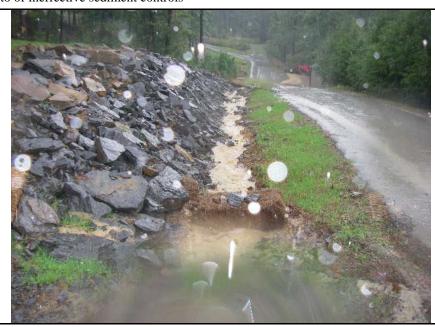
Photographer:		Bruce K		Witness:	none		
Photo #	10	Of	16	Date:	9/16/09	Time:	1742

Description: Photo of ineffective sediment controls

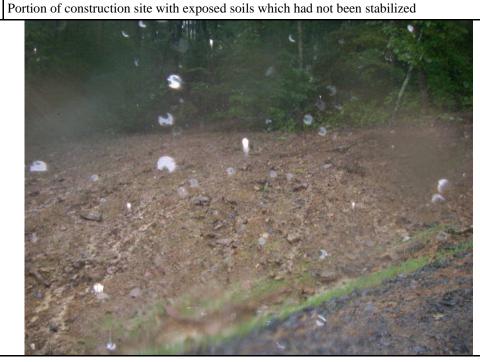
Water Division NPDES Photographic Evidence Sheet												
Location:	ocation: Robert Pennington construction site												
Photographer	:	Bruce K	irkpatrick		Witness:	none	none						
Photo #	hoto # 11 Of 16 Date: 9/16/09 Time: 1743												
Description:	Description: Portion of construction site with exposed soils which had not been stabilized

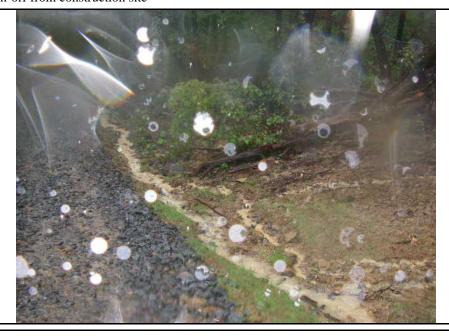
Photo #
 12
 Of
 16
 Date:
 9/16/09
 Time:
 1743

Description: Run-off from construction site

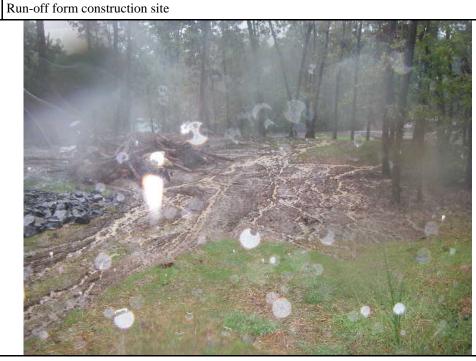
Water Division NPDES Photographic Evidence Sheet												
Location:	Location: Robert Pennington construction site												
Photographer	:	Bruce K	ruce Kirkpatrick Witness: none										
Photo #	Photo # 13 Of 16 Date: 9/16/09 Time: 1743												
Description:	Description: Run-off form construction site

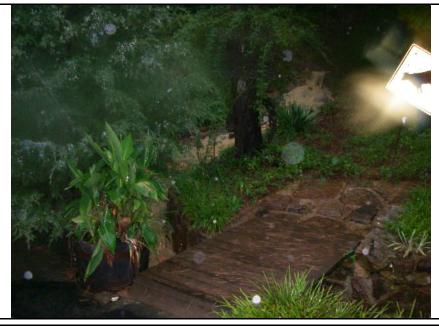
Photo #
 14
 Of
 16
 Date:
 9/16/09
 Time:
 1747

Description: Run-off in complainant's yard

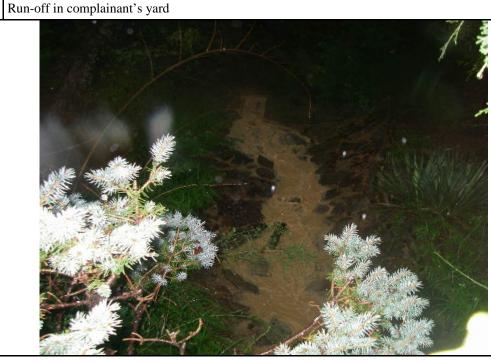
Water Division NPDES Photographic Evidence Sheet												
Location:	and the second s												
Photograph	Photographer: Bruce Kirkpatrick Witness: none												
Photo #													
Description	Description: Run-off in complainant's yard

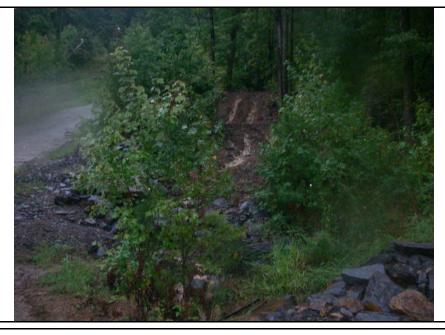
Photo #
 16
 Of
 16
 Date:
 9/16/09
 Time:
 1749

Description: Photo of area of disturbed soils adjacent to Pearce Road where permittee brought equipment to/from construction site
