RE: AHTD Job #BR6401 Calf Creek Bridge, Searcy County

STAA INSPECTION FORM

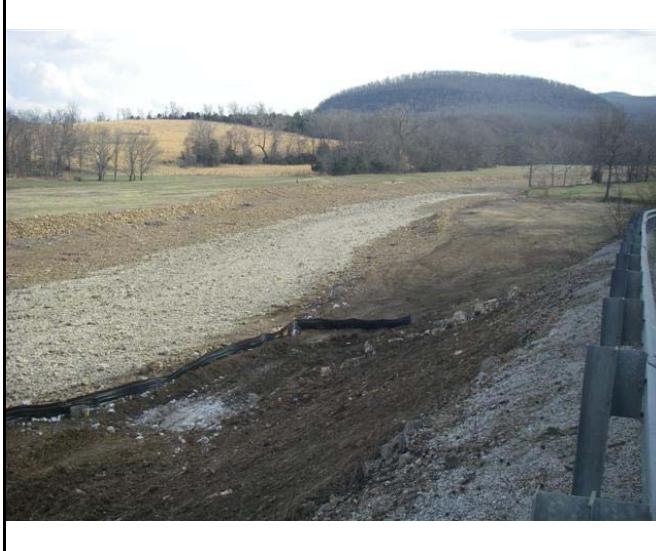
Location:	Calf Creek along Highway 74, Searcy County						
Photographer:	Tony Morris				Witness:		
Photo #	1	Of	2		Date:	03/10/10	Time: 15:41
Description:	Looking up stream on Calf Creek at channelized reach above bridge location.

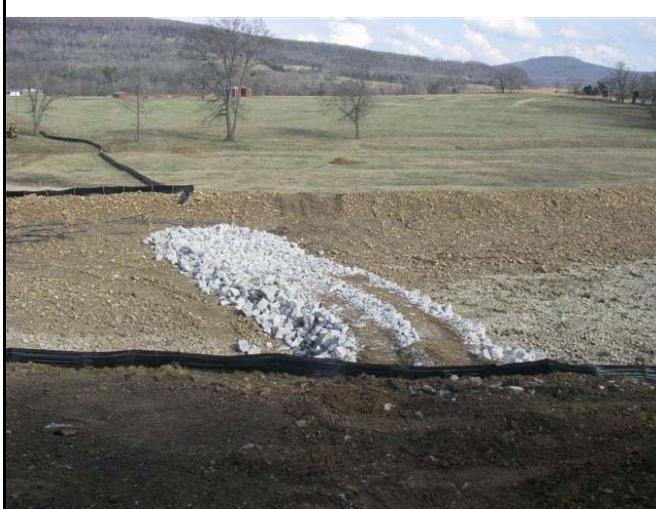
Photographer:	Tony Morris				Witness:		
Photo #	2	Of	2		Date:	03/10/10	Time: 15:41
Description:	A vented ford crossing under construction on Calf Creek.
