ARKANSAS
Department of Environmental Quality

January 17, 2012

AFIN: 26-00980

NPDES Permit No.: ARR152120

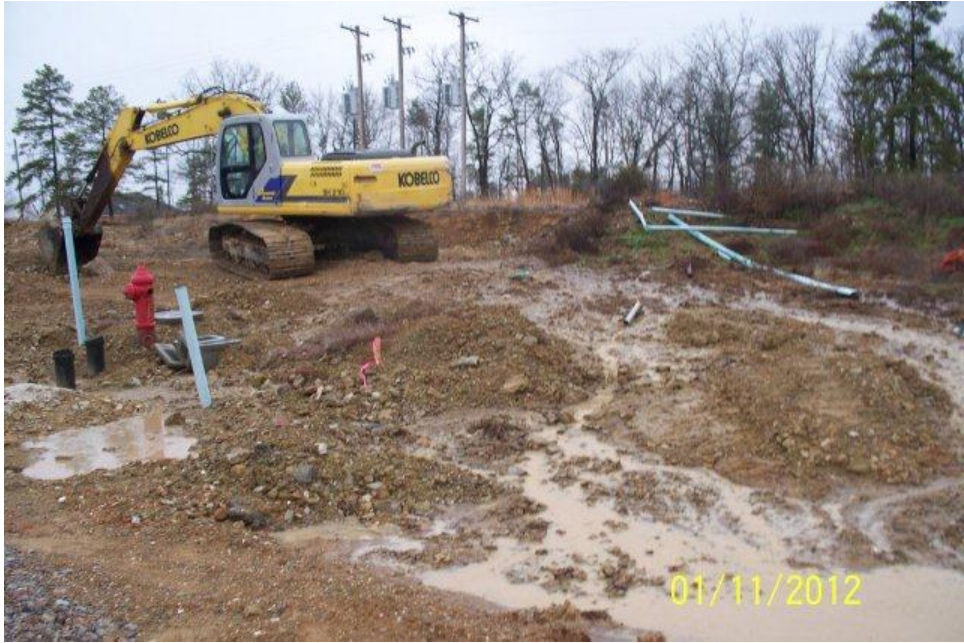
6. Locations on the map where stormwater is discharged off site were not found and / or accurate. Stormwater from a pit dewatering project that was taking place during the inspection was found to be discharging offsite. No controls were located in this area and this discharge location was not indicated on the map.

Sec. II, D, 11 – Locations on the map where stormwater is discharged off site was not found and / or accurate. Stormwater from a pit dewatering project that was taking place during the inspection was found to be discharging offsite. No controls were located in this area and this discharge location was not indicated on the map.

Location:	Hamilton Park Addition						
Photographer:	Tommy Kerr			Witness:	Shan Lynch		
Photo #	1	Of	14	Date:	1-11-2012	Time:	
Description:	Using a trackhoe to dewater a pit with off-site runoff

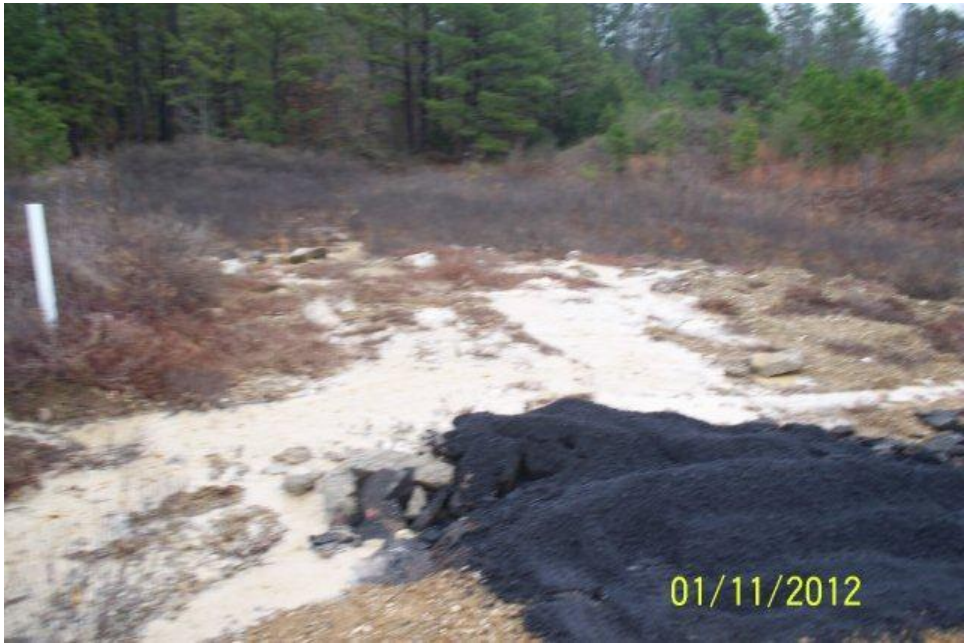
Photographer:	Tommy Kerr			Witness:	None		
Photo #	2	Of	14	Date:	1-11-2012	Time:	
Description:	Runoff of pit dewatering. No controls. Runoff enters pond at treeline.

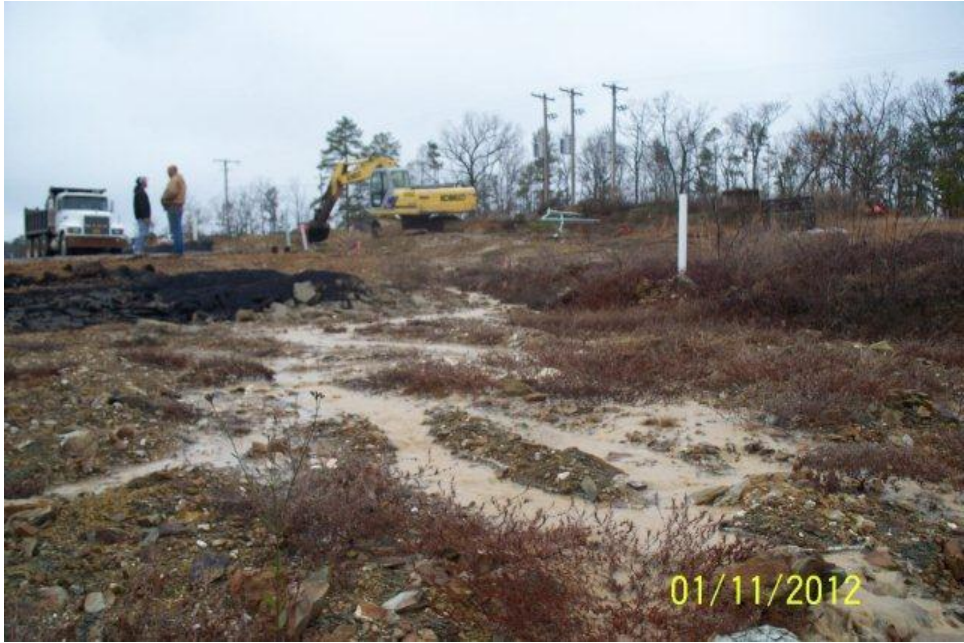
Location:	Hamilton Park Addition						
Photographer:	Tommy Kerr			Witness:	Shan Lynch		
Photo #	3	Of	14	Date:	1-11-2012	Time:	
Description:	Pit dewatering runoff offsite with no controls

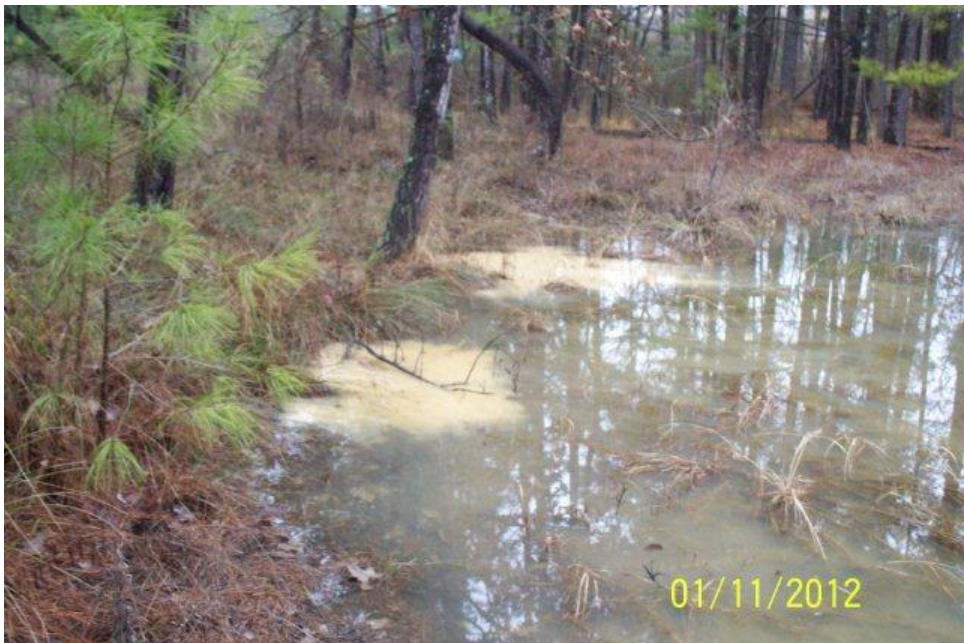
Photographer:	Tommy Kerr			Witness:	Shan Lynch		
Photo #	4	Of	14	Date:	1-11-2012	Time:	
Description:	Pit dewatering water into offsite pond on adjacent property.

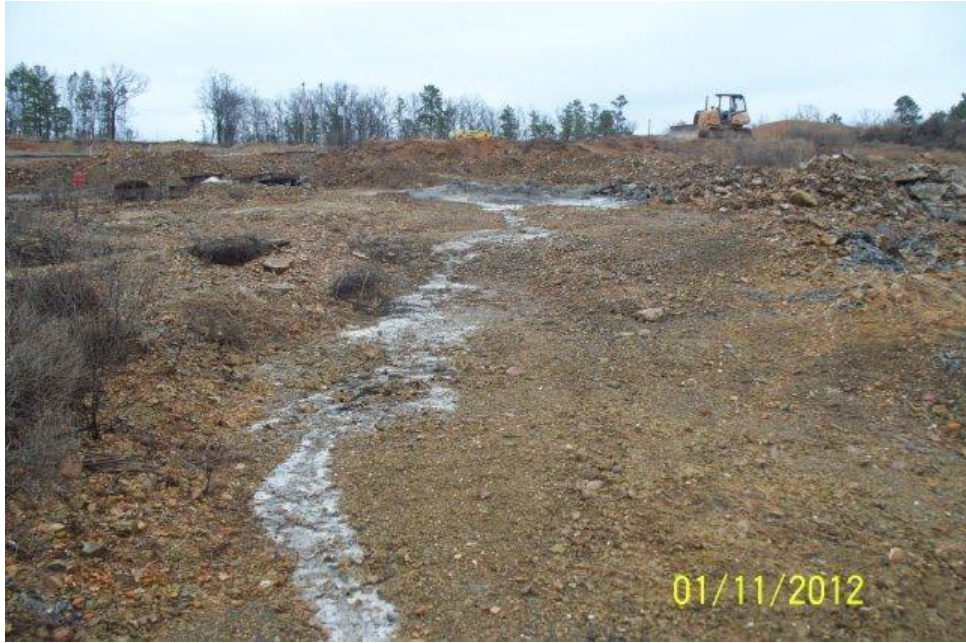
17. Unsatisfactory concrete washout area. Currently concrete is being washed out in an uncontrolled area. NO BMP's are in place to prevent runoff.

Location:	Hamilton Park Addition						
Photographer:	Tommy Kerr			Witness:	Shan Lynch		
Photo #	5	Of	14	Date:	1-11-2012	Time:	
Description:	Uncontrolled concrete washout area. No offsite runoff.

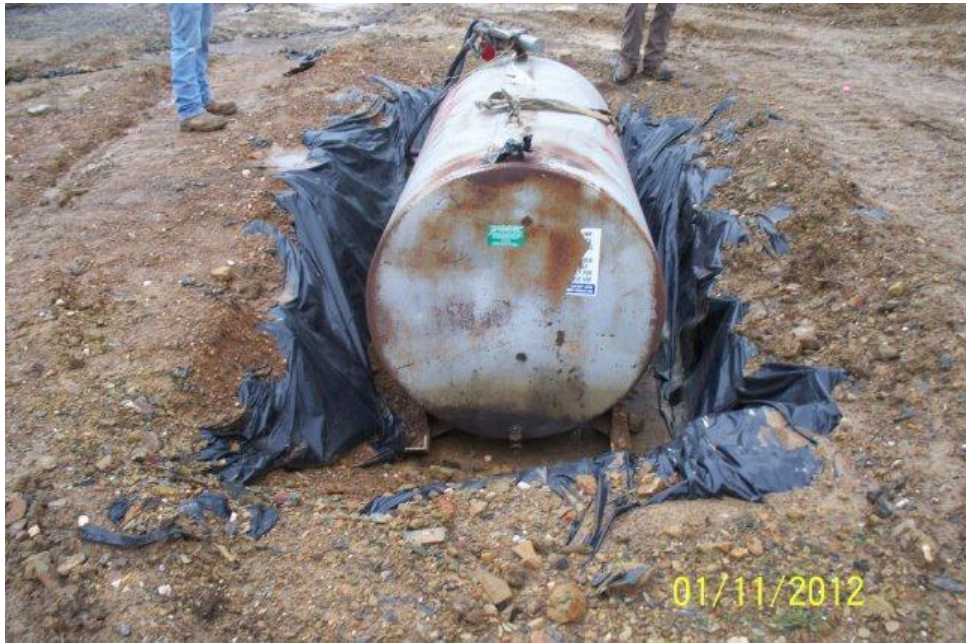
The diesel fuel storage area may be unsuitable for containing any fuel spills. The fuel tank is stored in a pit lined with plastic. The inspection was performed after a rain event that left several large puddles around the site. No stormwater was found to be in the containment area. It is possible that this plastic may be compromised.

Sec. II, G, 7 – The diesel fuel storage area may be unsuitable for containing any fuel spills. The fuel tank is stored in a pit lined with plastic. The inspection was performed after a rain event that left several large puddles around the site. No stormwater was found to be in the containment area. It is possible that this plastic may be compromised.

Photographer:	Tommy Kerr			Witness:	Shan Lynch		
Photo #	6	Of	14	Date:	1-11-2012	Time:	
Description:	Diesel fuel storage system

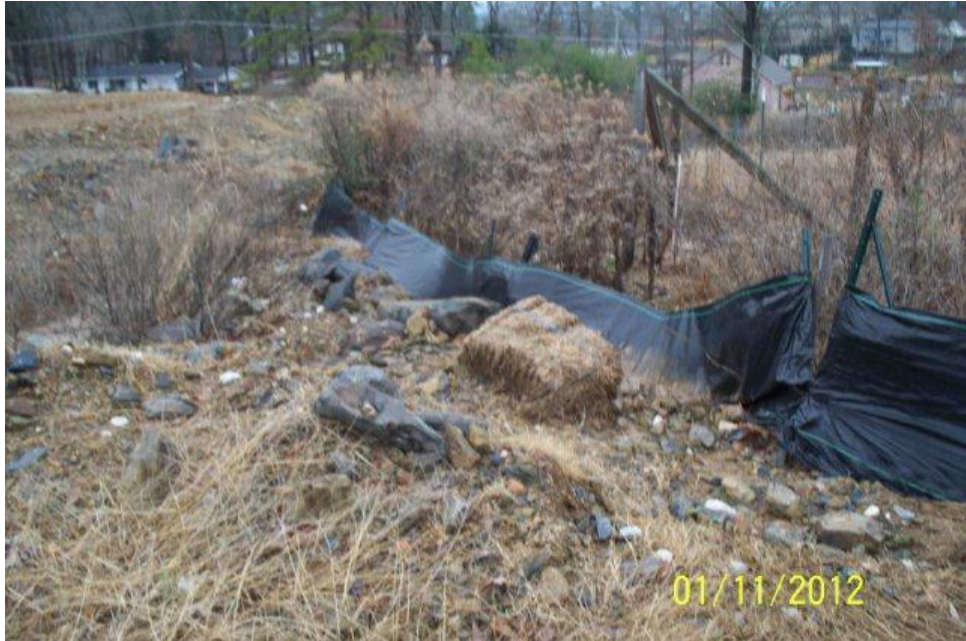
Sec. II, E, 2 – Maintenance was found to be needed to the silt fencing in some areas. Some fencing was down and undercutting was noted in some places.

Location:	Hamilton Park Addition						
Photographer:	Tommy Kerr			Witness:	Shan Lynch		
Photo #	7	Of	14	Date:	1-11-2012	Time:	
Description:	Silt fence conditions

7. Site map has been updated showing current BMPs.
8. All silt fences that were inadequate have been corrected and all silt fences have been maintained to meet ADEQ requirement.

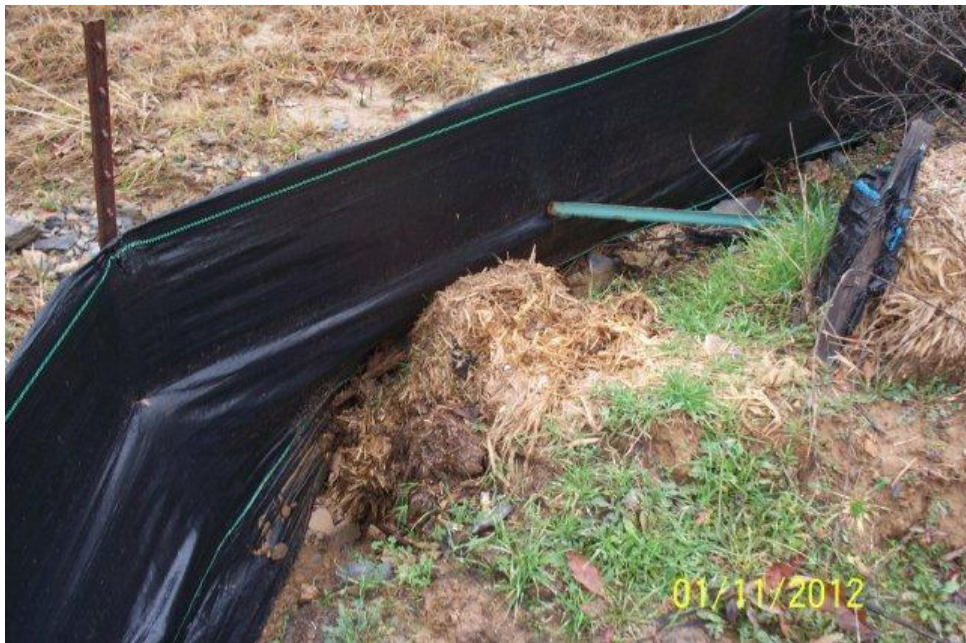
Photographer:	Tommy Kerr			Witness:	Shan Lynch		
Photo #	8	Of	14	Date:	1-11-2012	Time:	
Description:	Silt fence conditions; note undercutting

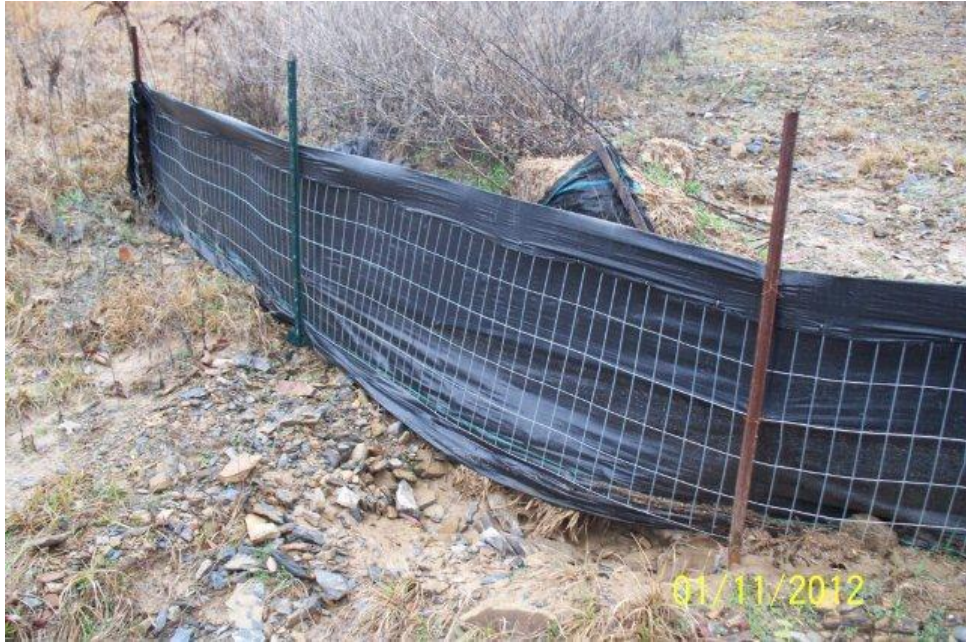
However, during this inspection, maintenance was indeed noted to be required. For instance, the inspection report stated that all silt fences were buried, however, several areas of unburied silt fence were found.

Location:	Hamilton Park Addition						
Photographer:	Tommy Kerr			Witness:	Shan Lynch		
Photo #	9	Of	14	Date:	1-11-2012	Time:	
Description:	Silt fence conditions; note undercutting and unburied

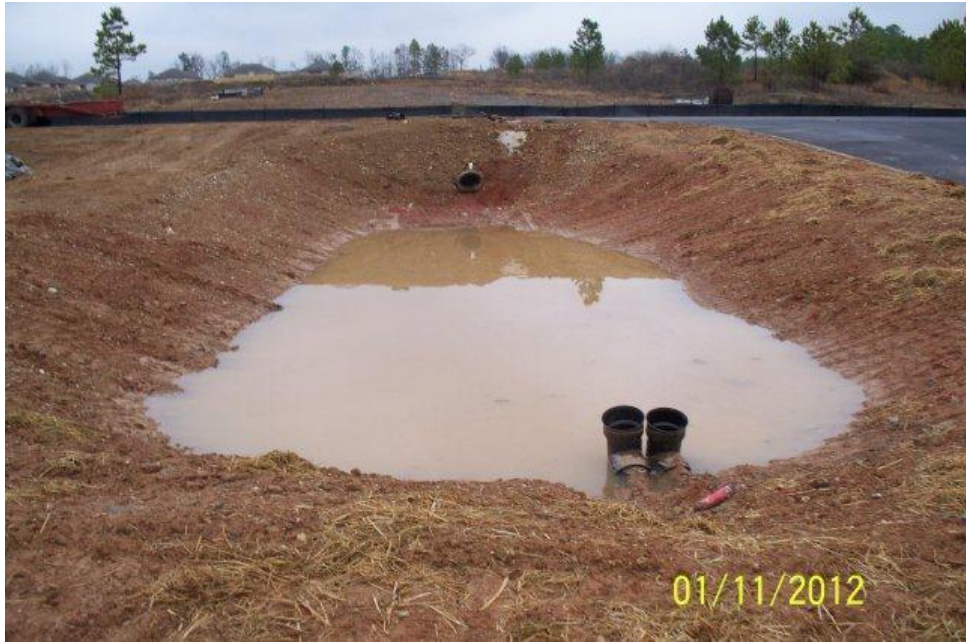
8. Maintenance was found to be needed to the silt fencing in some areas. Some fencing was down and undercutting was noted in some places.
9. The sediment pond for Phase II appears to be incorrectly utilized. The storm water drainage system has been piped so that this pond only receives runoff from the stormwater inlets located along the paved streets. Although this pond will provide some benefit by reducing the amount of sediment that leaves the site, it can only remove sediment that may enter the curbside storm drains.

Photographer:	Tommy Kerr			Witness:	Shan Lynch		
Photo #	10	Of	14	Date:	1-11-2012	Time:	
Description:	Phase II sediment pond. Upper pipe connected to storm drain inlets. No other runoff to pond. Two lower pipes discharge to street side ditch, then to Lake Hamilton

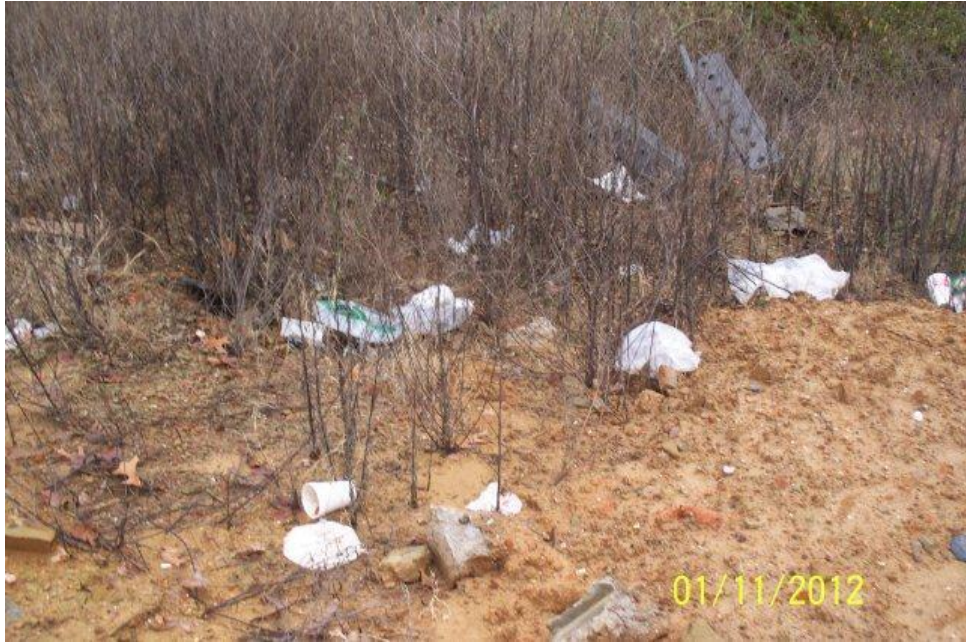
Sec. II, G, 1 – A high amount of solid waste was found to be scattered around the few construction sites on Phase I and also in a few locations of Phase II.

Location:	Hamilton Park Addition						
Photographer:	Tommy Kerr			Witness:	Shan Lynch		
Photo #	11	Of	14	Date:	1-11-2012	Time:	
Description:	Solid waste on site.

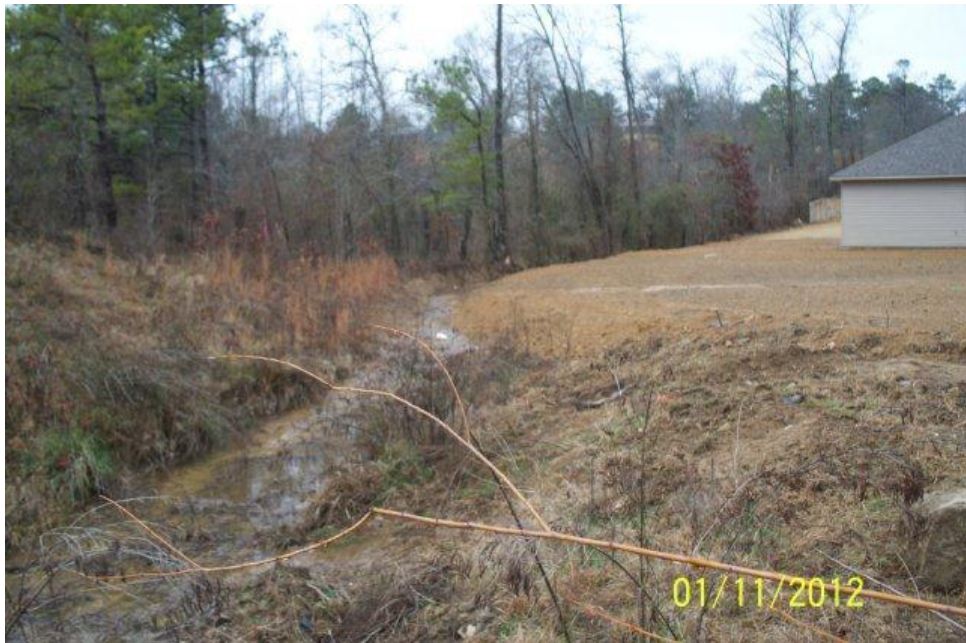
15. A high amount of solid waste was found to be scattered around the few construction sites on Phase I and also in a few locations of Phase II.
16. Sediment from one particular lot in the south west corner of Phase I is entering a tributary of Lake Hamilton. This is due to dirt work being done to the edge of this tributary. This was evidenced by the turbidity in this creek. Also, during the inspection, a pit was being dewatered with the use of a trackhoe. This runoff was flowing offsite and into a neighboring pond. No stormwater controls were located in this area.

Photographer:	Tommy Kerr			Witness:	Shan Lynch		
Photo #	12	Of	14	Date:	1-11-2012	Time:	
Description:	Unstabilized lot with direct runoff into small tributary. Notice turbid conditions of creek. This enters Lake Hamilton

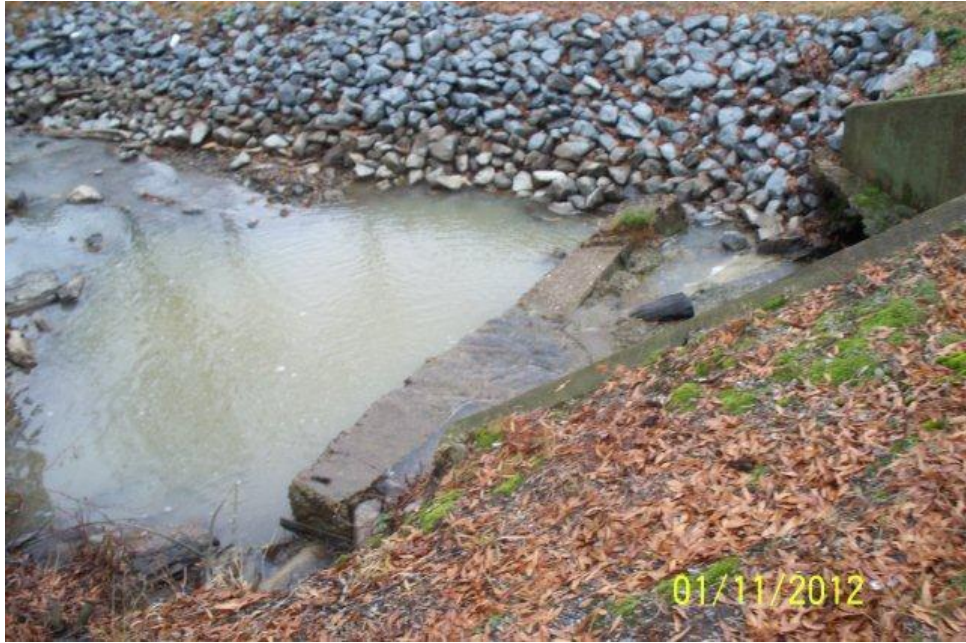
Location:	Hamilton Park Addition						
Photographer:	Tommy Kerr			Witness:	Shan Lynch		
Photo #	13	Of	14	Date:	1-11-2012	Time:	
Description:	Where tributary from subdivision enters Lake Hamilton. Slight turbidity.

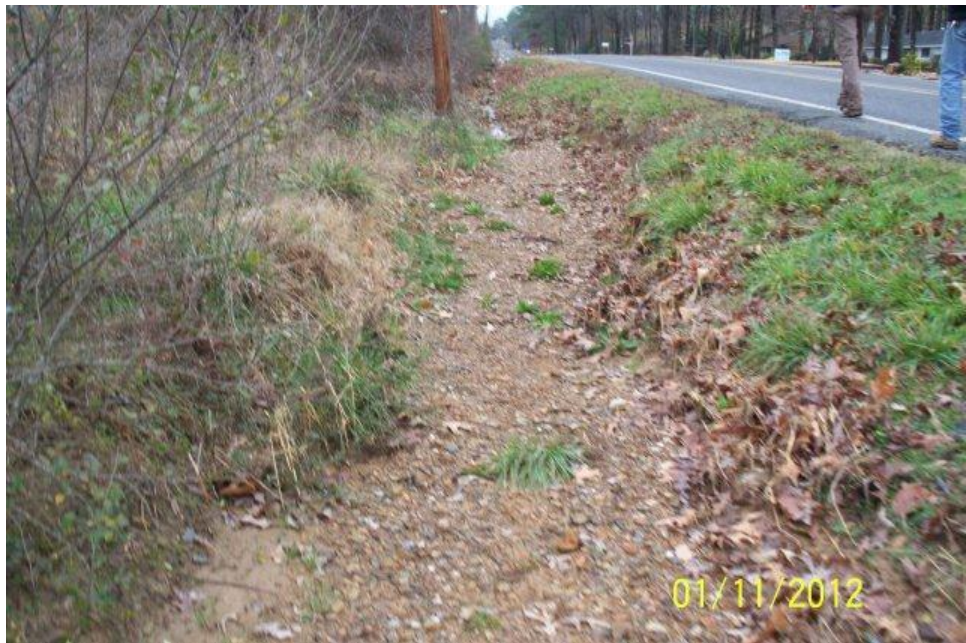
Sec. II, E, 5 & Sec. II, G, 4 – Sediment and mostly fine shale particles has gotten off site and were found in the roadside ditch on the south side of the project, just above an inlet to Lake Hamilton. This material has not been removed as required.

Photographer:	Tommy Kerr			Witness:	Shan Lynch		
Photo #	14	Of	14	Date:	1-11-2012	Time:	
Description:	Sediment and fine shale in roadside ditch from construction project.

10. The sediment and other fine shale particles has been removed that was found in road side ditch.
11. Old forms have been replaced with new forms that show when maintenance occurs and when maintenance ceases.
