Mr. Mike Sigman  
L&W Environmental, LLC  
Pulaski County Recycling and Disposal Facility  
9611 Ironton Road  
Little Rock, AR 72206

NPDES Permit No.: ARR000462

On August 24, 2012, Dennis Benson, Inspector, ADEQ Water Division and I performed a reconnaissance level industrial stormwater investigation of the waste treatment facility at the request of Lori Burke, Inspector, ADEQ Solid Waste Division. The inspection was conducted in accordance with the provisions of the Federal Clean Water Act, the Arkansas Water and Air Pollution Control Act, and the regulations promulgated thereunder. The following violations were revealed at the time of inspection:

## NPDES Compliance Inspection Report

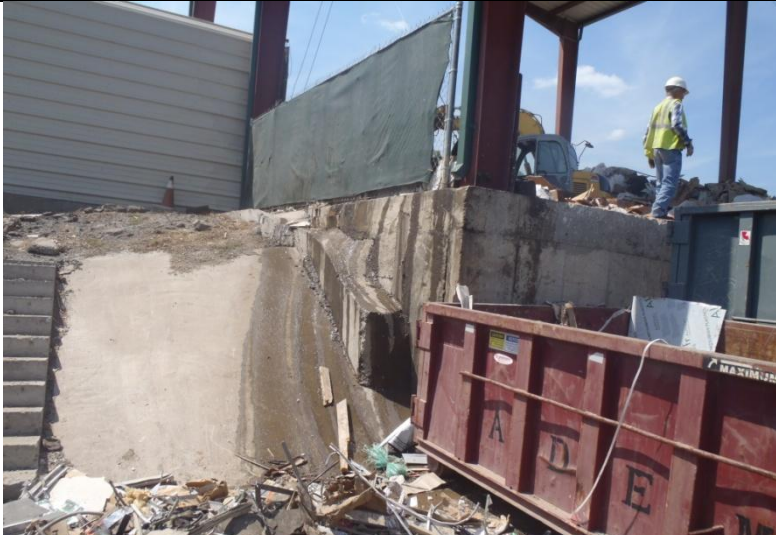
| Water Division NPDES Photographic Evidence Sheet | | | | | | | |
|---|---|---|---|---|---|---|---|
| <b>Description:</b> | Water being utilized to facilitate the processing of materials being handled at the recycling facility; contacting the materials; bypassing the on-site collection system, and subsequently flowing into a drainage course which discharges into a stormwater pond. | | | | | | |

**Response:** The practice has been modified to prevent flow of the process water back to the stormwater pond. A temporary sump has been excavated and the water is collected and treated properly. It should be noted that L&W is in the process of redesigning the process area for the wood. This will involve moving the grinder further north away from the pond. This should mitigate or lessen the issues of wood ejected from the grinder entering the pond.

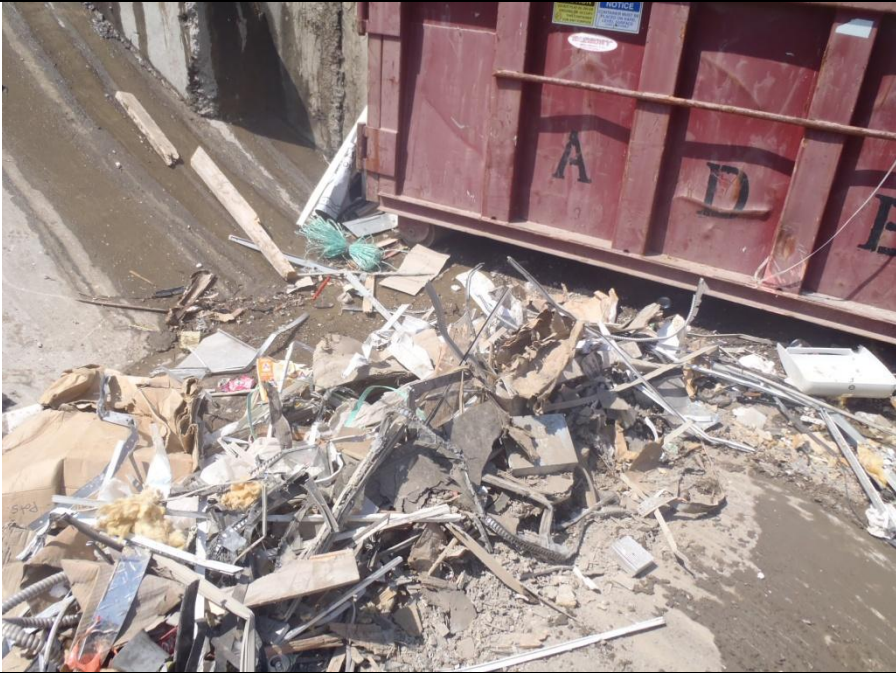
| Water Division NPDES Photographic Evidence Sheet | | | | | | | |
|---|---|---|---|---|---|---|---|
| <b>Description:</b> | Water being utilized to facilitate the processing of materials being handled at the recycling facility; contacting the materials; bypassing the on-site collection system, and subsequently flowing into a drainage course which discharges into a stormwater pond. | | | | | | |

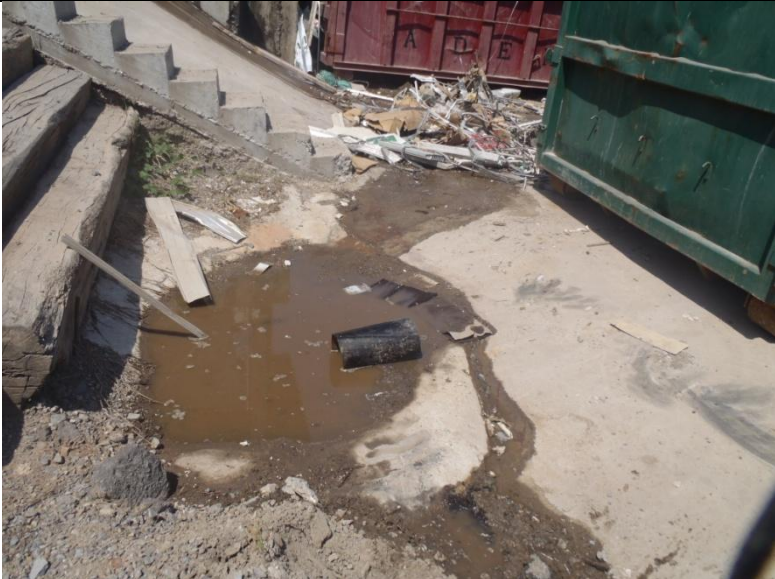
| Water Division NPDES Photographic Evidence Sheet | | | | | | | | | |
|---|---|---|---|--|---|---|---|---|--|
| <b>Description:</b> | | Water being utilized to facilitate the processing of materials being handled at the recycling facility; contacting the materials; bypassing the on-site collection system, and subsequently flowing into a drainage course which discharges into a stormwater pond. | | | | | | | |

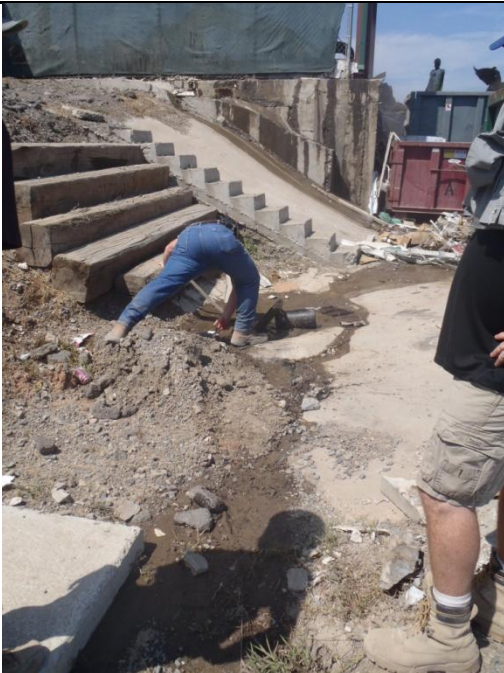
| Water Division NPDES Photographic Evidence Sheet | | | | | | | | | |
|---|---|---|---|--|---|---|---|---|--|
| <b>Description:</b> | | Water being utilized to facilitate the processing of materials being handled at the recycling facility; contacting the materials; bypassing the on-site collection system, and subsequently flowing into a drainage course which discharges into a stormwater pond. On-site personnel opened the drain to the collection system during the ADEQ inspection. | | | | | | | |

- ADEQ Response: Please specify the methods used for collection (i.e. location of the sump in relation to the on-site collection system identified in Photo 4 of 16, NPDES Report Page 6, Water Division inspection report dated August 30, 2012); and the methods used for treatment and disposal of the process water utilized to facilitate the processing of materials at the site. Additionally, it is noted in the response that a 'temporary collection sump' has been excavated. Please identify the permanent method which

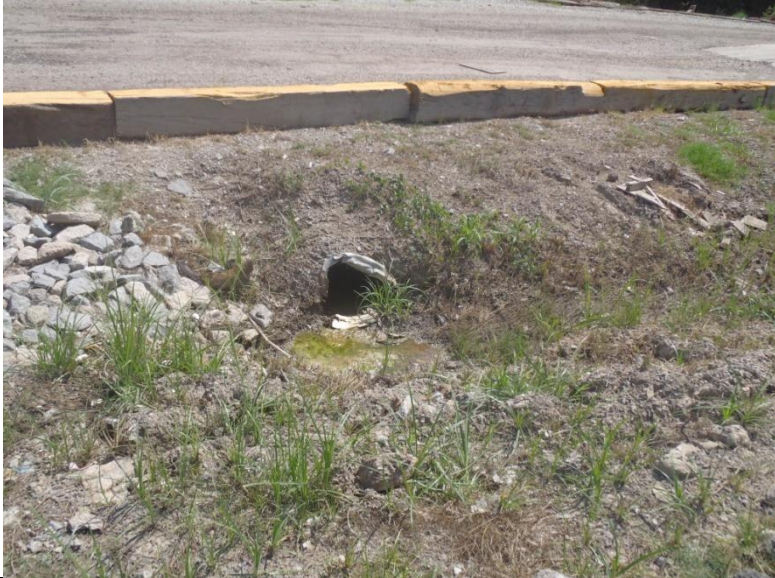
| Water Division NPDES Photographic Evidence Sheet | | | | | | | | | |
|---|---|---|---|--|---|---|---|---|--|
| <b>Description:</b> | | Receiving ditch for water being utilized to facilitate the processing of materials being handled at the recycling facility; this ditch conveys flow into a stormwater pond. | | | | | | | |

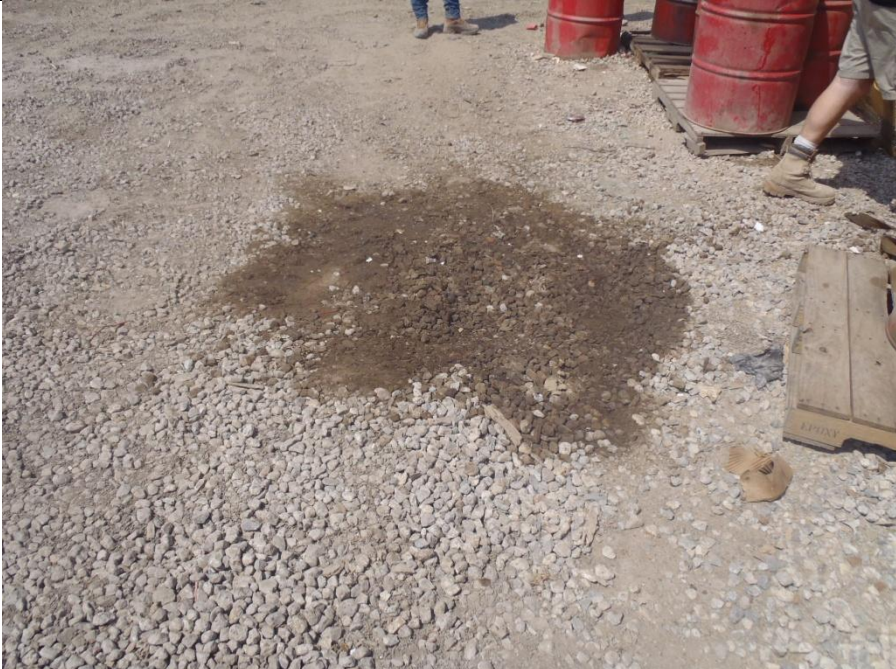
| Water Division NPDES Photographic Evidence Sheet | | | | | | | | | |
|---|---|---|---|--|---|---|---|---|--|
| <b>Description:</b> | | Evidence of a hydrocarbon spill. | | | | | | | |

**Response:** This area has been cleaned and the hydrocarbon contaminated material removed and dispose of properly.

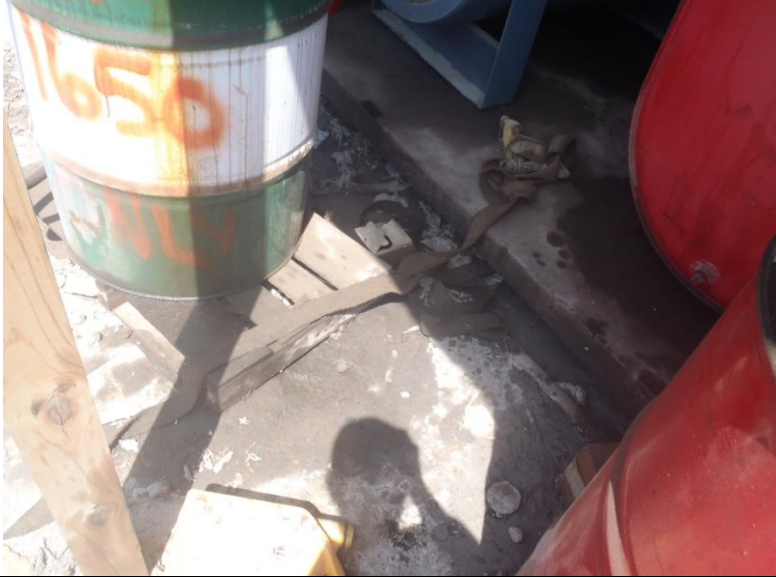
| Water Division NPDES Photographic Evidence Sheet | | | | | | | | | |
|---|---|---|---|--|---|---|---|---|--|
| <b>Description:</b> | | Evidence of a hydrocarbon spill. | | | | | | | |

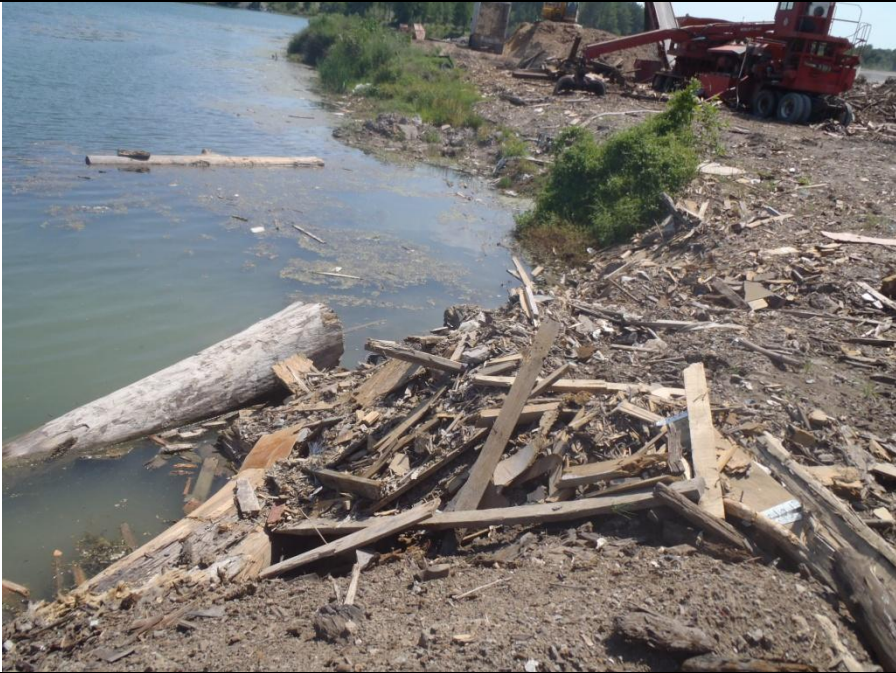
| Water Division NPDES Photographic Evidence Sheet | | | | | | | | | |
|---|---|---|---|--|---|---|---|---|--|
| <b>Description:</b> | | Construction and demolition material including ground wood material and processed wood material being utilized for fill along and within the western perimeter of a stormwater pond. Material observed floating in the stormwater pond. | | | | | | | |

**Response:** The placement of any wood along or in the pond has immediately ceased. This was the result of placing unclean fill be used in a low lying area adjacent to the pond. The placement of concrete along the perimeter of the pond is continuing. The concrete provides a direct benefit to L&W. The majority of the site includes a mine pit that is currently full of water. The north and west perimeters of the mine pit are shallow. By filling in these areas L&W can increase the area of land available for daily operation. In addition, the placement of concrete in typically low pH water provides additional buffering and improvement in the water quality. L&W inspects and screens each load to minimize detrimental materials. Additional screening is performed after placement. Any material that is not inert is removed.

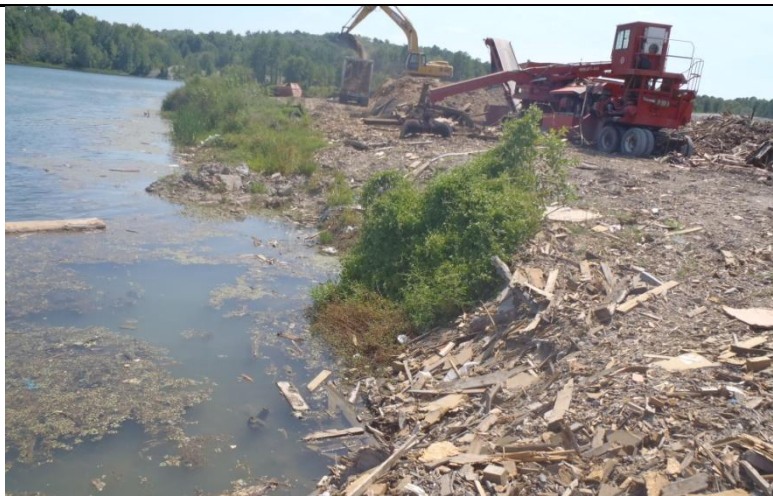
| <b>Photo #</b> | 9 | <b>Of</b> | 16 | <b>Date:</b> | 8/23/12 | <b>Time:</b> | 2:15 pm |

Construction and demolition material including ground wood material and processed wood material being utilized for fill along and within the western perimeter of a stormwater pond. Material observed floating in the stormwater pond.

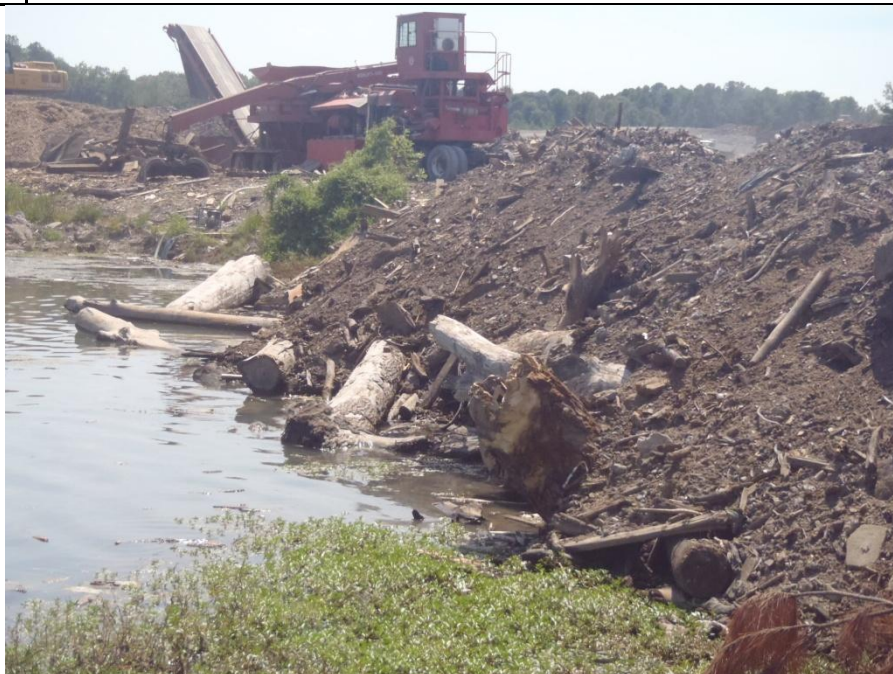
| <b>Photo #</b> | 10 | <b>Of</b> | 16 | <b>Date:</b> | 8/23/12 | <b>Time:</b> | 2:13 pm |

Construction and demolition material including ground wood material and processed wood material being utilized for fill along and within the western perimeter of a stormwater pond. Material observed floating in the stormwater pond.

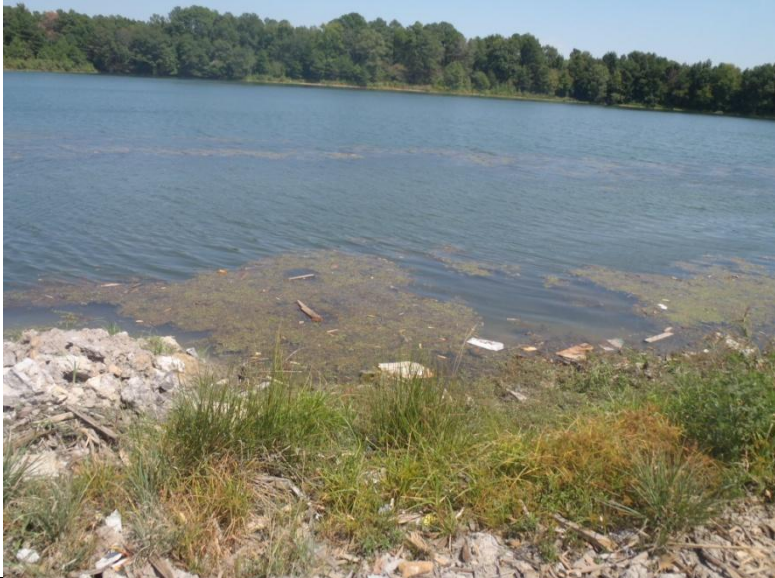
| Water Division NPDES Photographic Evidence Sheet | | | | | | | | |
|---|---|---|---|--|---|---|---|---|
| <b>Description:</b> | Construction and demolition material including ground wood material and processed wood material being utilized for fill along and within the western perimeter of a stormwater pond. | | | | | | | |

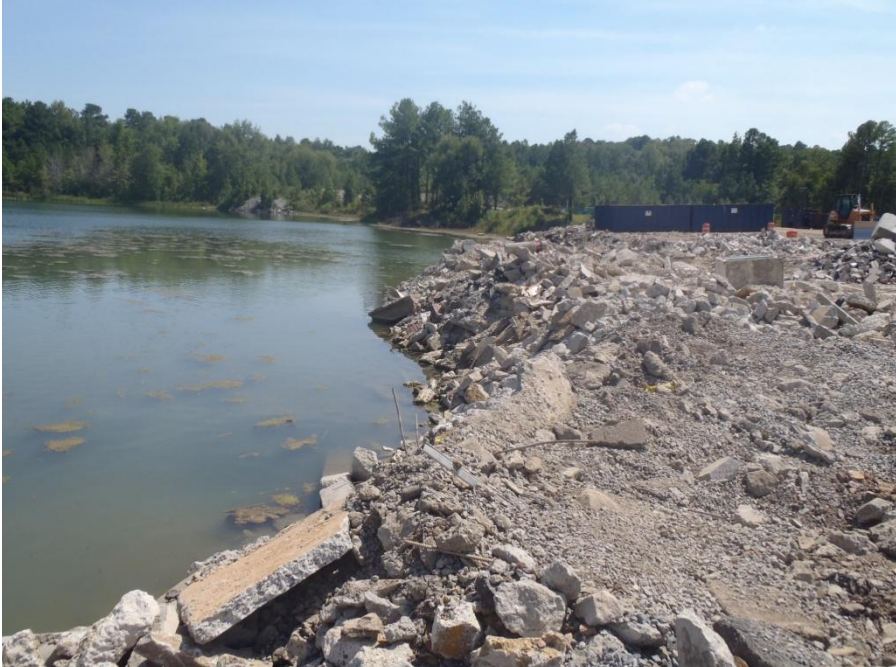
| Water Division NPDES Photographic Evidence Sheet | | | | | | | | |
|---|---|---|---|--|---|---|---|---|
| <b>Description:</b> | Construction and demolition material including ground wood material and processed wood material being utilized for fill along and within the western perimeter of a stormwater pond. | | | | | | | |

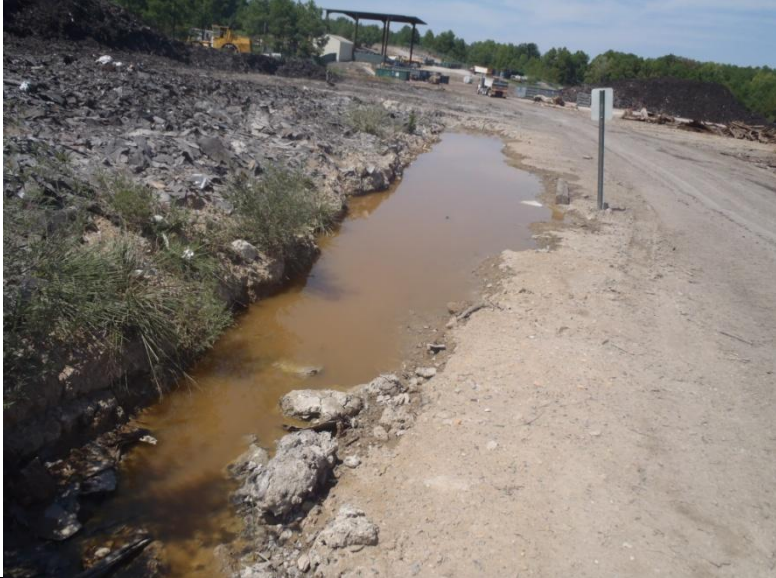
| Water Division NPDES Photographic Evidence Sheet | | | | | | | | | |
|---|---|---|---|--|---|---|---|---|--|
| <b>Photo #</b> | 13 | <b>Of</b> | 16 | | <b>Date:</b> | 8/23/12 | <b>Time:</b> | 2:20 pm | |

| Water Division NPDES Photographic Evidence Sheet | | | | | | | | | |
|---|---|---|---|--|---|---|---|---|--|
| <b>Description:</b> | | Leachate from shingles pile located in a ditch which ultimately conveys flow to a stormwater pond. | | | | | | | |

As requested in the Inspection Letter, a report will be submitted upon completion of the removal of shingle from the Class 4 area. If you have any questions or concerns please contact me at (501) 276-5625.

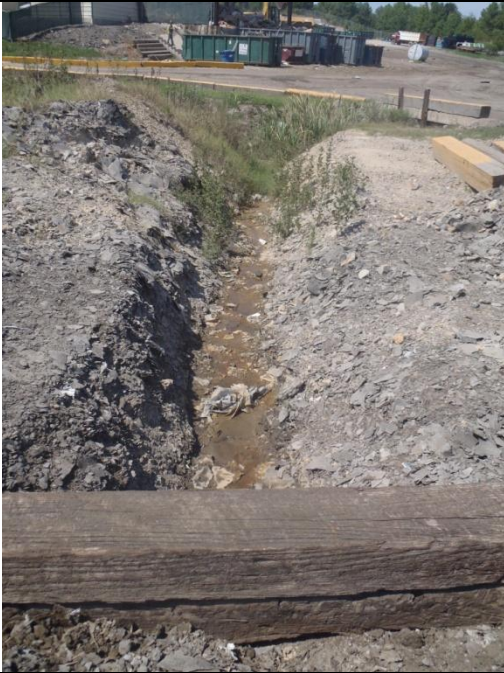
| Water Division NPDES Photographic Evidence Sheet | | | | | | | | | |
|---|---|---|---|--|---|---|---|---|--|
| <b>Photo #</b> | 14 | <b>Of</b> | 16 | | <b>Date:</b> | 8/23/12 | <b>Time:</b> | 2:36 pm | |

| Water Division NPDES Photographic Evidence Sheet | | | | | | | | | |
|---|---|---|---|--|---|---|---|---|--|
| <b>Description:</b> | | Leachate from shingles pile located in a ditch which ultimately conveys flow to a stormwater pond. | | | | | | | |

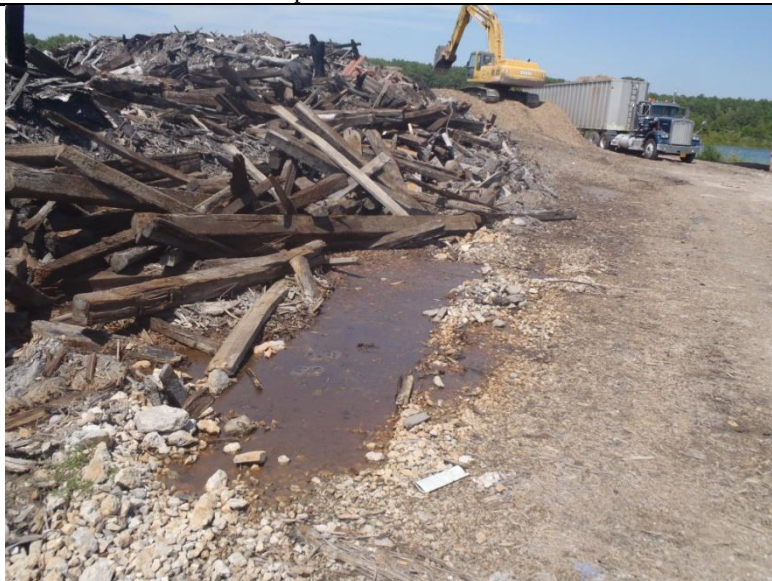
| <b>Description:</b> | Leachate generated from railroad tie pile; located upslope of a stormwater pond. Neither a leachate collection system nor Best Management Practices (BMP's) were being utilized at the time of inspection which would properly dispose of and prevent the flow of leachate from these materials into the stormwater pond. | | | | | | |

**Response:** Since the time of the inspection L&W has put full effort in removing all wood and waste from this area. As stated above L&W is in the process of redesigning the wood processing area. Upon final removal of the wood from the present soil will be placed to provide proper drainage and preventing any ponding. This should be completed no later than September 30, 2012

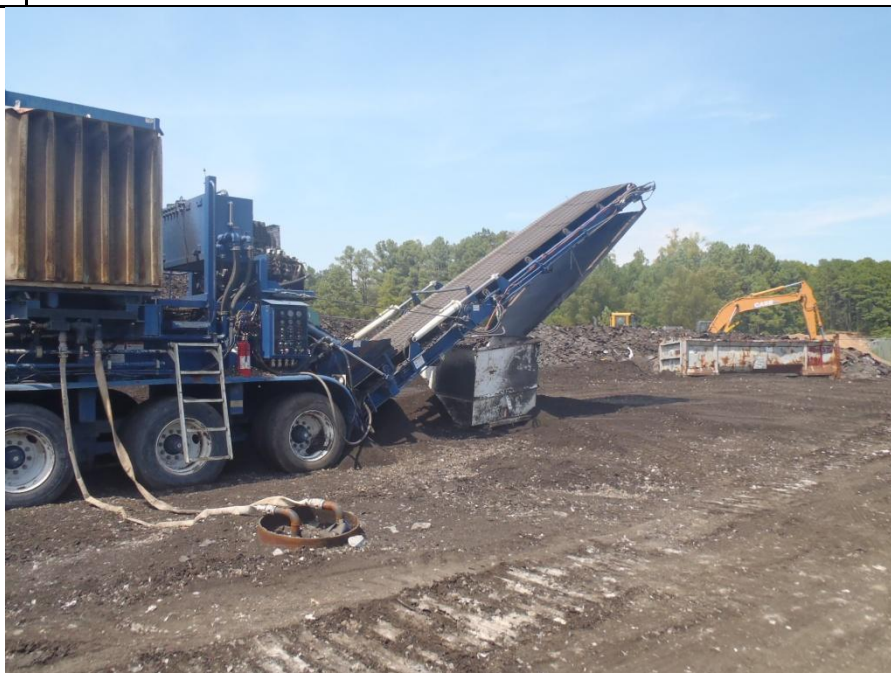
| <b>Photo #</b> | 16 | <b>Of</b> | 16 | | <b>Date:</b> | 8/23/12 | <b>Time:</b> 2:05 pm |

| <b>Description:</b> | Hoses utilized to extract water from a stormwater pond and discharge into material processing machinery. | | | | | | |

**Response:** Process water is used in the grinding process as a means of dust suppression and fire control. The majority of the water is soaked into or combines with the material. Previously, any remaining flow was allowed to reenter the stormwater pond. This practice has ceased and a temporary collection sump has been constructed to collect this water. Upon collection is properly treated and disposed.
